# Hurricane Irma Impact on South Florida Water Management System and Storm Surge

*Wossenu Abtew*

GEER 2019

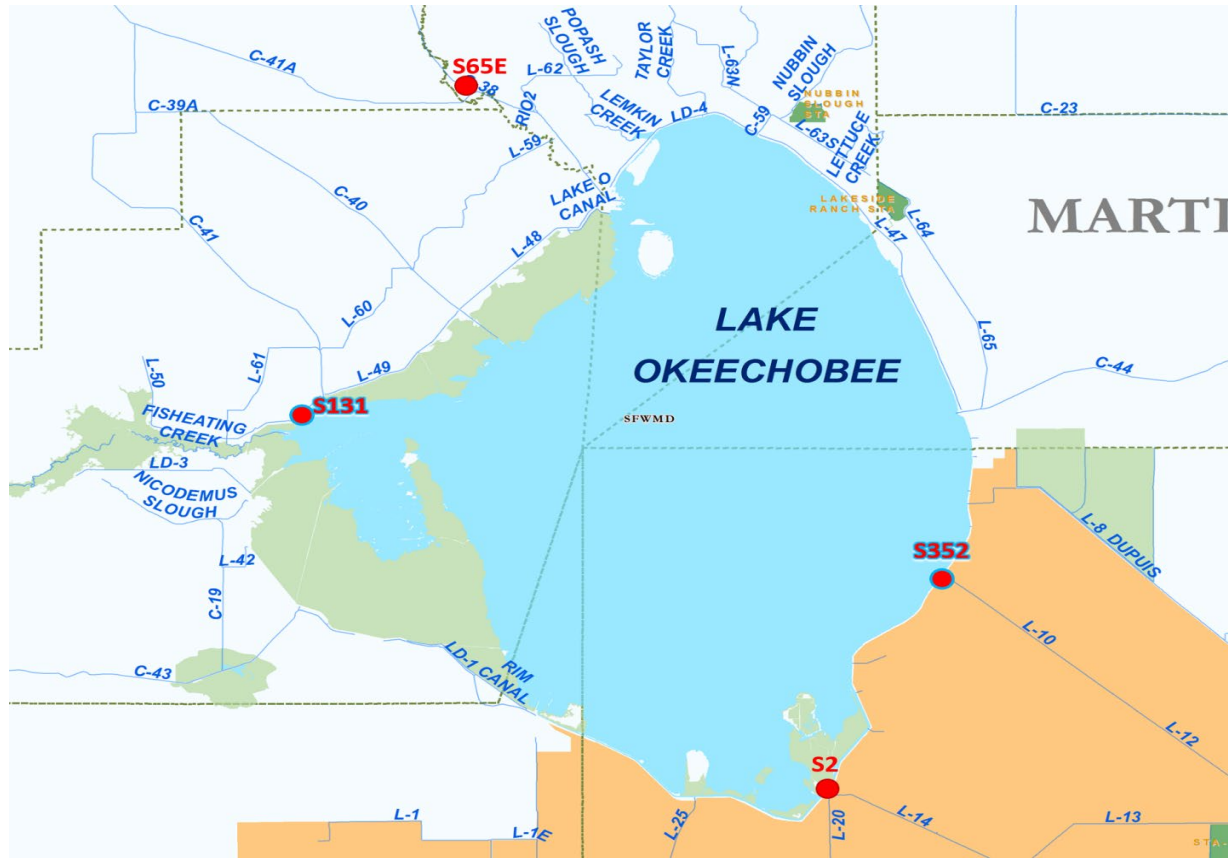
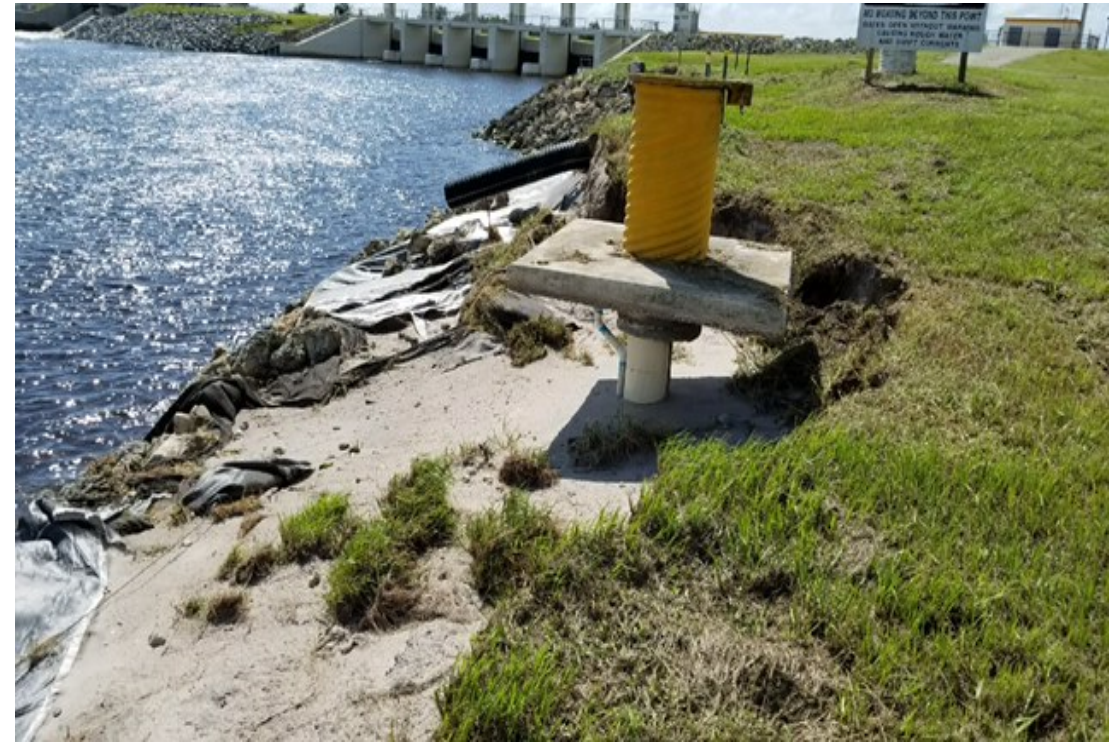
# Erosion Damage from Hurricane Irma on S-65E tailwater

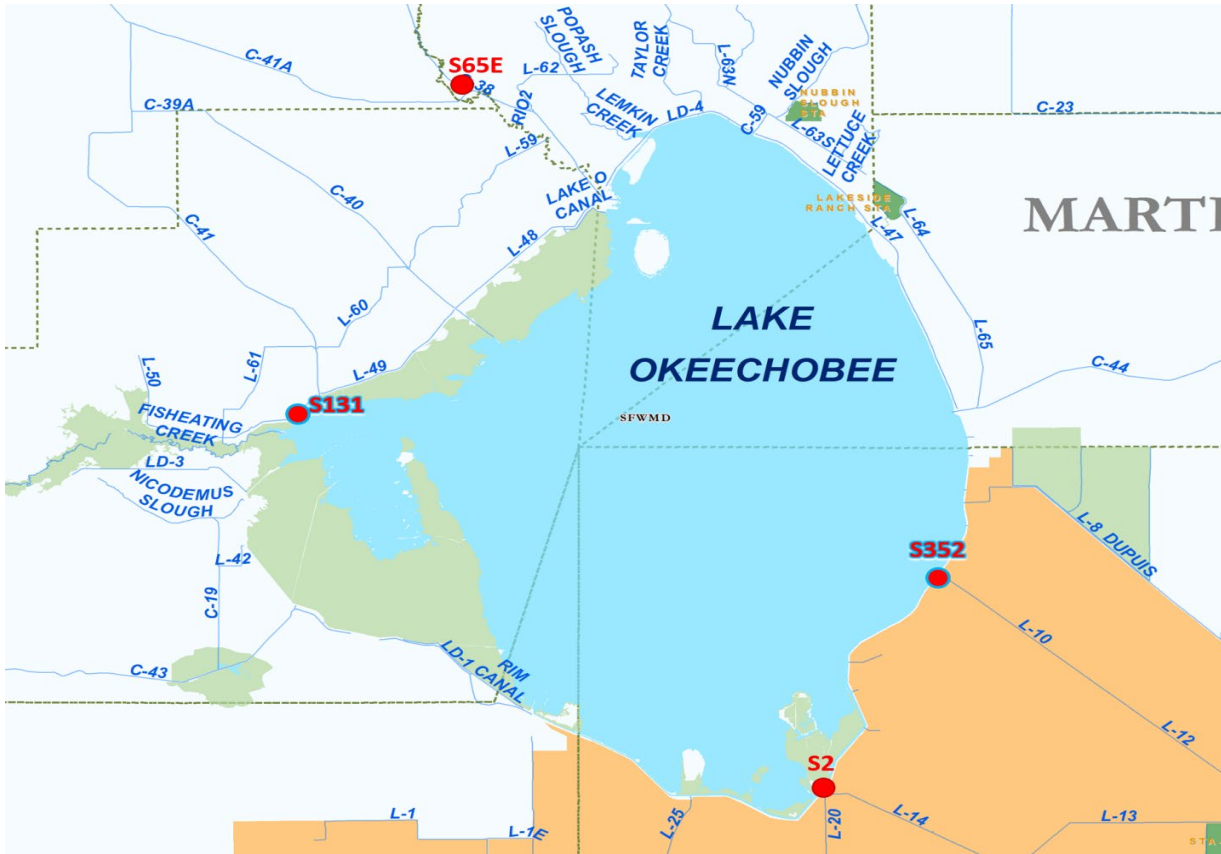
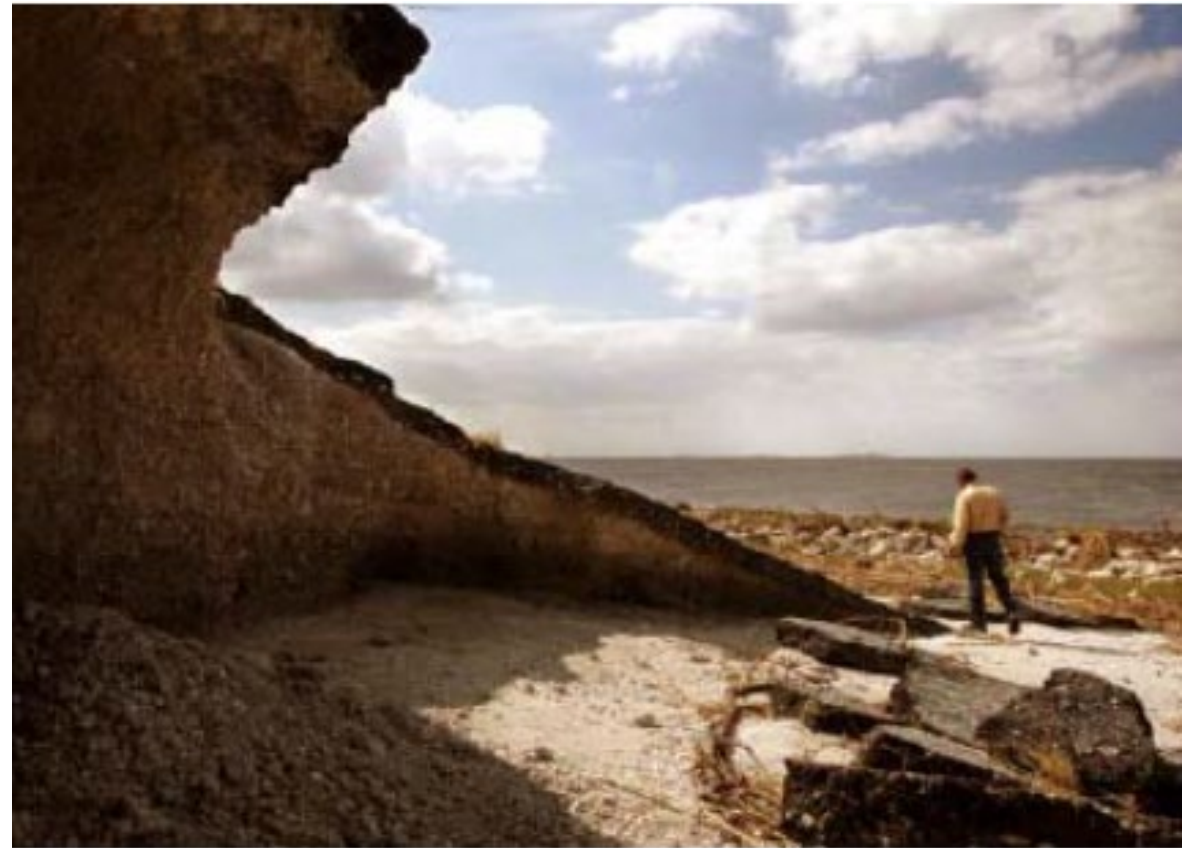
# Lake Okeechobee Damage from Hurricane Wilma

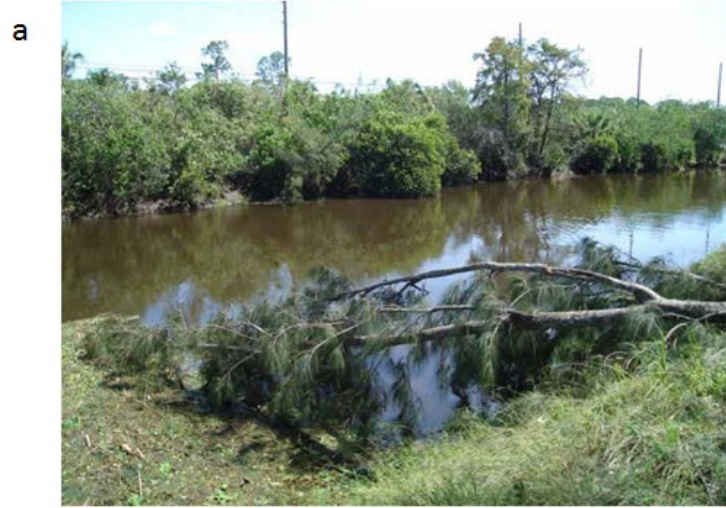
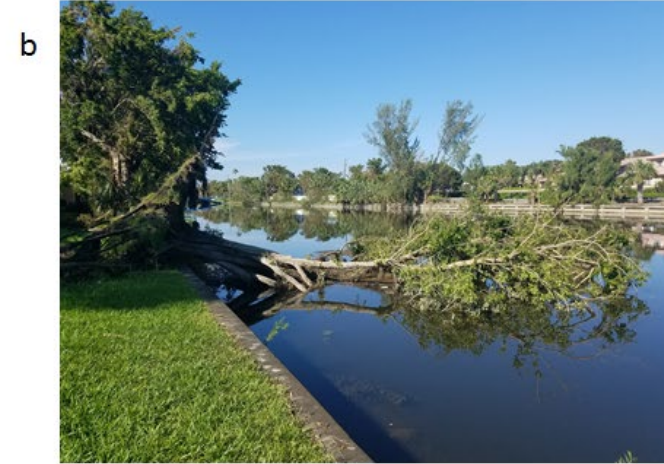
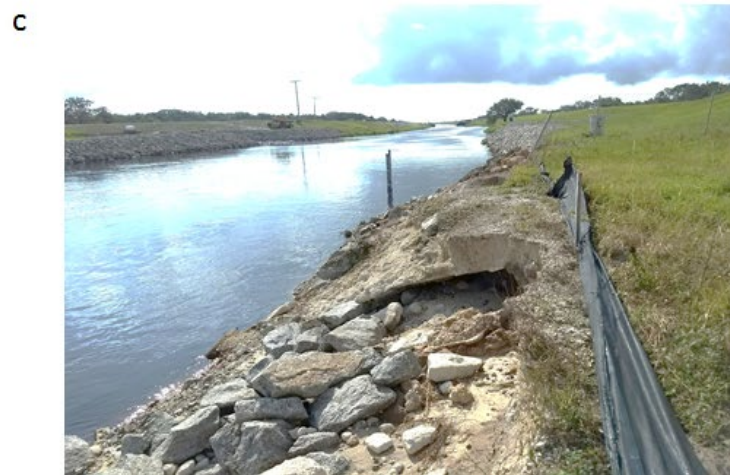
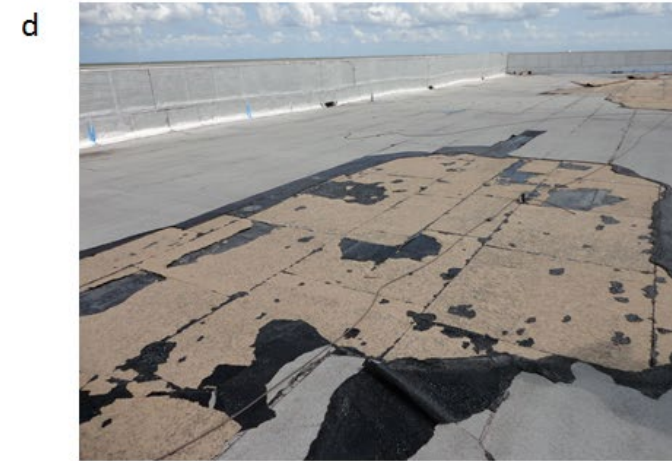
# Hurricane Irma Impact a) Fallen tree in C-51 Canal b) Fallen Tree in C-13 Canal c) S-72 Canal Bank Damage and d) G-310 Pump Station Roof

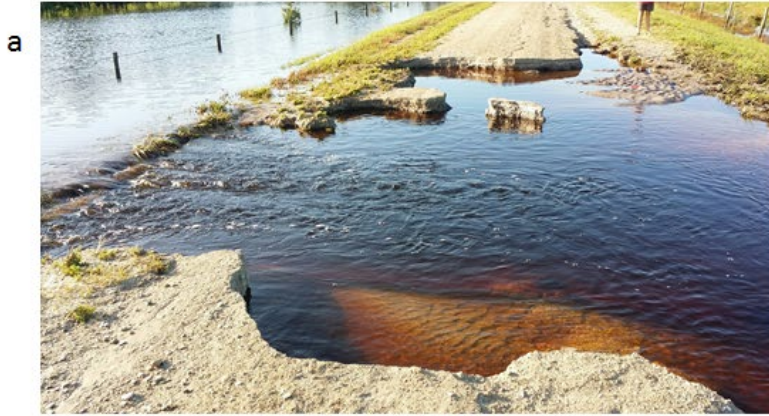
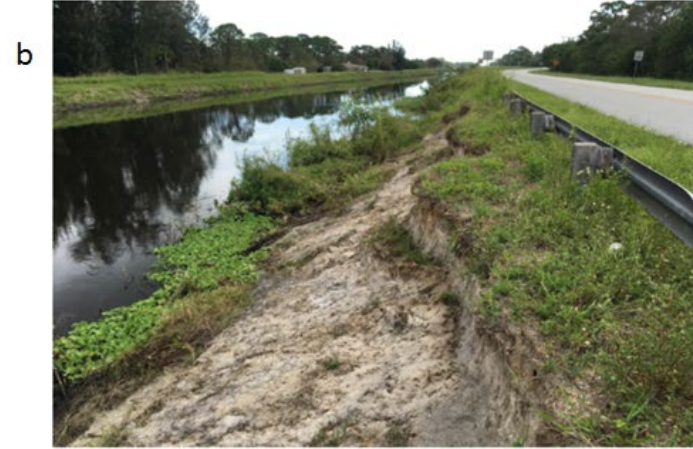
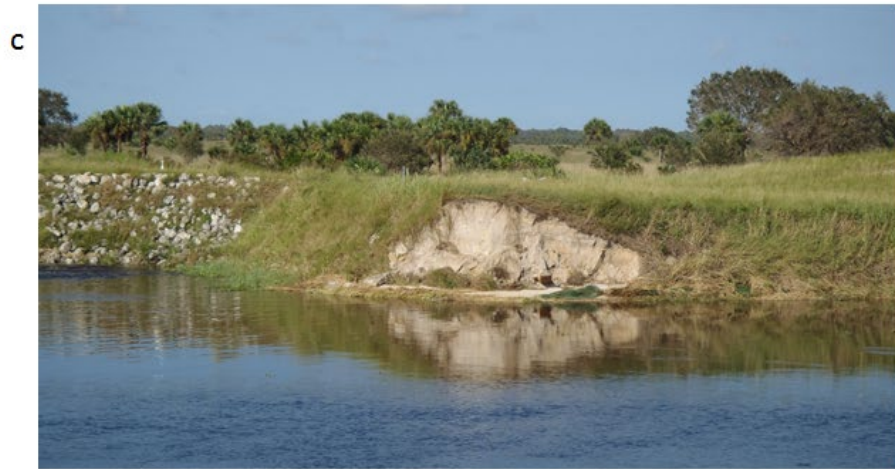
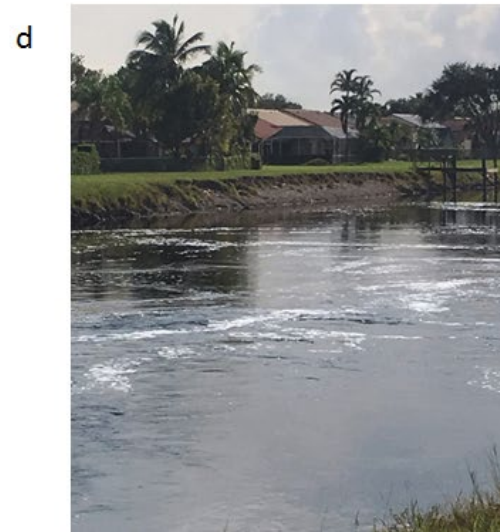
# Hurricane Irma Impact a) S-65A Access Road Flooding and Washout b) C-25 Bank Erosion c) C-41 Bank Erosion and d) C-14 Bank Erosion

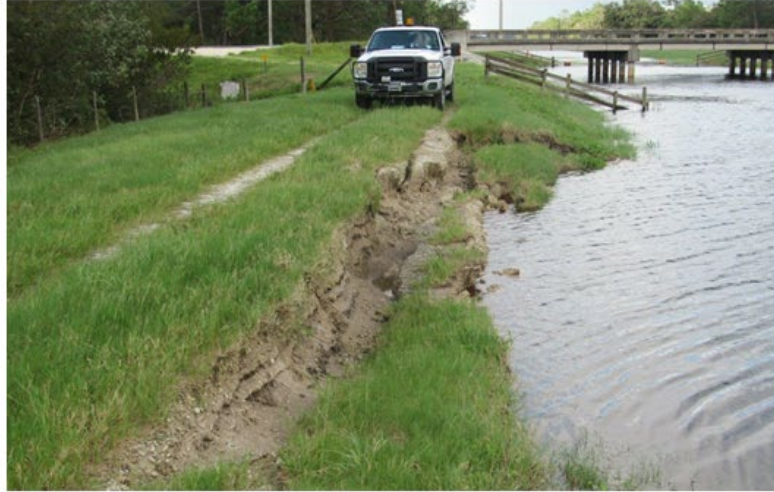
a

# Hurricane Irma Impact a) C-23 Bank Erosion b) Faka Union Canal Bank Erosion c) Flooded Community Along Shingle Creek and d) West Palm Beach Field Station Structure Damage

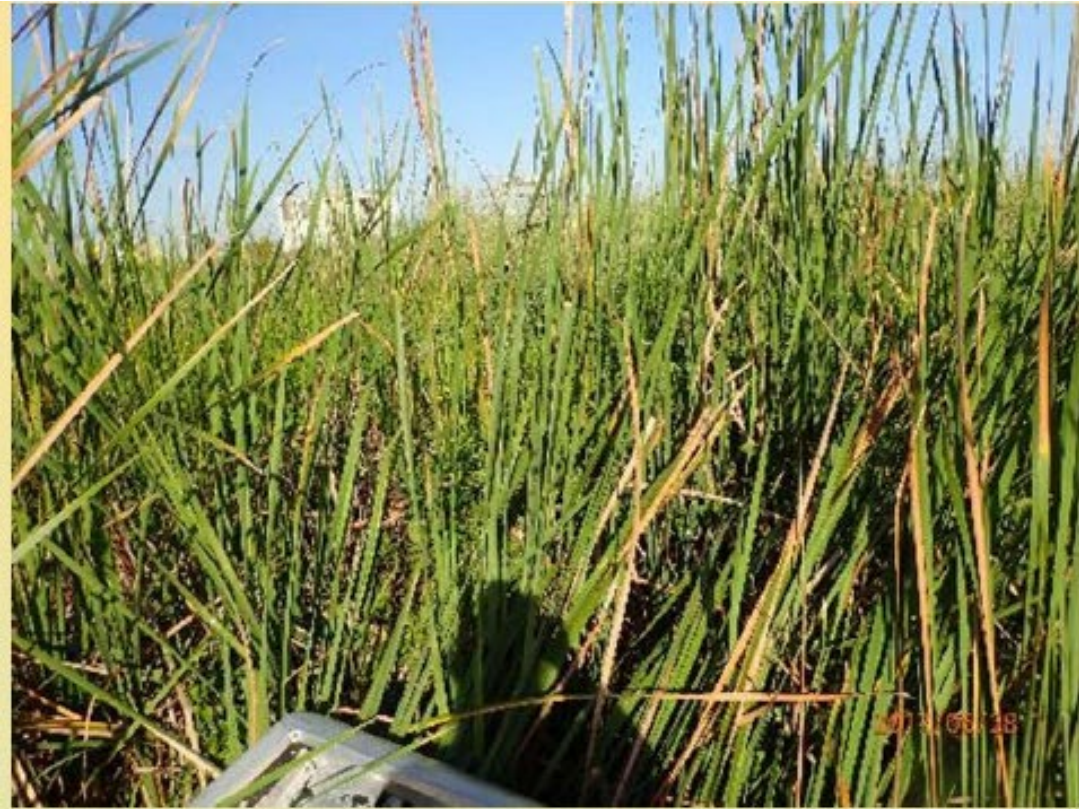
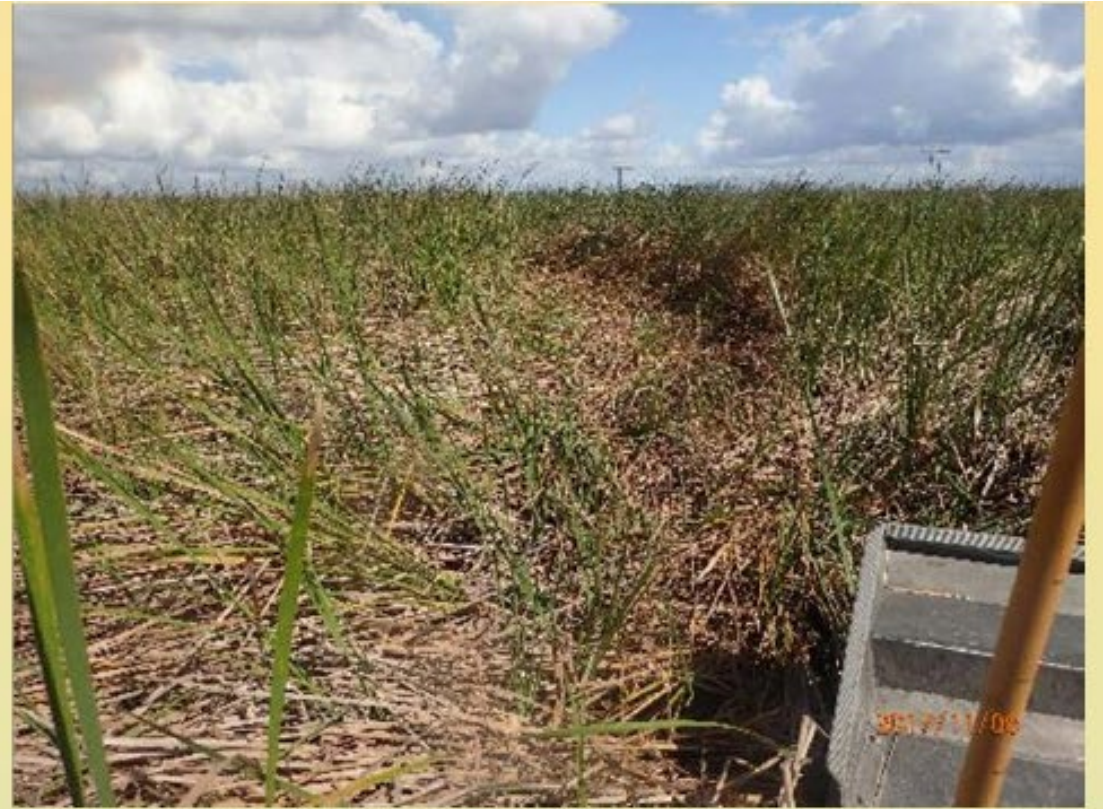
# STA-1W Cell 4 Cattails Before and After Hurricane Irma

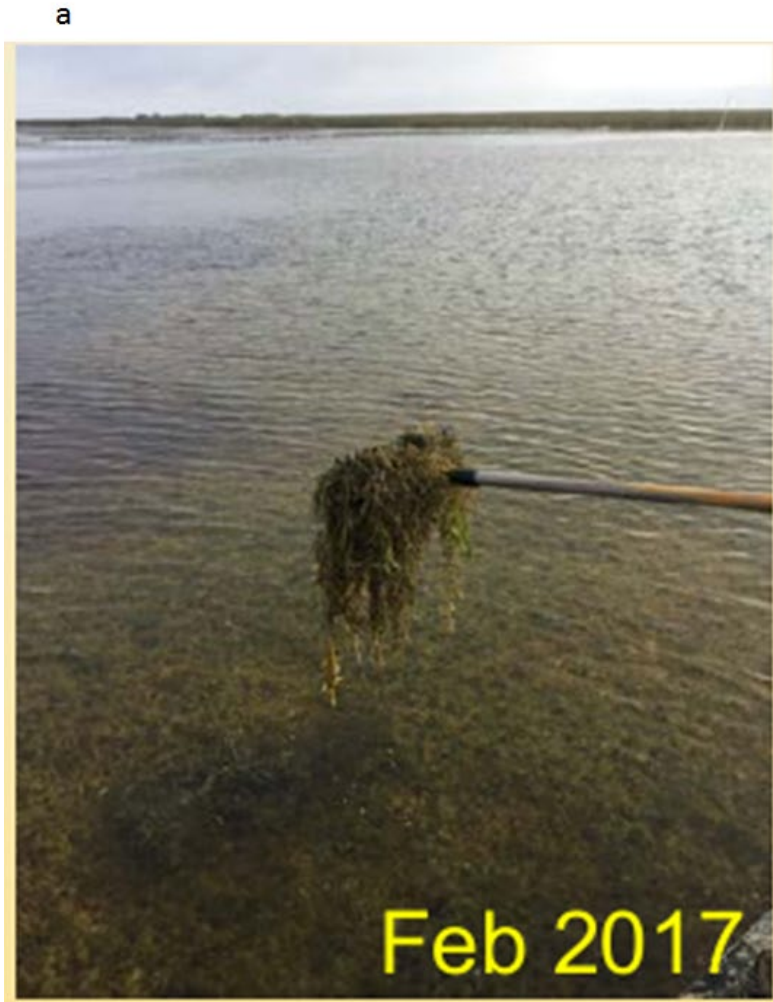
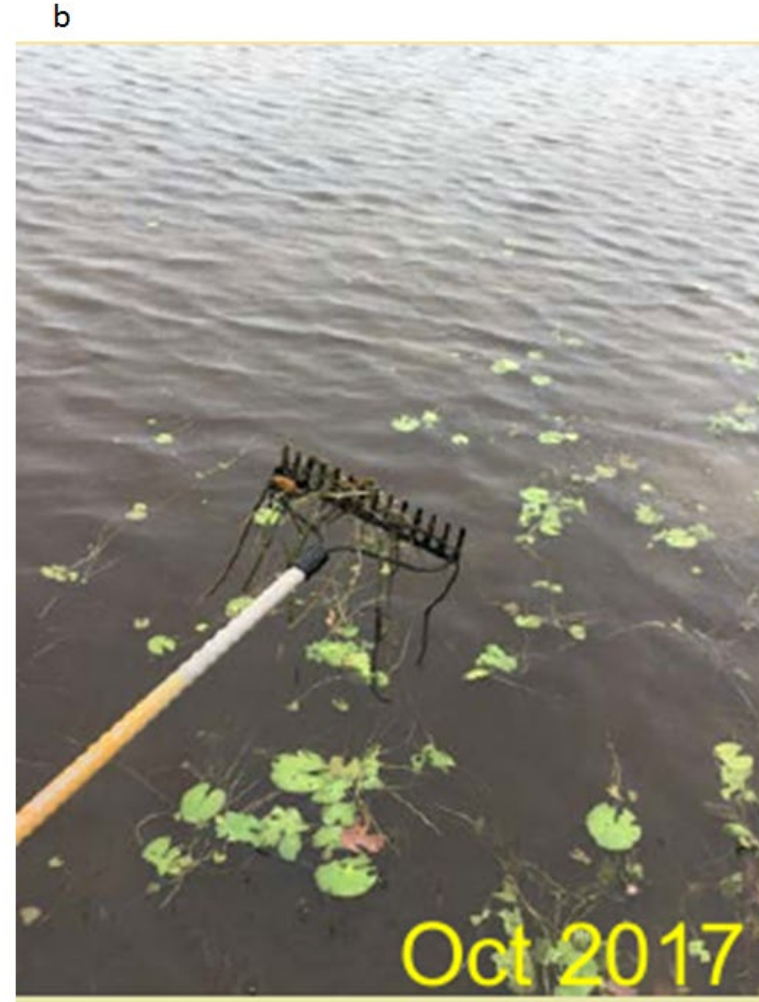
Hurricane Irma Impact a) STA-2 Flow-Way 3 (Mid Flow-Way) Pre-Storm SAV Density and b) Post-Storm Reduced Density. (photos by N. Ralph and W. Larson, SFWMD)

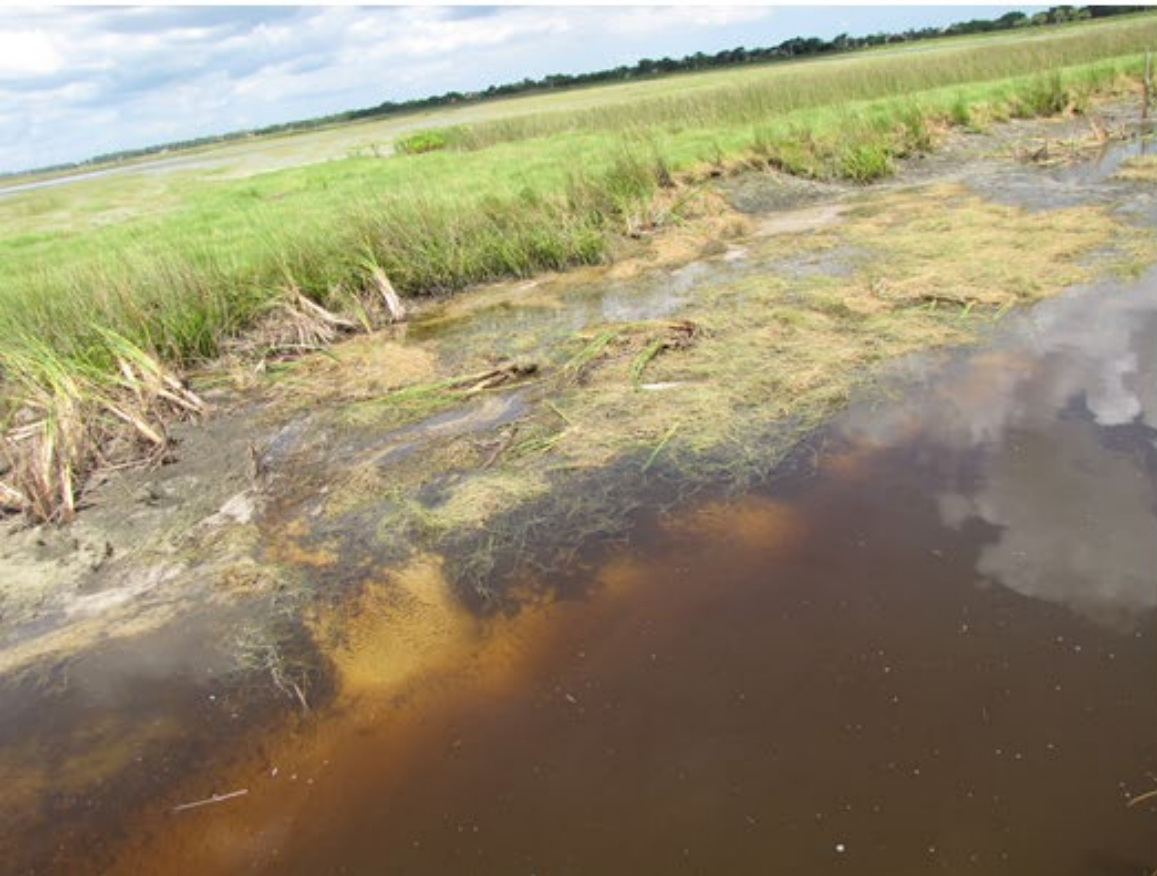
a

# Uprooted Vegetation from Hurricane Irma Impact in STA-1E Cell 2, b) STA-1W Cell 4 (photos by N. Ralph and W. Larson)

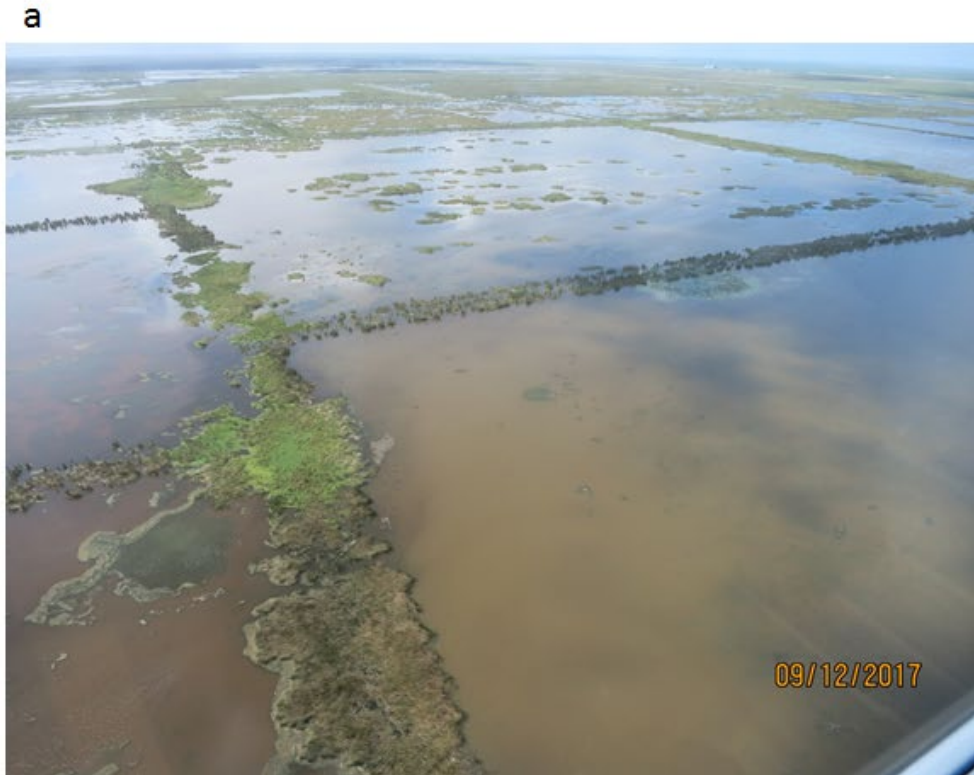
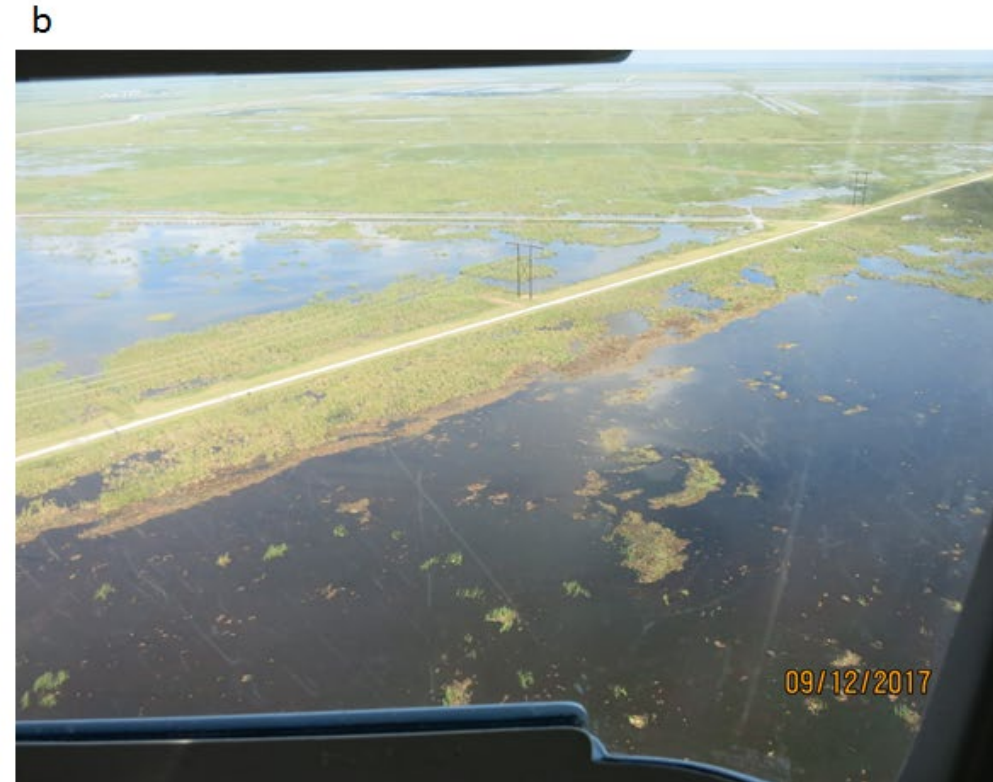
# Sediment Resuspension from Hurricane Irma Impact in a) STA-1W Cell 5B and b) Cell 2B (photos by N. Ralph and W. Larson)
