Lilburn, GA

STORMWATER BMP AND STREAM RESTORATION IN A CITY PARK

July | 2013

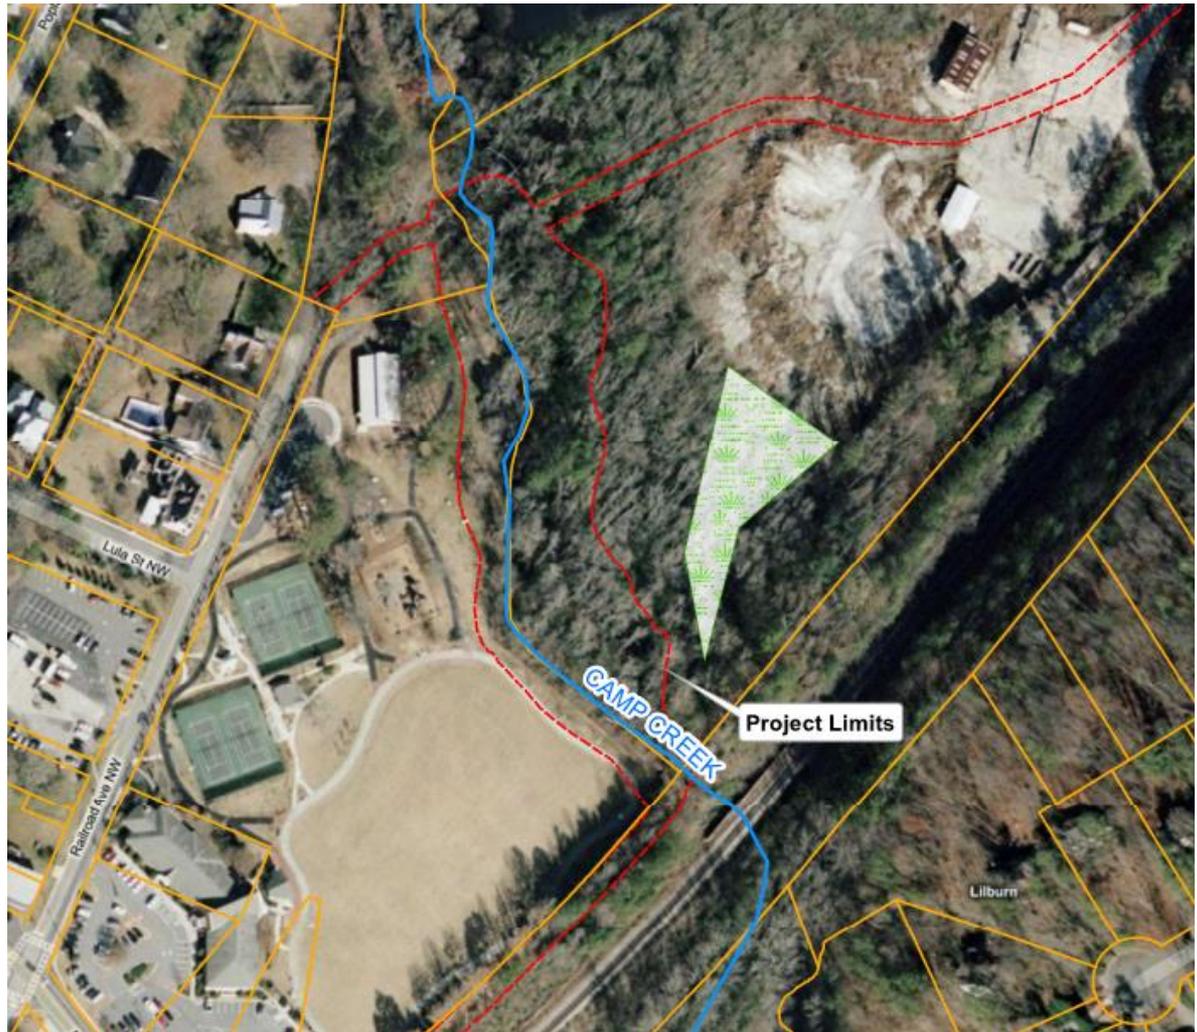
- Incised channel, no connection to floodplain (Rosgen F-5)
- Poor habitat
- Stream eroding into left bank and encroaching historic inert waste landfill and park facilities
- Steep, vertical banks - safety hazard to park patrons
- Debris jams throughout

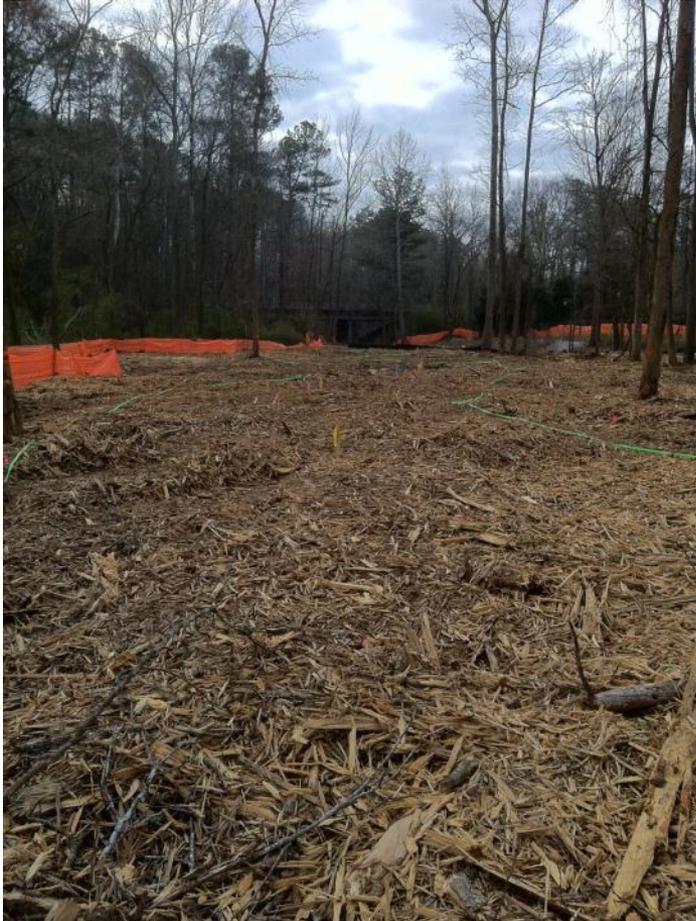
Cleared and flagged for new channel

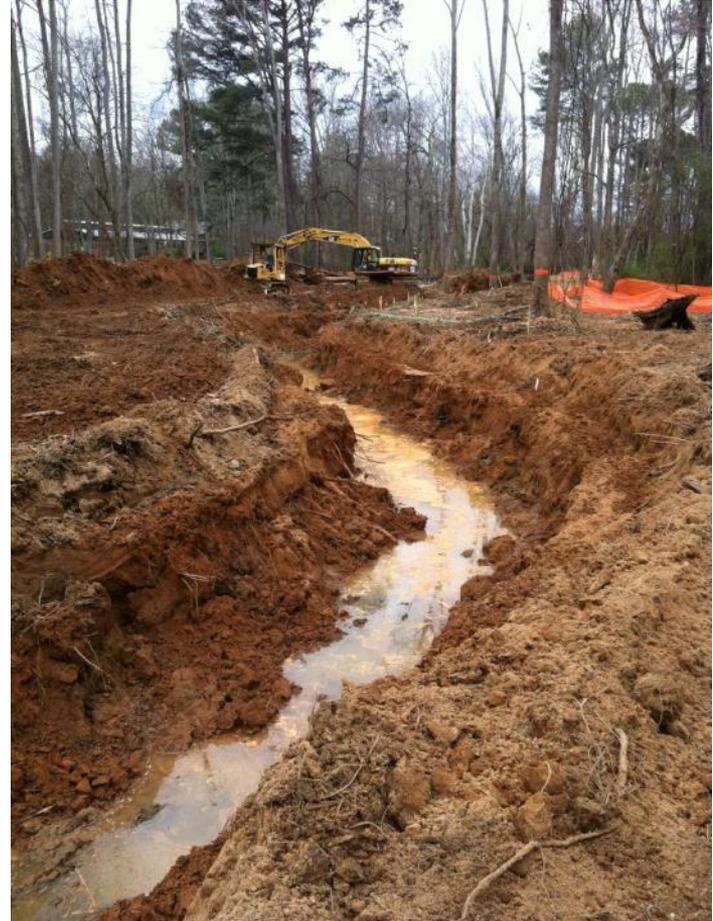
Roughed in new channel

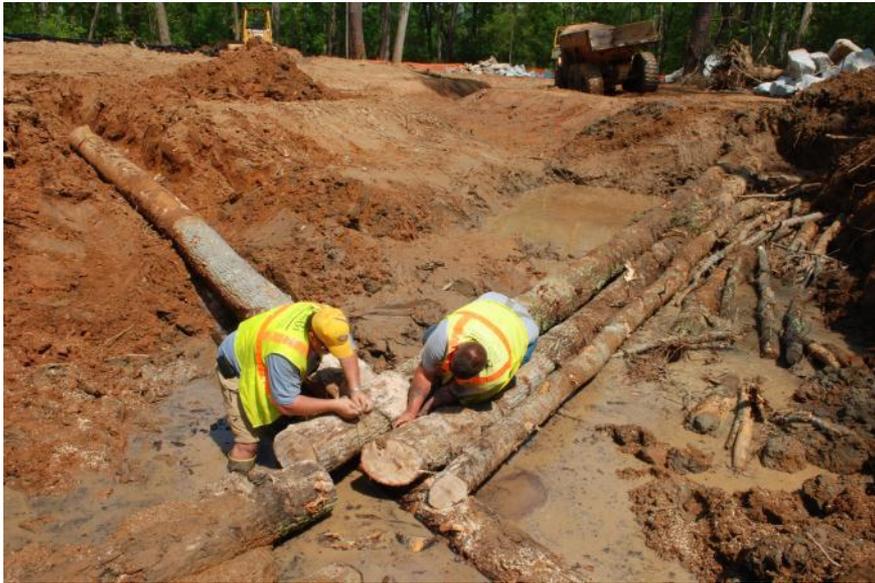
Log vane

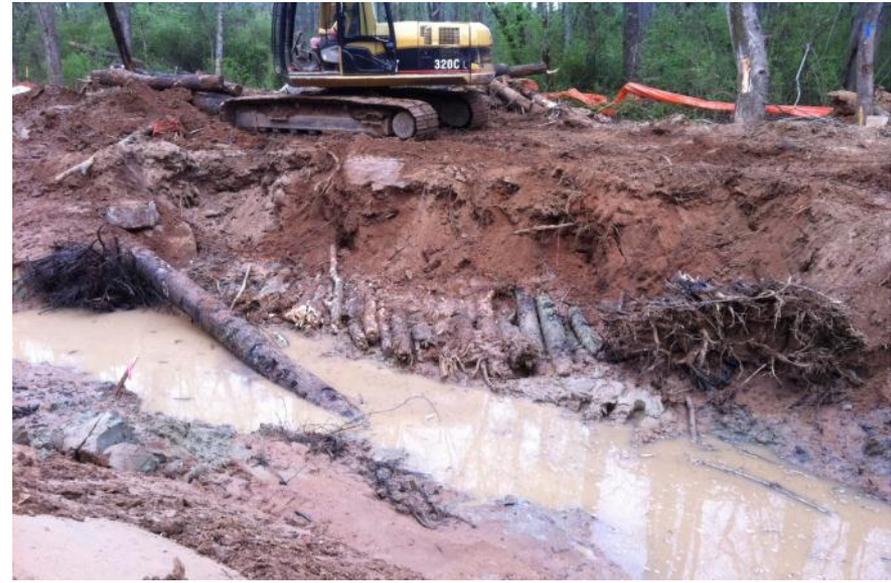
Scour log and toe wood/brush mattress

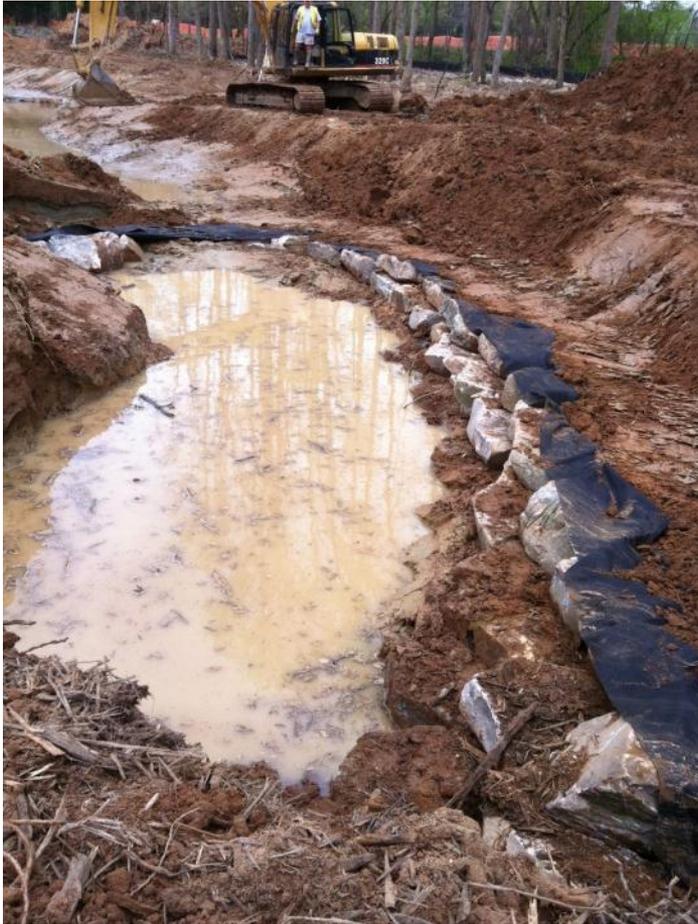
Stone J-hook

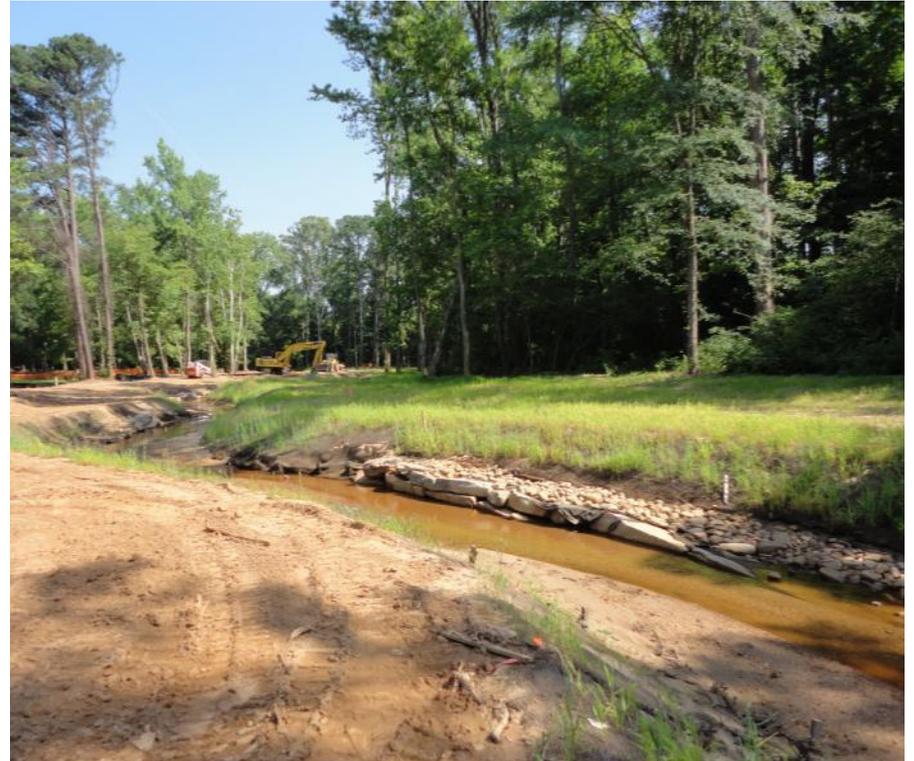
Completed Stone J-hook

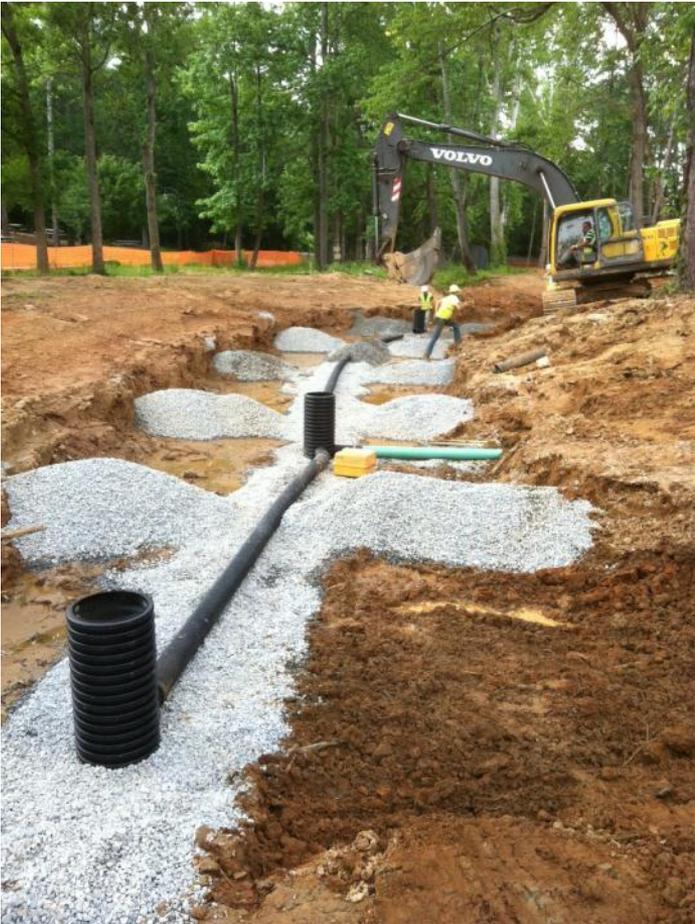
Underdrain Installation

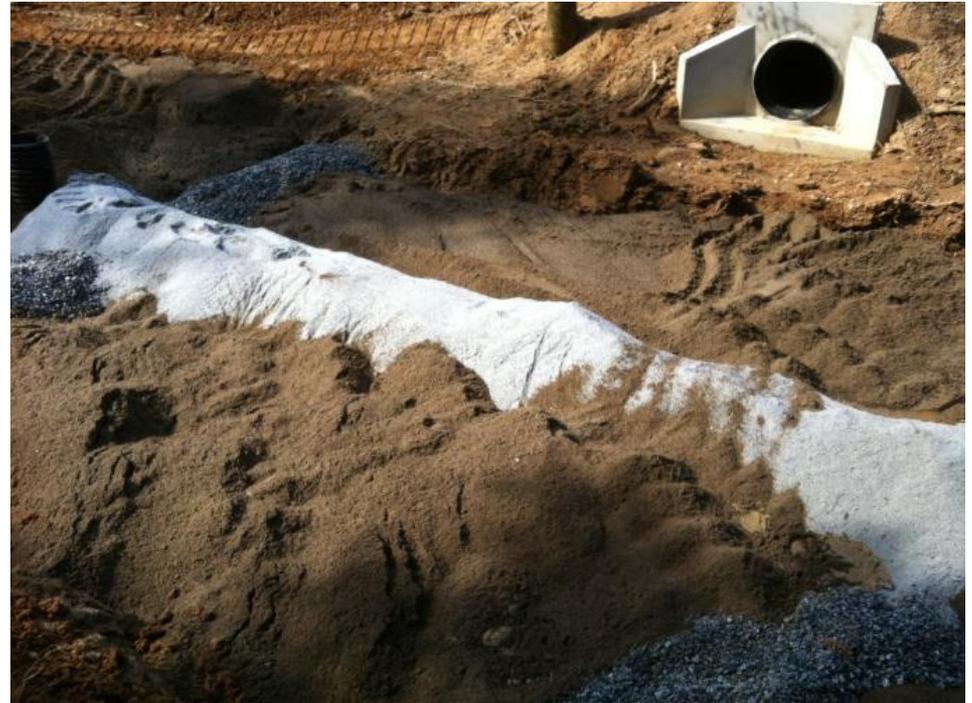
Installing Engineered Soil

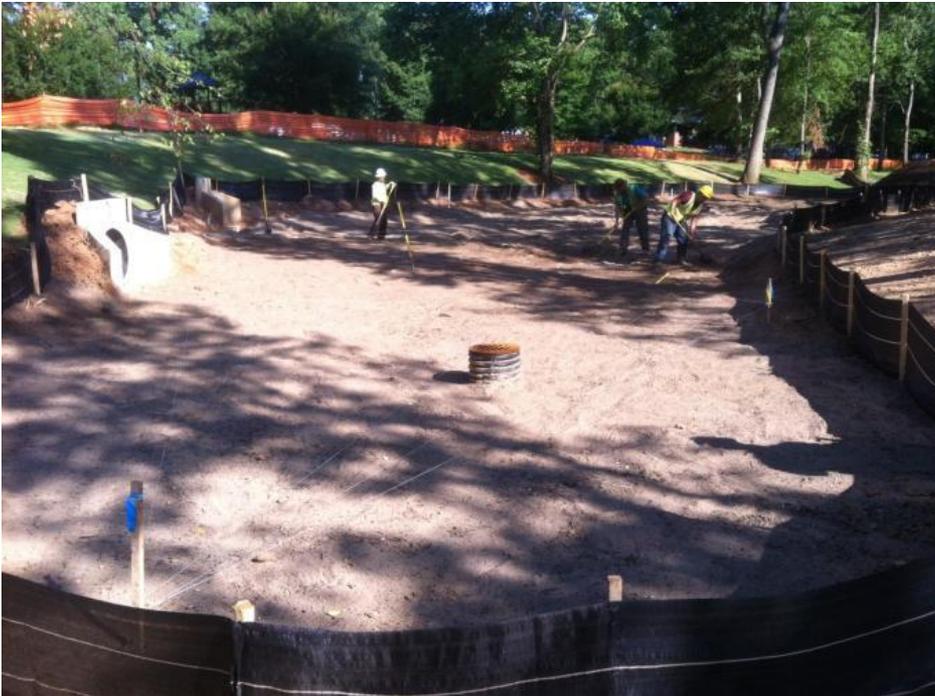
Engineered soil Installed in 1-ft lifts,
water in, no compaction

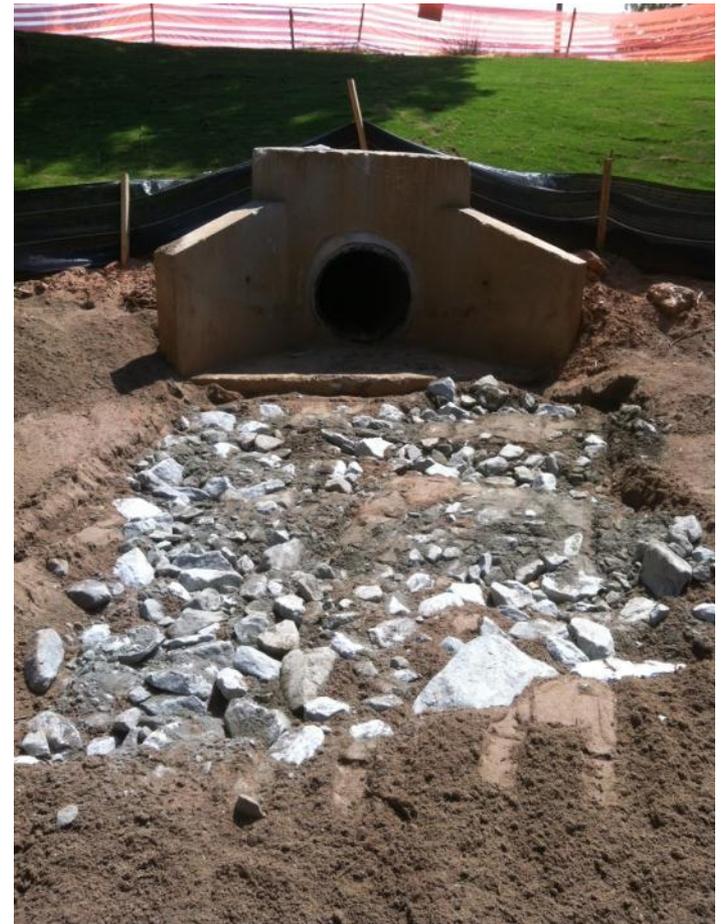
Type 3 Rip-rap at outfalls

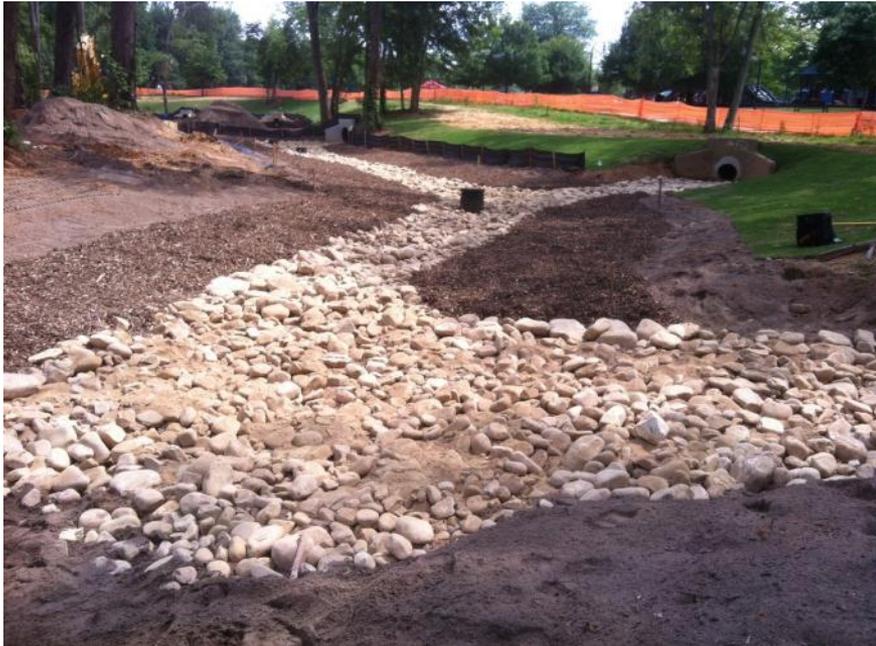
Cobble and mulch installed

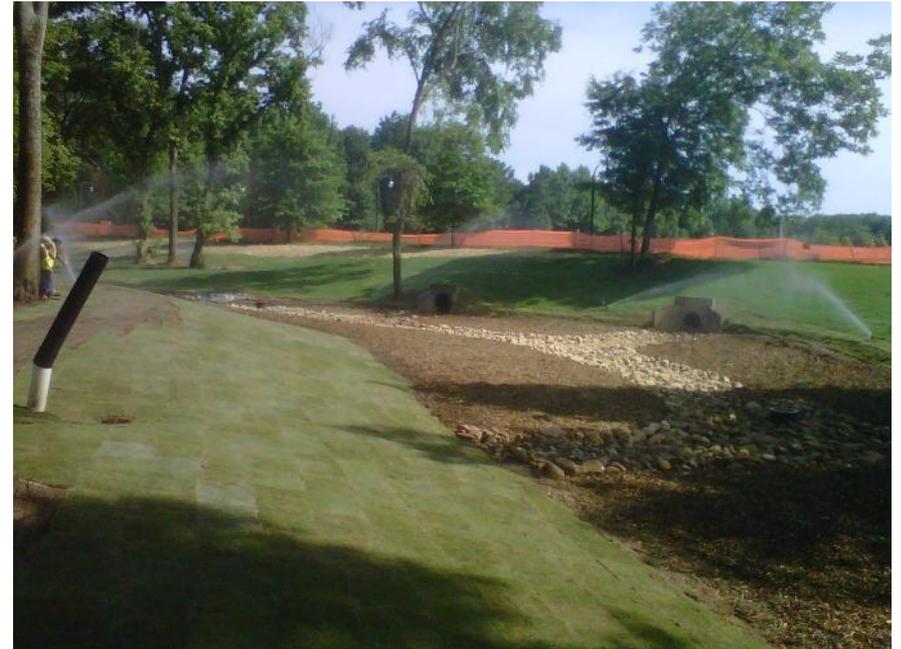
Sod and Irrigation System

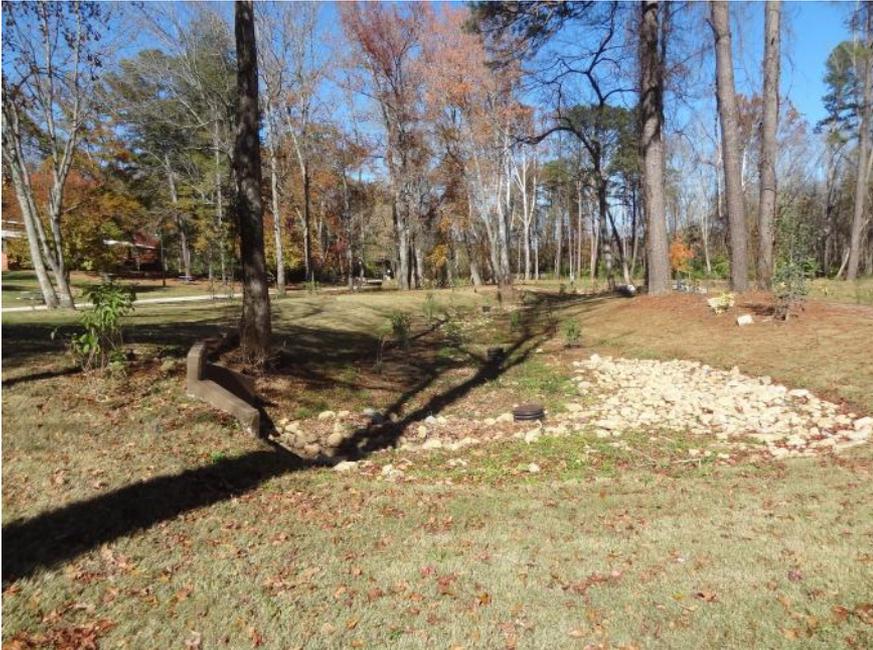
Complete, planted BMP

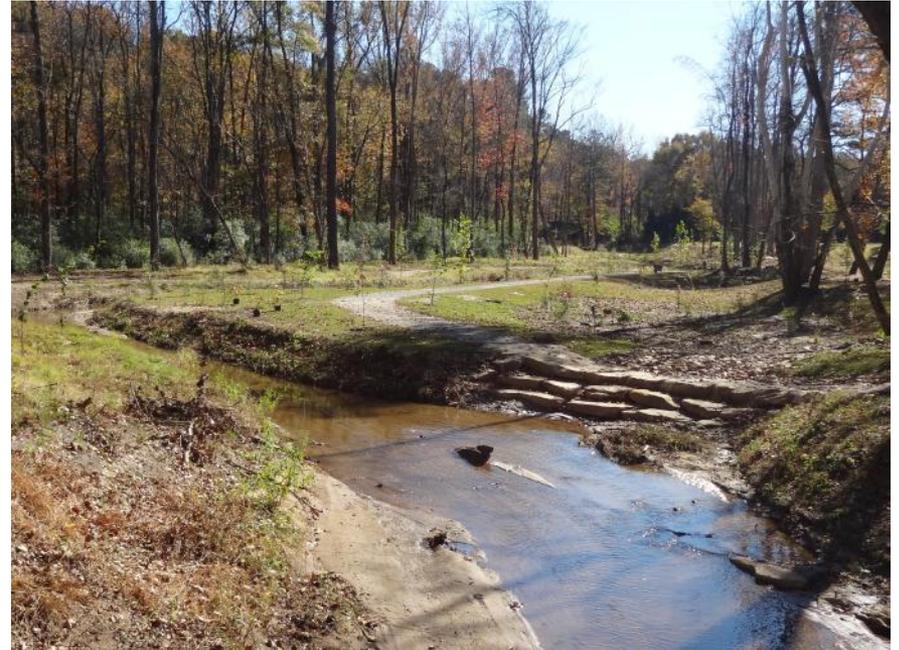
Fieldstone Outfall Structure
Connection to creek

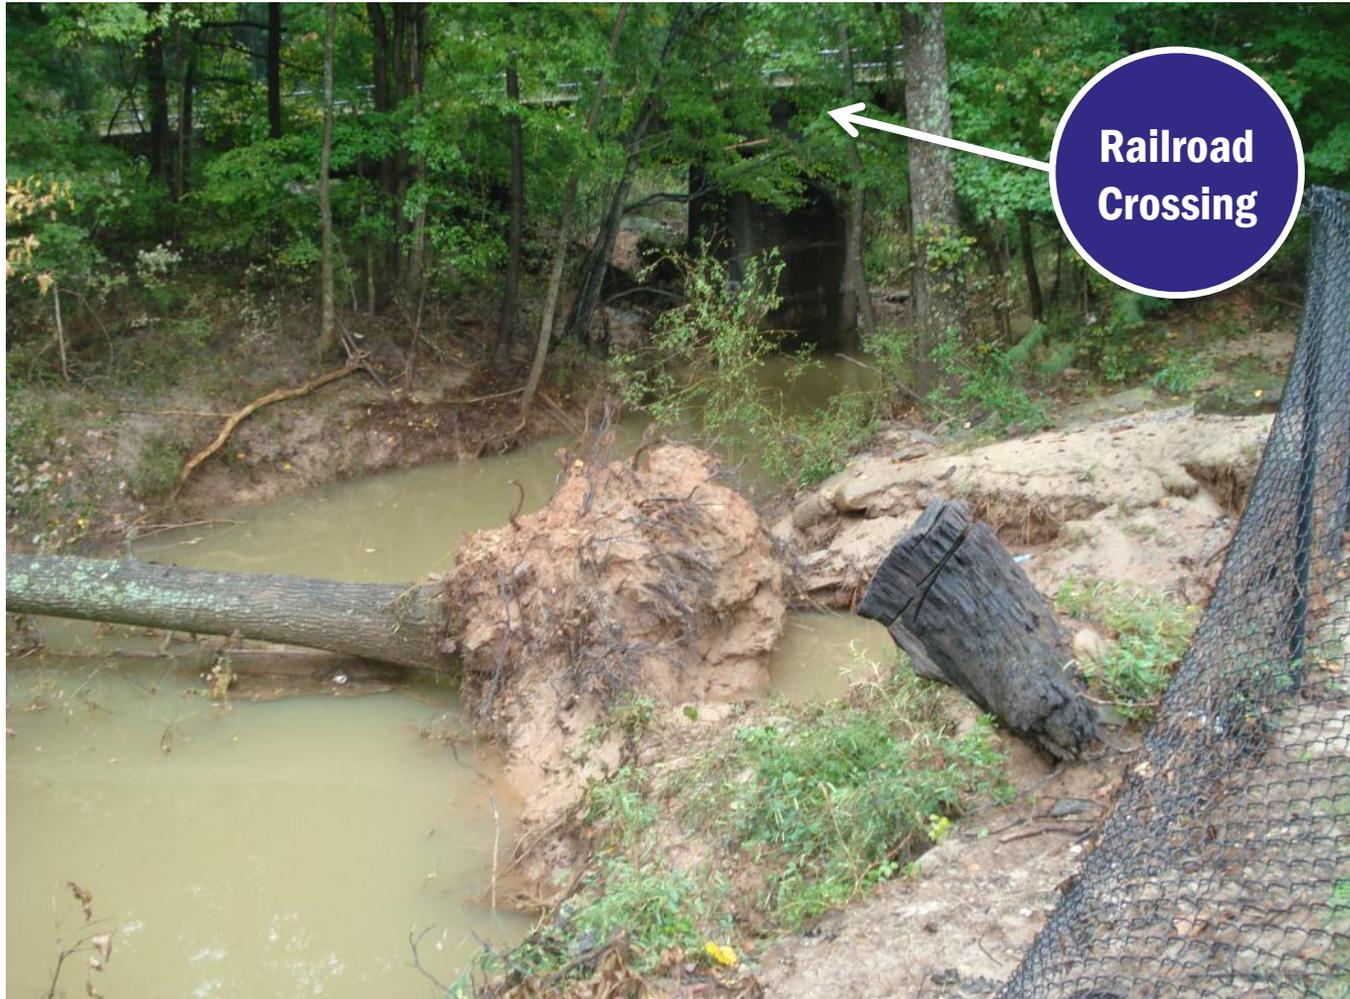
Flood of September 2009

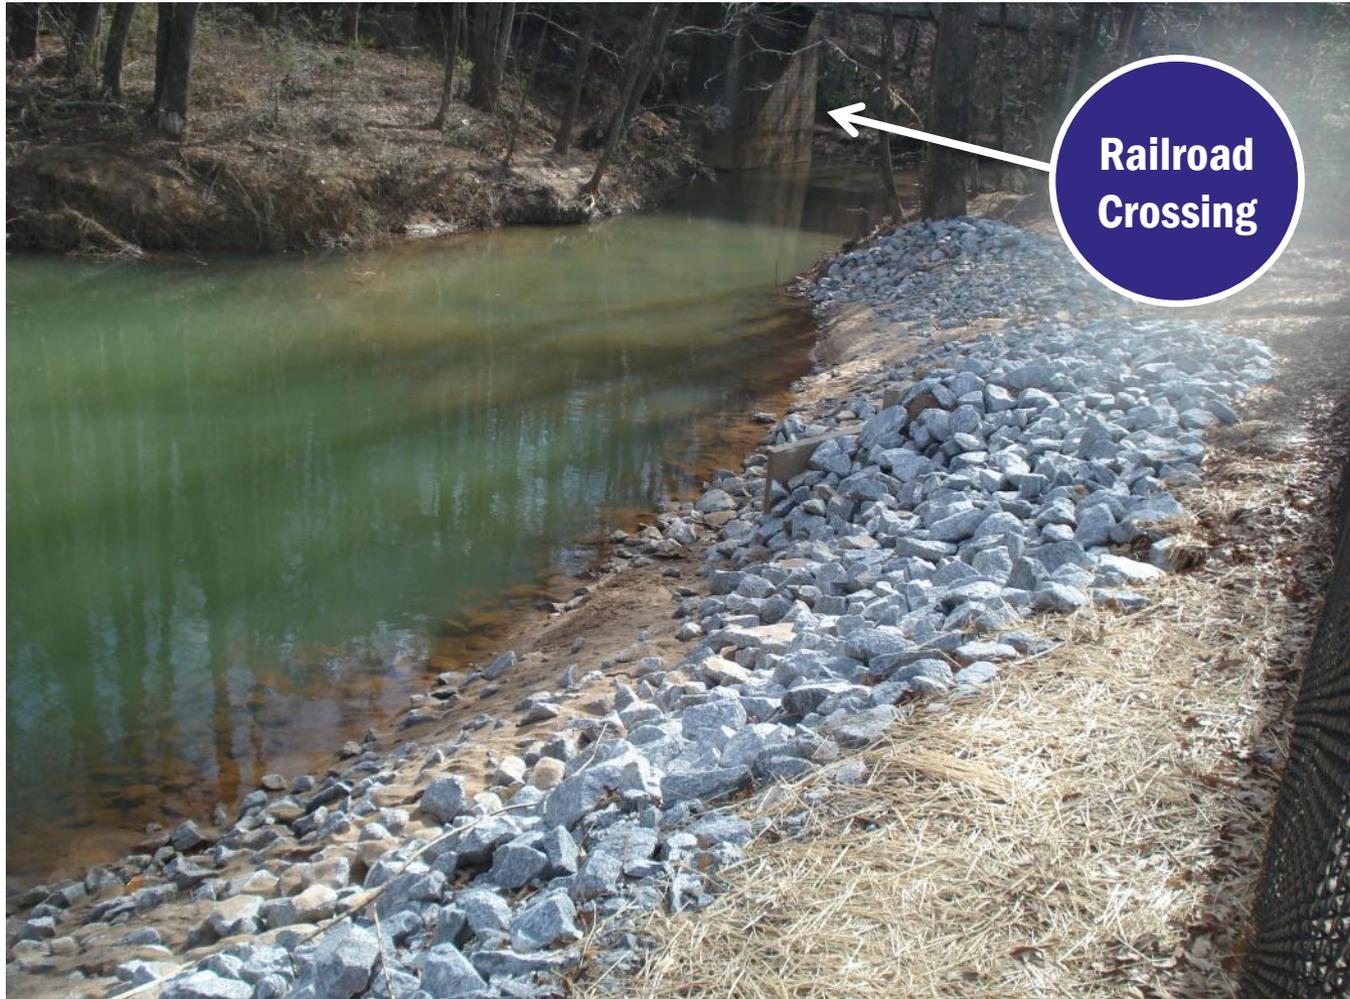
Post Flood Repairs by City

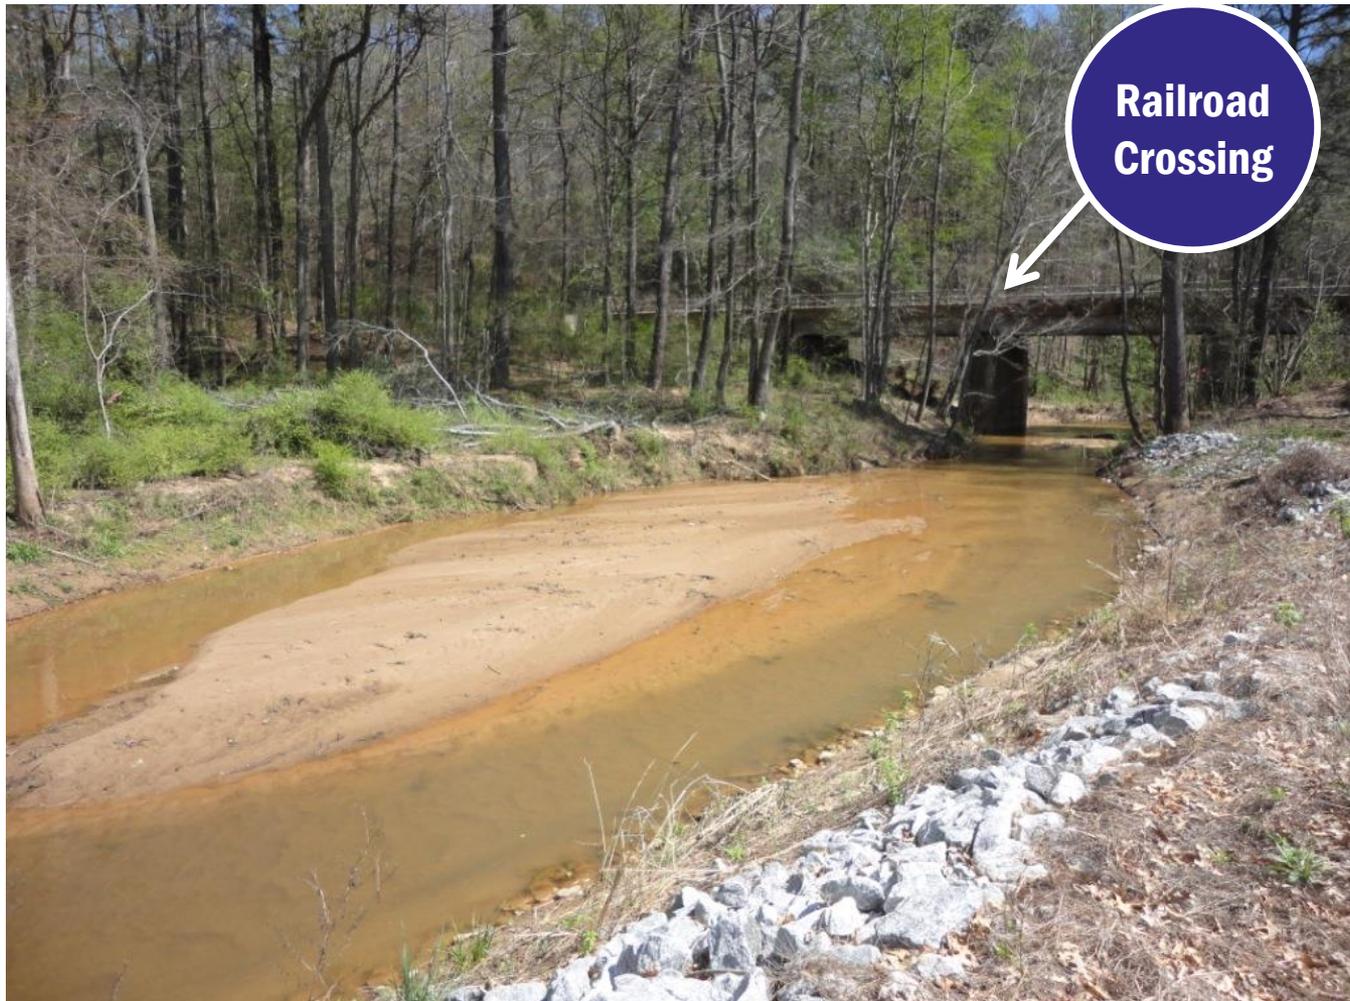
February 2011 - Preconstruction

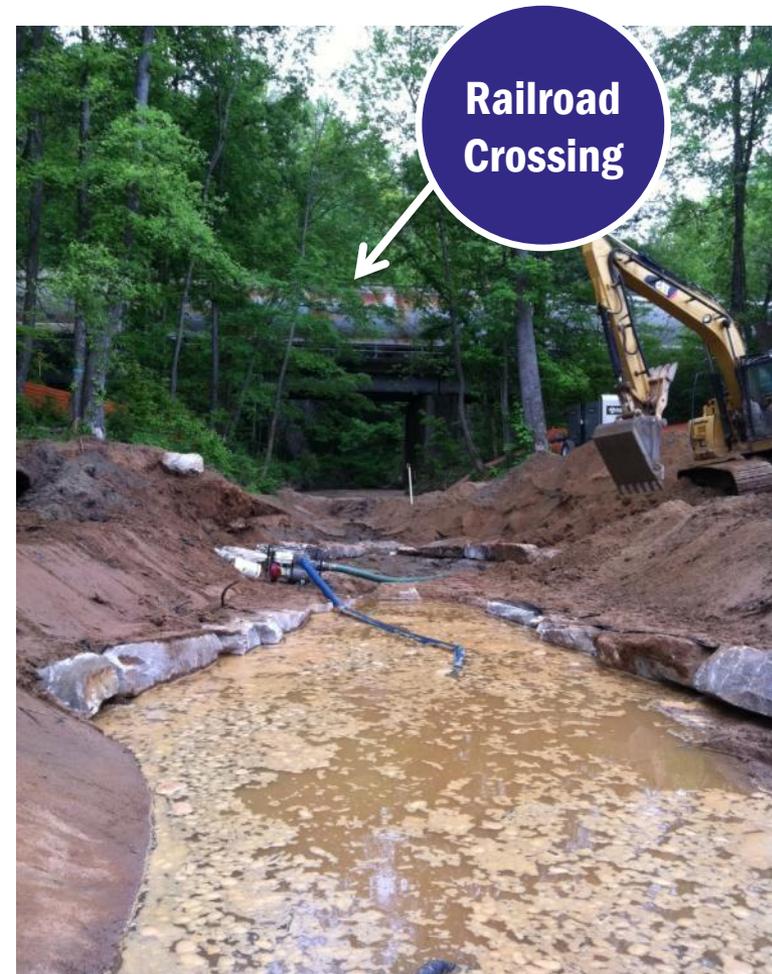
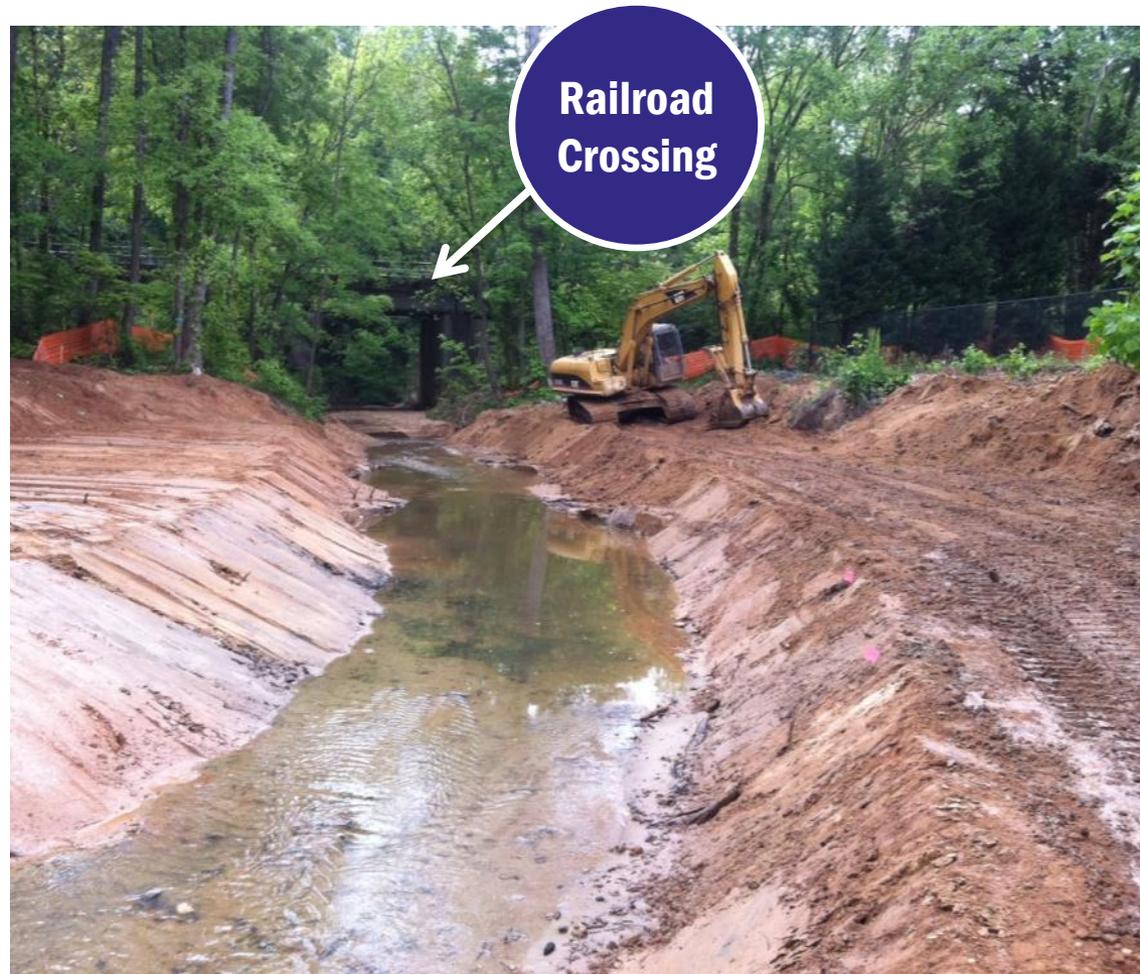
During Construction – Installing Fieldstone Cross Vanes, Structures 1 and 2

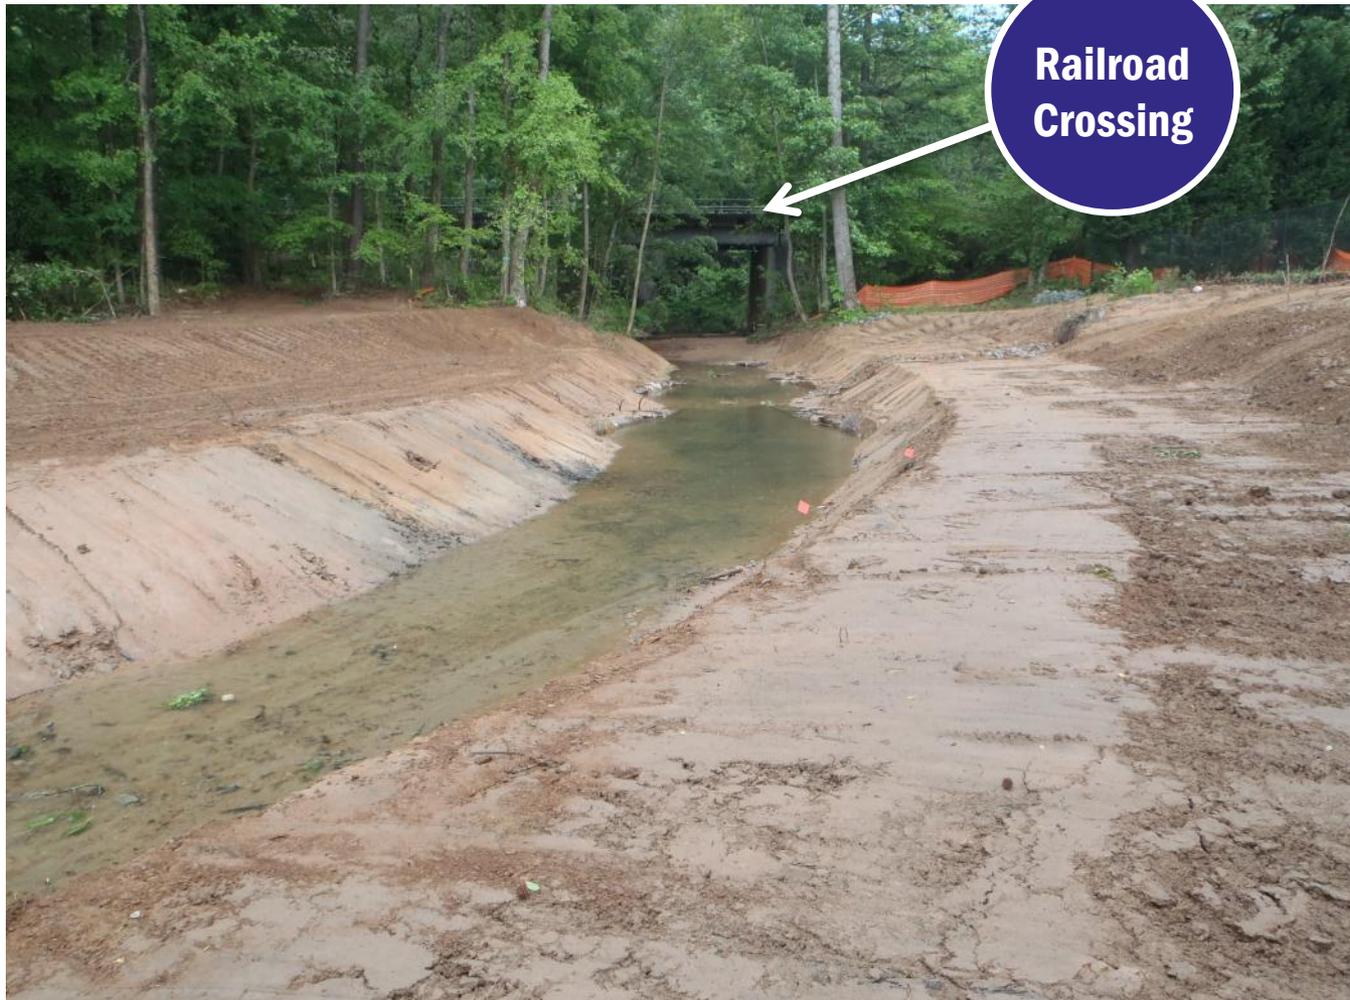
April 2012 – Construction

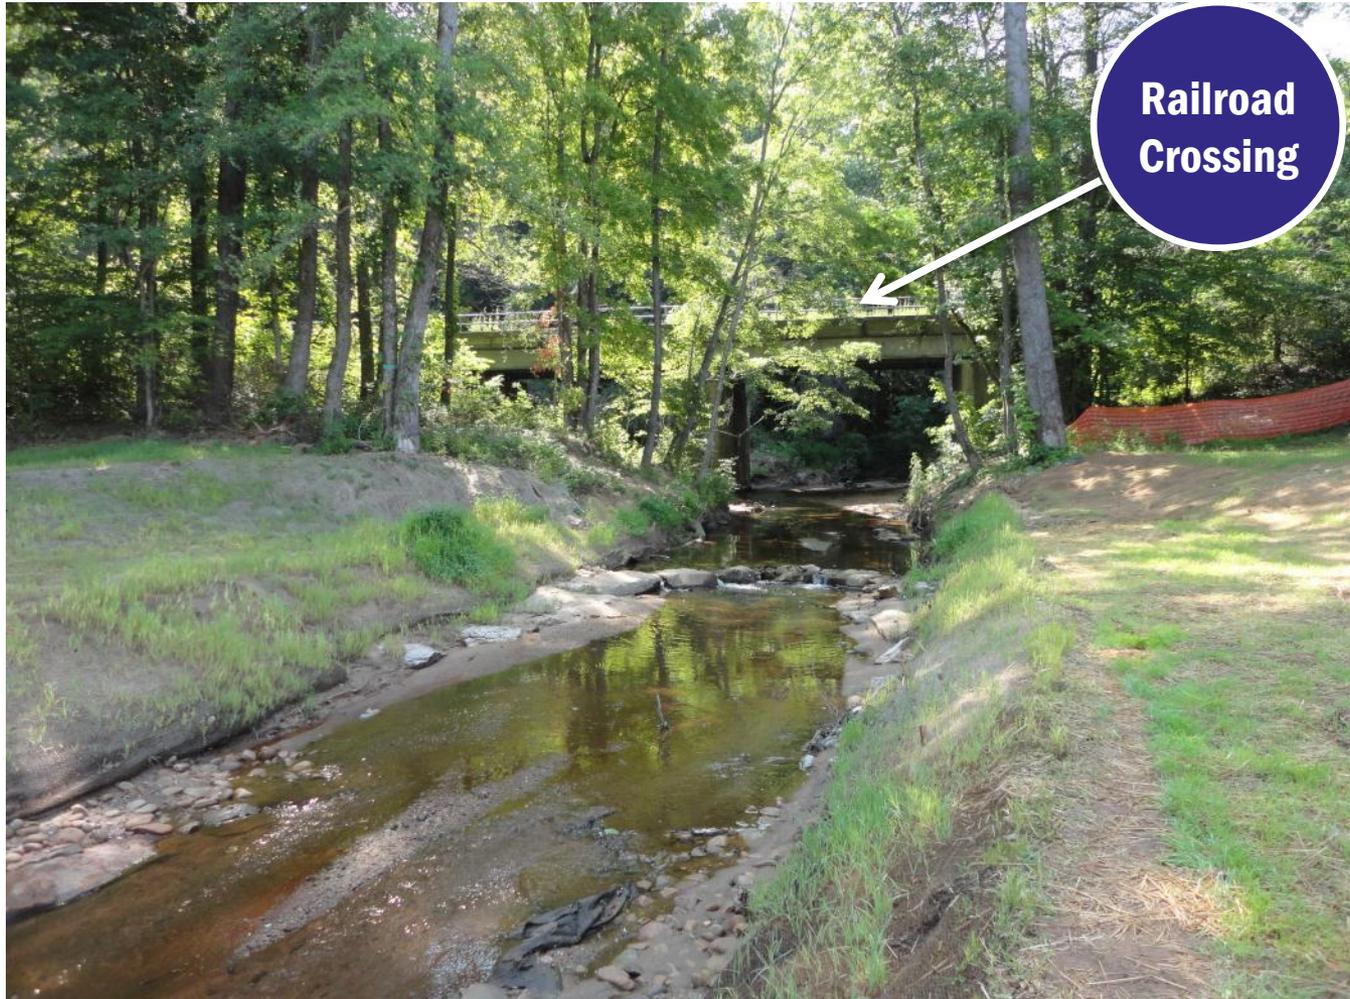
June 2012 – End of Construction

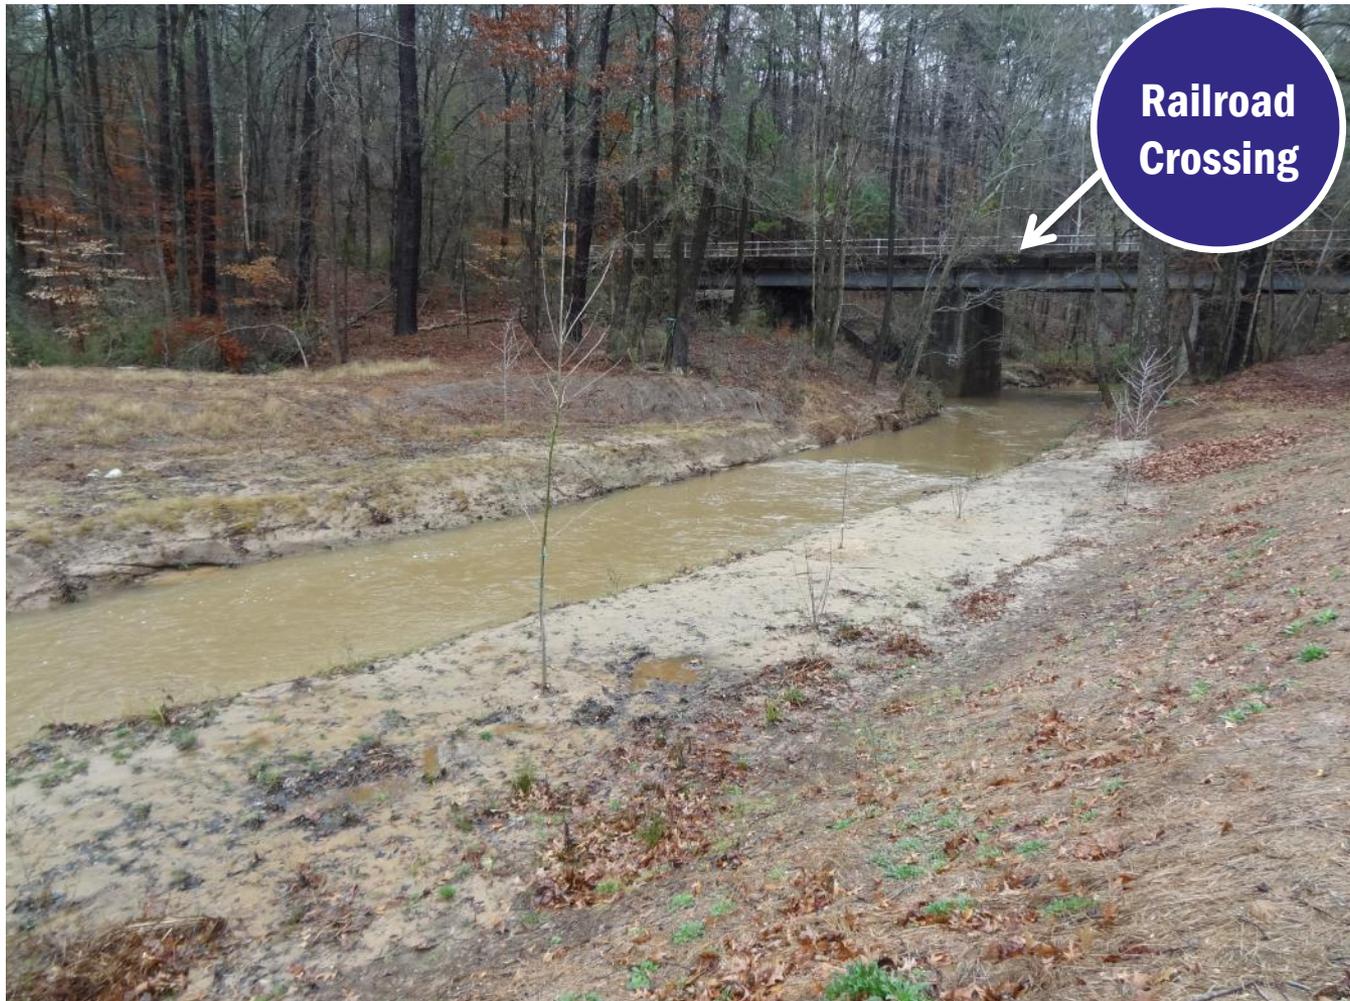
January 2013 – Near Bankfull Event
