Kinnickinnic River: Rehabilitation in an Urban Watershed

Stuart C. Trabant, Michael D. Harvey, Robert A. Mussetter (Tetra Tech, Inc.),
David Fowler (Milwaukee Metropolitan Sewerage District)

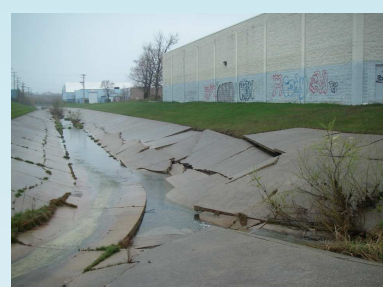
The urbanization resulted in an approximately 10-fold increase in the magnitude of the peak flows. Much of the existing concrete lining (installed between the late 1950's and early 1970's) is aged and deteriorating (Figure 4) and the channels no longer convey the design flows. The Milwaukee Metropolitan Sewerage District (MMSD) is exploring options for removing the concrete and rehabilitating the channels. MMSD's goals include improved aquatic and riparian habitat and enhanced recreational opportunities while providing increased public safety and reduced impacts from flooding. In the channels that are not concrete-lined, MMSD is concerned with bank erosion (Figure 5) and vertical downcutting, as well as resulting sedimentation in the Lake Michigan estuary.

Figure 4. Damaged concrete lining in Holmes Avenue Creek.

- Problem:** Failed and poor-condition, open-channel concrete lining, primarily in the KKR that was constructed in the early 1960s and is coincident with the impaired hydraulic capacity.

- Rehabilitation Opportunity:** Given the coincidence between the poor state of the concrete and the impaired hydraulic capacity, the compound channel identified to mitigate problems with channel capacity would also remedy the problems with the concrete lining.

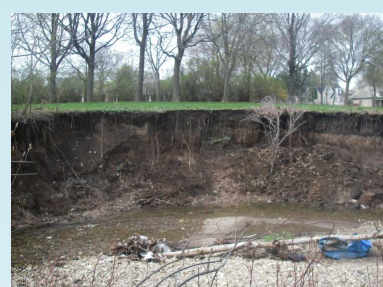
Figure 5. Bank erosion in the unlined portion of the KKR.

- Problem:** Eroding unlined channel segments in the KKR and tributaries that both threaten streamside infrastructure and supply sediment to the downstream estuary of the KKR where it is deposited.

- Rehabilitation Opportunity:** Stabilization of the eroding banks that are currently threatening infrastructure could be achieved by installing a rock toe designed to withstand movement at the 100-yr RI flow with bio-engineered upper banks (Figure 12). Rock riffle grade control structures will be necessary in areas of downcutting, and will also enhance habitat (Figure 13).

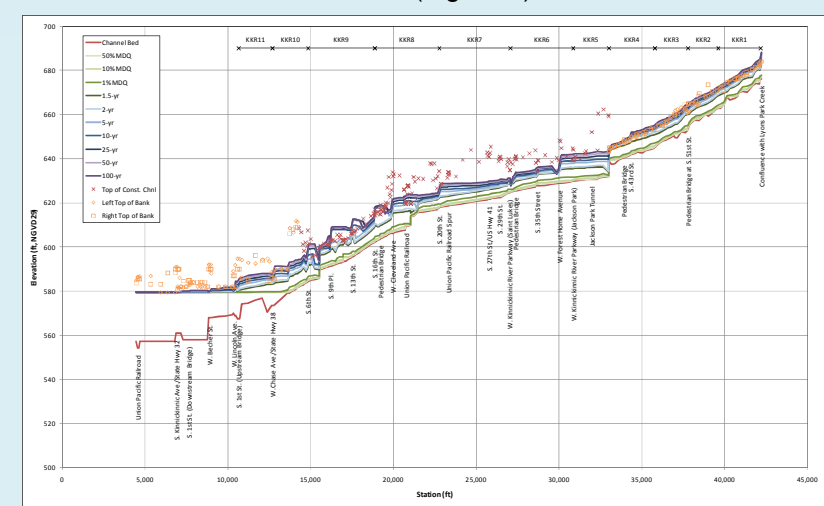
Figure 8. Channel capacity evaluation in the KKR.

HEC-RAS modeling was used to identify the channel capacity along the KKR (Figure 8), and to provide input to the sediment-transport analysis. The HEC-RAS model was initially developed by the Southeast Wisconsin Regional Planning Committee (SWERPC), and was updated for this study using the most recent topographic mapping and survey data. In the unlined portions of the KKR, the channel capacity ranges from the 2- to 10-yr RI peak flows. In the concrete-lined portions of the KKR, the channel capacity is generally greater than the 100-yr RI peak flow, except in areas that are affected by localized backwater zones created by bridges and in one reach with heavy residential encroachment where the channel capacity is less than the 25-yr RI peak flow.

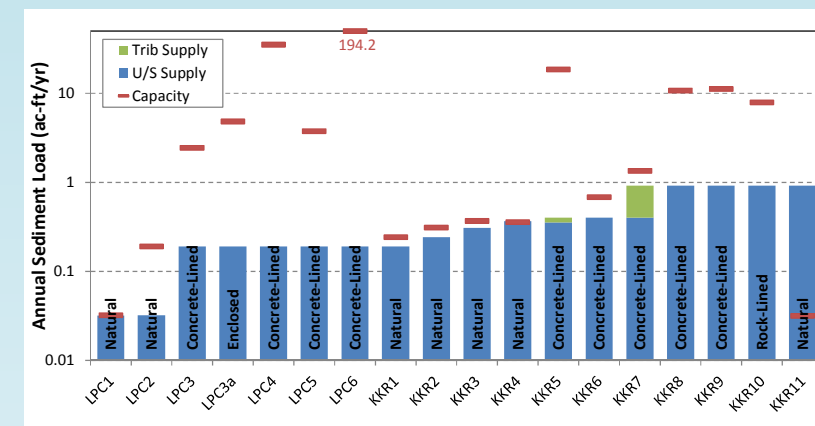
For purposes of this analysis, the KKR and its tributaries were divided into 47 subreaches. Reach-averaged hydraulics from the HEC-RAS model and bed material gradations for the individual subreaches were used to conduct a sediment continuity analysis of the KKR for existing and future conditions. The results indicate that the most significant erosion will occur in the unlined reaches of the KKR and Lyons Park Creek, and that aggradation in the lined reaches is unlikely (Figure 9).

Figure 9. Results of the sediment-continuity analysis in Lyons Park Creek and the KKR.
