POST-RESTORATION MONITORING OF PICAYUNE STRAND RESTORATION PROJECT

Mary T Fesmire¹, Michael J Duever², and Amanda D McKenzie¹

¹South Florida Water Management District, West Palm Beach, FL, USA

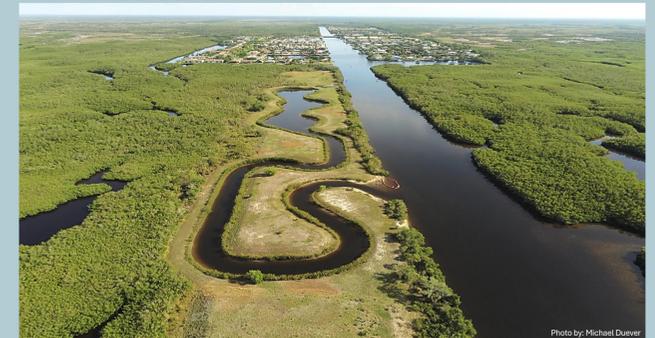
Manatee Mitigation Feature – 3 October 2024

Two-acre warm water refugium area south of Port of the Island Marina along the western bank of the Faka Union Canal

❖ The 55,000-acre restoration project will restore close to 100,000 acres, including adjacent and downstream state and federal conservation lands
❖ Initial road removal and canal plugging on Prairie began 2004, completed 2007
❖ Merritt Pump Station, road removal, and canal plugging initiated 2009, completed 2015
❖ Manatee mitigation feature completed 2016

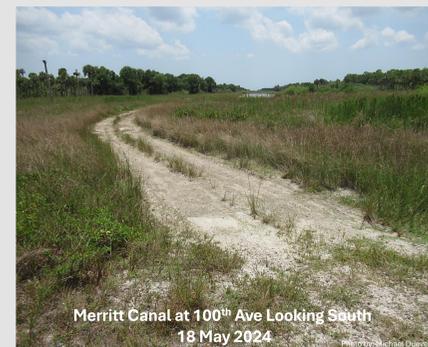
Landscape Responses to Hydrologic Restoration

- ❖ Increased wetland species in the vegetation communities
- ❖ Reduced upland species, wildfires, and exotic vegetation

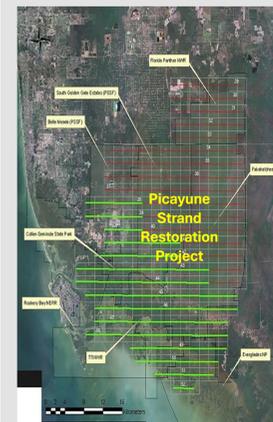
Location of Wading Bird Aerial Transects within the Picayune Strand Restoration Project Area

- ❖ Study area includes adjacent public lands and coastal areas consistent with other CERP wading bird surveys
- ❖ Assess the distribution and abundance of wood storks and other wading birds
- ❖ Target – establishment of natural hydroperiods suitable for wading birds
