# Adapting Lake Okeechobee Habitat Management to Changes in Lake Stages

Florida Fish and Wildlife **Conservation** Commission

Presenter: Alyssa Jordan

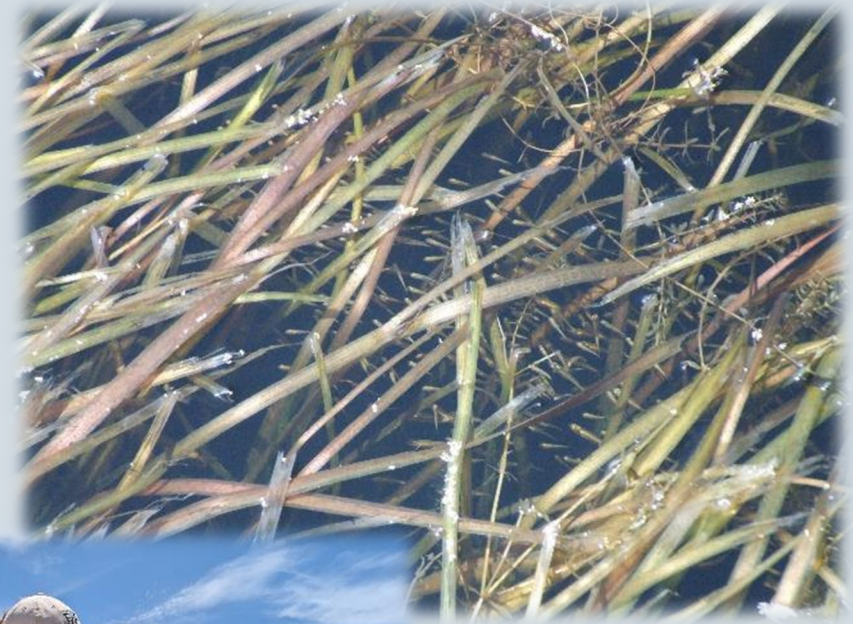
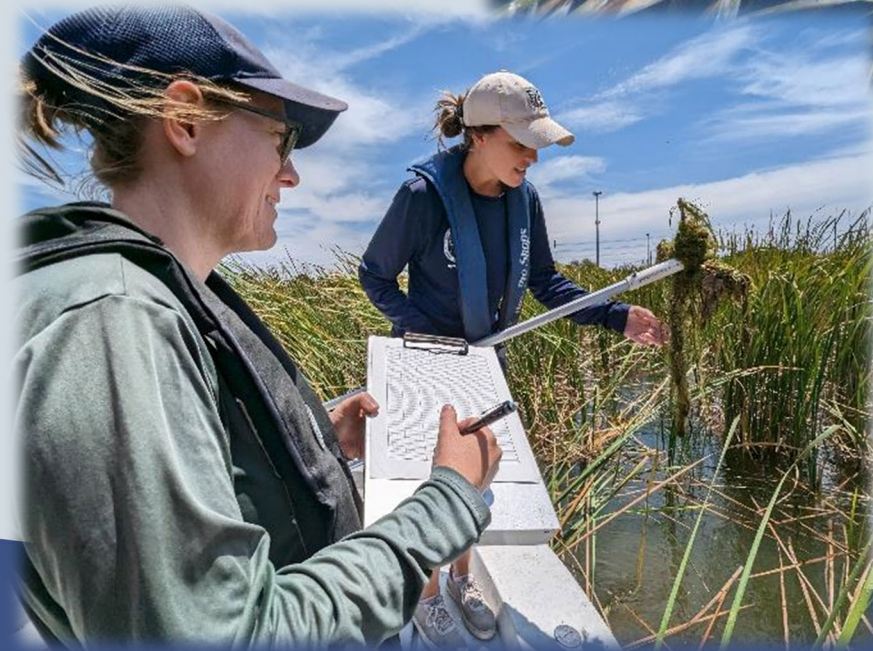
# Submersed Aquatic Vegetation Monitoring

1. Finer resolution - smaller grids  
(3 acres vs 247 acres)
2. Side scan sonar
3. Density estimates
4. Percent frequency and density of emergent vegetation

Okeechobee (FE Bay to Clew) Submersed Vegetation 2022

Calculated Analysis:  
PAC: 26%

Heat map created from point intercept data at a spacing of 110 meters.

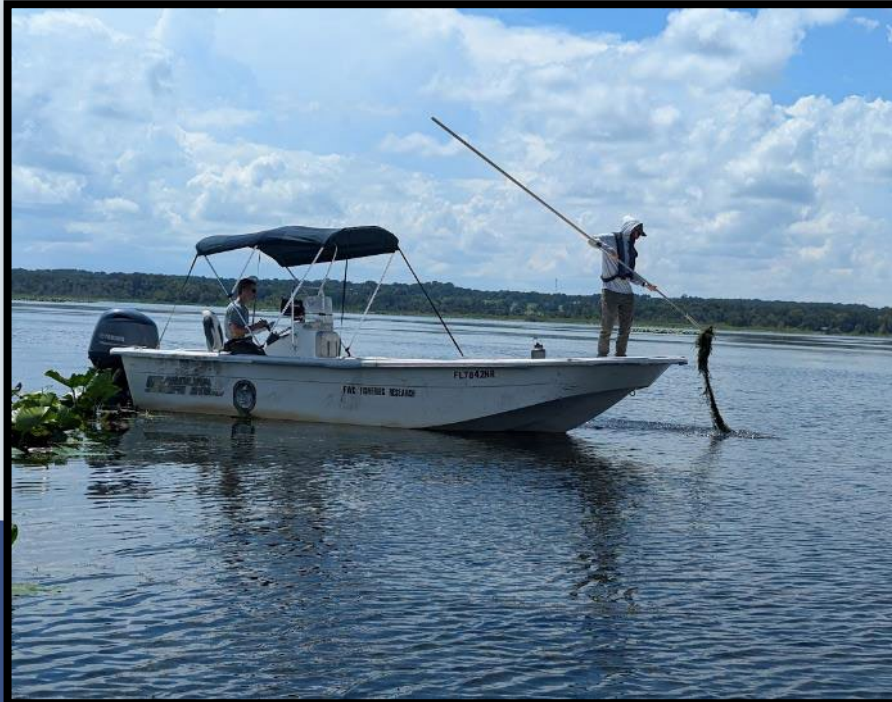
Okeechobee (Clew to Pel Bay) Submersed Vegetation 2022

Calculated Analysis:  
PAC: 1%

Heat map created from point intercept data at spacing of 110 meters.

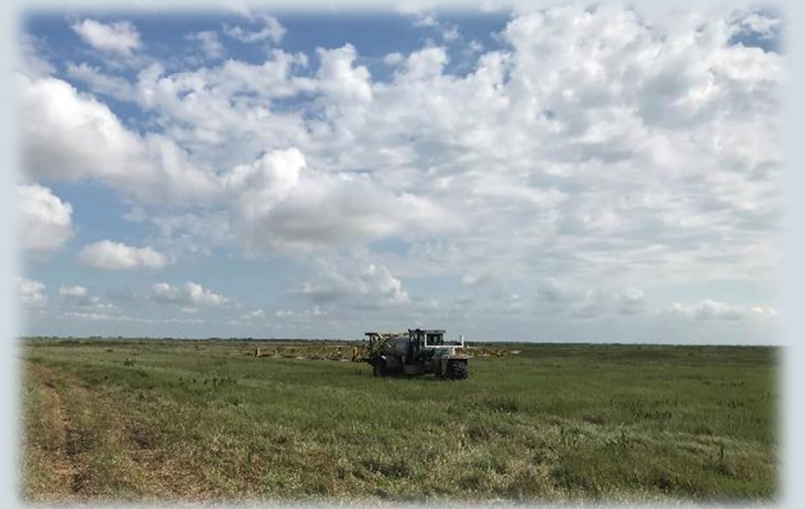
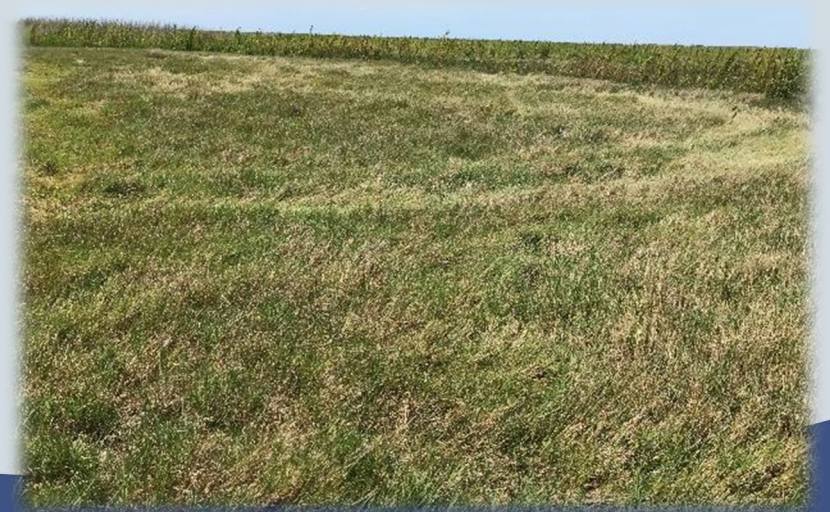
# Lake Okeechobee Torpedograss Management

- 1990's to 2017: > 16,000 acres. Big treatments.
- 2019: 10,000 - 14,000 acres

**Annual Spot management within previous broadcast areas**

- 2019 - 2024: >7,000 acres in management
- 2025: 5,000 - 8,000 acres remaining
- 2025: 1,500 acre treatment planned

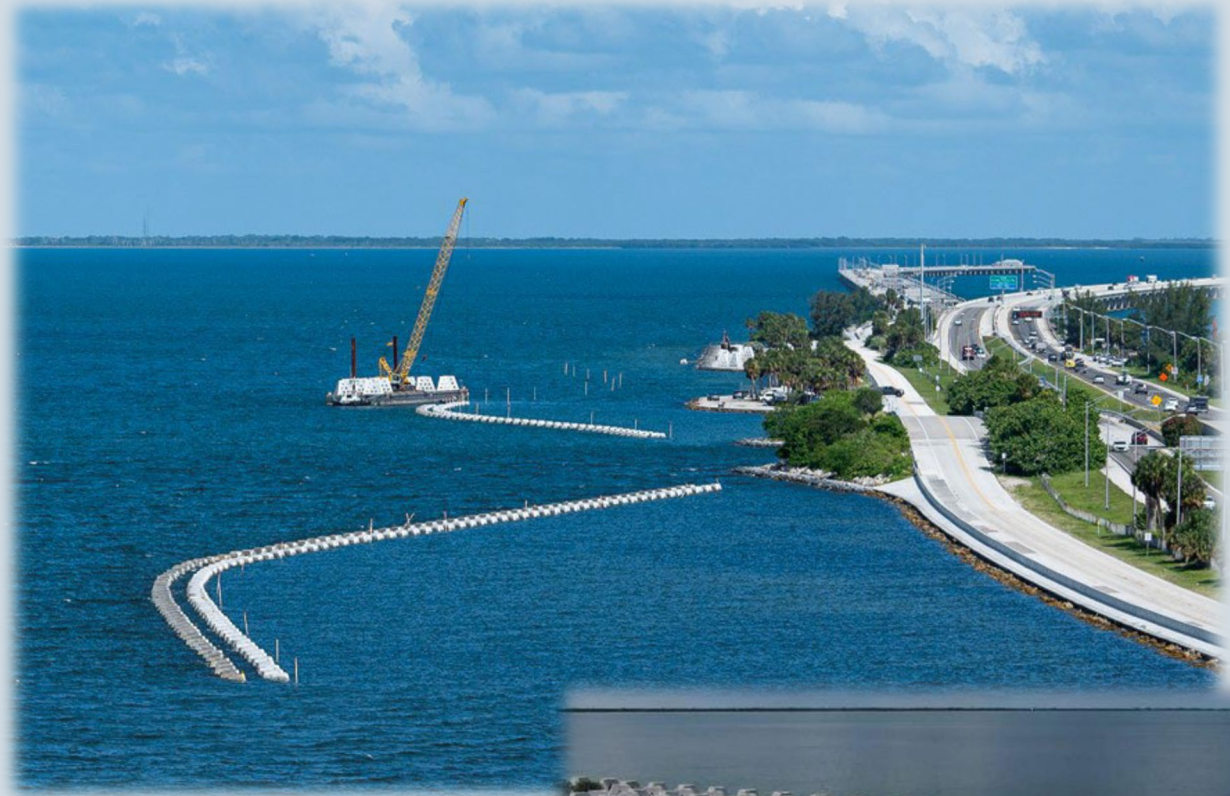
# Wave Attenuation Devices (WADs)

- Reduce damaging waves
- Reduce wave energy
- Reduce turbidity
- Increase water clarity
- Re-establish nearby vegetation
- Fish reef
- Bird perch/roosting

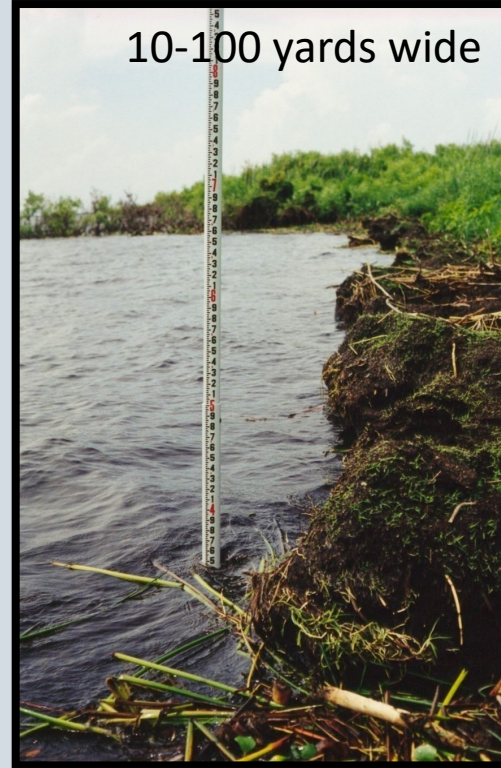
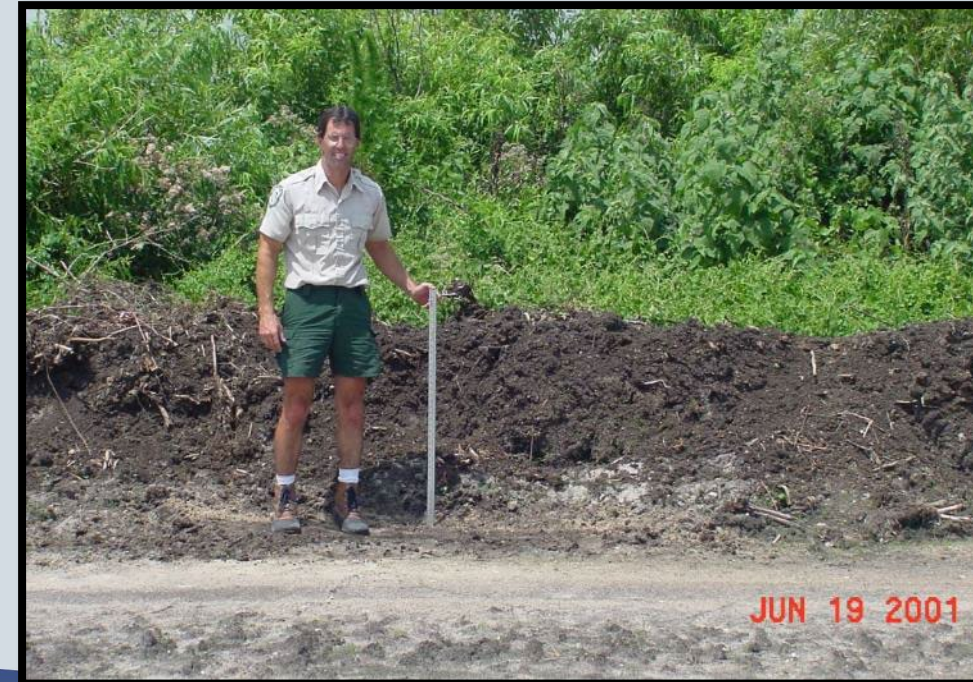
# Organic Berm Management

- Accumulation of dead vegetation from high water and storms
- Piles against cattail edge, drops to the bottom, forms a “berm”
- Accumulates over time

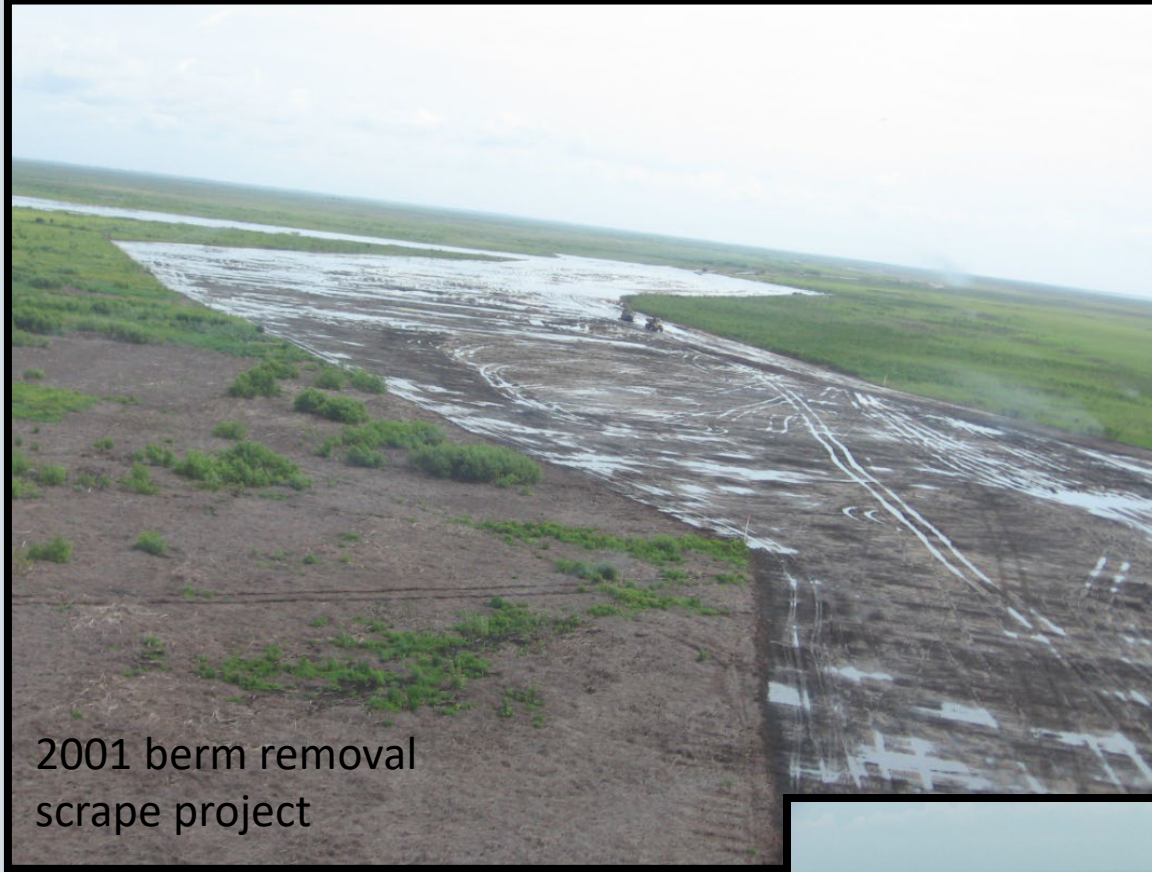
7 mile long berm

2001 berm removal  
scrape project

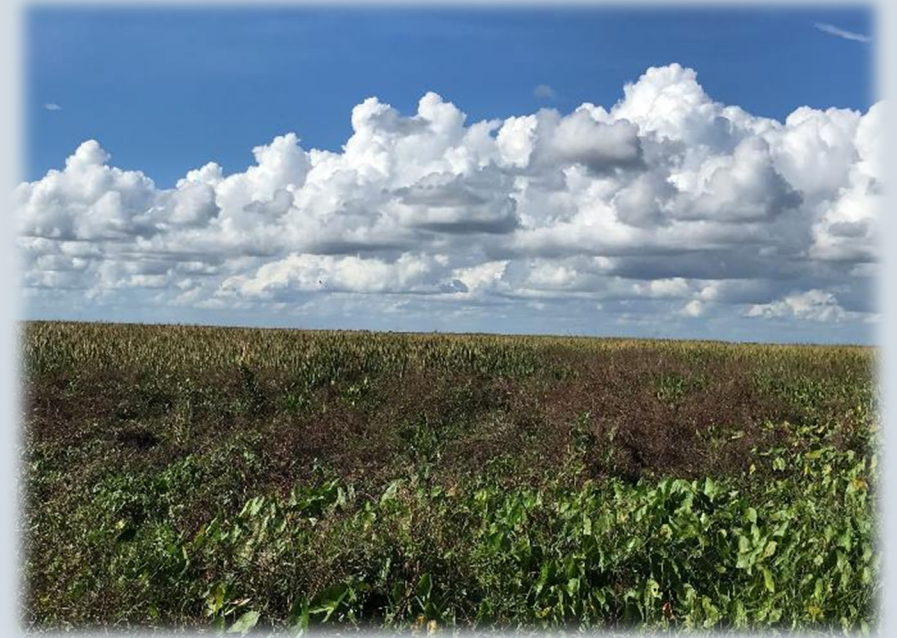
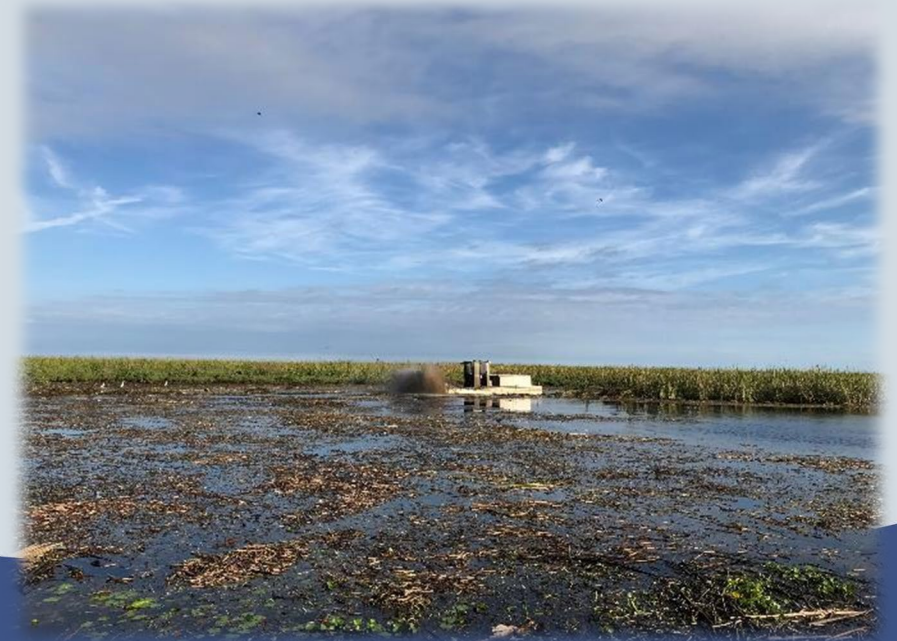
- Use Mechanical Shredders
- Target tussocks blocking navigation
- Management increases when water levels increase
- Target tussocks that form on cattail edge when water is high
