Application of 2D & 3D Hydrodynamic Models to Kissimmee River Restoration Project

Matahel Ansar, Ph.D., P.E., Jie Zeng, Ph.D., P.E., Alexandra Serna Salazar, Ph.D. South Florida Water Management District

Kissimmee River Restoration Project – S69 Weir

S69 Weir Pre-, Post-Storm and Refurbishment Scenarios HEC-RAS 2D & 3D CFD Model Assessment

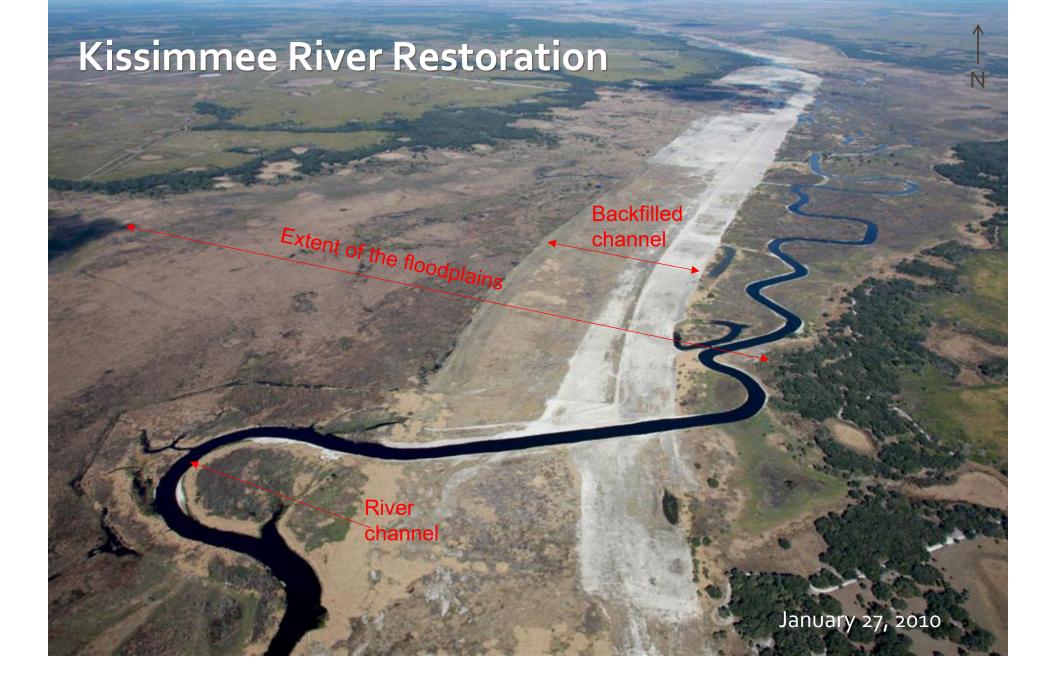
A U-shaped weir, named S69, was added at the end of the restoration reach to serve as the terminus structure and help inundate the floodplains in Pool B,C and D.

Looking north from the south end of the Phase IVB backfill which was completed in December 2009.

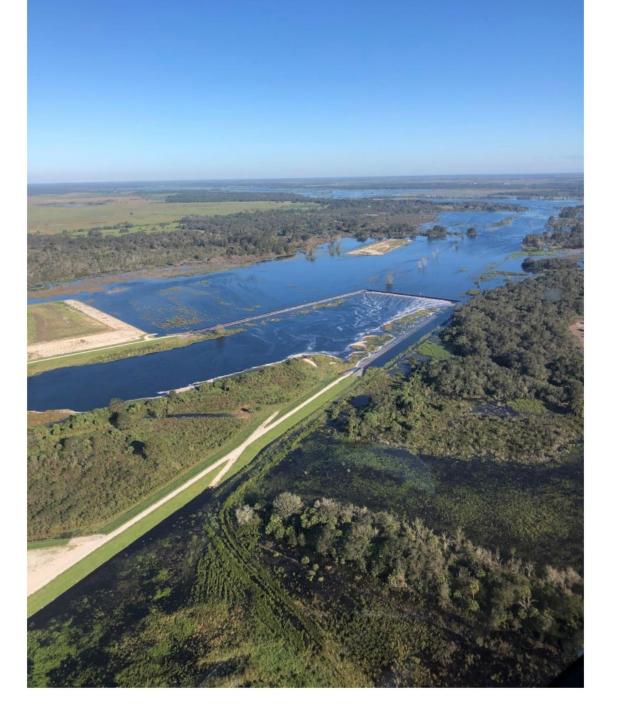
Oct 07, 2022

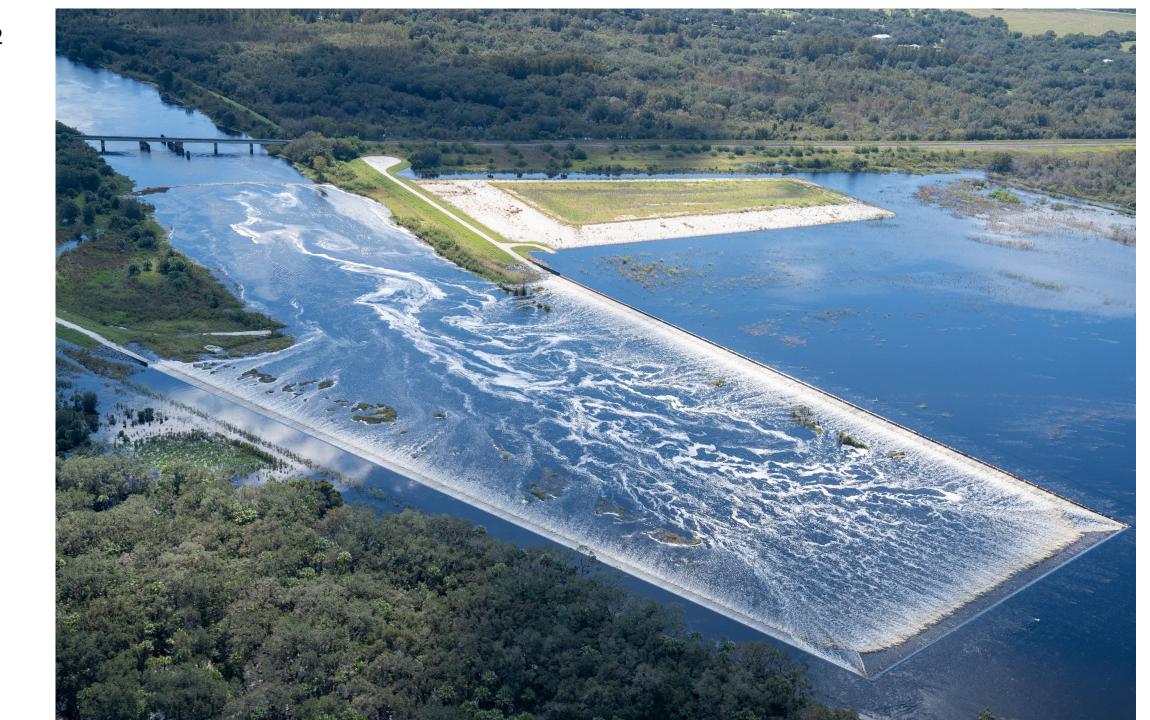
Kissimmee River Restoration S-69 Weir • January 3, 2023, aerial photo

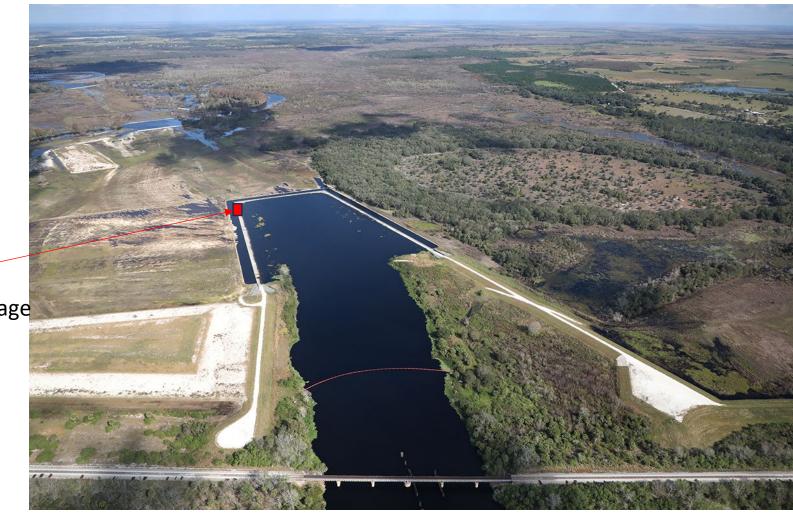
location of the damage
