Mapping Kissimmee River Floodplain Vegetation: An Approach Using Machine Learning In Small Plots

Lake and River Ecosystems Section
South Florida Water Management
District

Greater Everglades Ecological
Restoration Conference

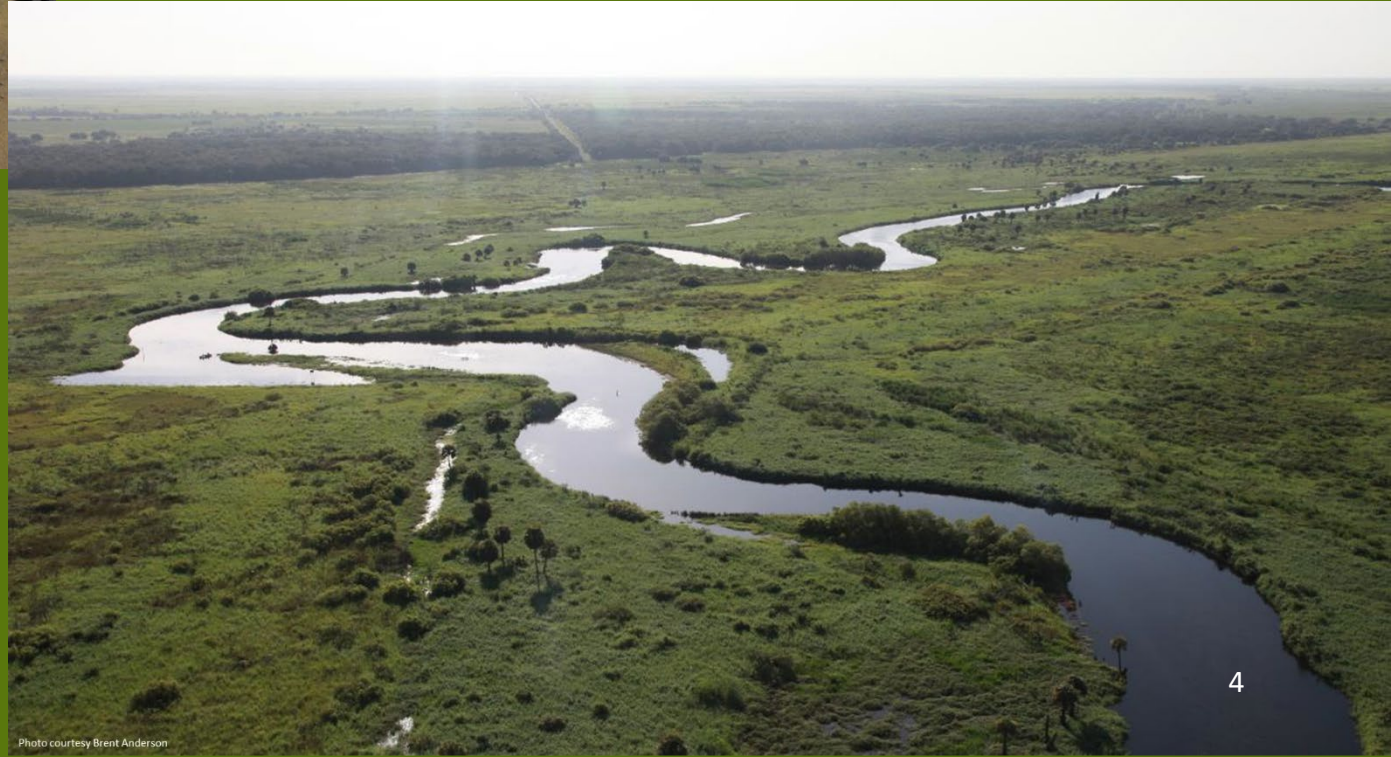
Kissimmee Restoration Project :

- Backfilled one-third of C-38 canal
- Re-established flow to 40-50 miles of river channel
- Potential inundation re-established to roughly 25,000 acres of floodplain area
- Intermittent floodplain inundation re-established

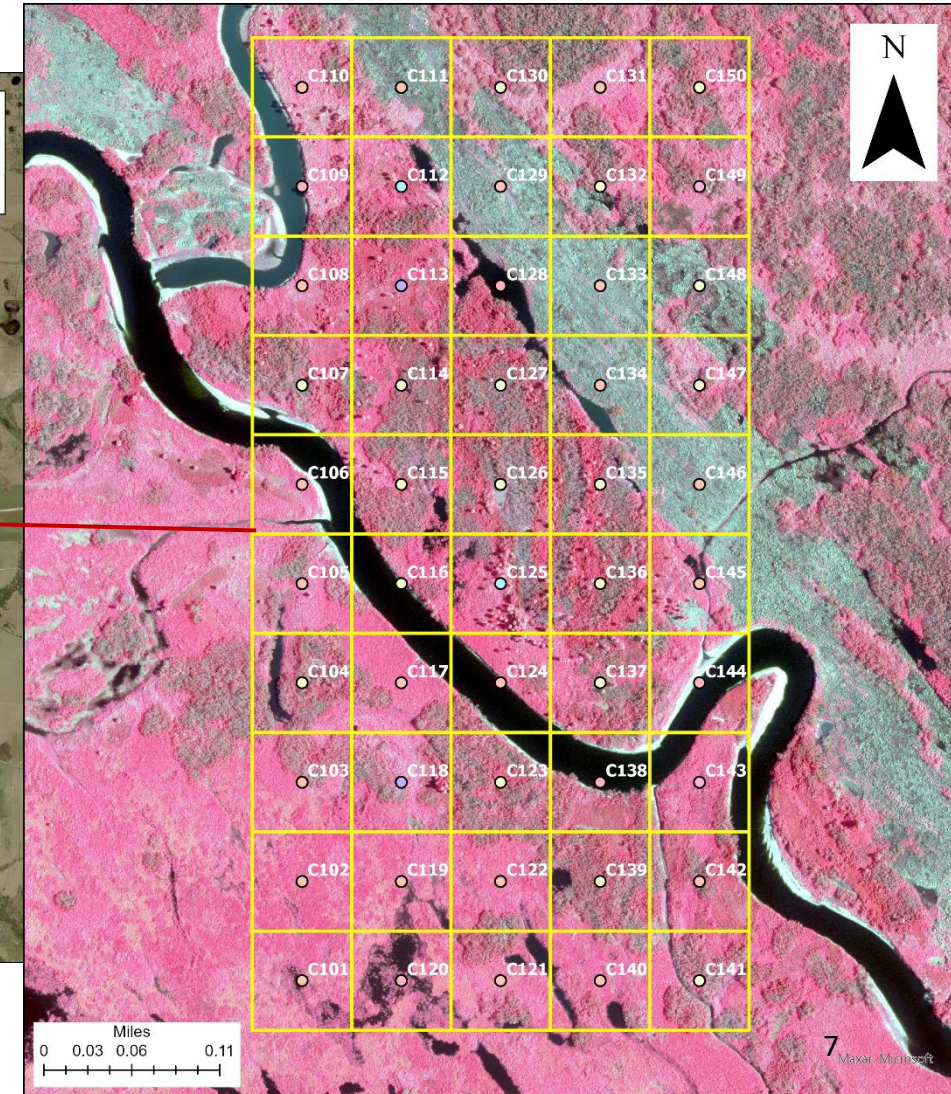
2023 Aerial Images in CIR

- For 2023 mapping effort, we began using grids of fifty 1-hectare cells (called Sentinel Sites) to collect vegetation signatures by helicopter and airboat
- When in helicopter, we collect GoPro video transects in these grids to maximize the generation of signatures
- Use ML techniques to map these smaller sites
- Then extrapolate to full floodplain extent

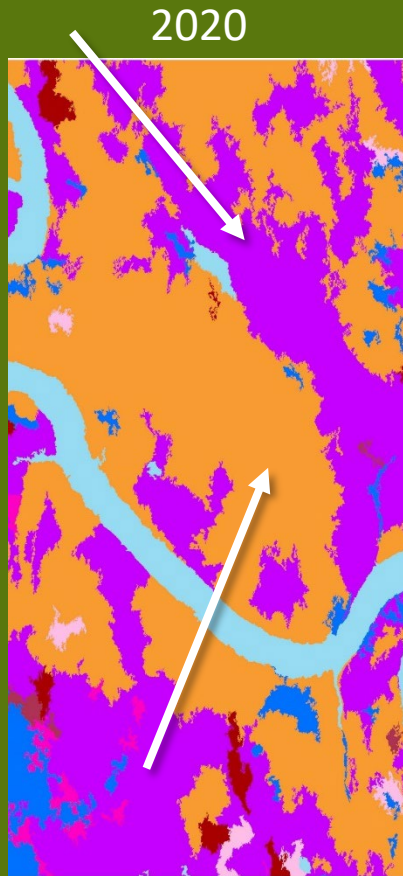
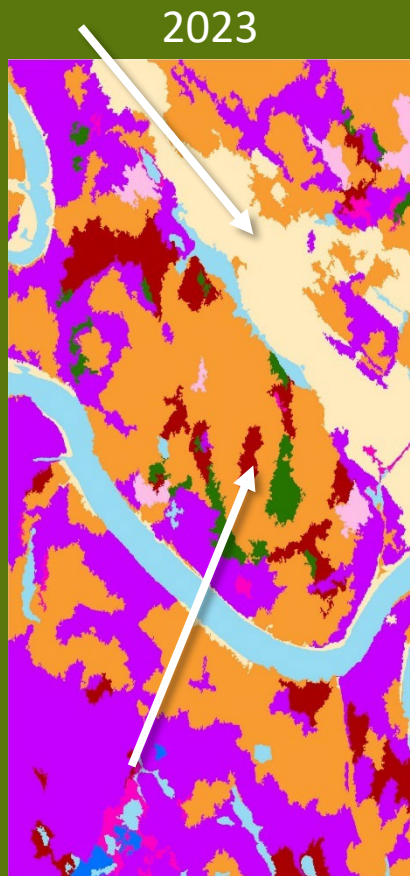
Site C10

- 2023 generally similar to 2020 map with some apparent differences.
- Herbicide spraying caused increase in bare ground areas.
- Possible confusion between buttonbush and willow apparent here.
- Possible confusion between WP and AQ apparent here.
- Decrease in hibiscus.
- Increase in wet prairie including smartweed and bulrush in some areas.
