Restoring the Pre-Development Hydrologic Regime in the Picayune Strand Restoration Project Area

**Michael Duever
Natural Ecosystems**

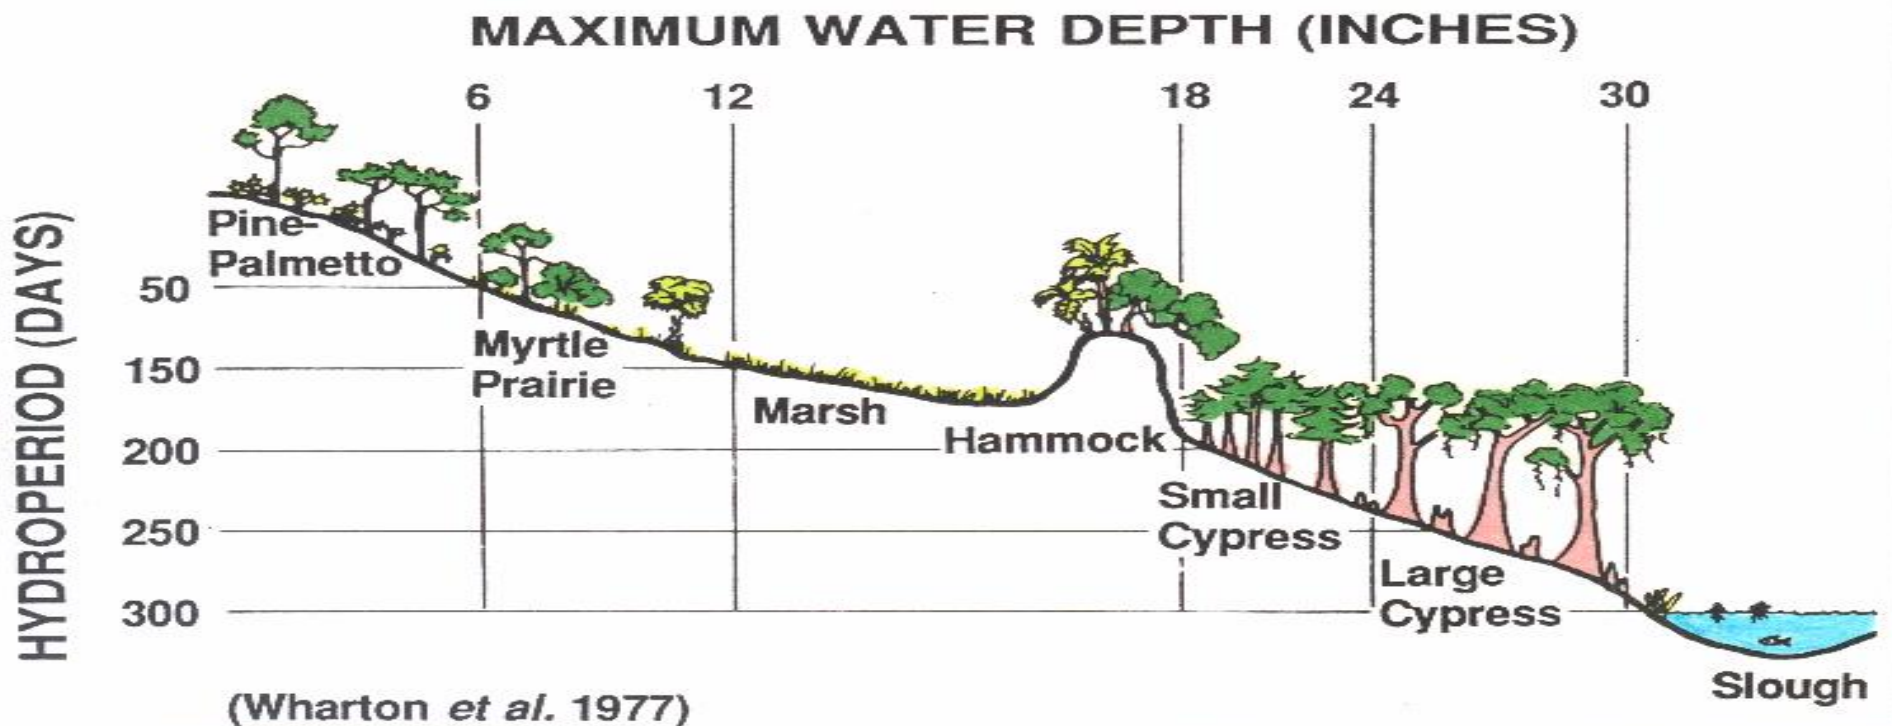
- Full Range of Wetland Communities Exists Over a 24 in Topographic Gradient

HYDROPERIODS AND MAXIMUM WATER DEPTHS

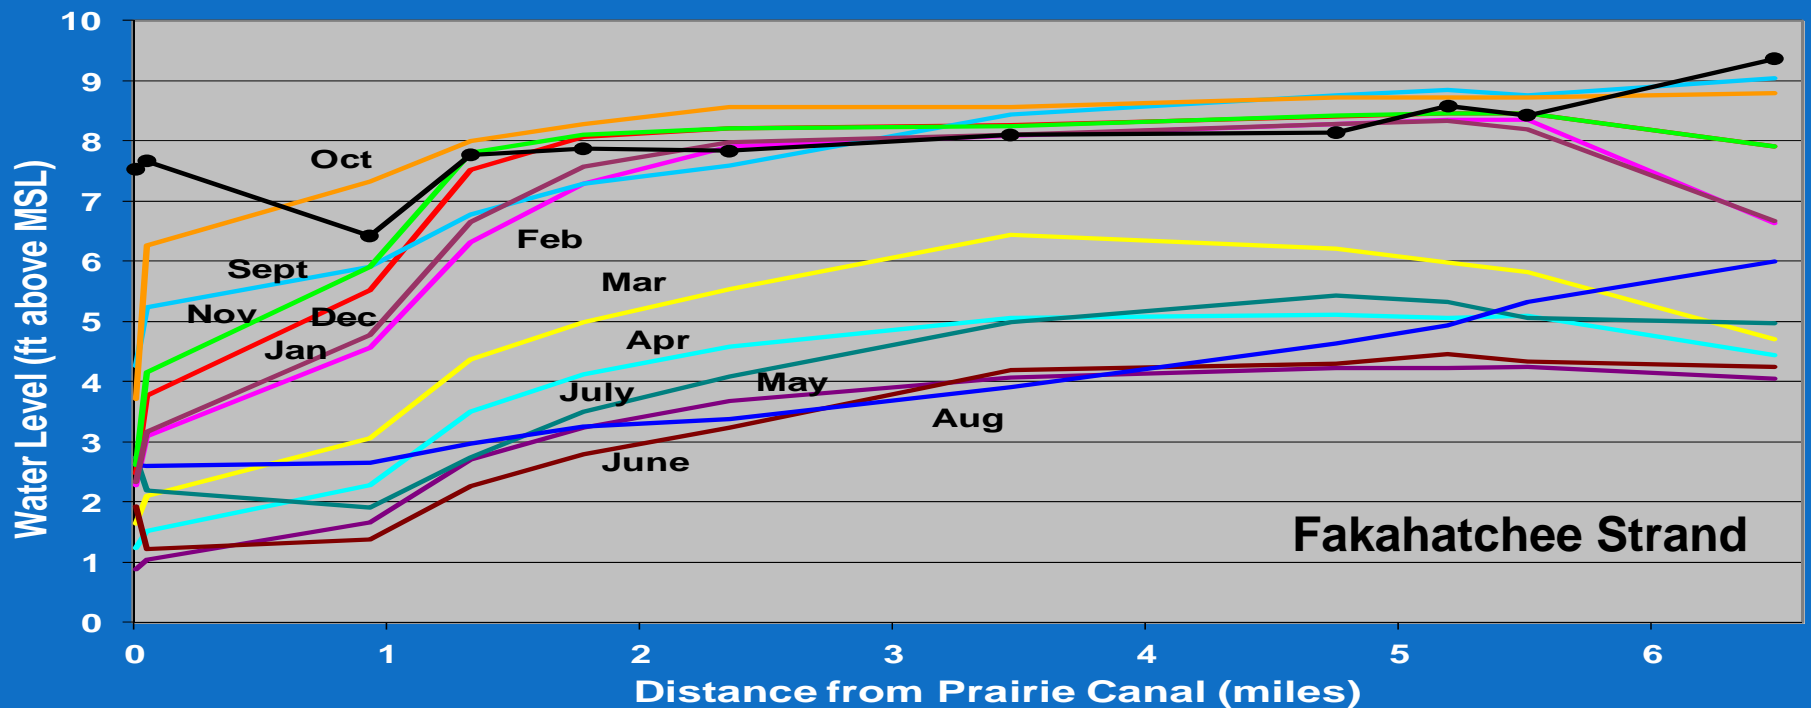
- Substrates are Very Porous with 2-5 ft Water Table Drawdowns Extending Miles from Canal

2000 Monthly Water Table Profiles - North Transect Wells

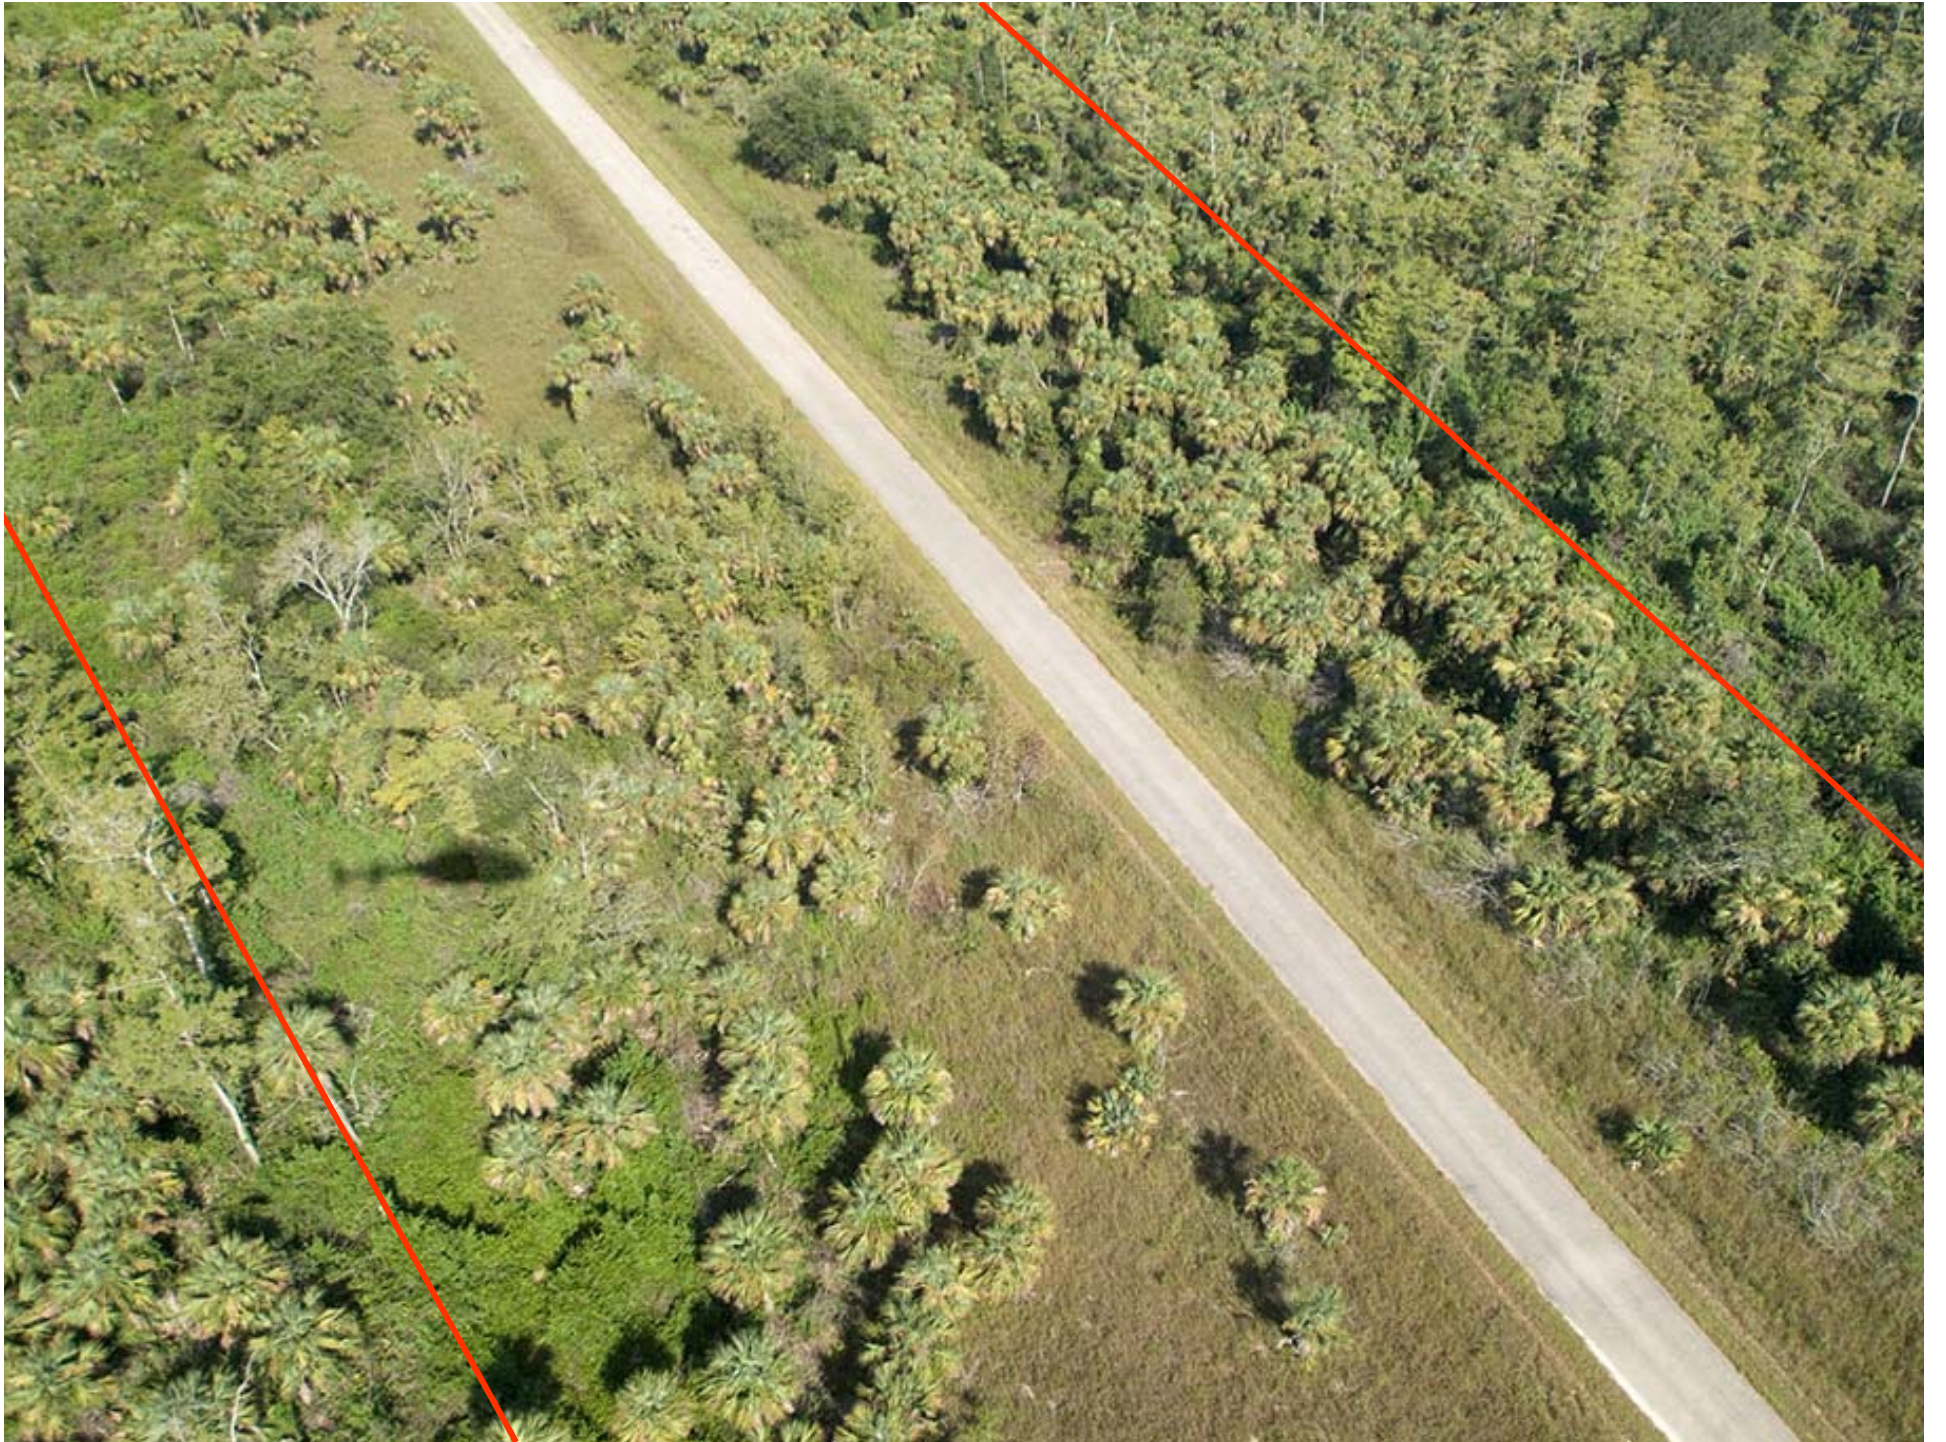
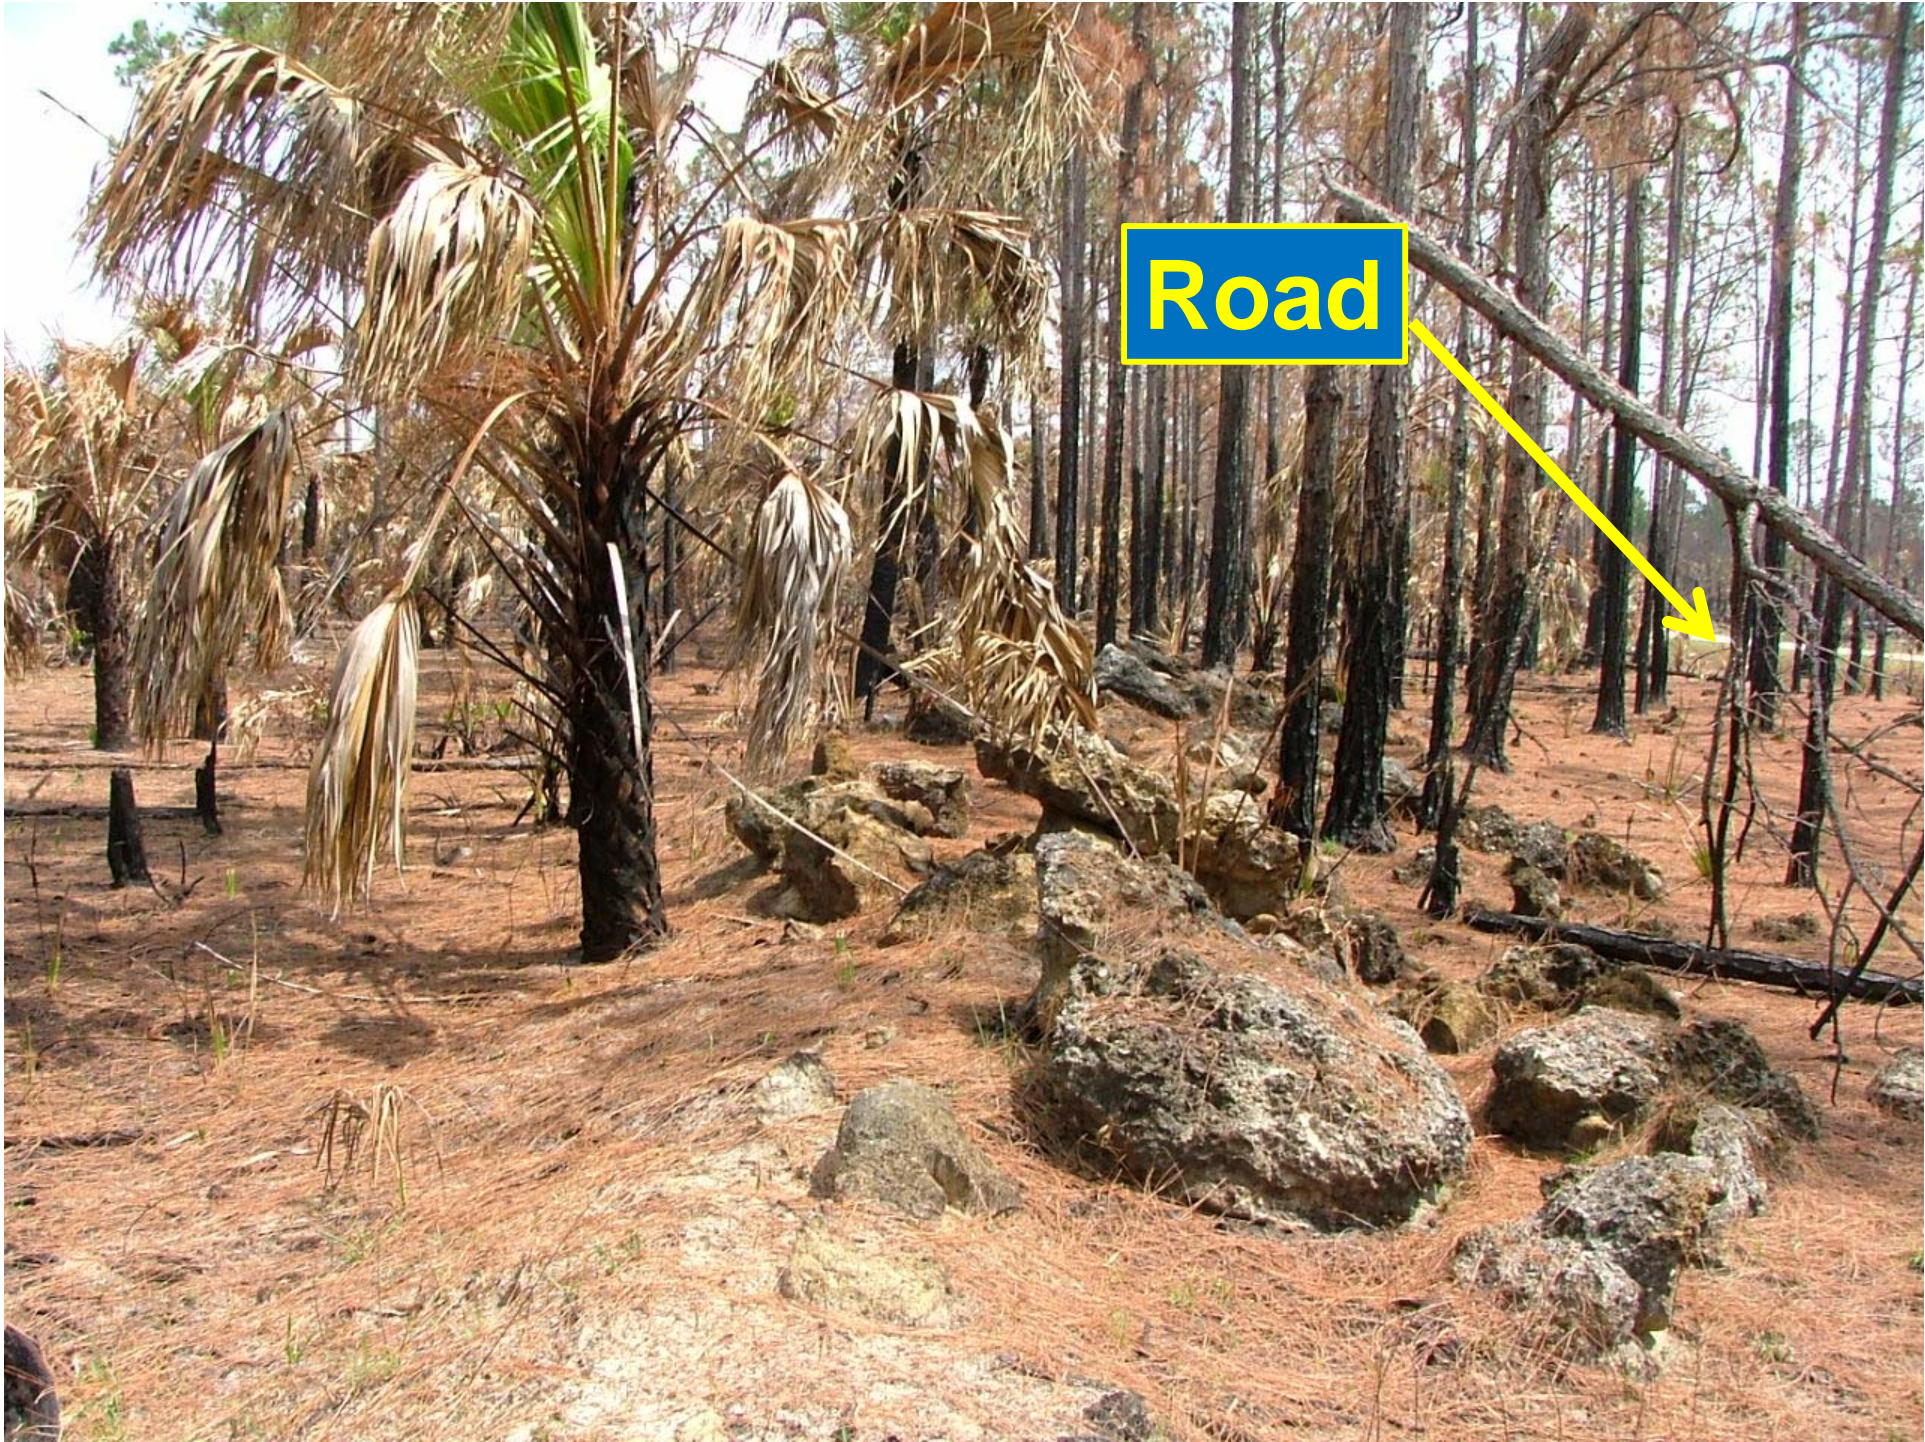
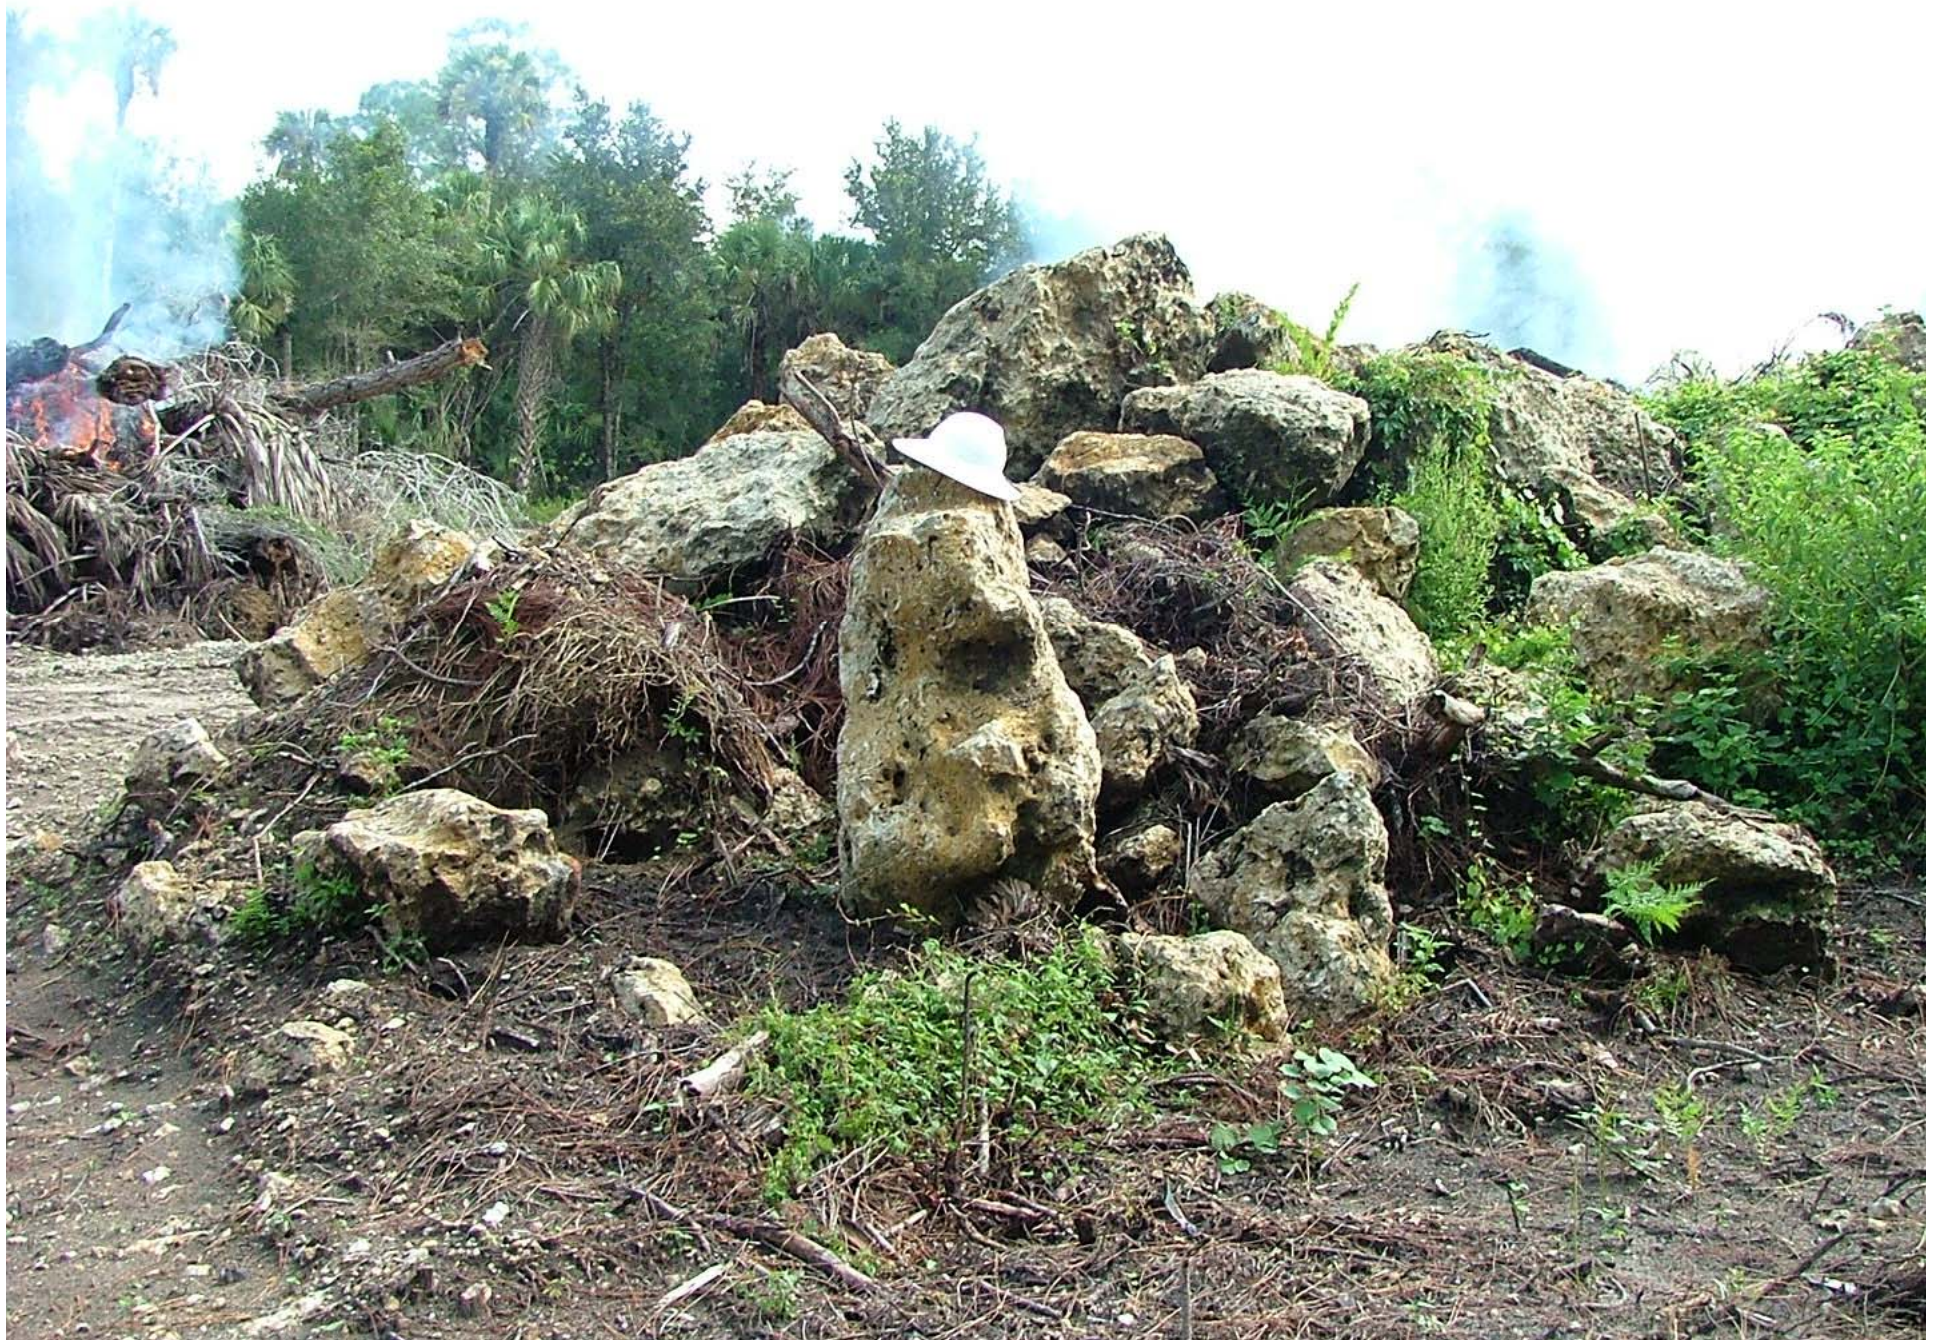
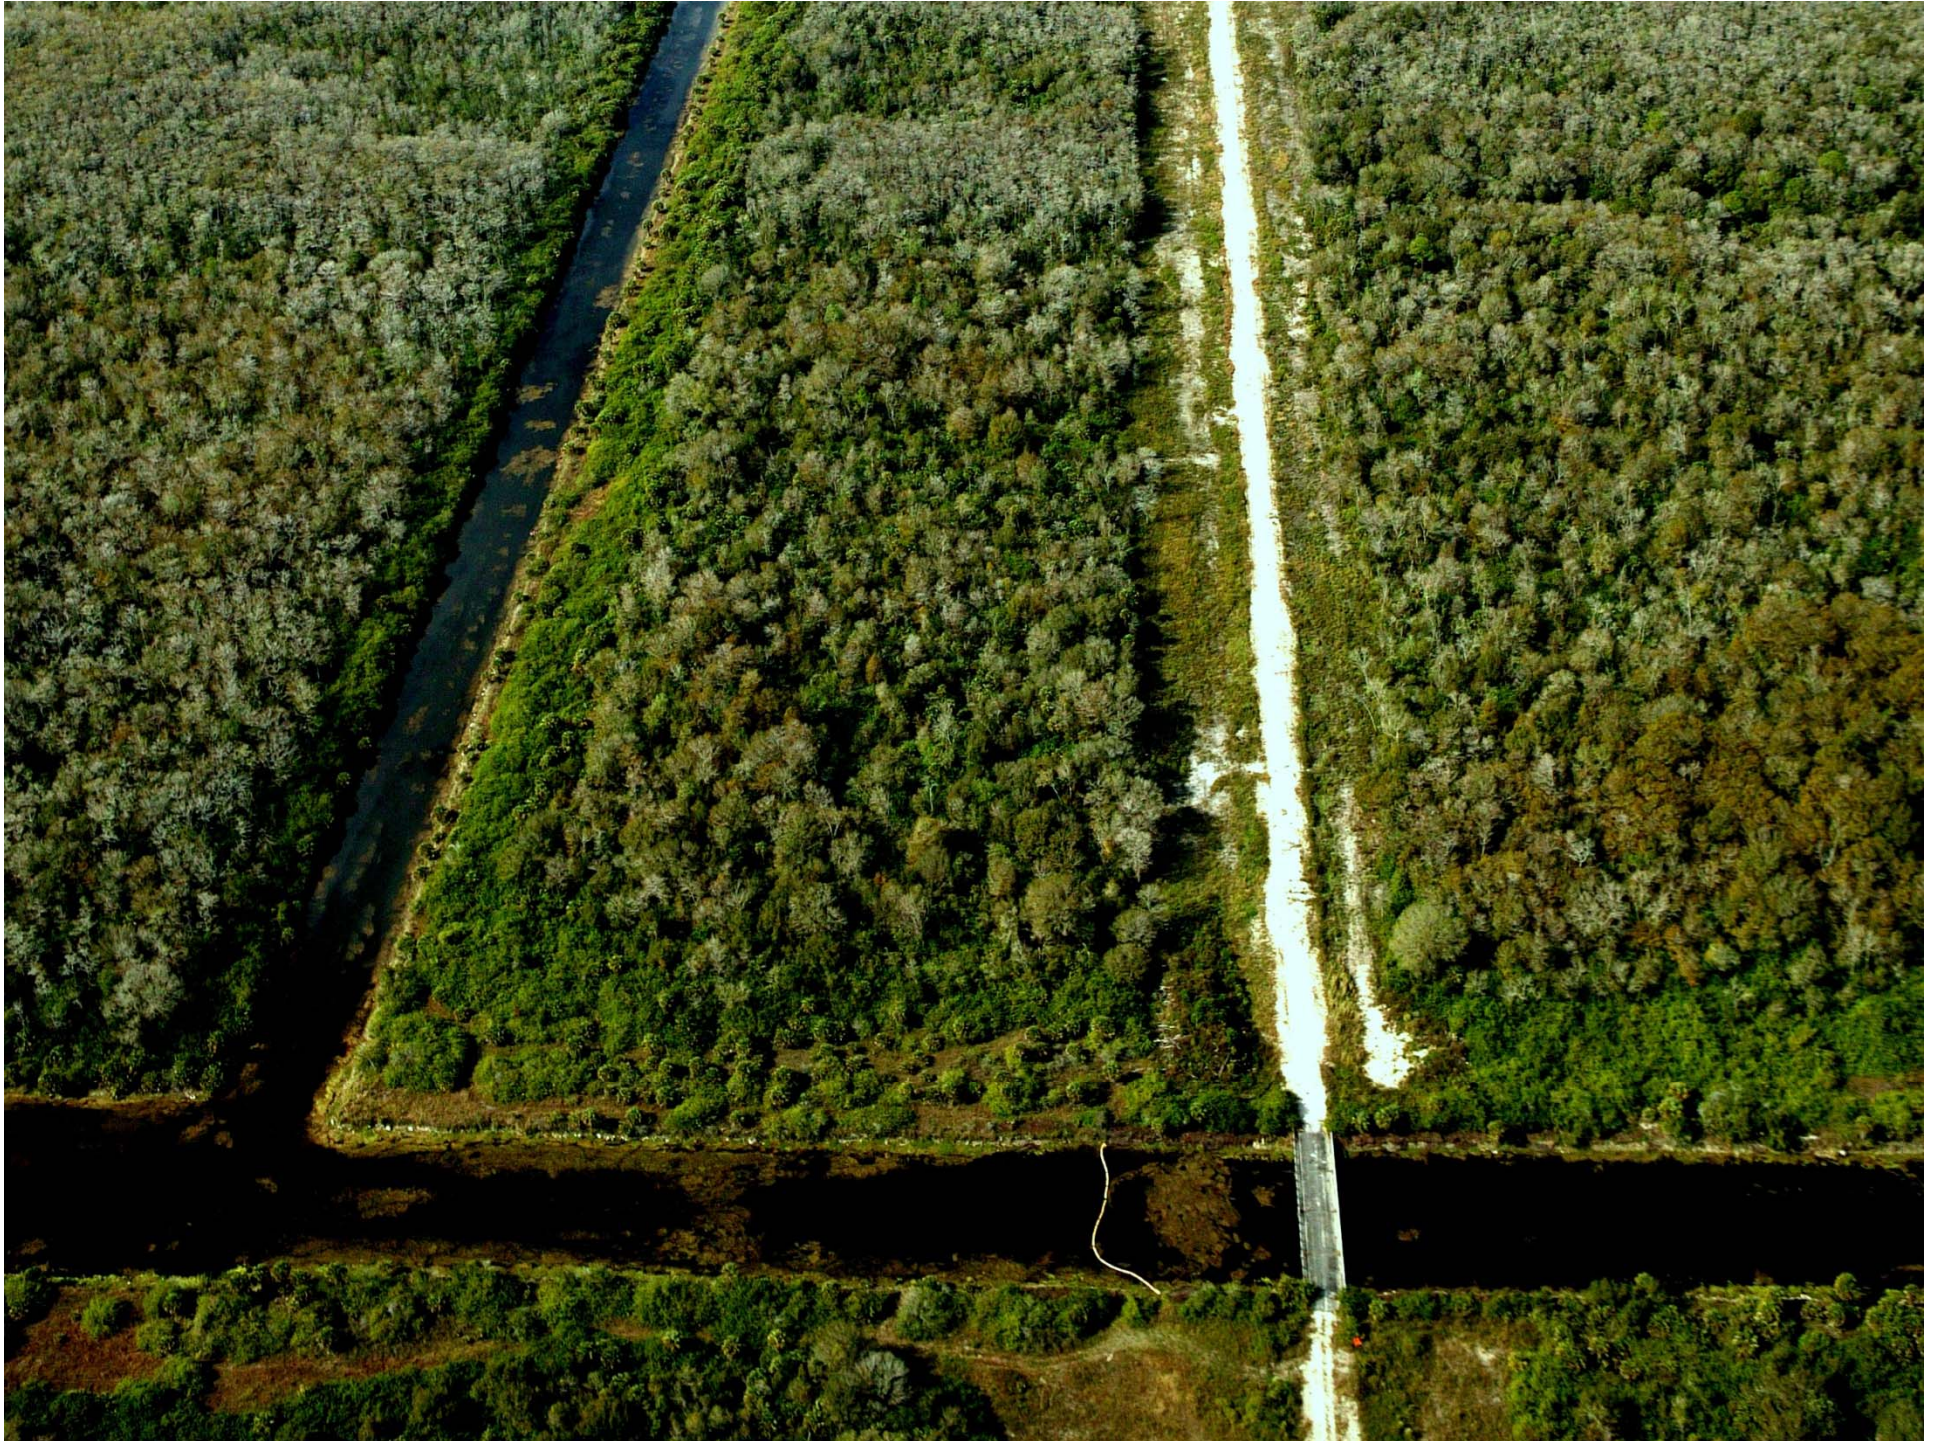
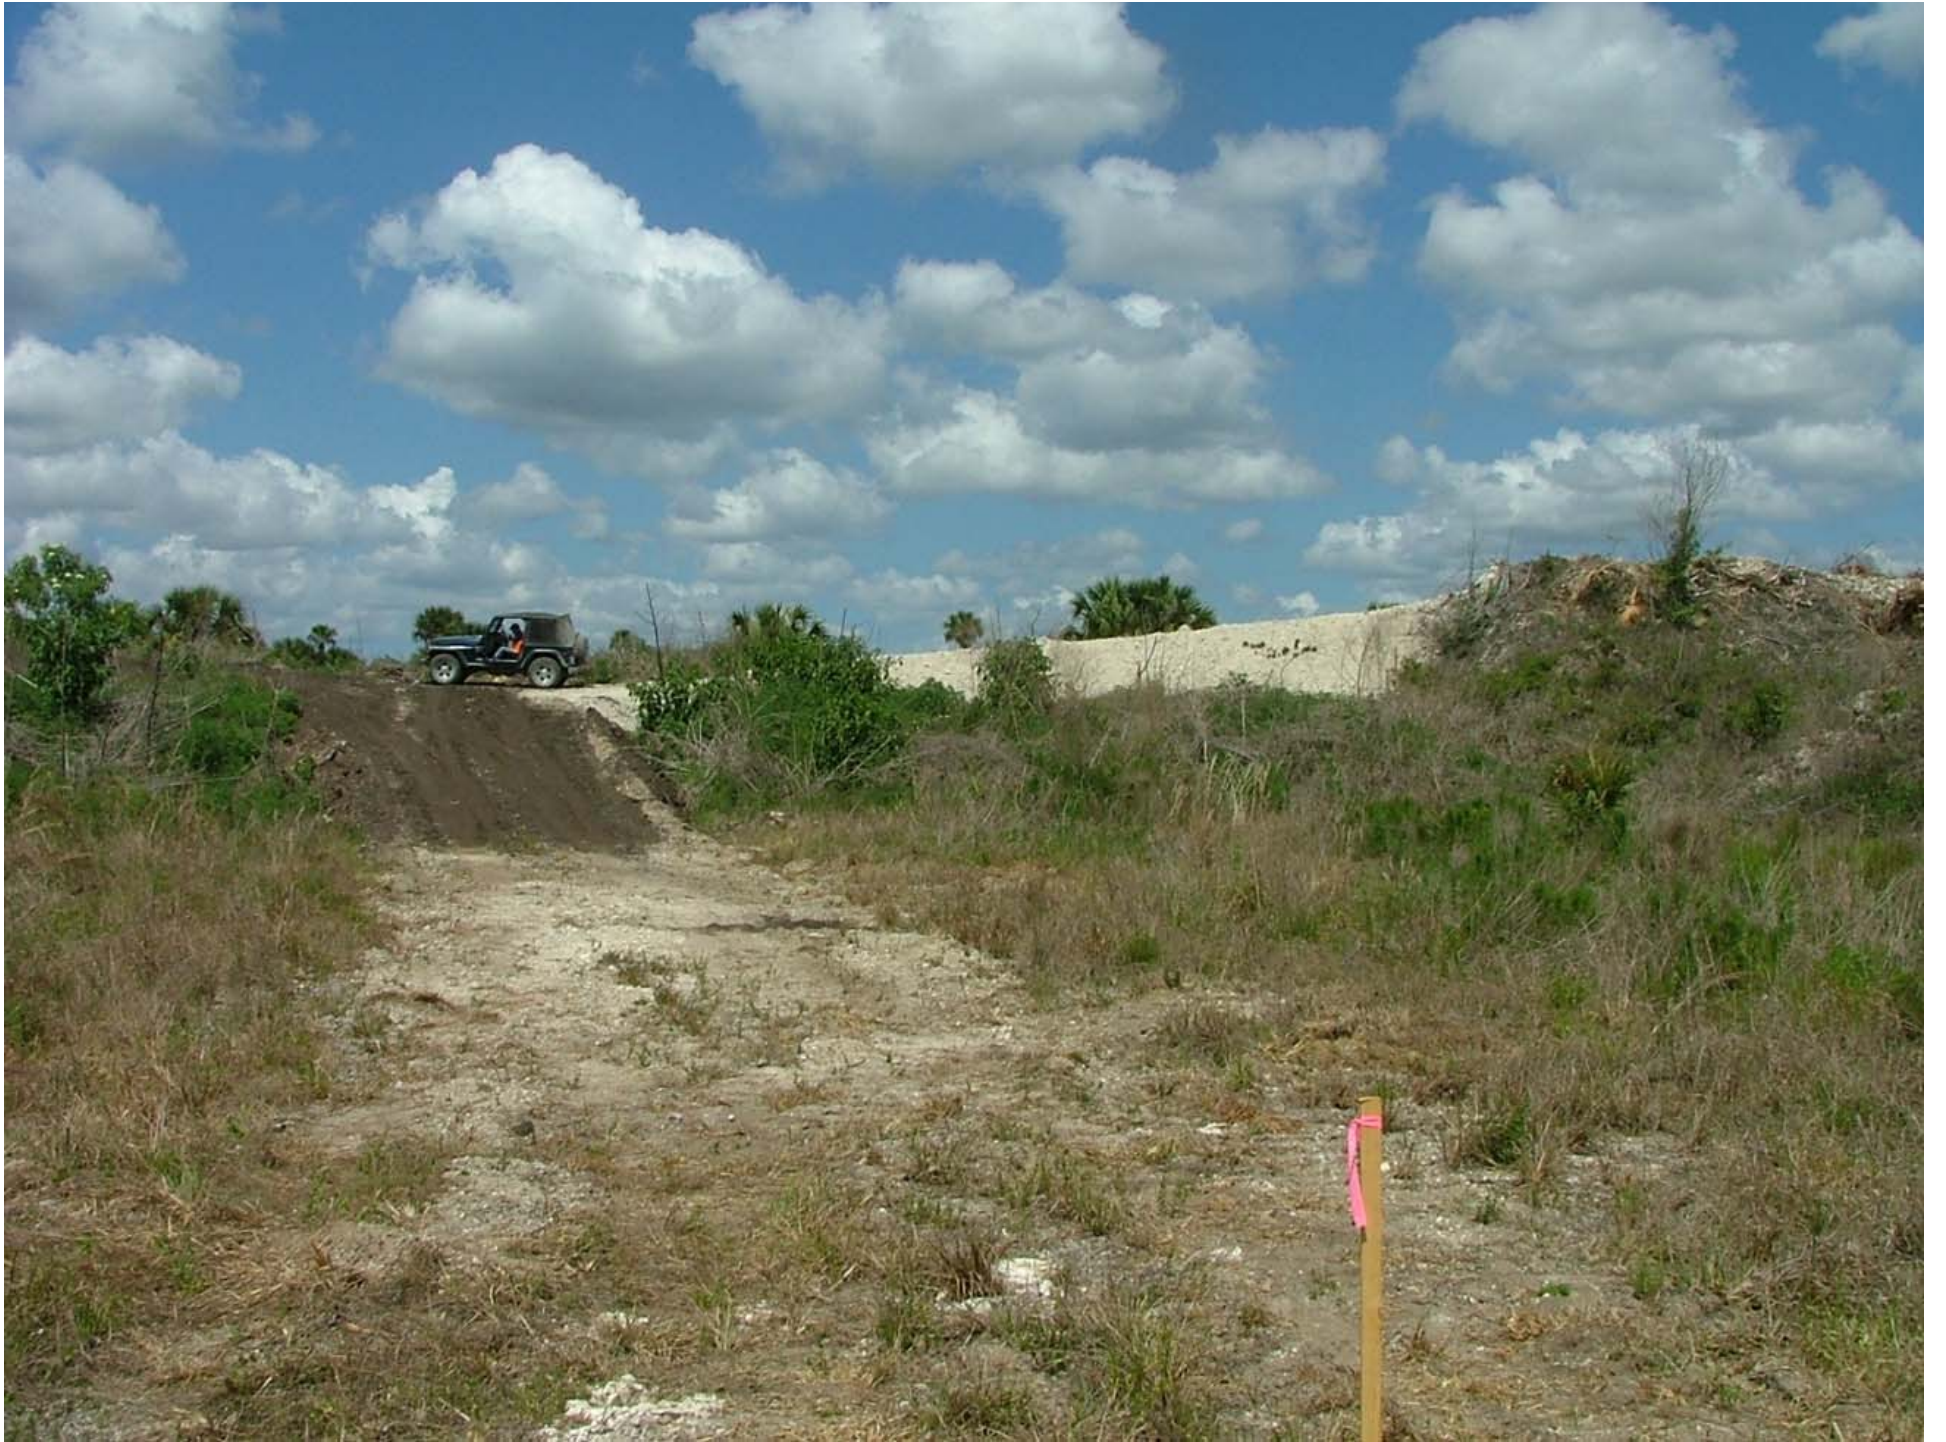
Road

- **Develop Specifications That Allow for Realistic Cost Estimates**
- **Spoil Covered with 40 Years Growth of Vegetation**
 - **What is Spoil and What is Vegetation**

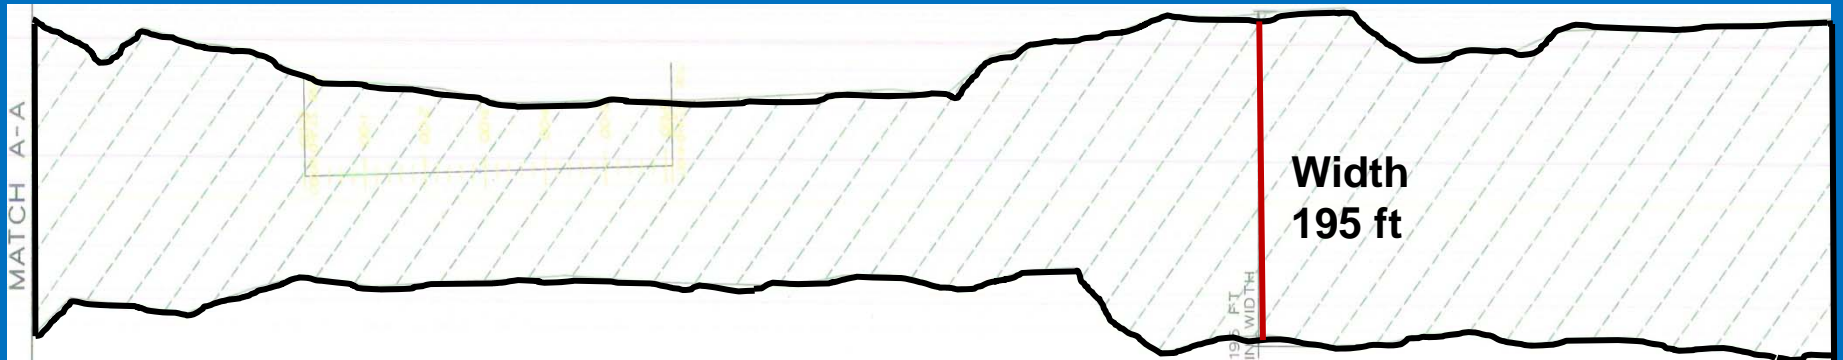
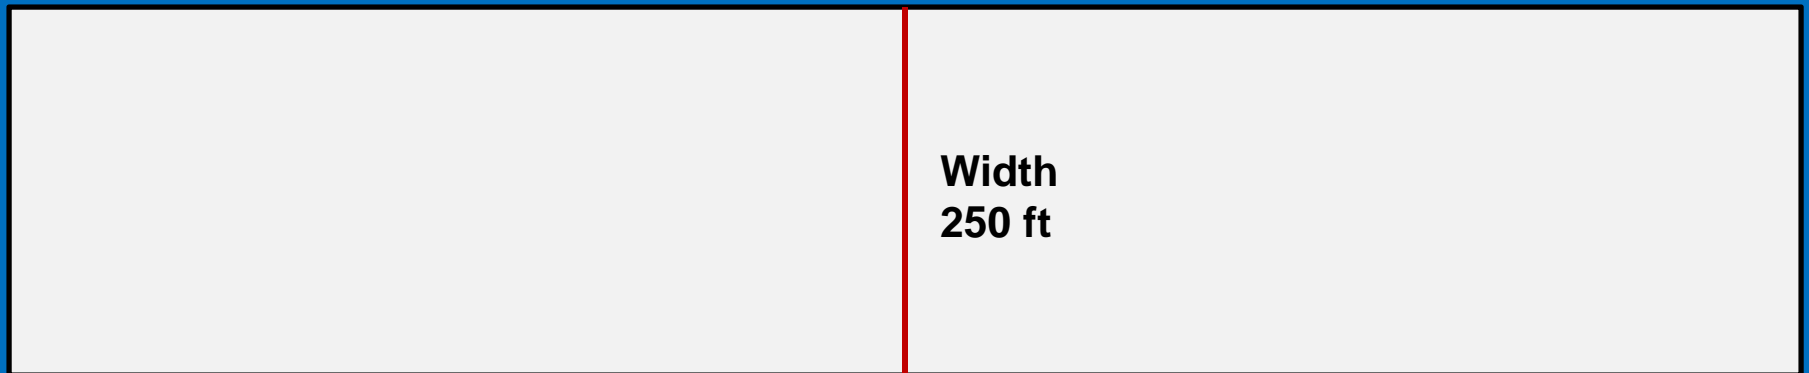
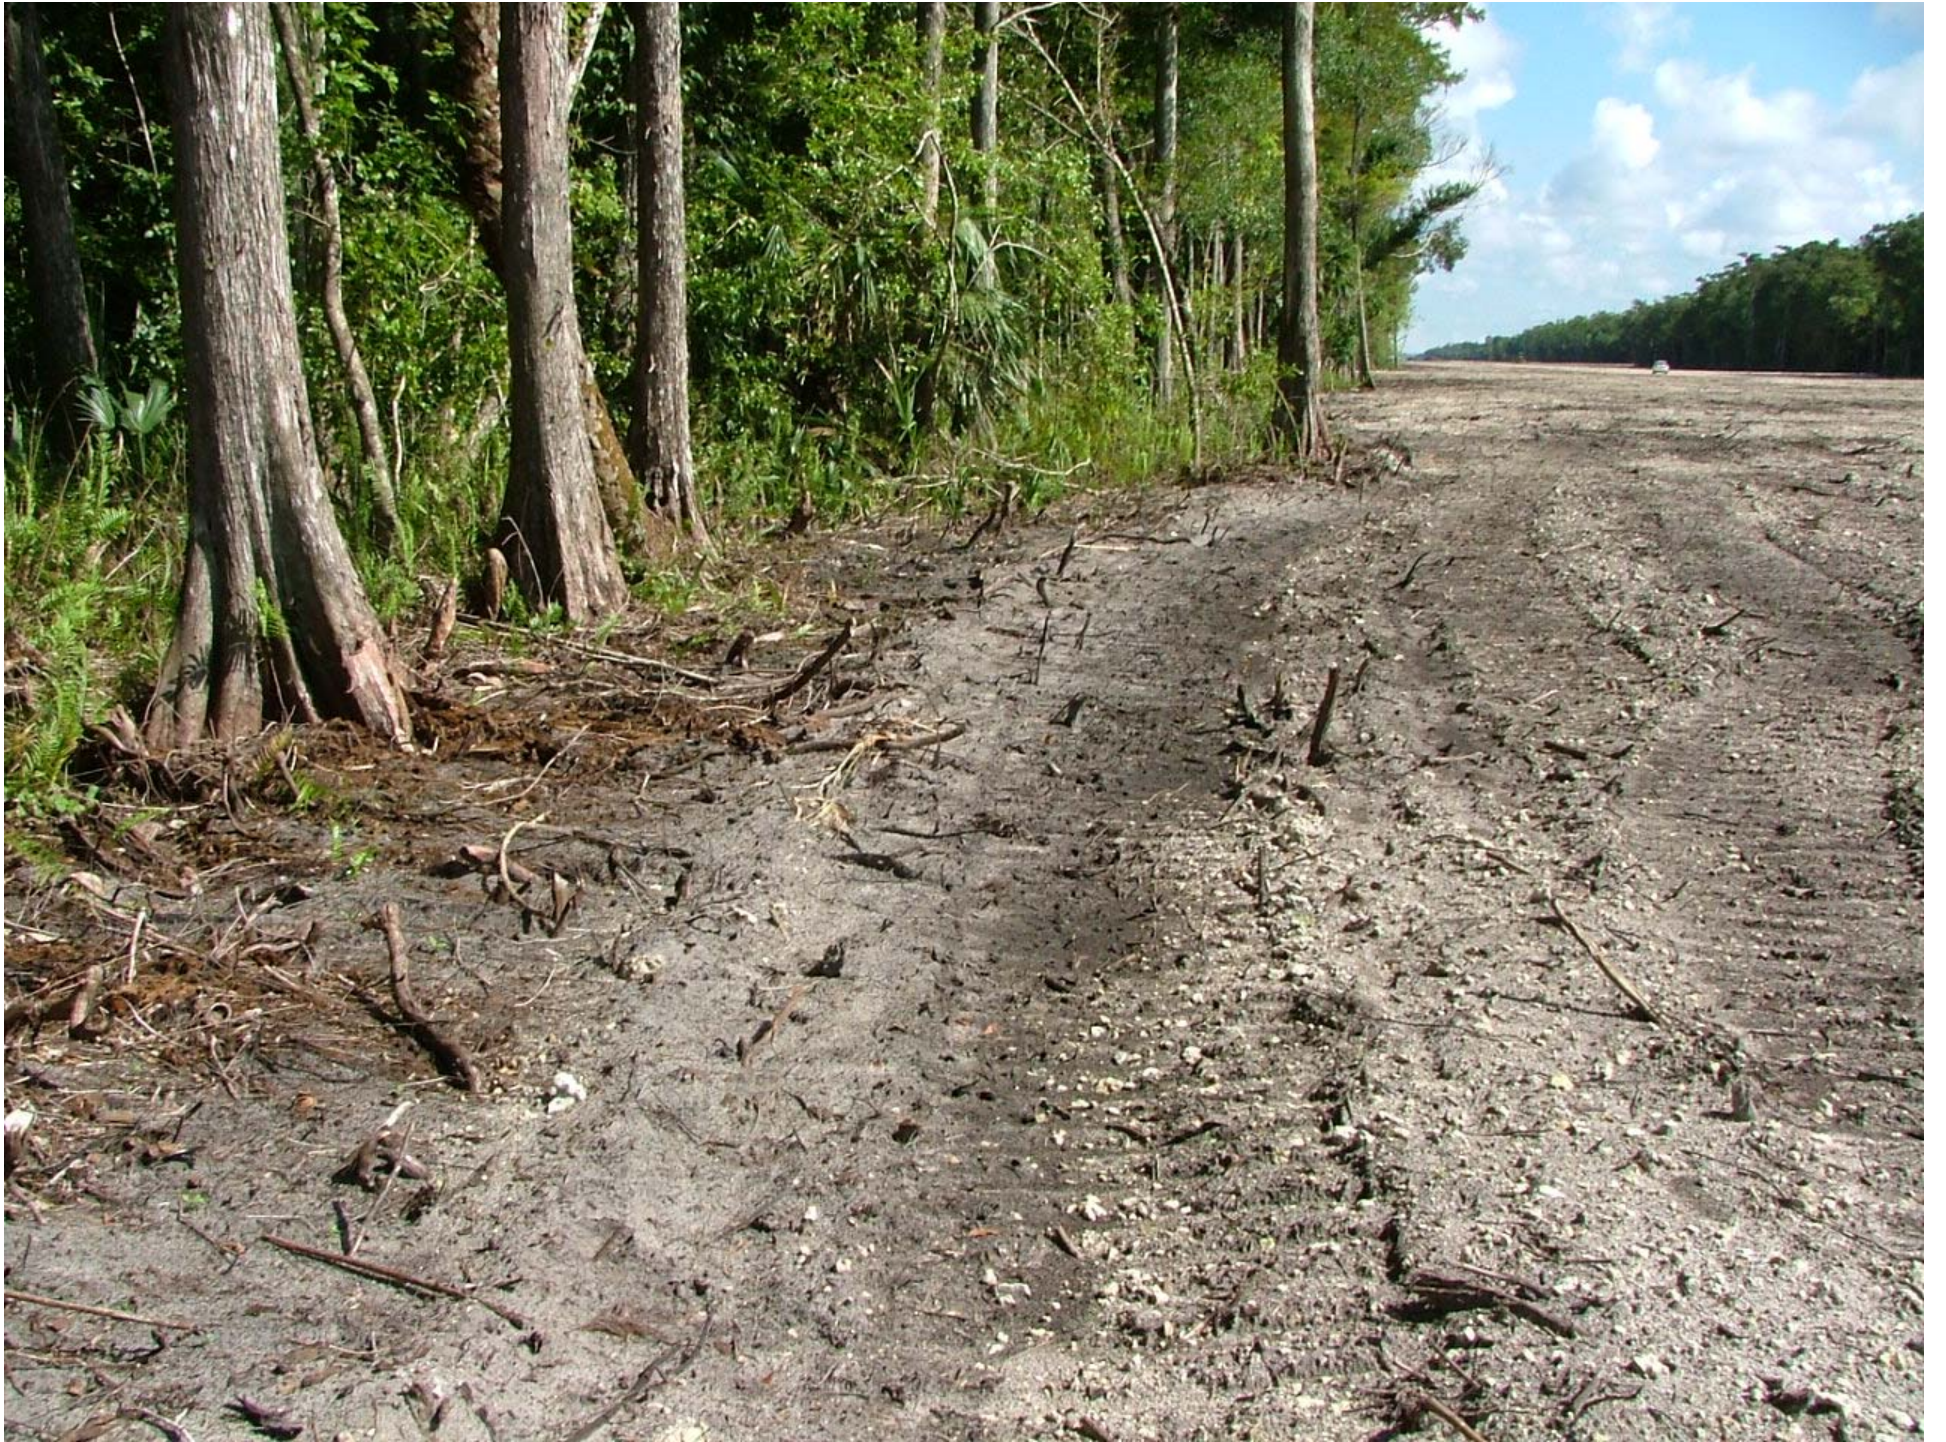
**Width of Clearing - To Outside Edge of Spoil
Approximately 250 ft**

First Contractor – Paid by the Linear Foot of Road

Second Contractor – Paid by the Acre of Cleared Area

- Originally Surveyed for Spoil Only 75 ft from Road Centerline
 - Subsequently Agreed to **Approximately** 250 ft Width of Clearing, But Clearing Should not Extend Beyond Where the Spoil Ended
 - Also, Clearing Was not Necessarily Based on the Road Centerline
