Restoring the Pre-Development Hydrologic Regime in the Picayune Strand Restoration Project Area

**Michael Duever
Natural Ecosystems**

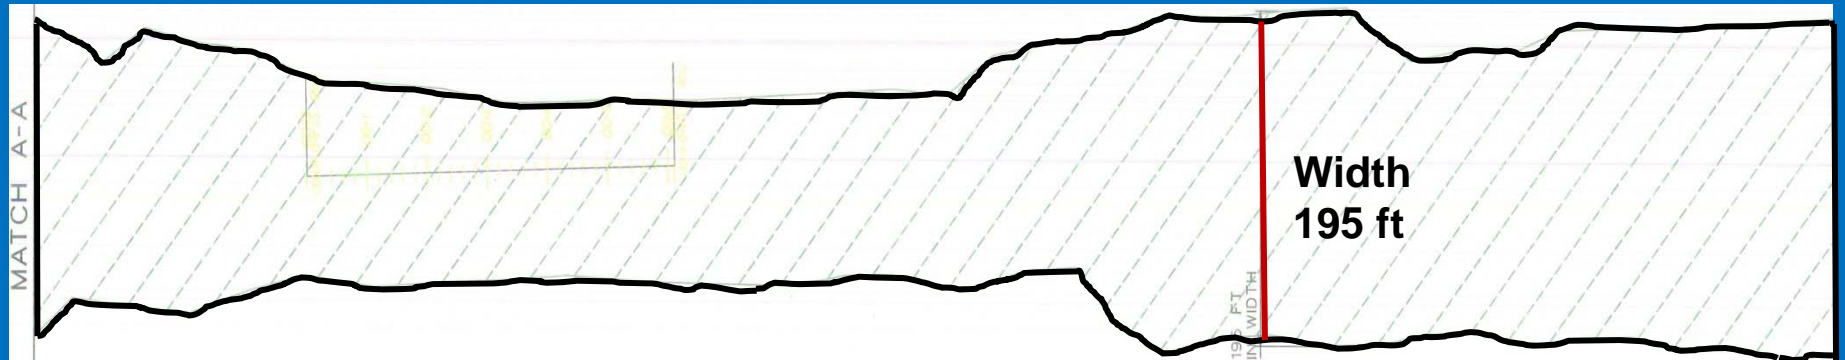
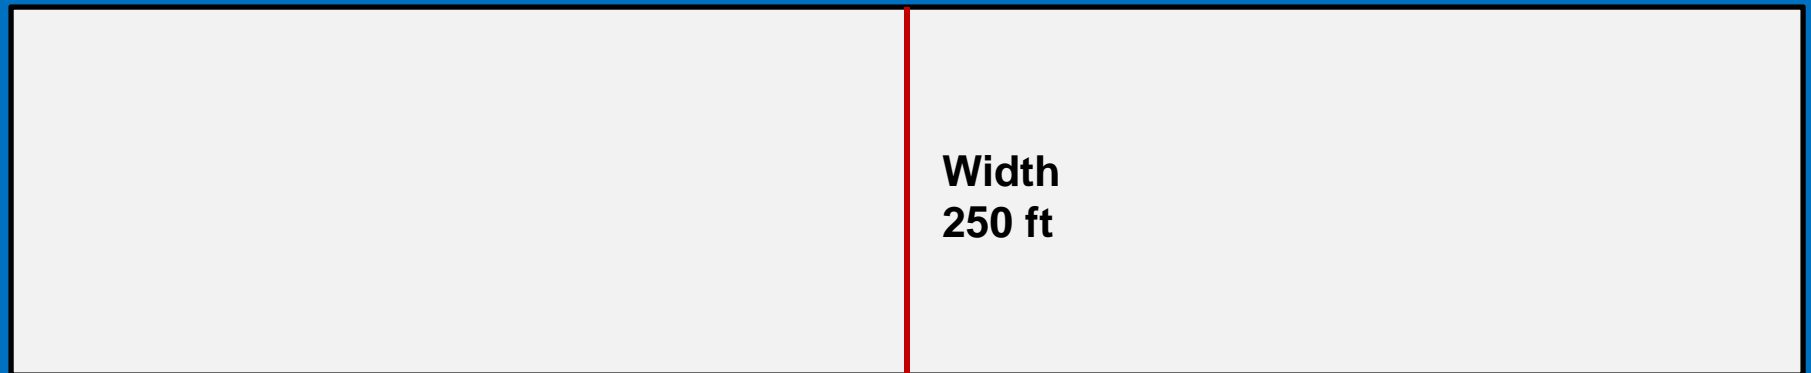
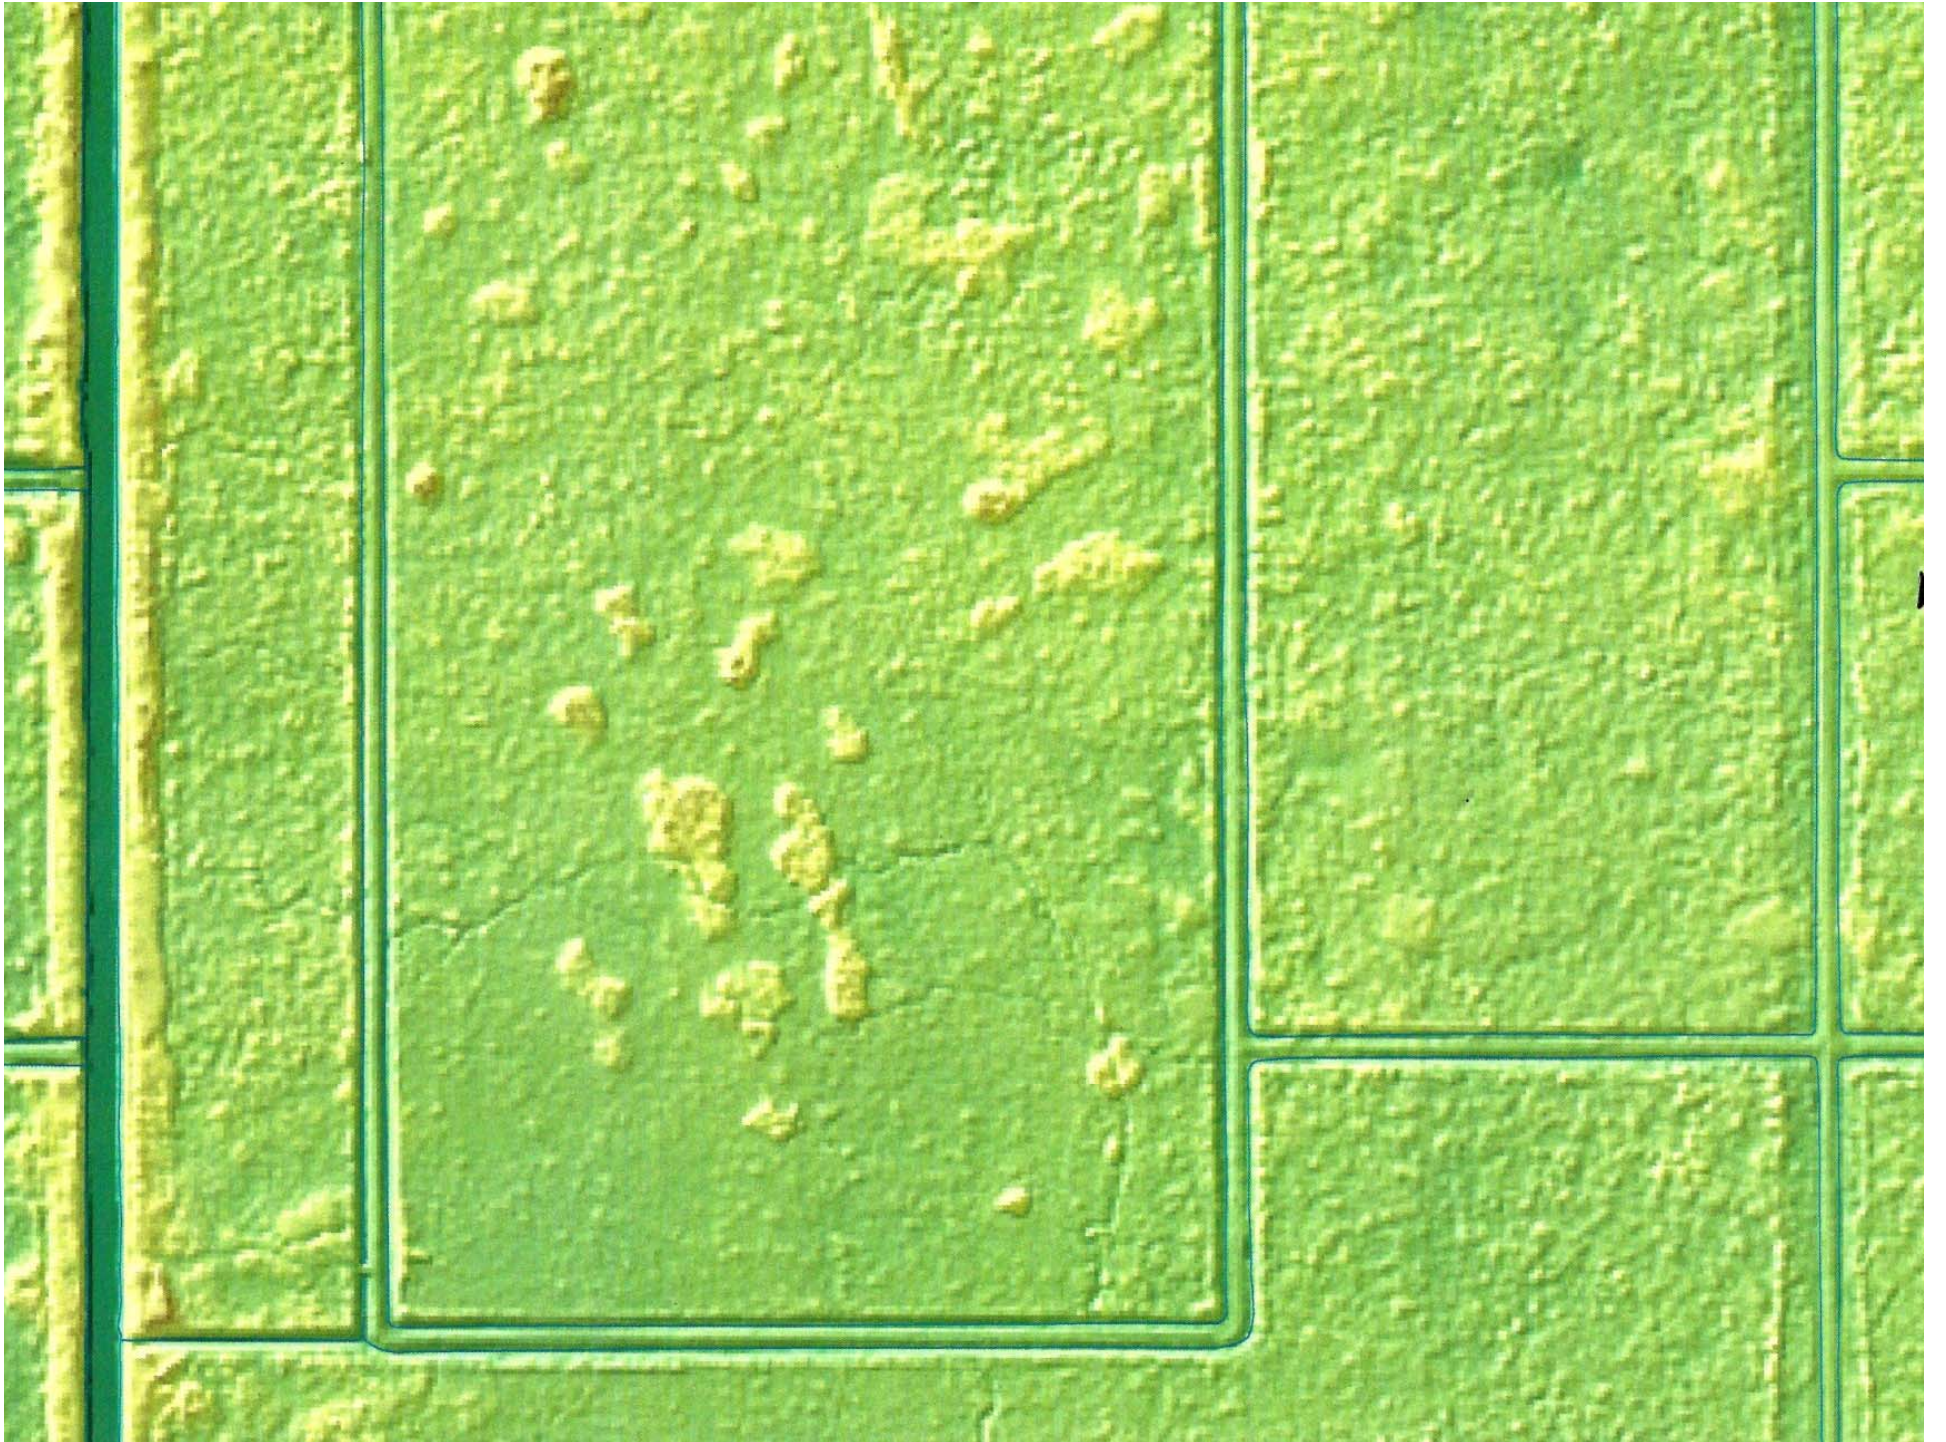
Width of Clearing - To Outside Edge of Spoil Approximately 250 ft

First Contractor – Paid by the Linear Foot of Road

Second Contractor – Paid by the Acre of Cleared Area

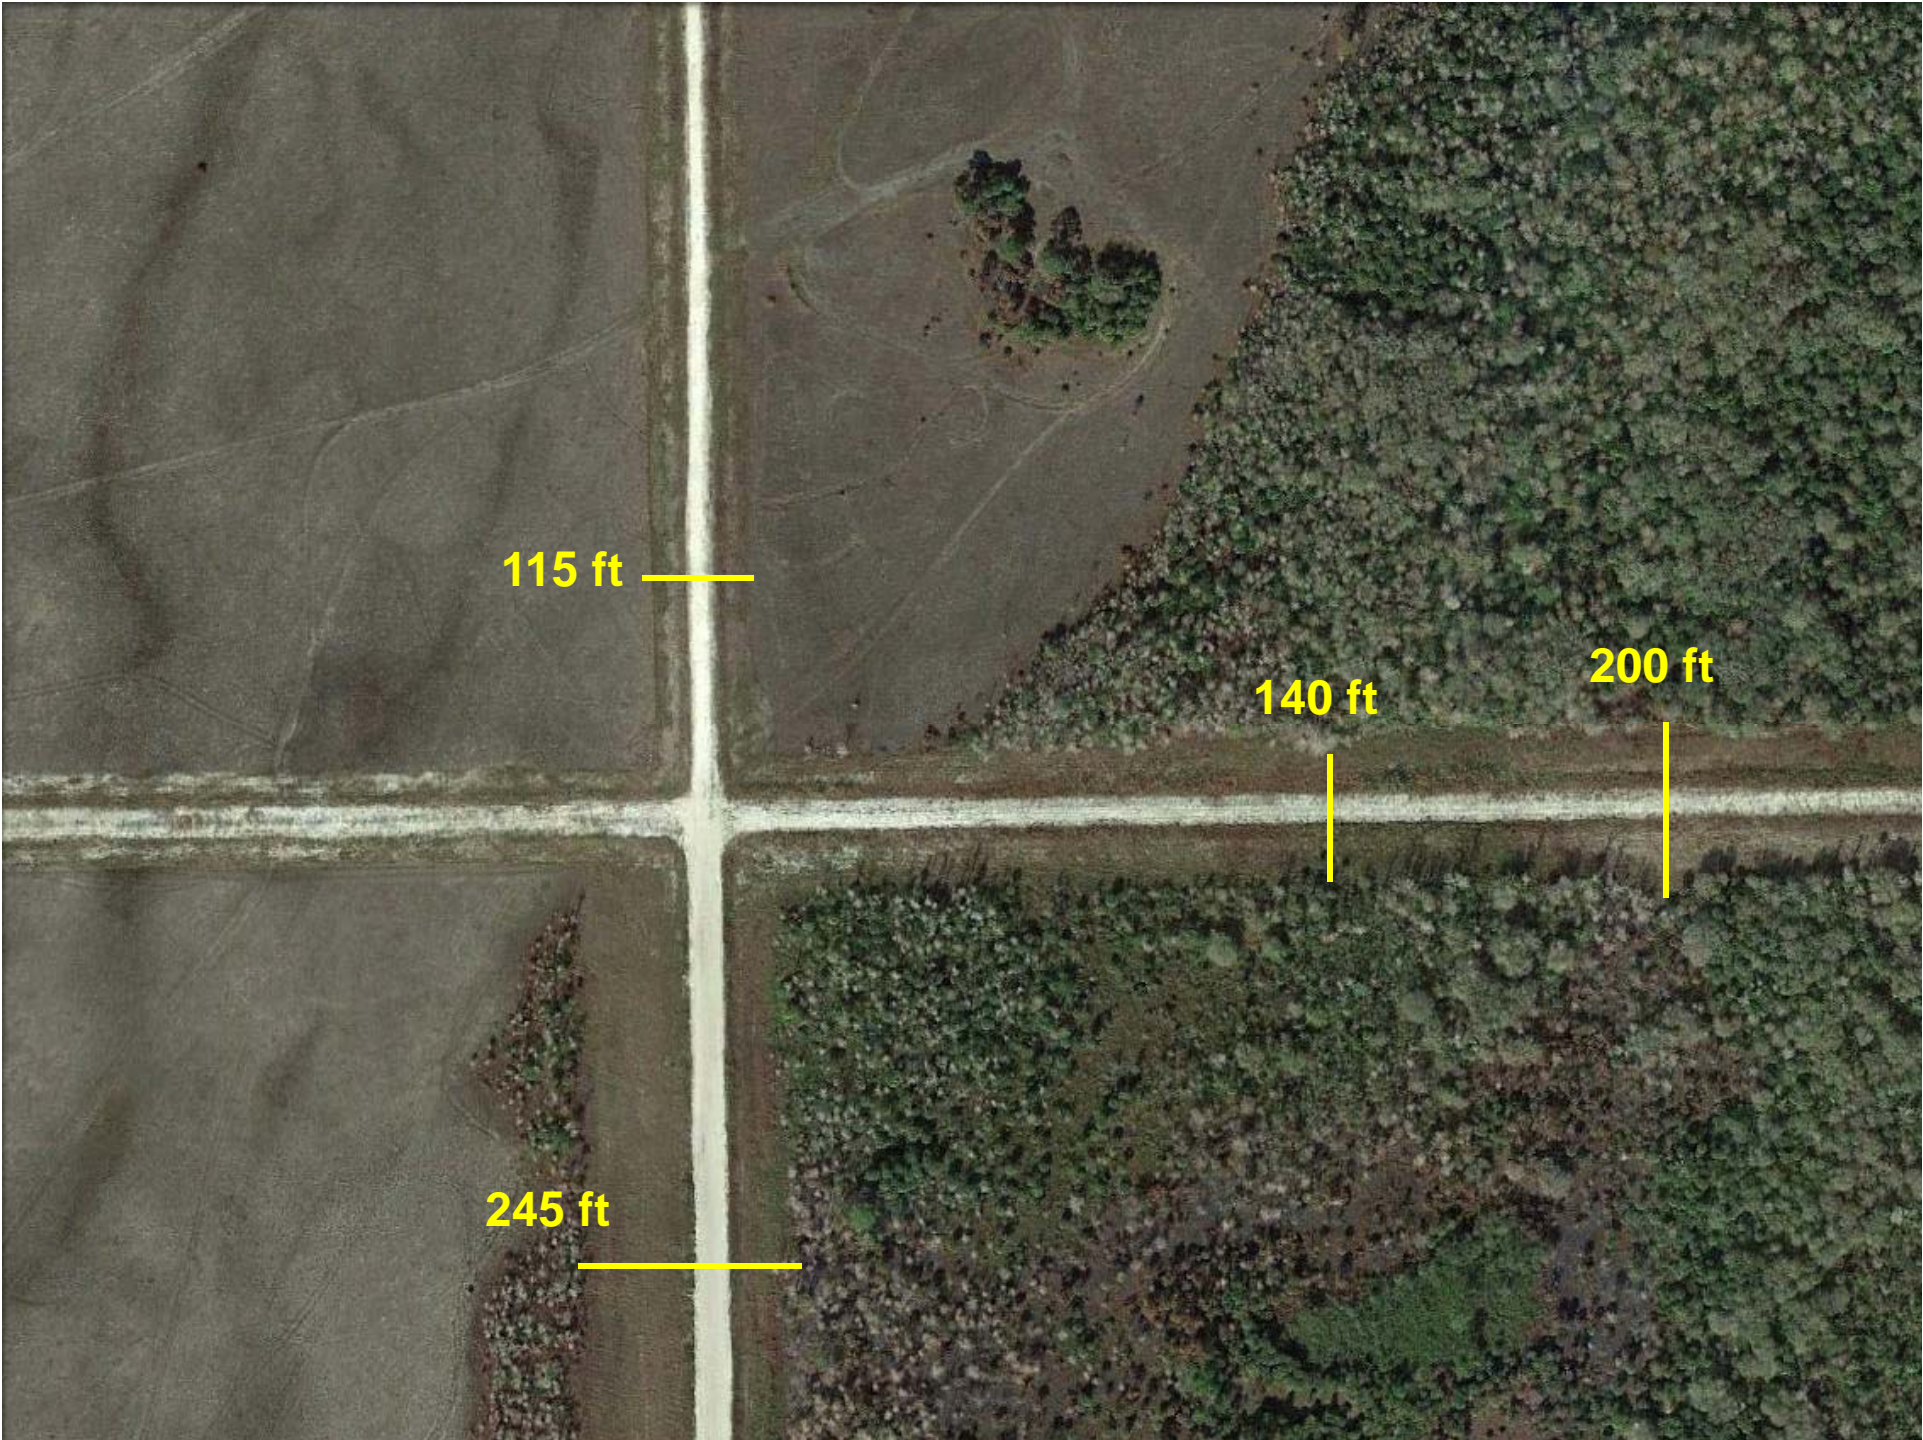
115 ft

140 ft

200 ft

245 ft

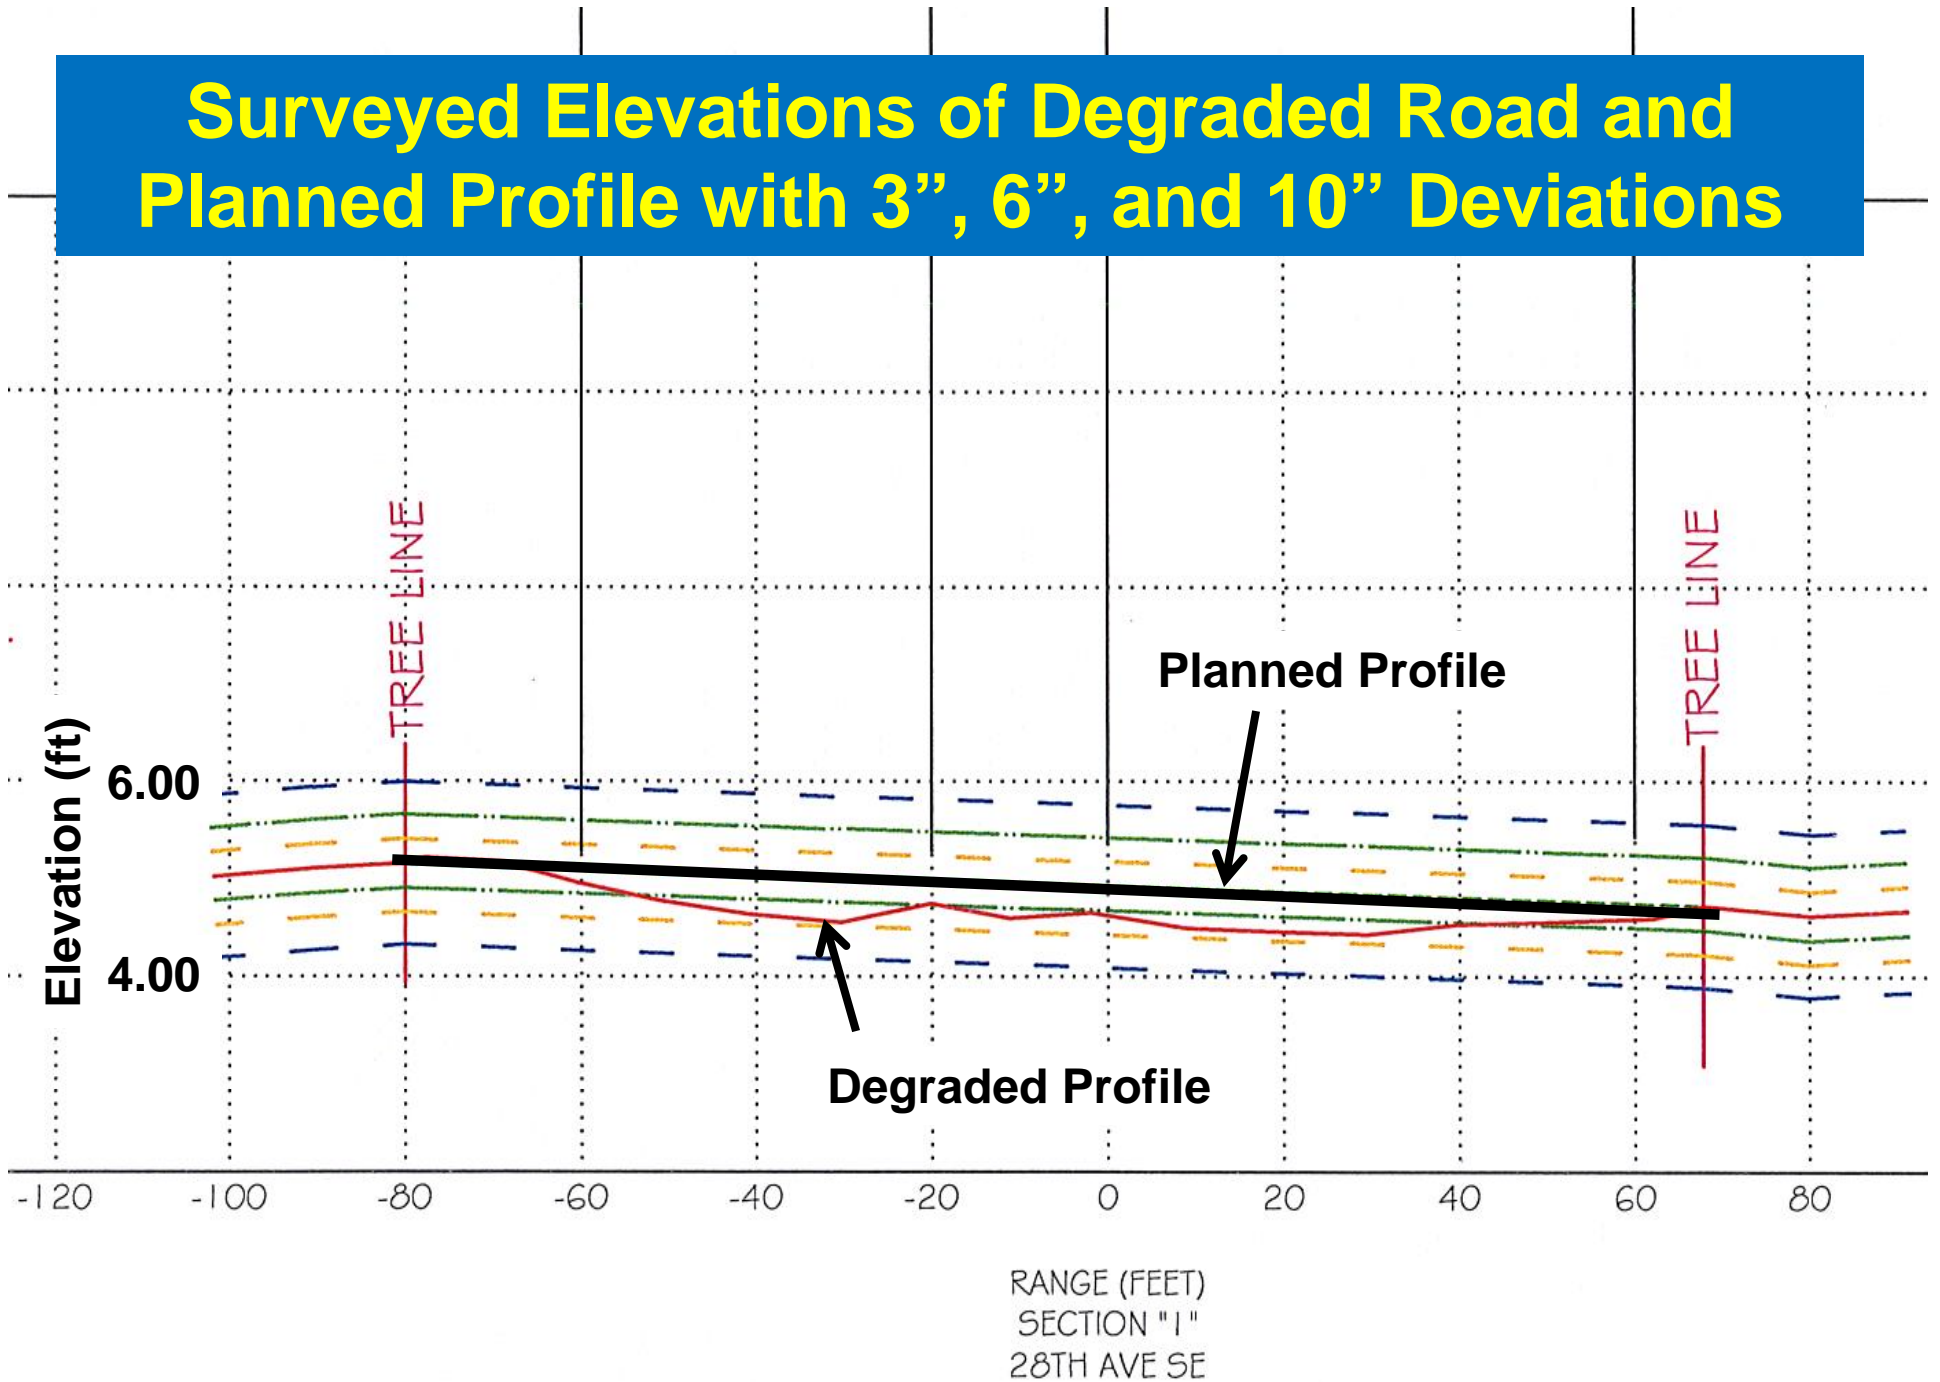
Surveyed Elevations of Degraded Road and Planned Profile with 3", 6", and 10" Deviations

- Specified the Roads would be Graded to Between ± 3 and ± 10 inches along a Straight Line Between Natural Grade on the Two Sides of Cleared Footprint

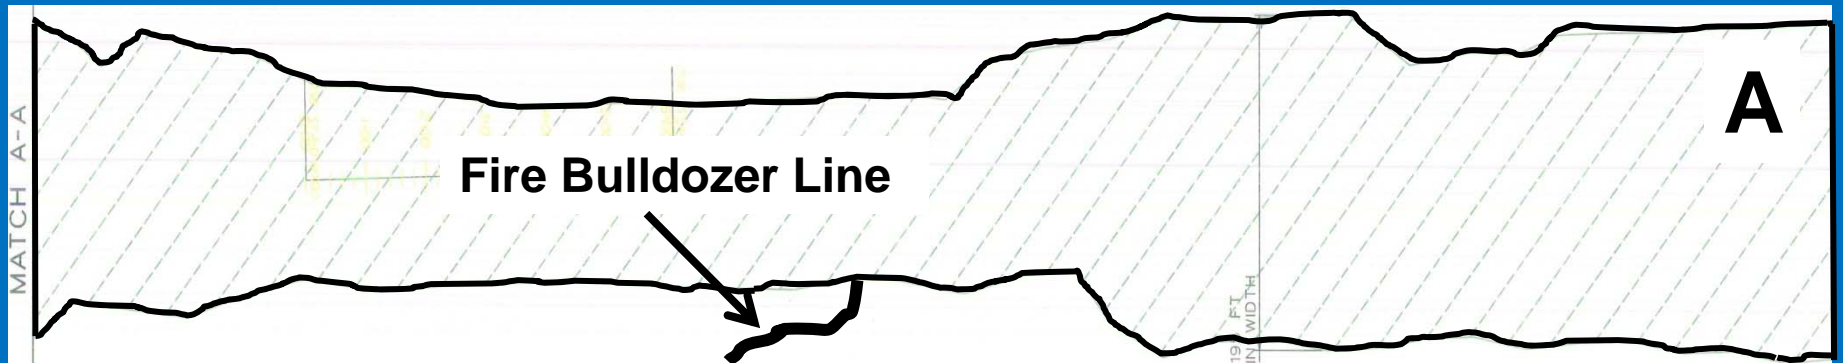
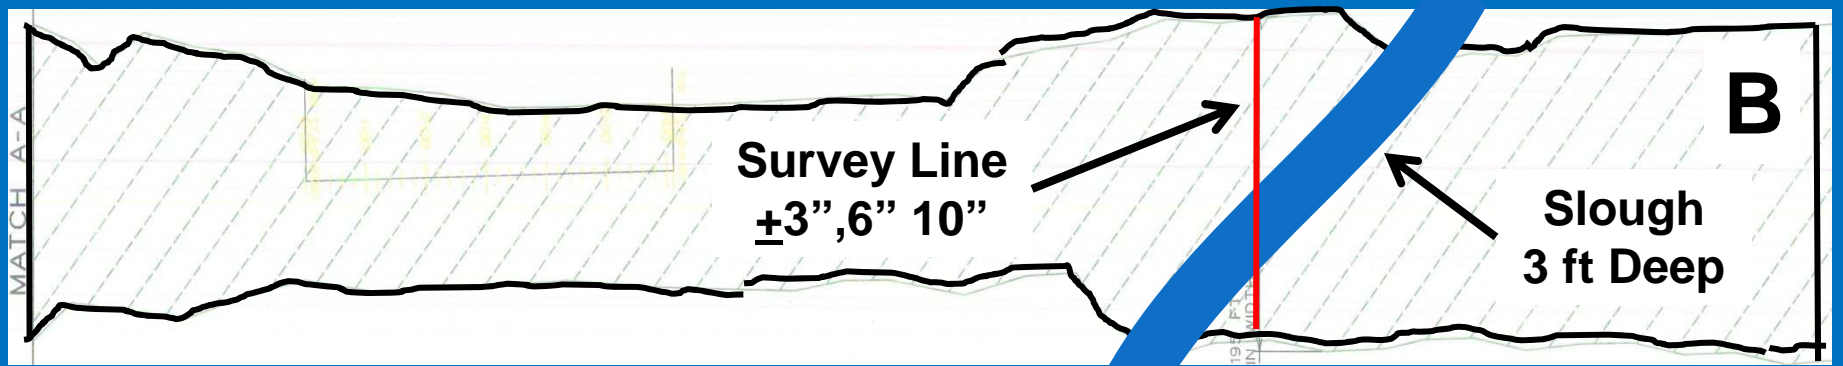
Landscape Features Requiring Modification of Contract Specifications

A. Fire Dozer Line Spoil Berm Not Part of Project

B. Wetland Slough Crossing the Road

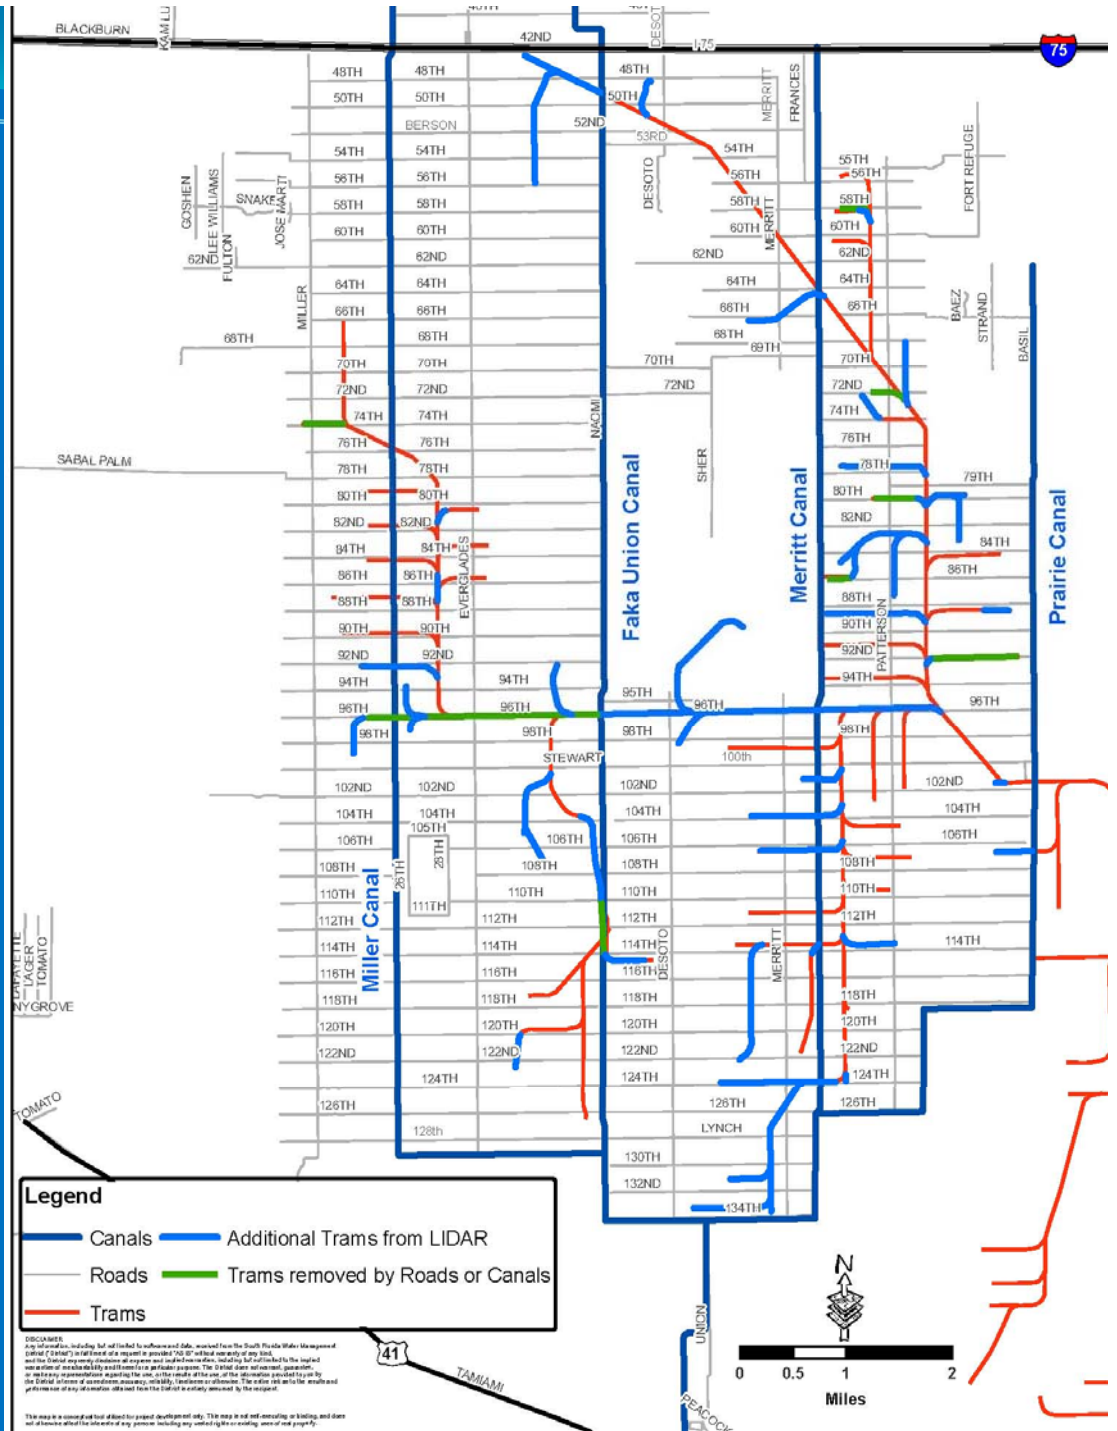
Picayune Logging Trams (~40 Miles)

Found by Contractor

I Located Them

Eliminated by Road or Canal Construction
