INTRODUCTION

Audubon Florida's partnership with Panther Island Mitigation Bank (PIMB), a ~4,500-acre wetland mitigation bank constructed by The Wetlandsbank Group and directly adjacent to Audubon's Corkscrew Swamp Sanctuary (CSS), provides an excellent opportunity for pre- and post-restoration monitoring (Fig. 1). We began a long-term monitoring program on PIMB in 2014 with a primary focus on ecological function provided for wading birds. Hydrology, aquatic fauna and wading birds are monitored to assess prey density and availability for wading birds throughout the nesting season and the value of restored wetlands for foraging. We are also monitoring herpetofauna, birds, and mammals in order to quantify habitat use by other wildlife.

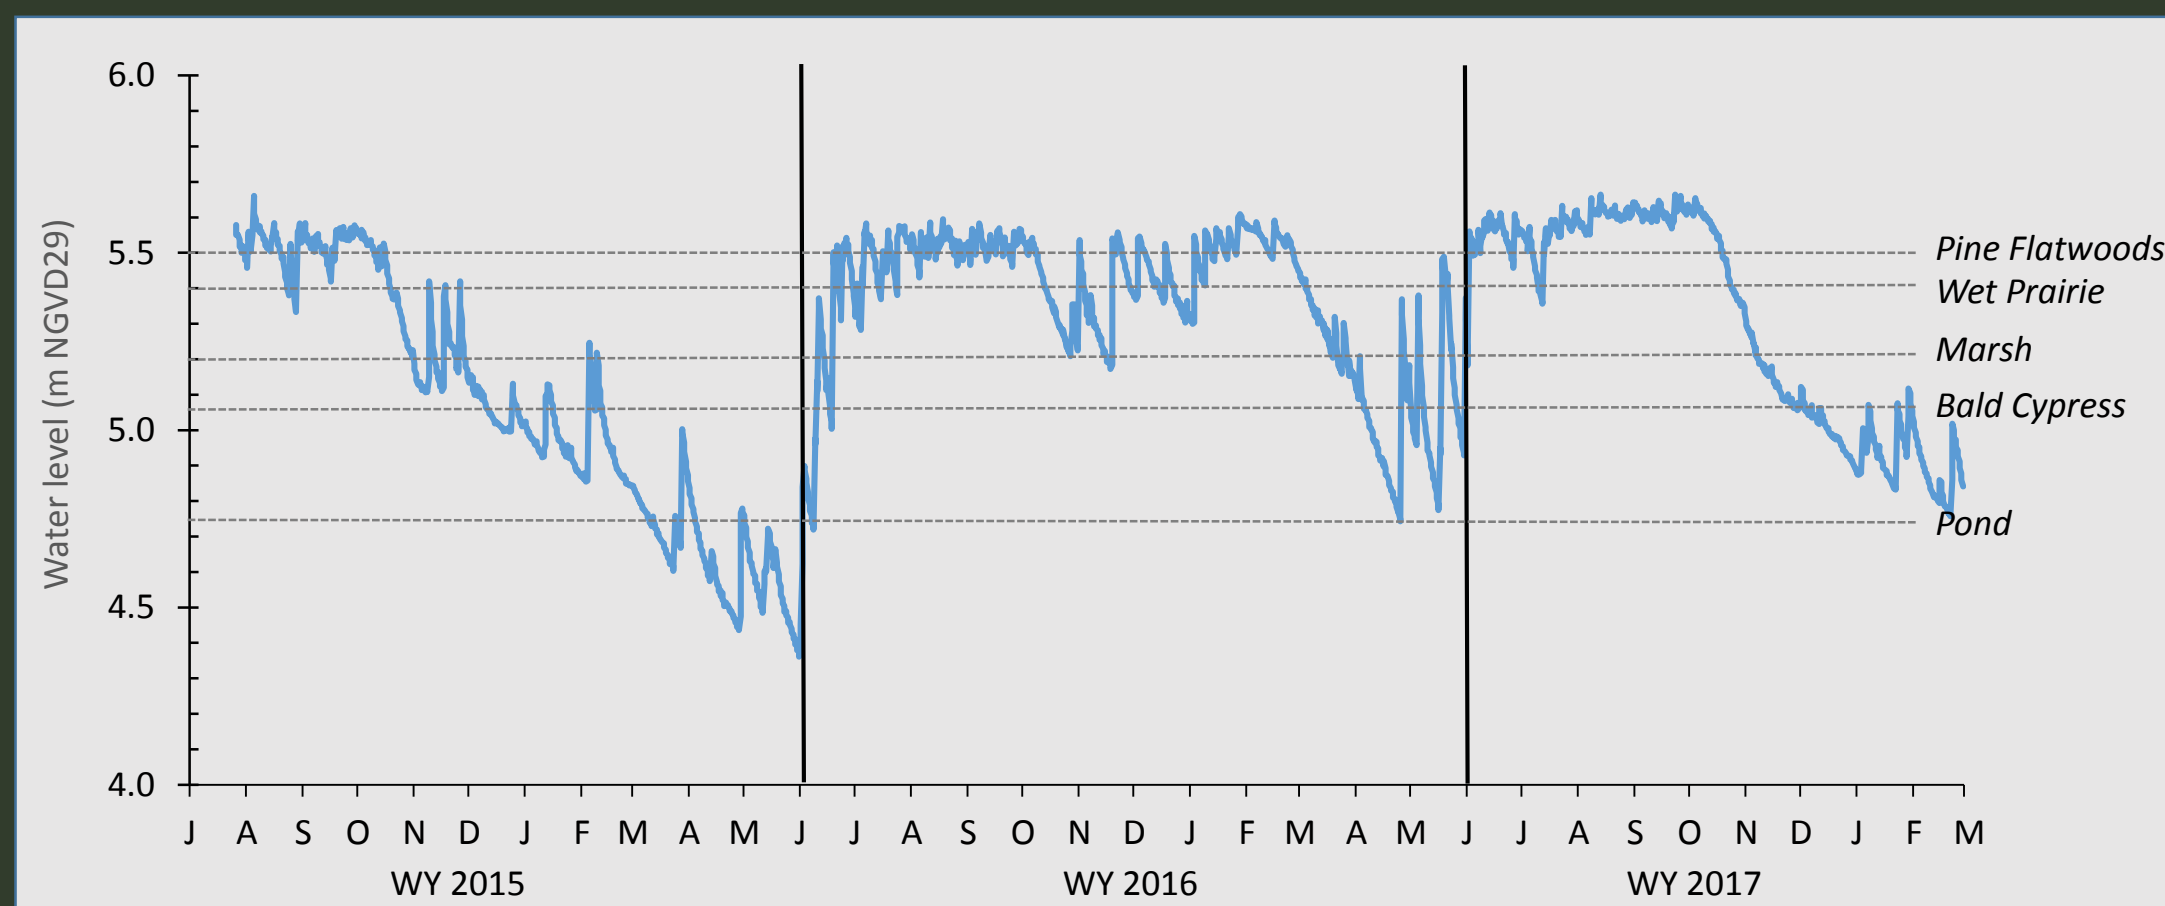
Fig 3. Daily water level (m NGVD29) from groundwater well 'NW' adjacent to a restored phase of PIMB WY2015 to present. Estimated elevations of wetland habitats are indicated to demonstrate approximate hydroperiods.

Results: Analyses of hydrologic data are ongoing. We present a hydrograph of daily water levels adjacent to a restored phase of PIMB for WY2015-present (Fig. 3).

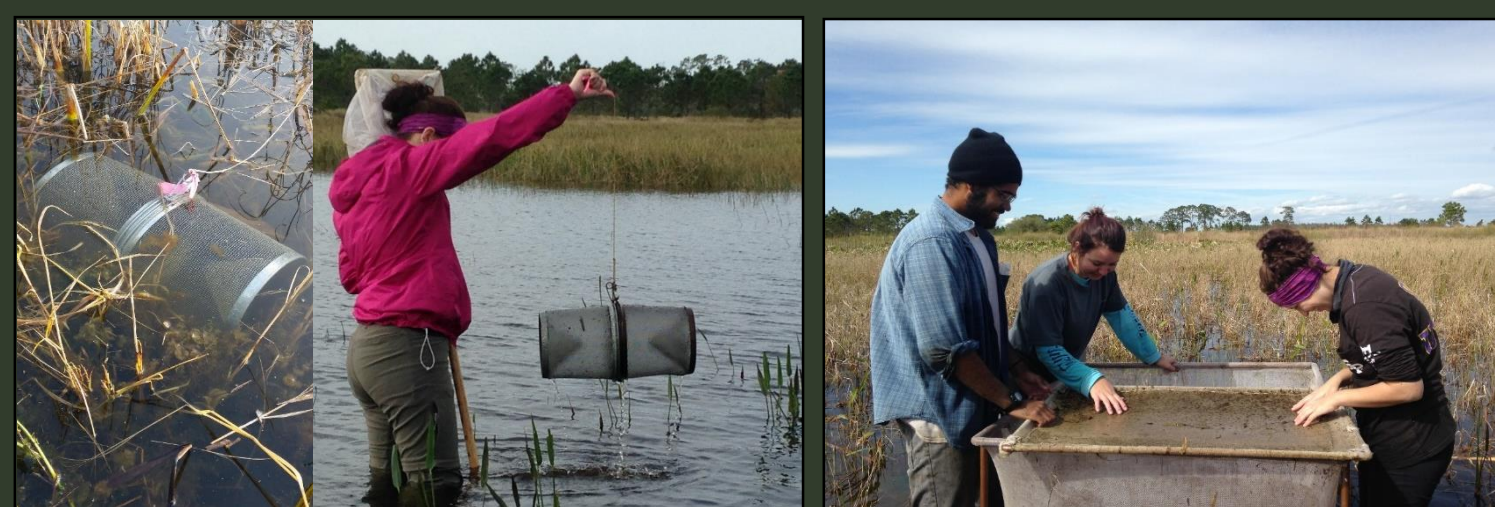
Fig 4. 1-m² throw trap (Right) and wire mesh minnow traps (Left) used for aquatic fauna monitoring.

Methodology: Sites were established opportunistically on pre-restoration sites (primarily ditches and ponds) and adjacent to intended prey concentration areas on post-restoration sites. Sites are sampled annually in October, December, and February using 1-m² throw traps (3 to 5 throws per site) and Gee's wire mesh minnow traps (3 3-mm mesh and 3 6-mm mesh traps per site, 24-h soak) (Fig. 4).
