# Modeling Restoration Outcomes for the Everglades Ridge-Slough Landscape

**Predicting outcomes of restored Everglades high flow:  
a model system for scientifically managed floodplains**

**Forecast outcomes of 4  
restoration options in  
different sub-basins**

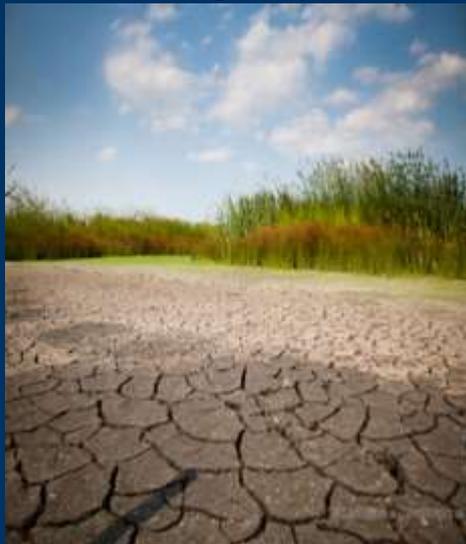
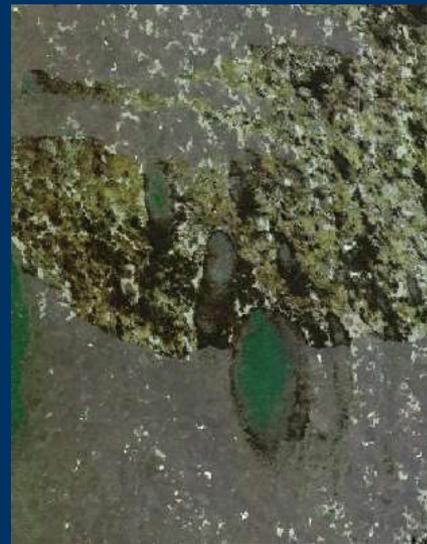
*Degraded*

Hydrologic Conditions:  
Maintain water depth and flow for vegetation communities and ecological processes

Functionalities of the Landscape:  
Deep water slough (60%) between ridges supports production and diverse ecosystem

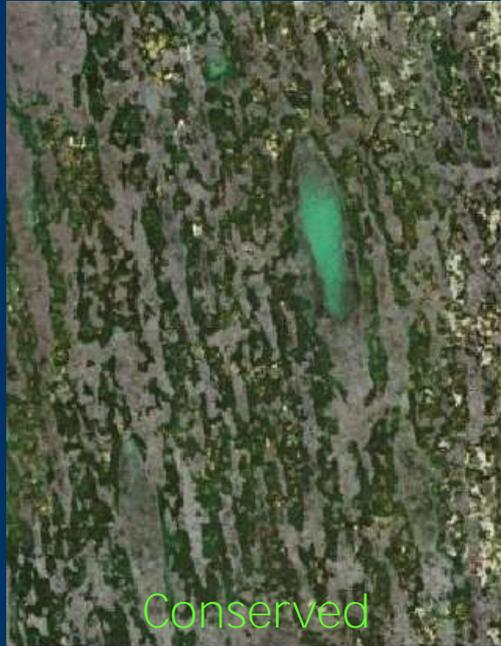
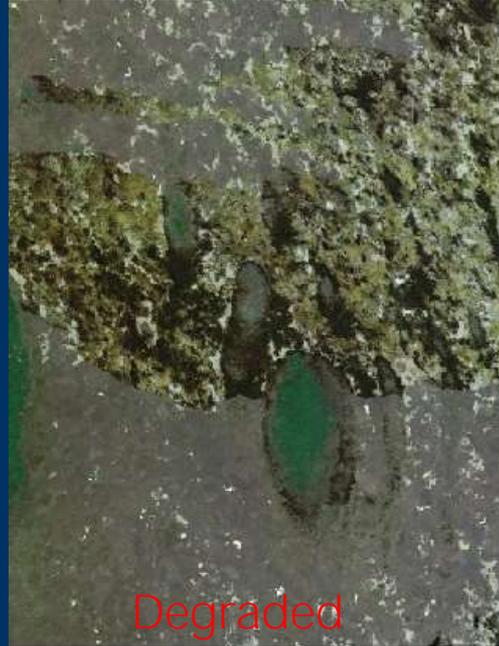
# Proliferation of Vegetation (Present-Day Sawgrass)

Good: <50%  
At Risk: 50-65%  
Poor: >65%

Metric	Sub-basin				
	WCA-3A North	WCA-3A Central	WCA-3A South	WCA-3B	ENP
Vegetation Coverage (%)	74	61	42	86	54
