Effects of a US-1 mitigation effort on hydrologic conditions and SAV abundance

Michael Kline, Jerome Lorenz, and Peter Frezza
Everglades Science Center

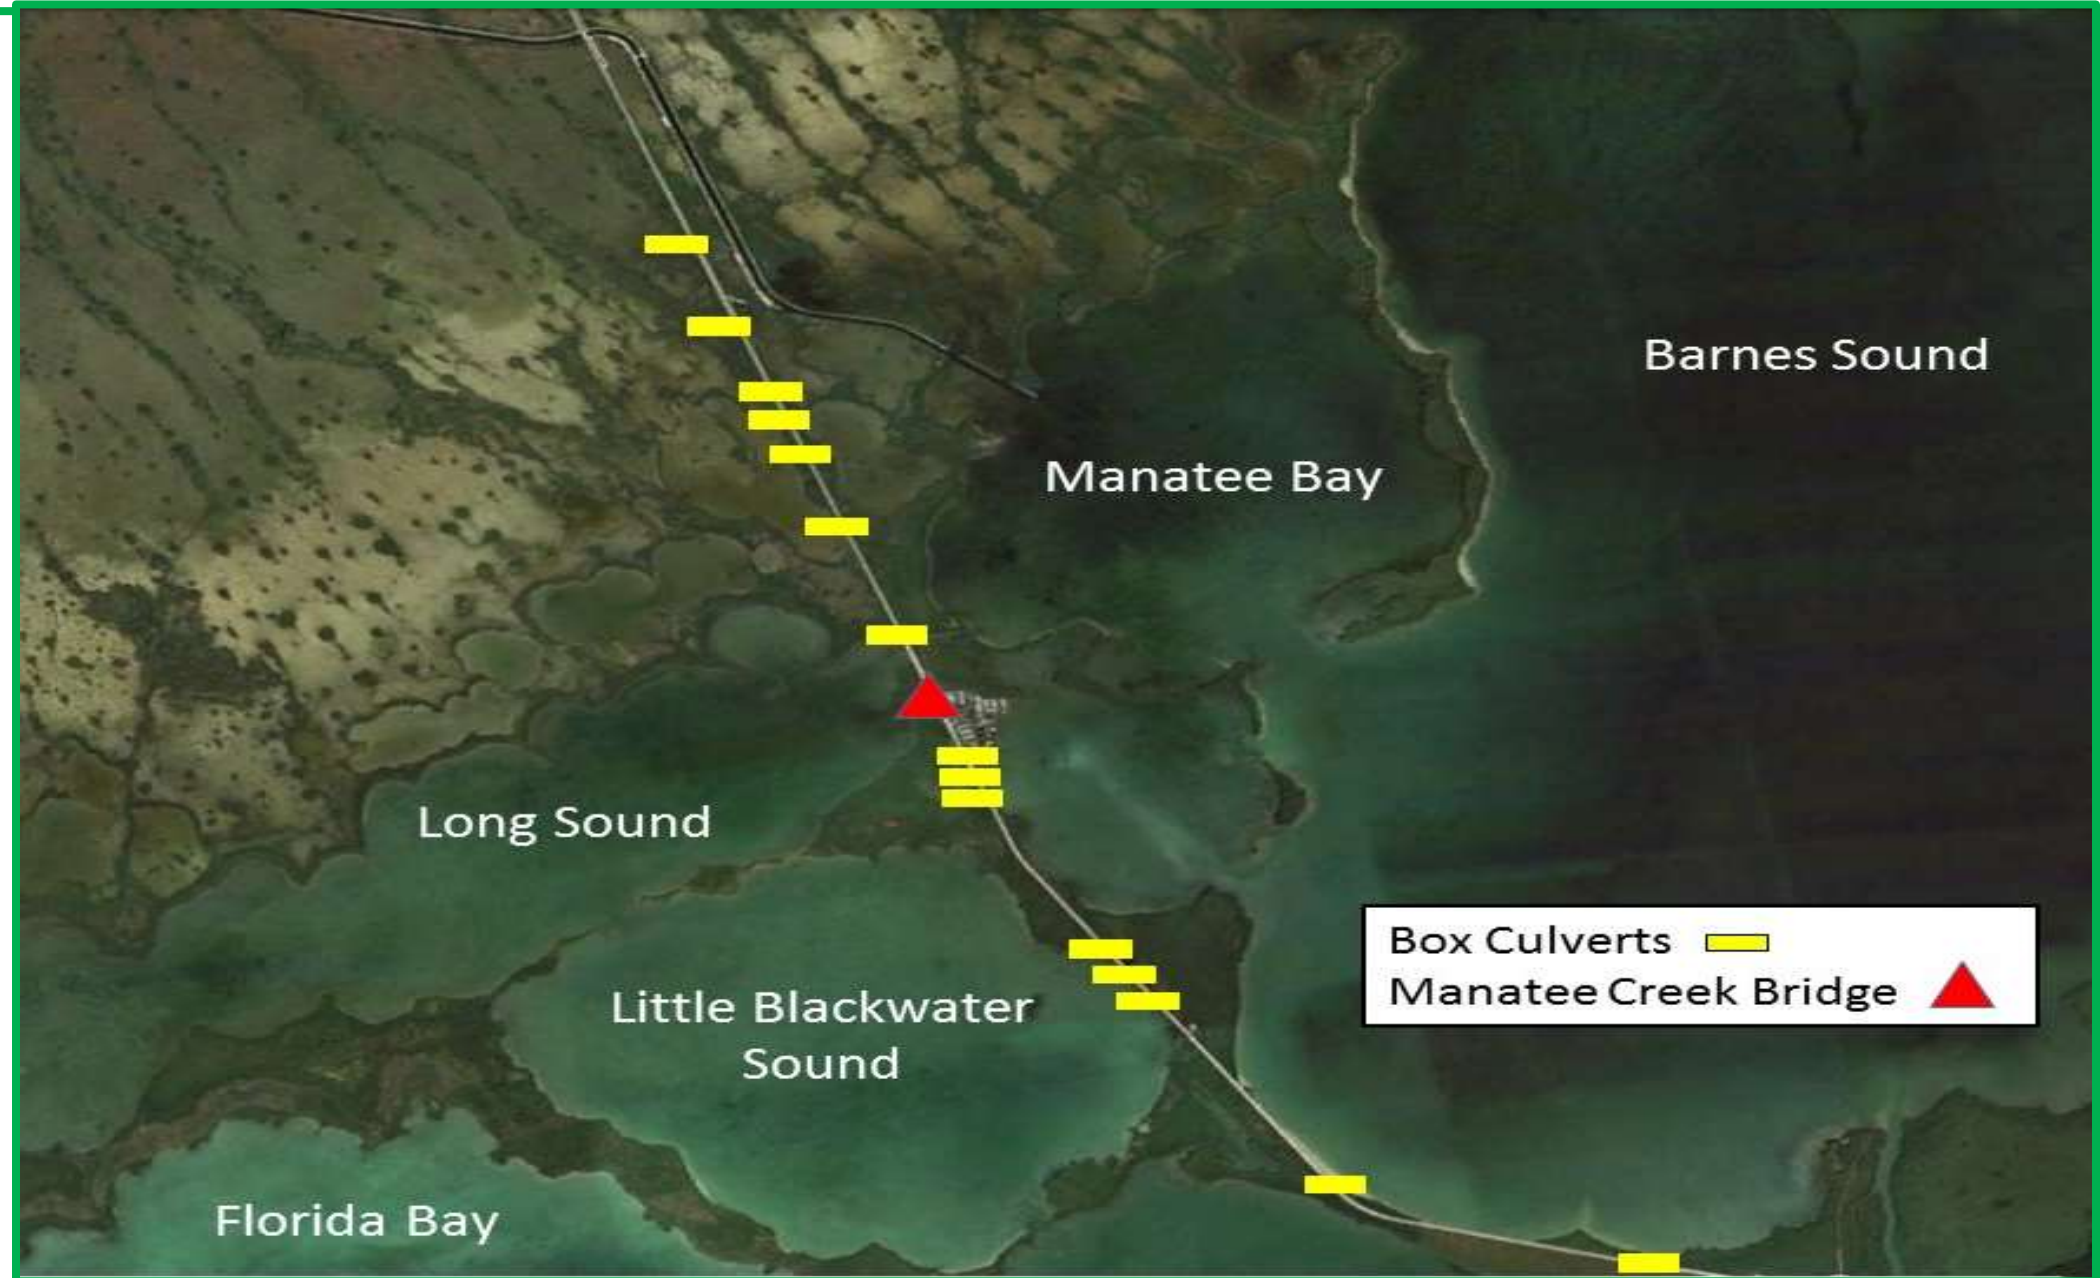
Location of Mitigation Structures along US-1

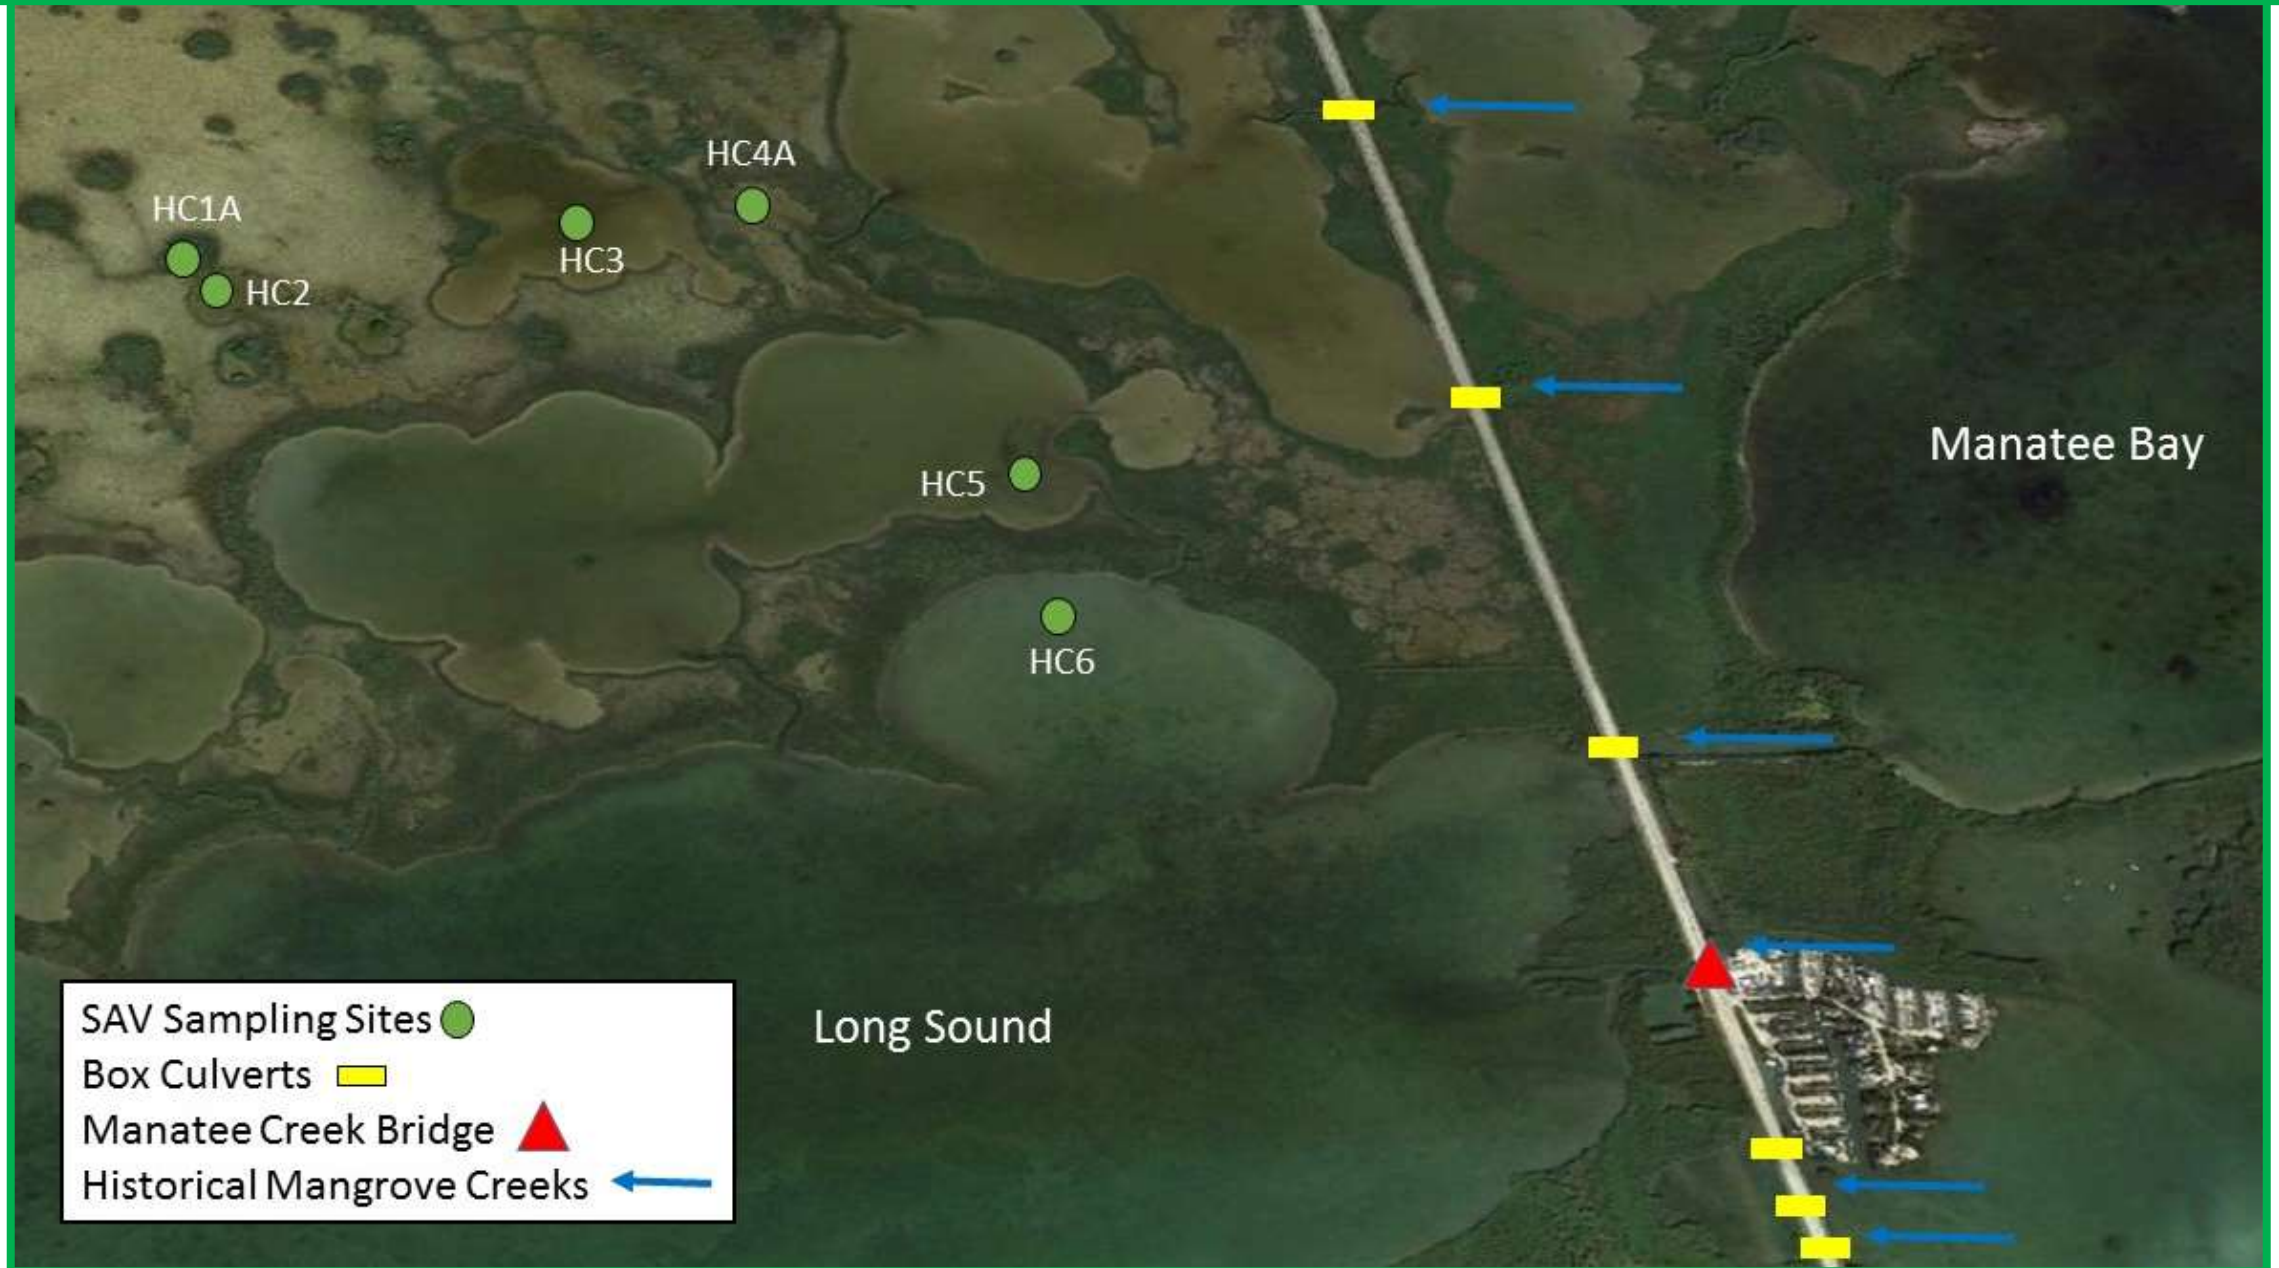
Highway Creek Site and Historic Mangrove Creeks

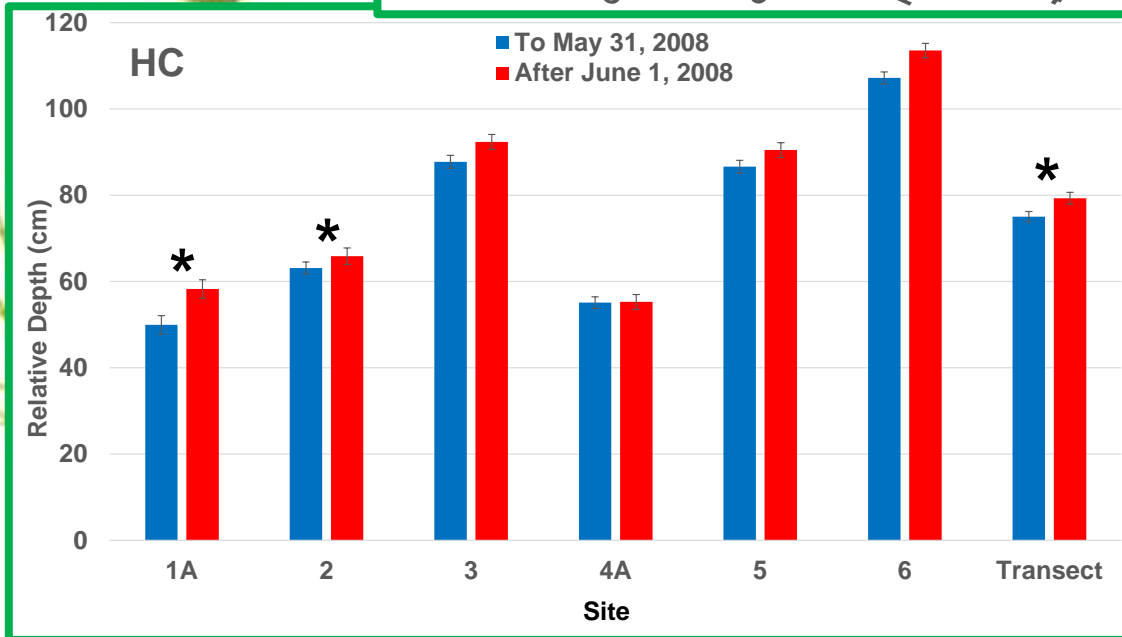
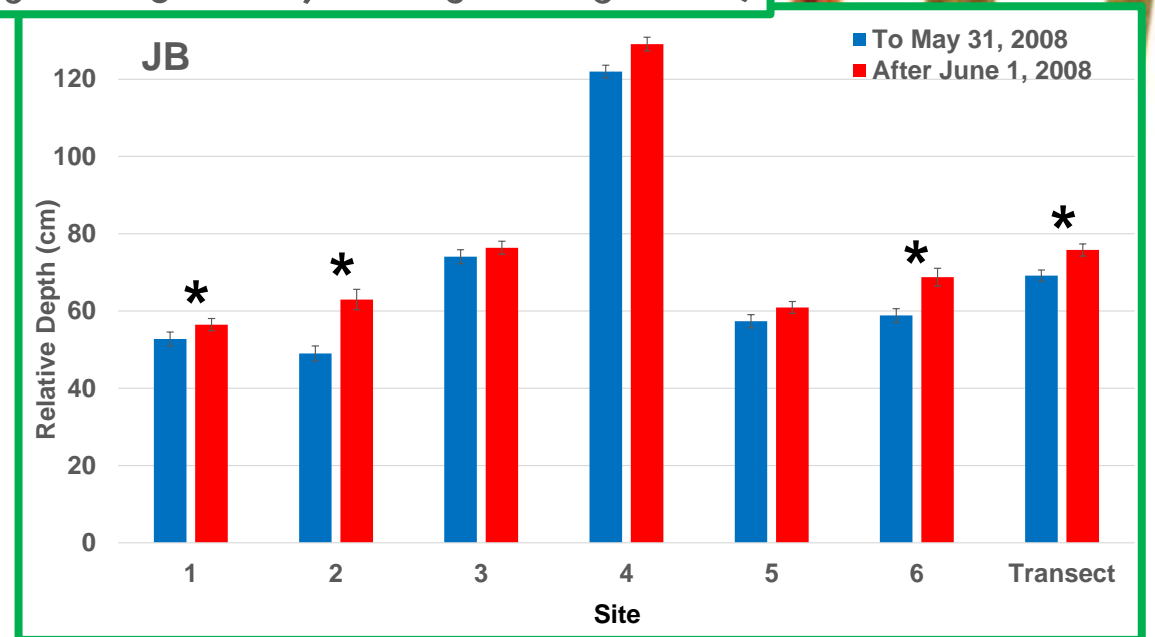
Water Depth

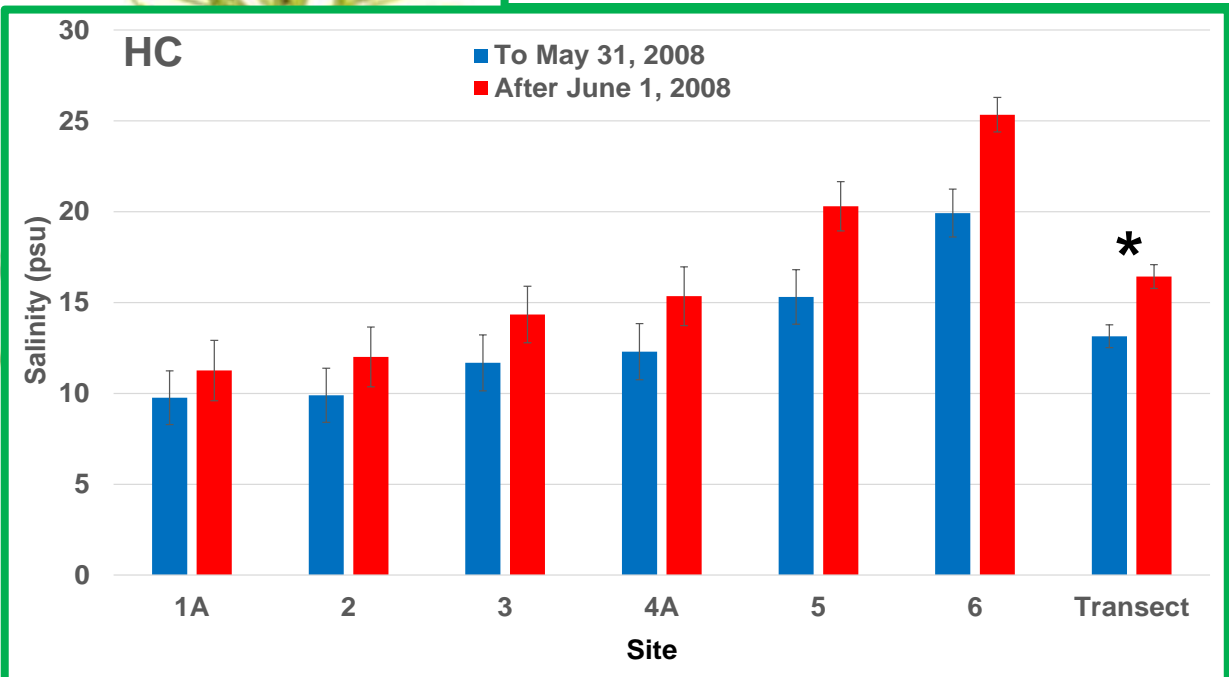
Salinity

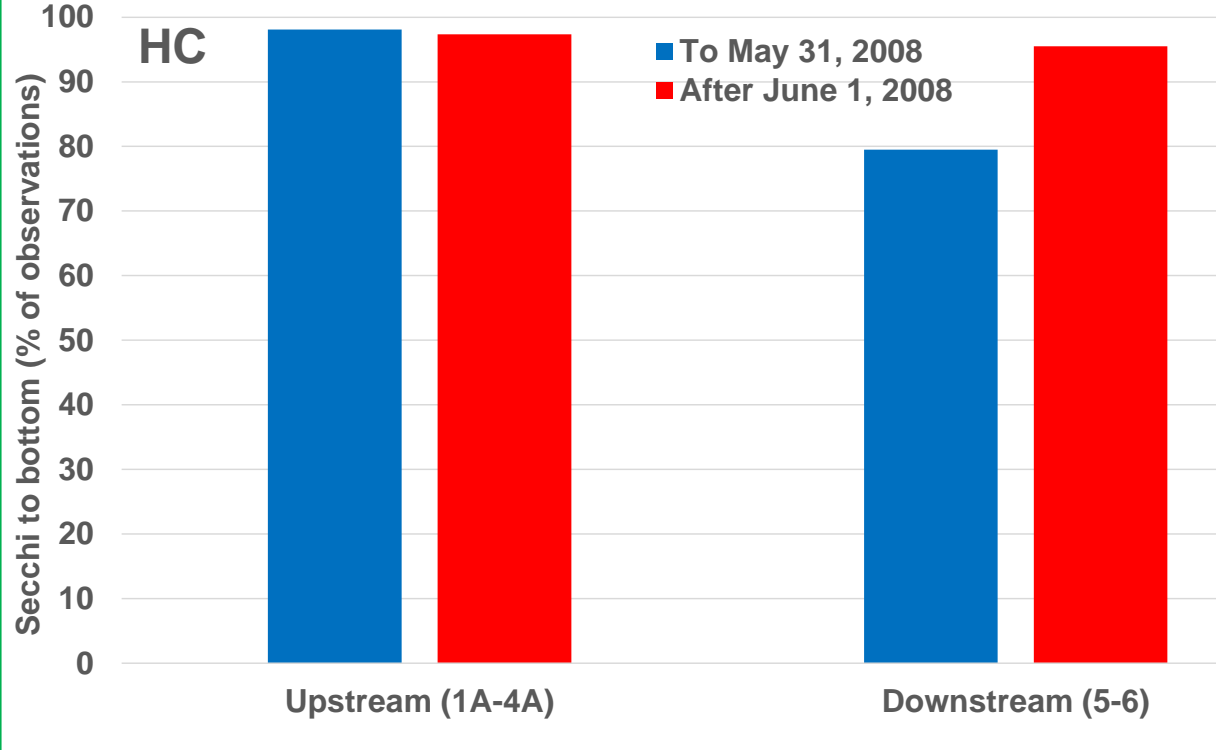
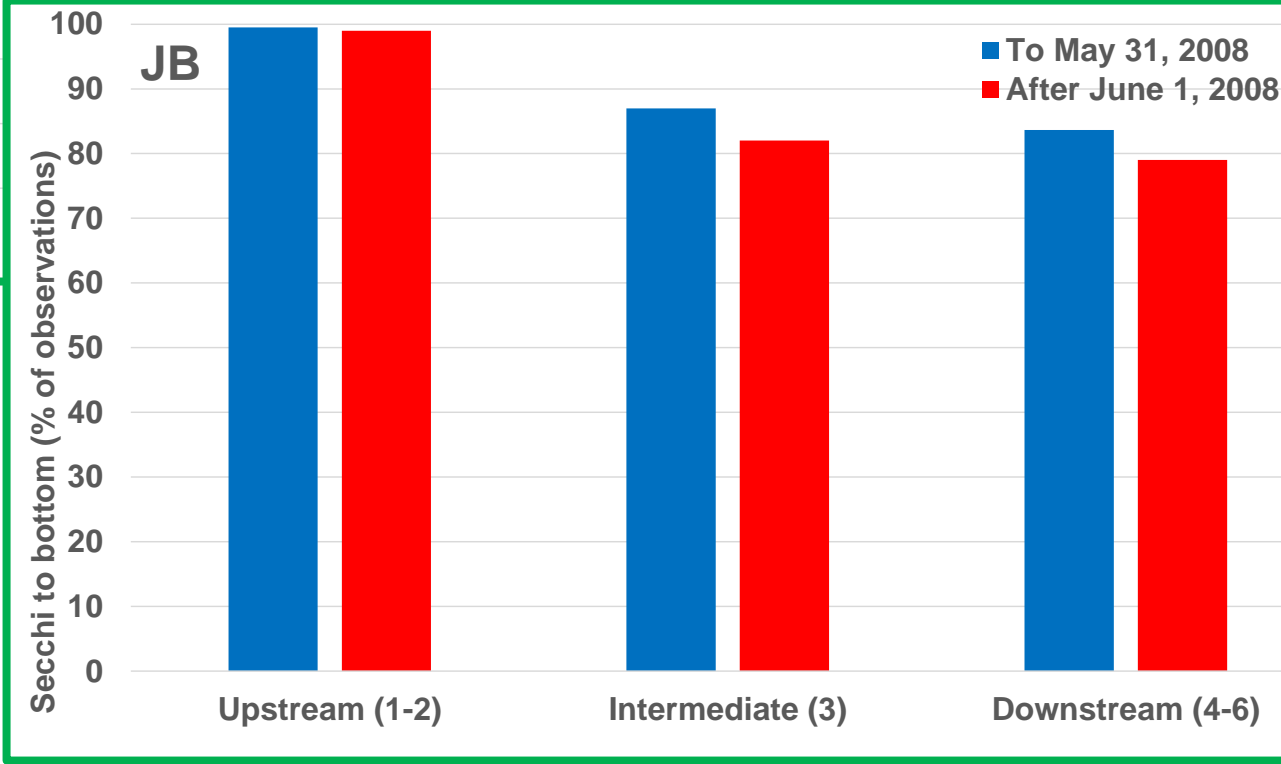
Water Clarity

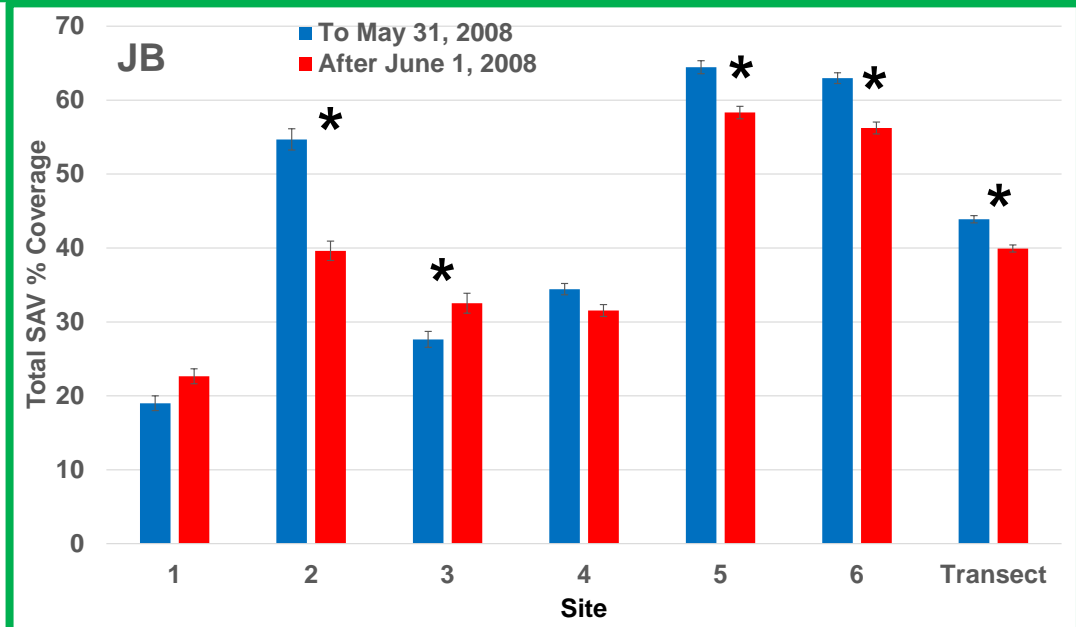
SAV Total Cover
