# WETLAND RESTORATION AT BUCK ISLAND RANCH A SUCCESS STORY?

**G. Sonnier, P. Bohlen, H. Swain, S. Orzell, E. Bridges and B. Boughton**

# WRPs at Buck Island Ranch

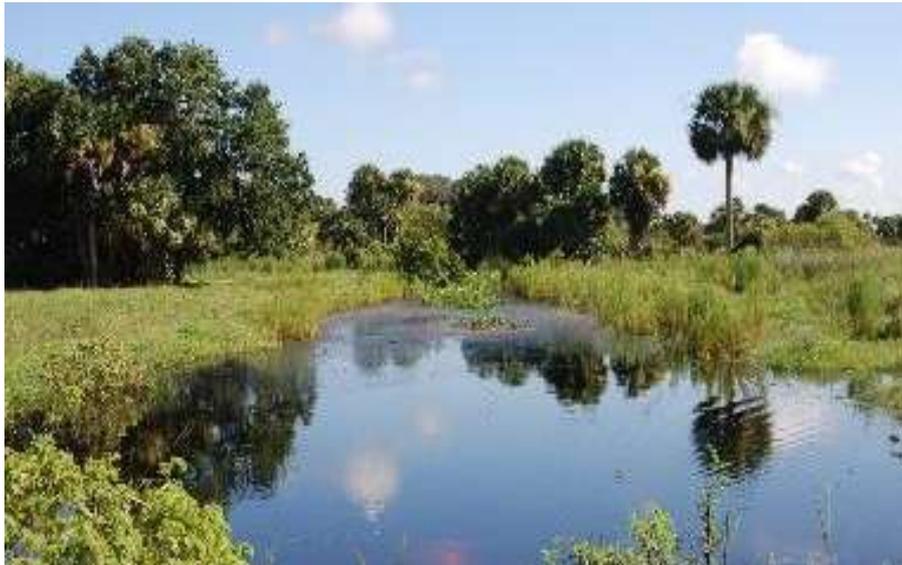
### East Marsh WRP Conceptual Plan Buck Island Ranch

South marsh and East Marsh  
(748 acres)

- |  |               |   |                         |

| | Culvert | | Outlet Structure |
| | Dike | | Structure removal |
| | Improved road | | Land smoothing |
| | Ditch plug | | East Marsh WRP Boundary |
| | Weir | | |

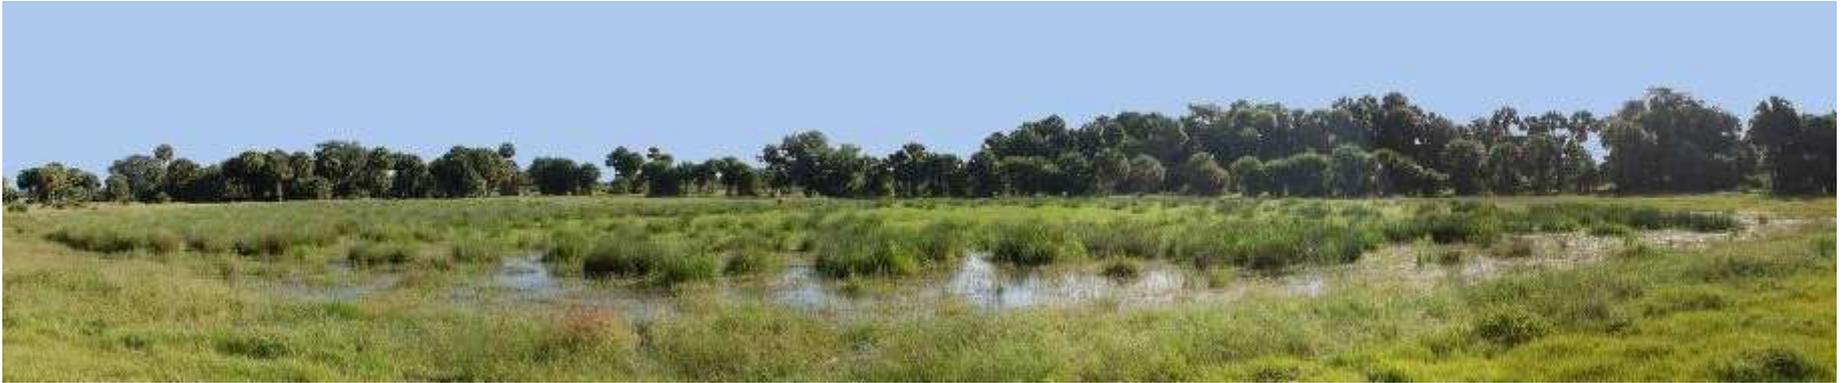
**Wetland within improved pastures**

# Material & Methods: Buck Island Ranch a fully operational cattle ranch

Improved pastures	Semi-native pastures
Cattle load	+++	+
Fertilization	++	0
Seeding	+++	0
Ditching	+++	+

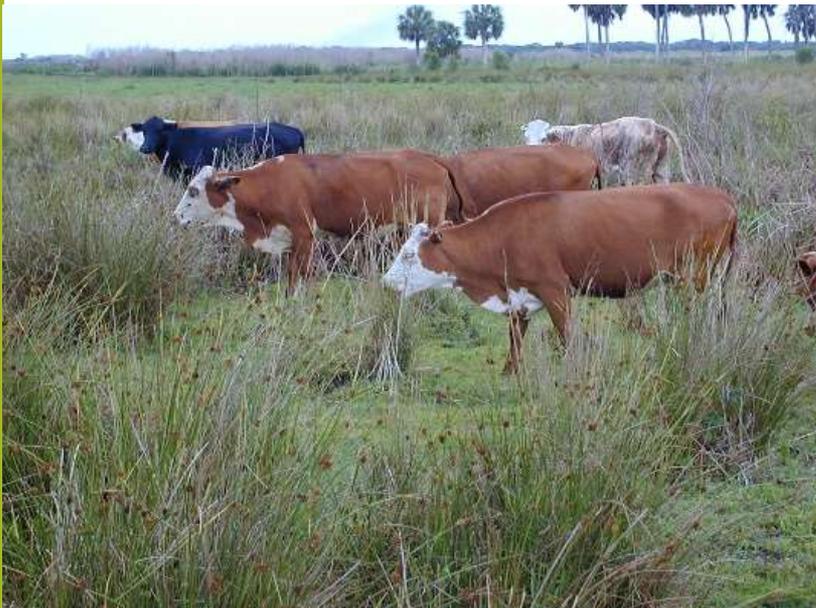
WRPs are located in **semi-native pastures** and in **lowest elevations** of the ranch

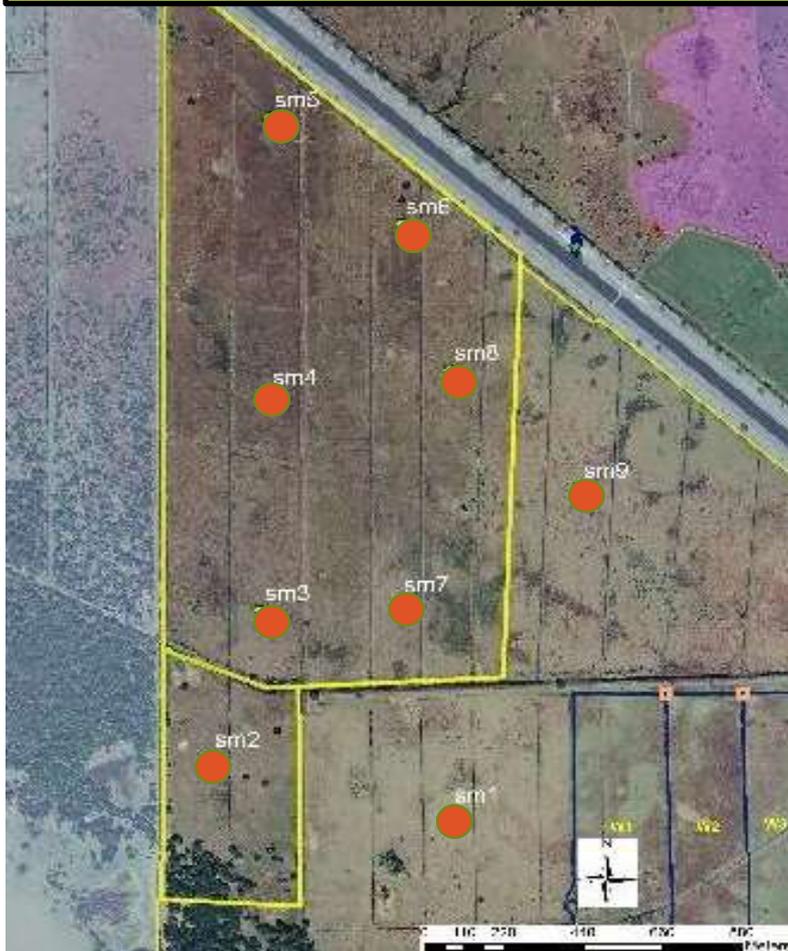
# Material & Methods: Following Water Levels

↑ Groundwater wells

↑ Hydrological restoration

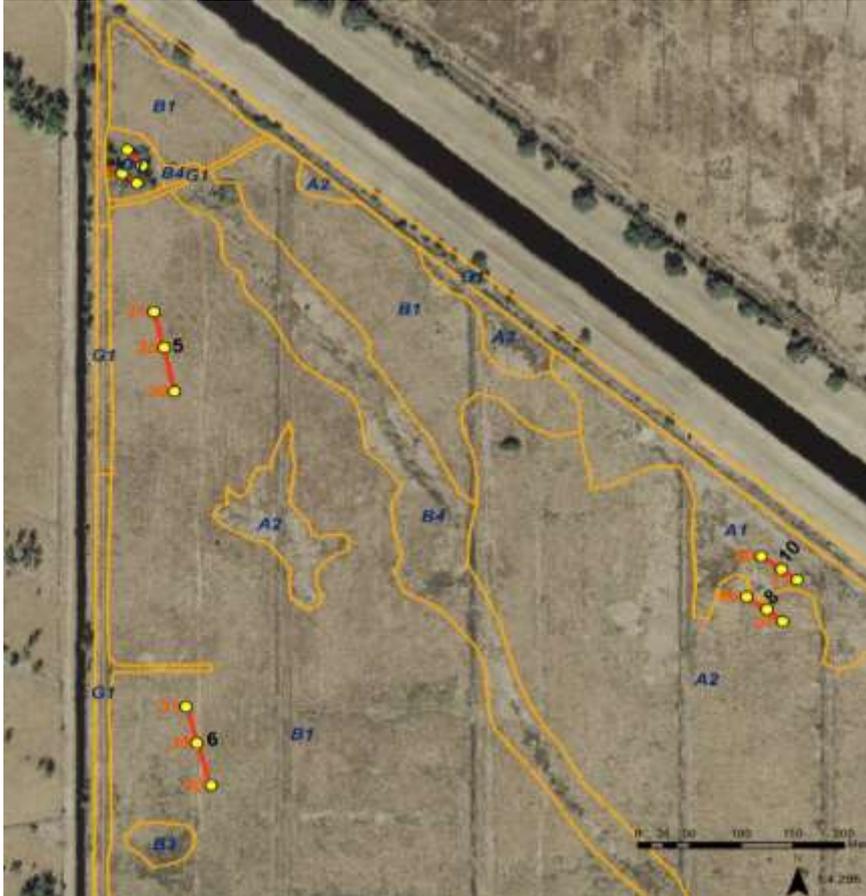
# Material & Methods: Following Shift in Vegetation

- Transects established in 2005 in different plant community types.
- 10 plots along each transect for a total of 300\*1 m<sup>2</sup> quadrats.
- Second sampling in 2012.
- Record presence and cover of each vascular species.

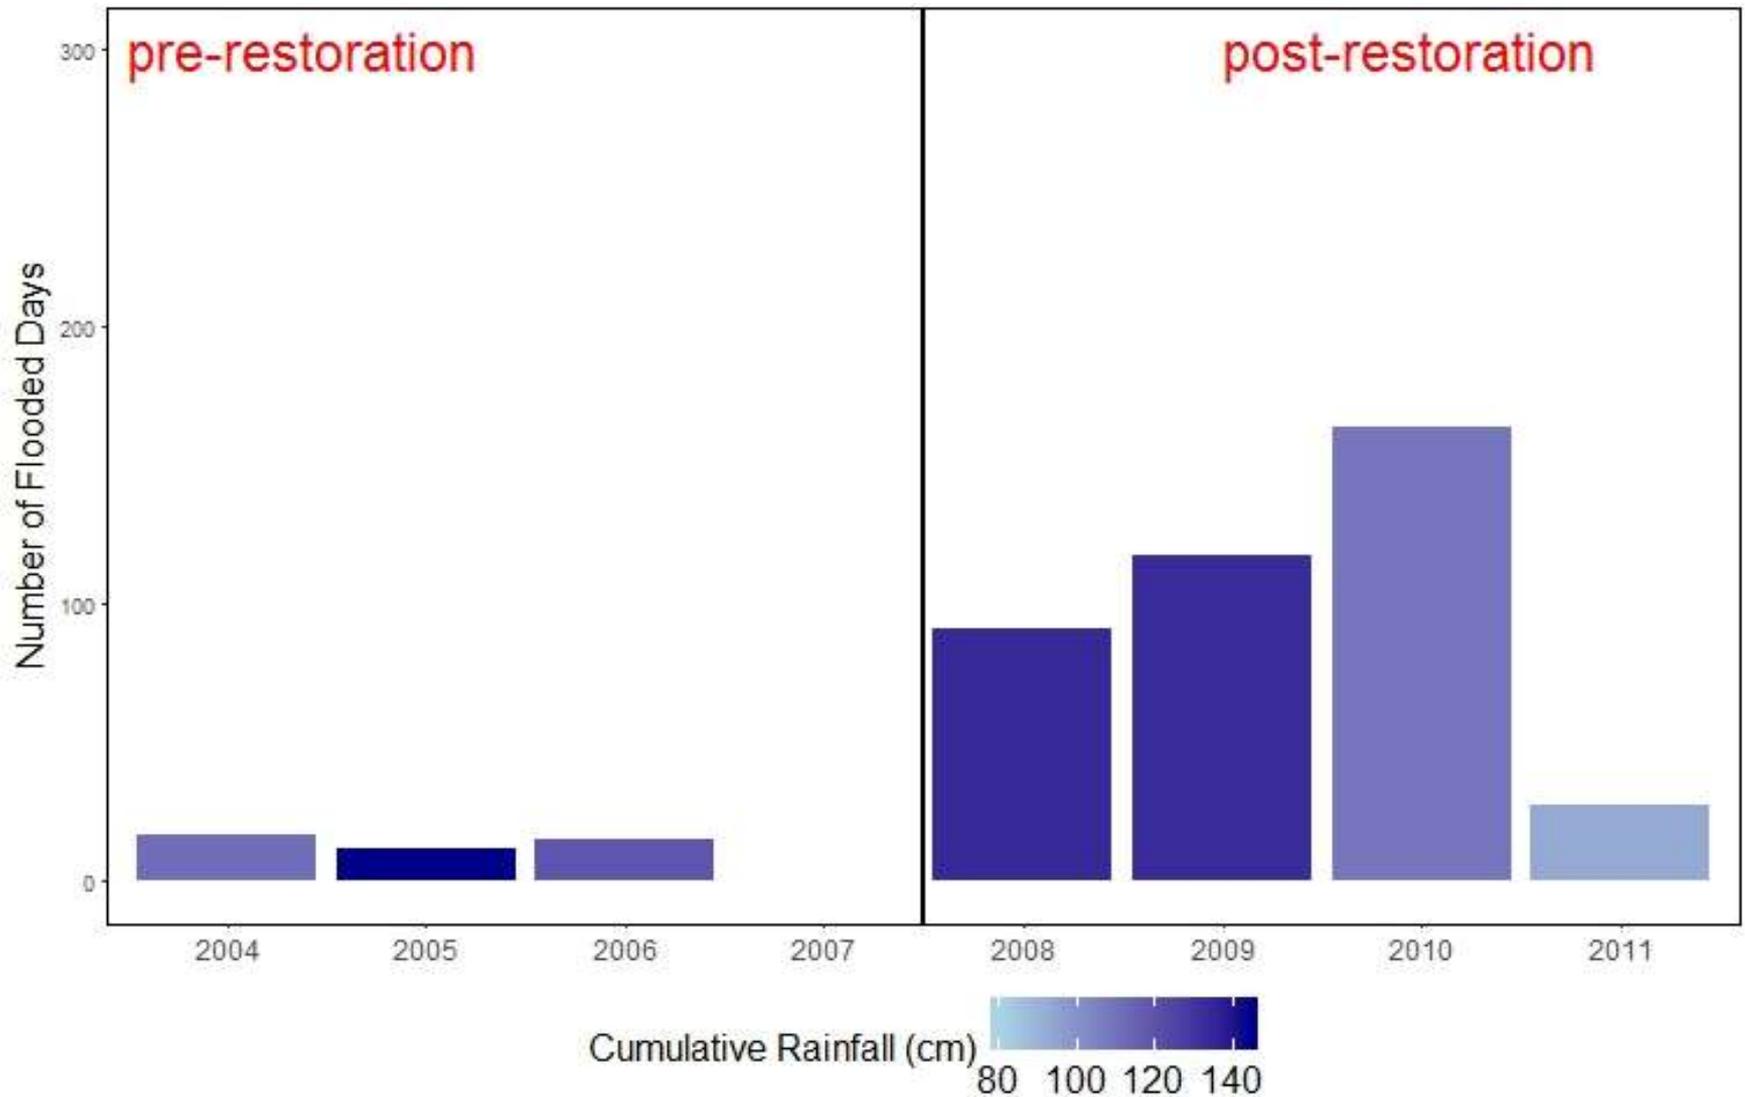
# Results: Hydrology of the South Marsh

## Numbers of flooded days

- Hydrological restoration **increased hydroperiod** in the South Marsh, but we could not confirm it did so in the East Marsh.

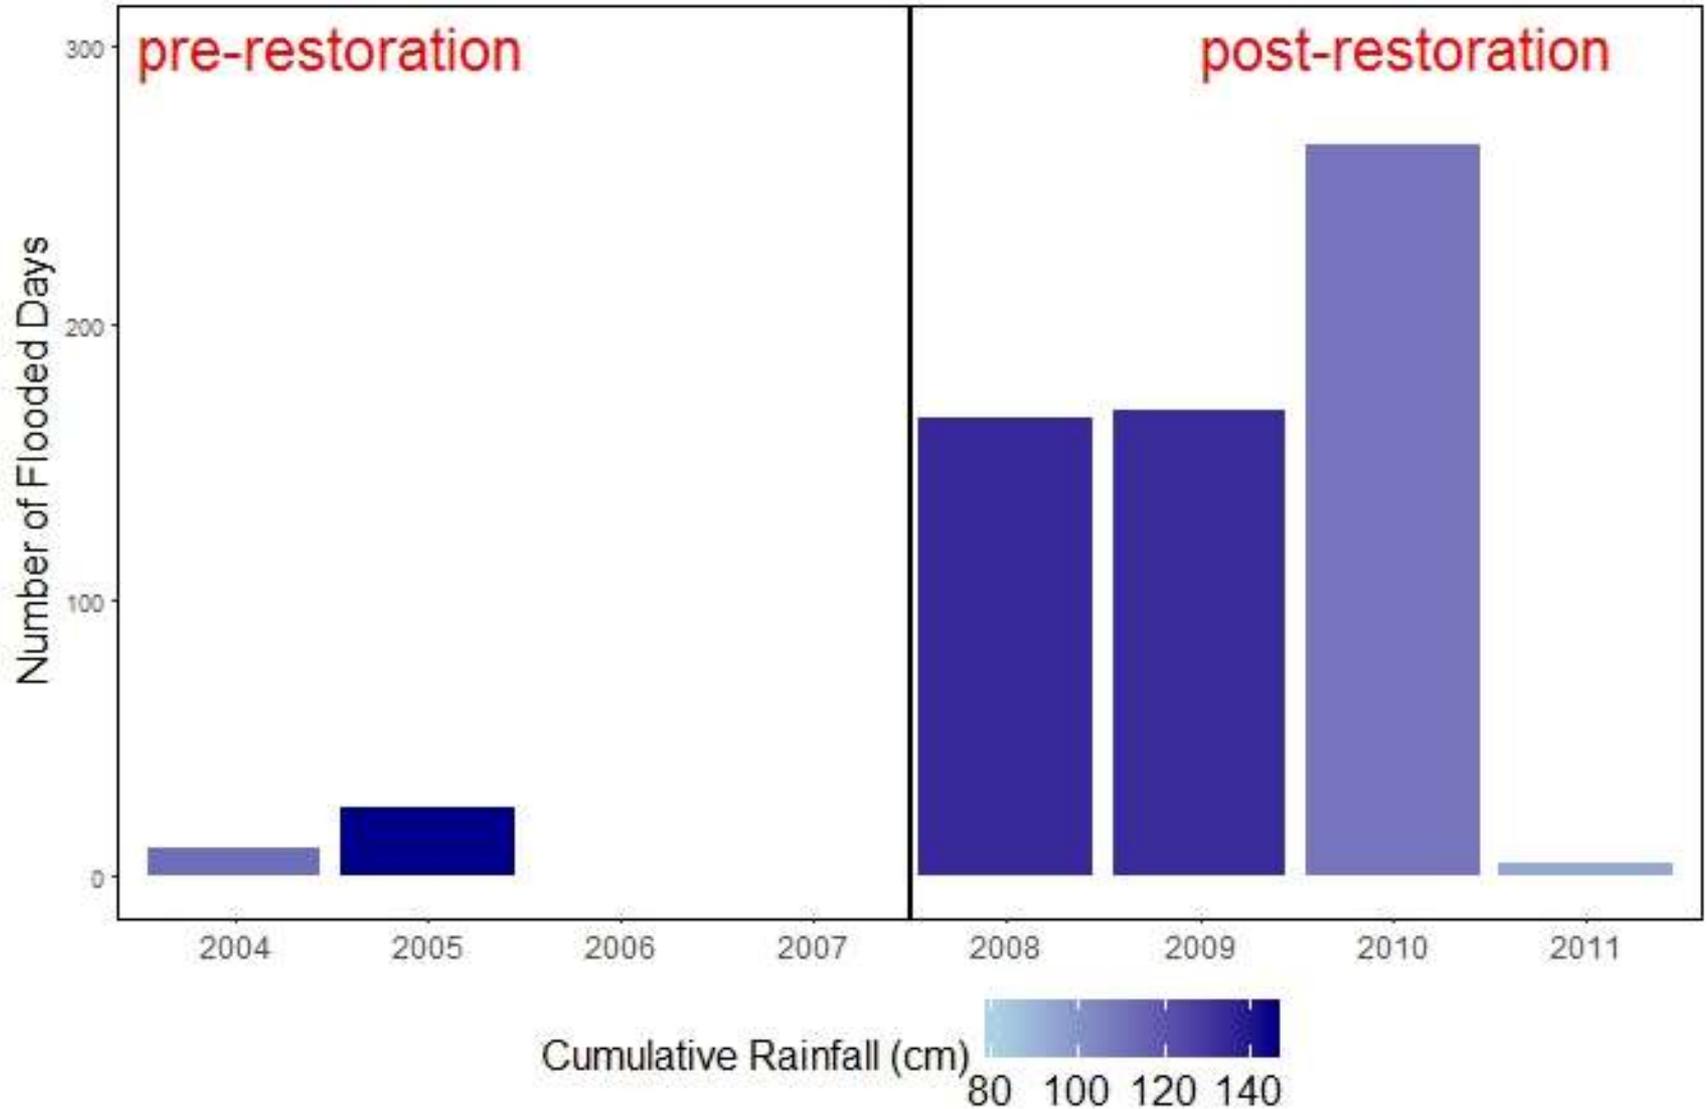
# Results: Hydrology of the South Marsh

## Numbers of flooded days

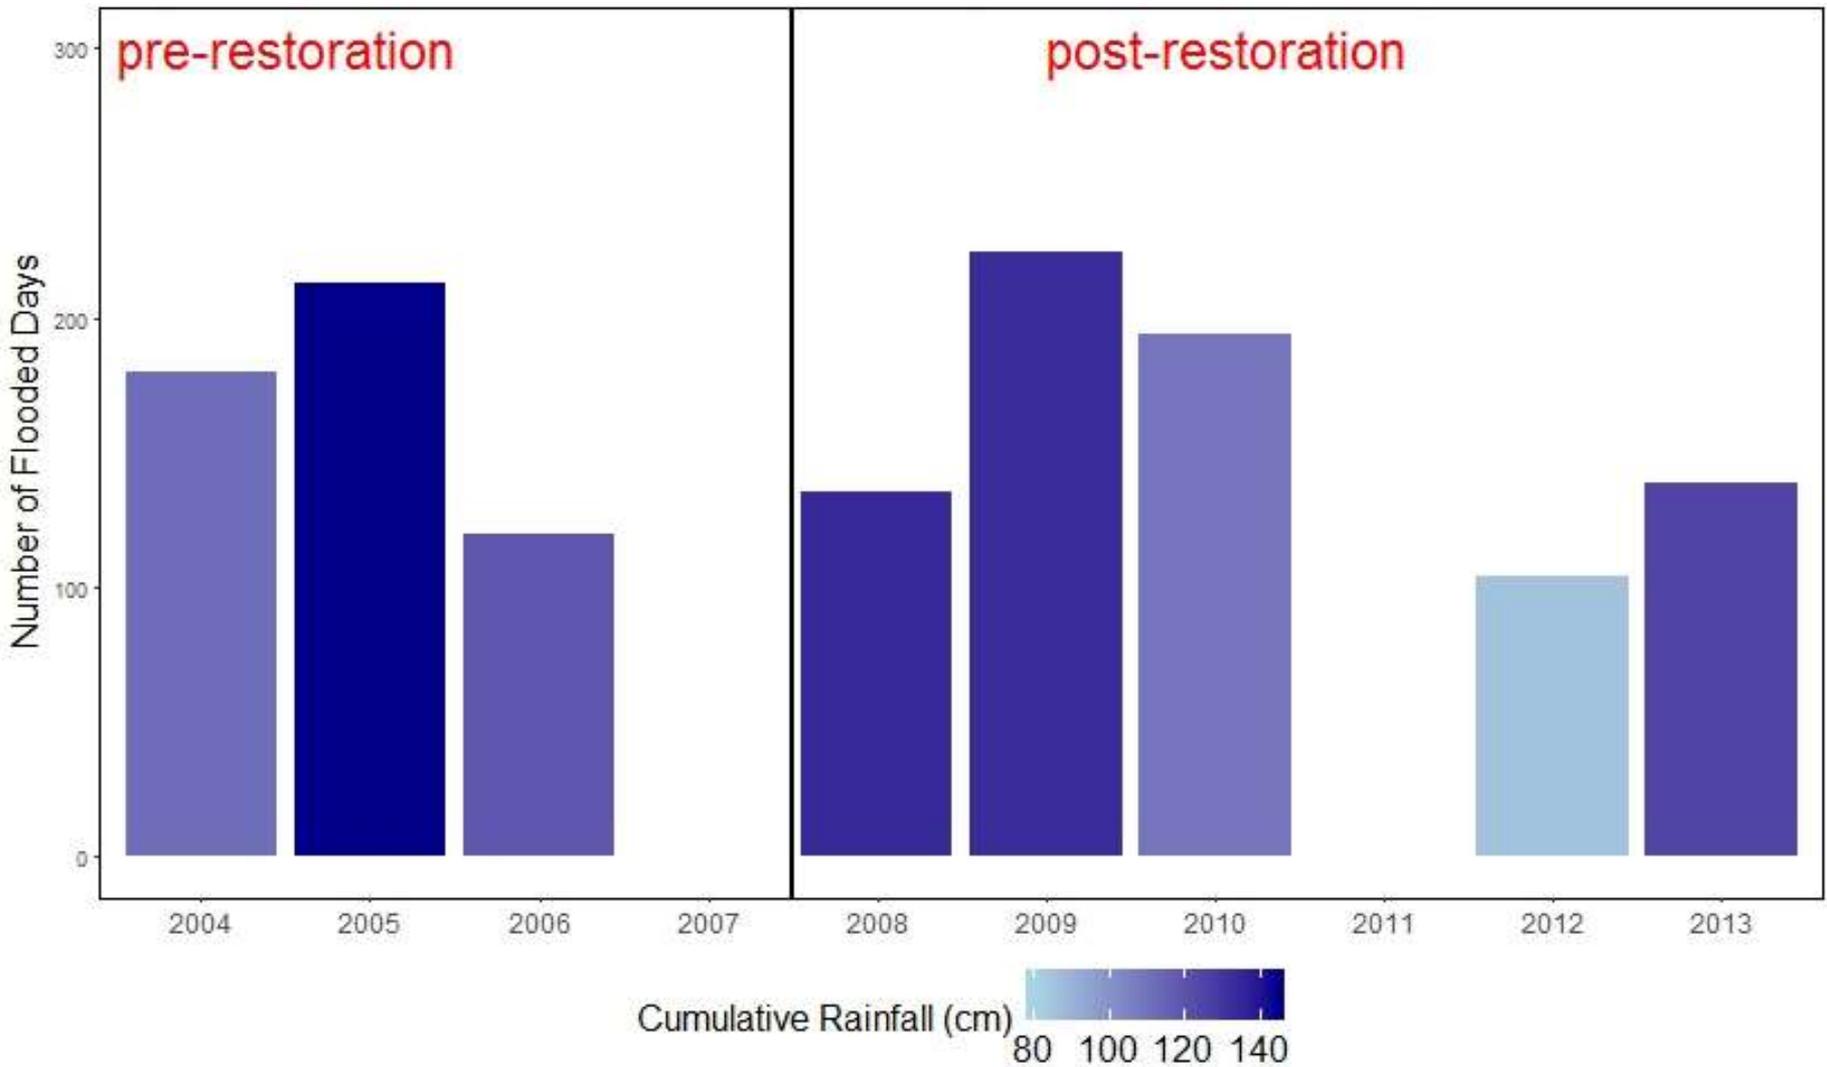
# Results: Hydrology of the East Marsh

## Numbers of flooded days

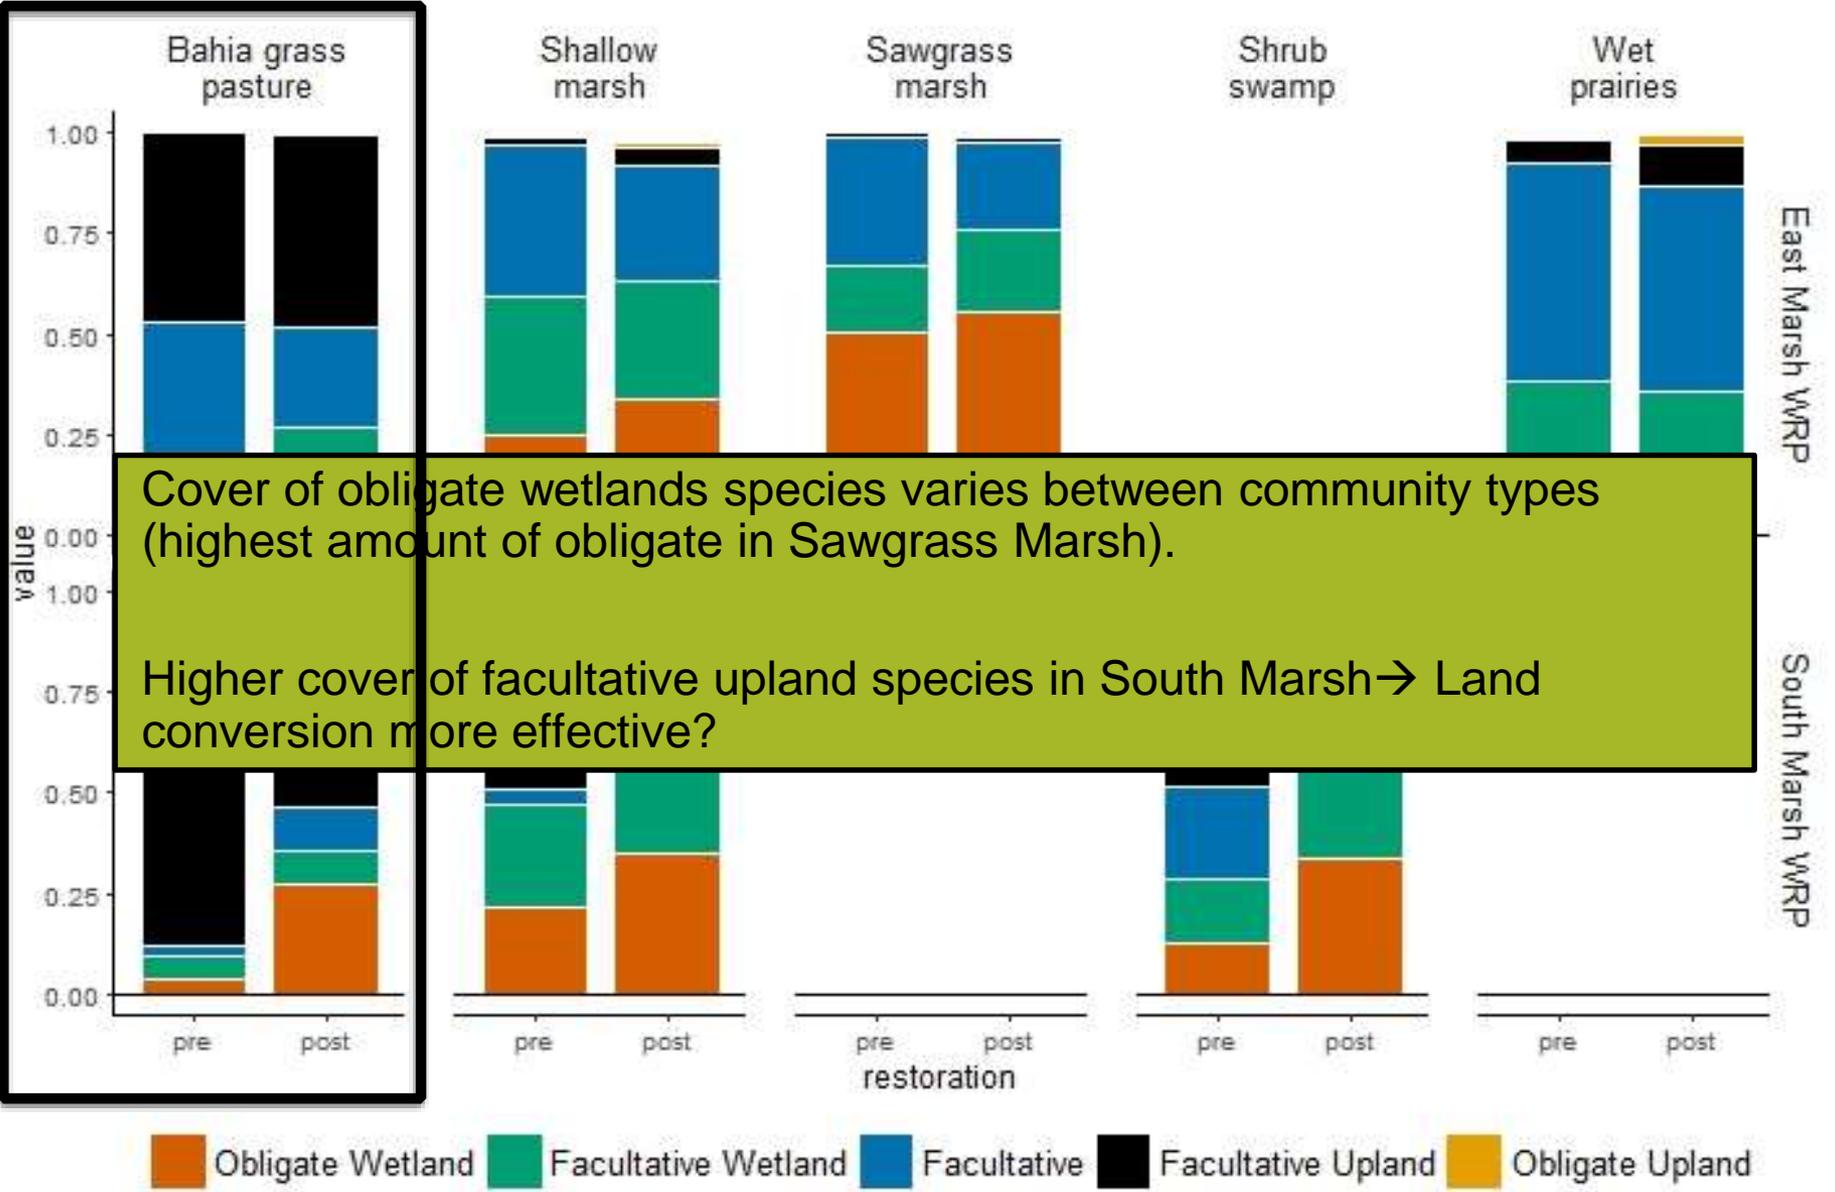
# Results: Shift in Wetland Indicator Status

Cover of obligate wetlands species varies between community types (highest amount of obligate in Sawgrass Marsh).

Higher cover of facultative upland species in South Marsh → Land conversion more effective?

- Hydrological restoration **increased cover of Obligate Wetland Species**. Cover of facultative wetland species do not necessarily increased.

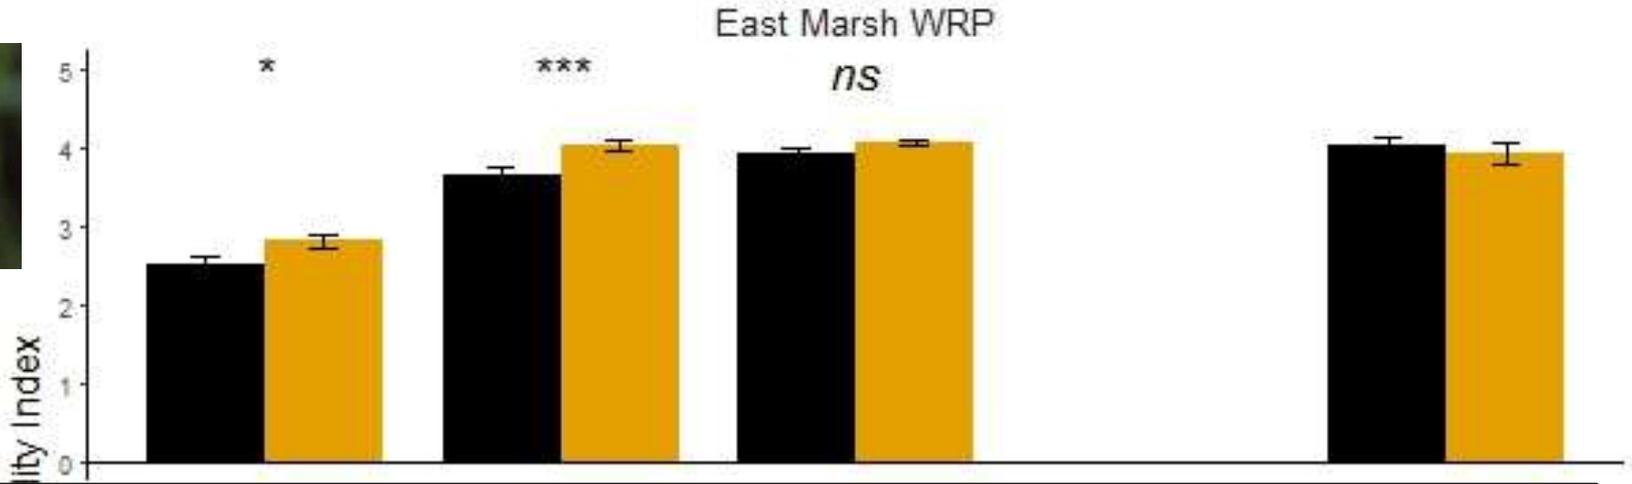
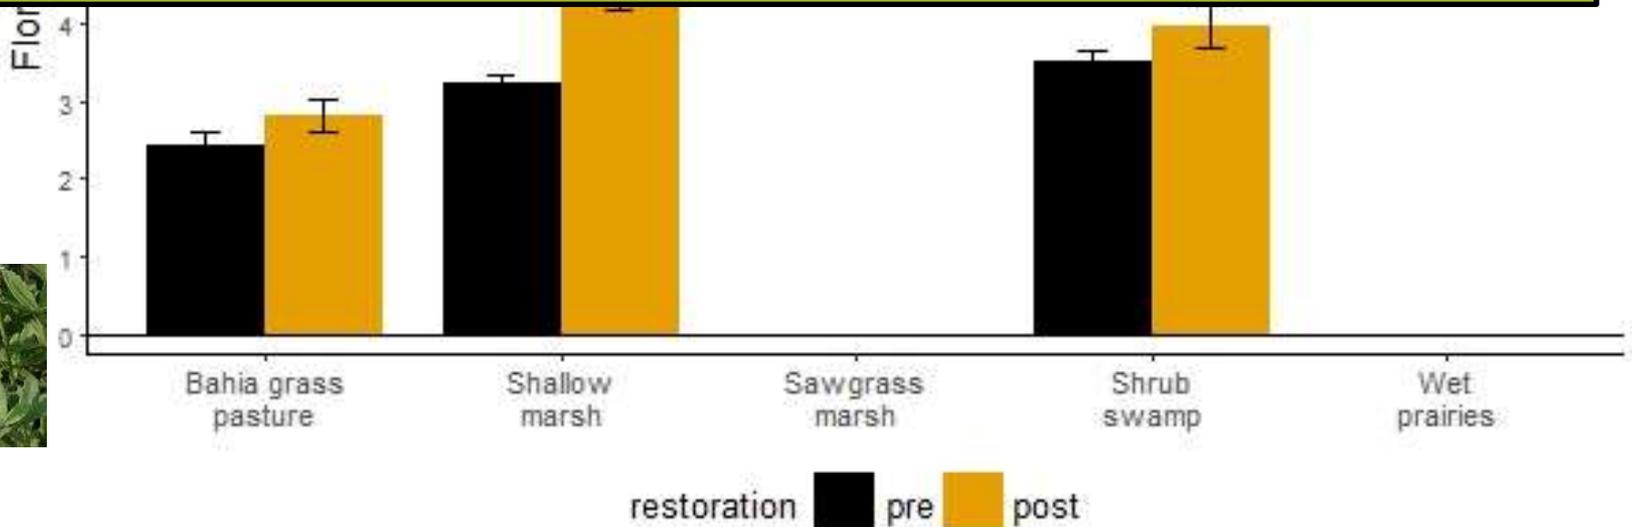
# Results: Shift in Floristic Quality

Floristic Quality lowest in Bahiagrass pastures

Floristic Quality increased in most community types (**H4 is verified**)

- Hydrological restoration **improved floristic Quality** in both WRPs.
