2017 Greater Everglades Ecosystem Restoration Conference
April 17-21, 2017

**THE GHOST TREE ISLANDS
OF EVERGLADES WATER
CONSERVATION AREA 2A:
TRACING A HISTORY OF
CHANGE**

Thomas W. Dreschel, Section Leader
Everglades System Assessment
Applied Sciences Bureau

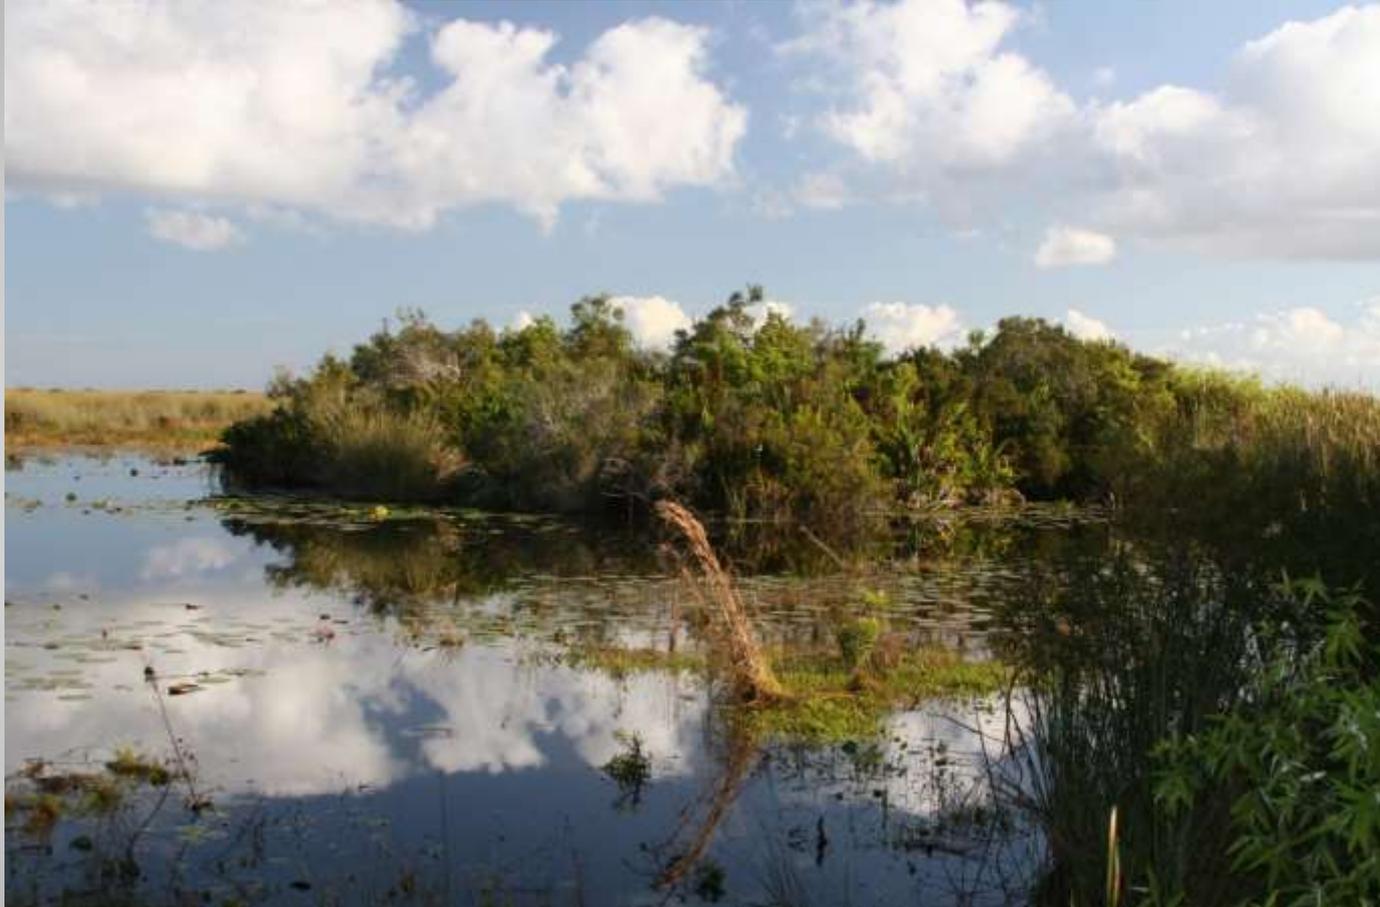
A Natural Process

Peat pop-up or floating tree islands in WCA-1 were used as the model for the described technique.

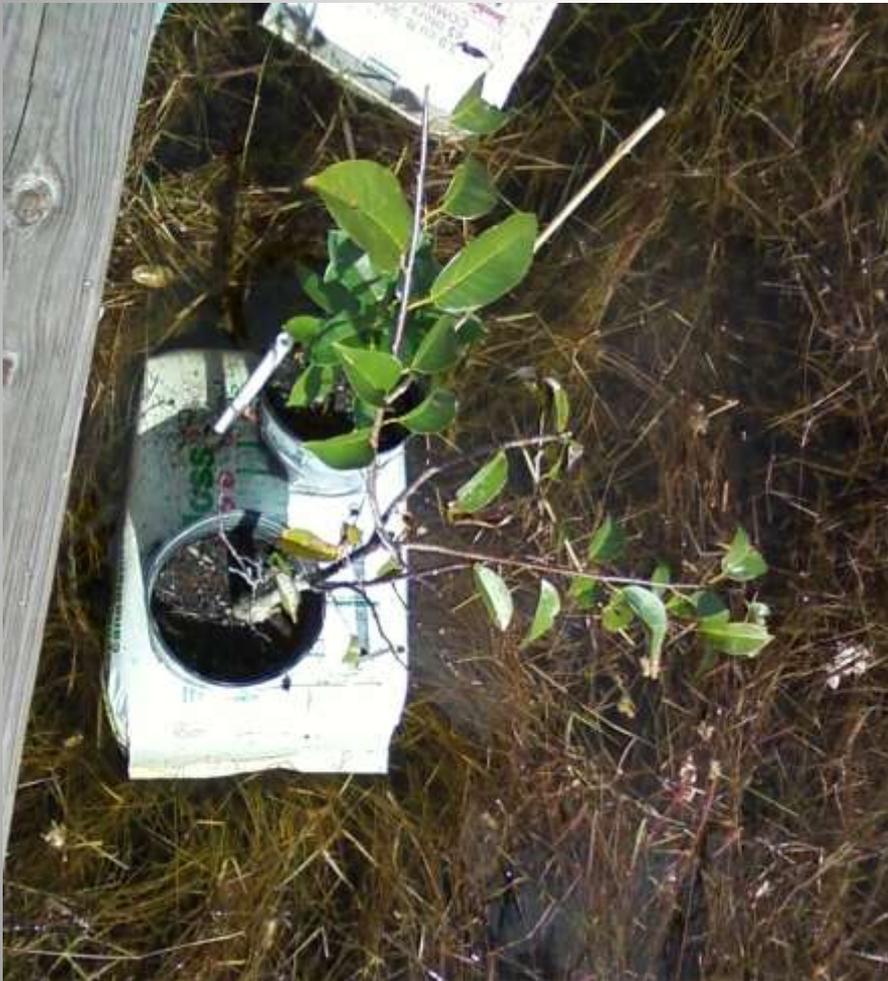
At planting

Pilot Study at LILA

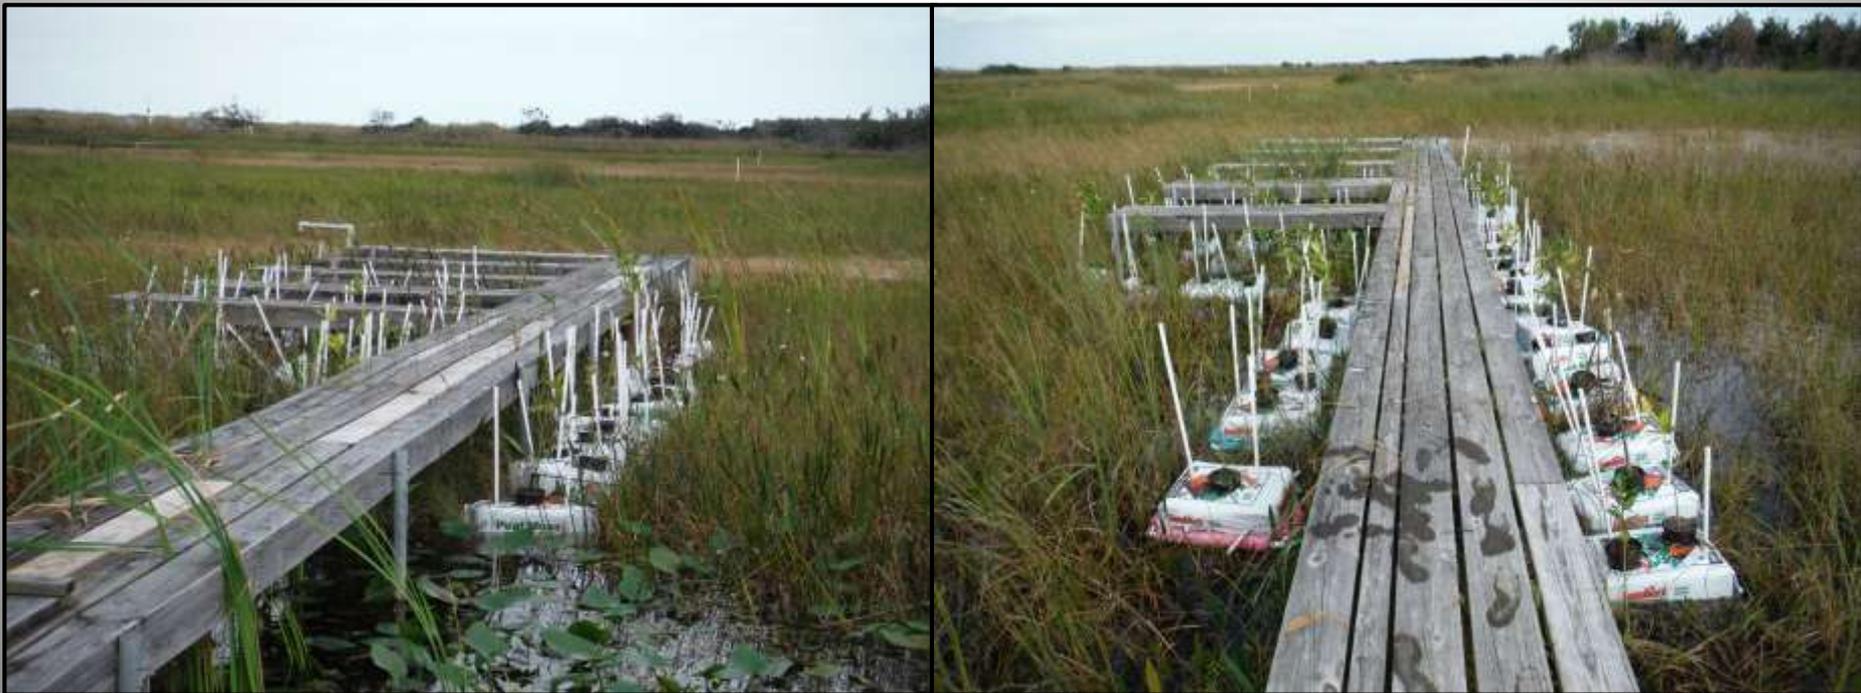
Current Study: Two bag orientations (controls), two fertilizer treatments, double planting and flotation (5 reps each), variable hydrology

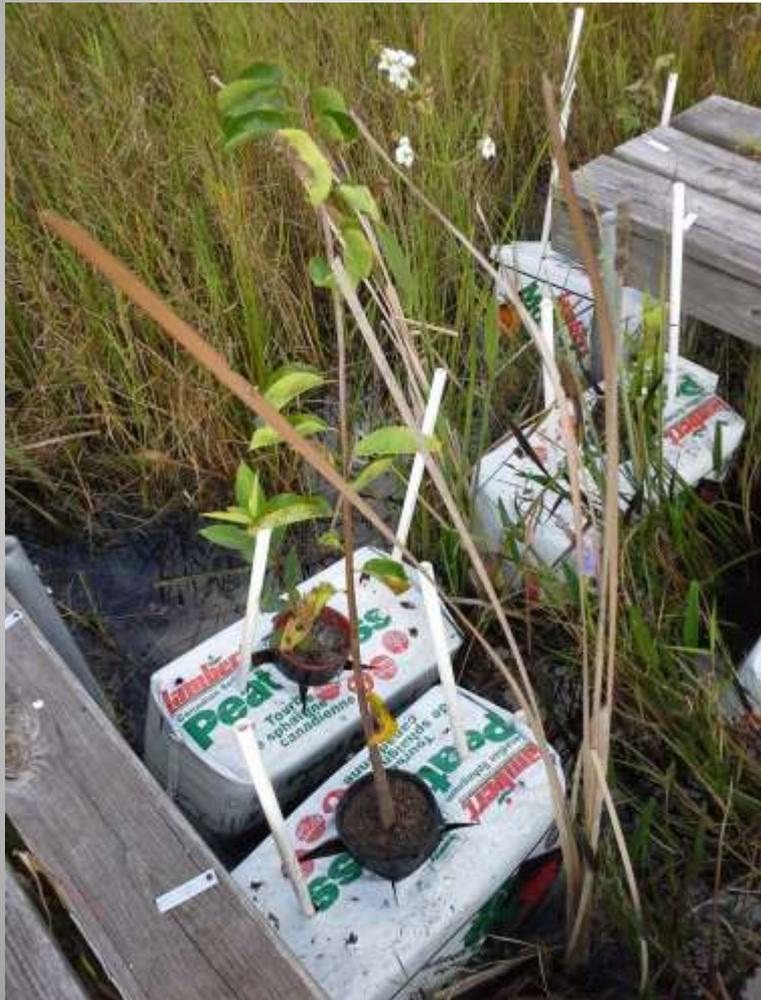
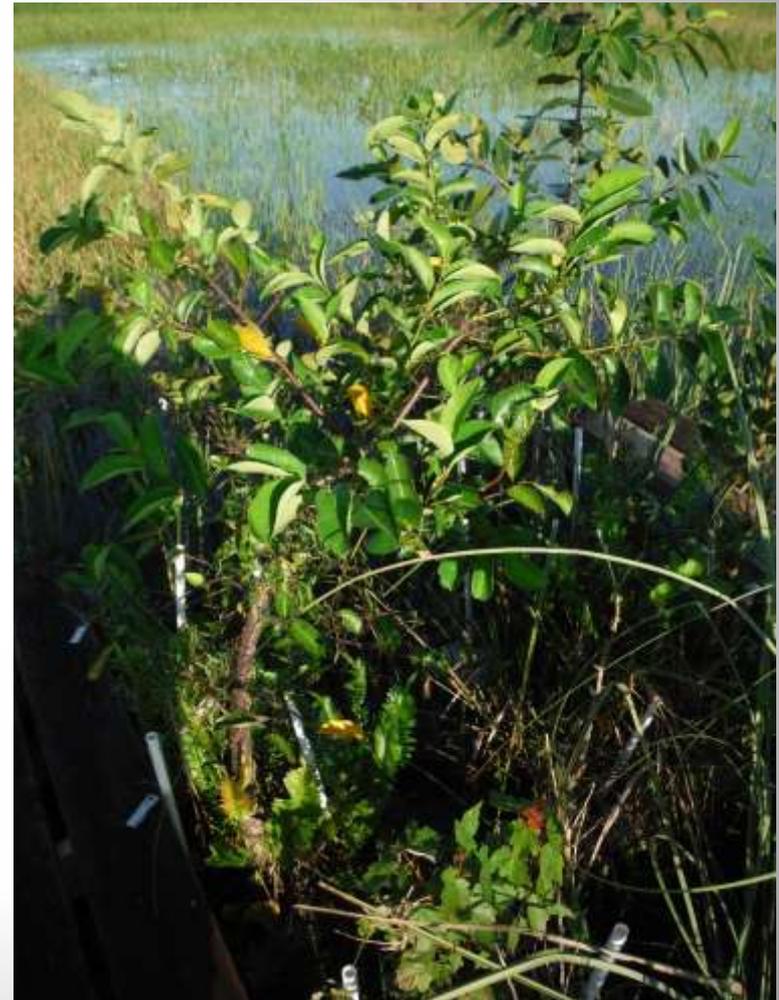
At planting and two years later (Pond Apple)

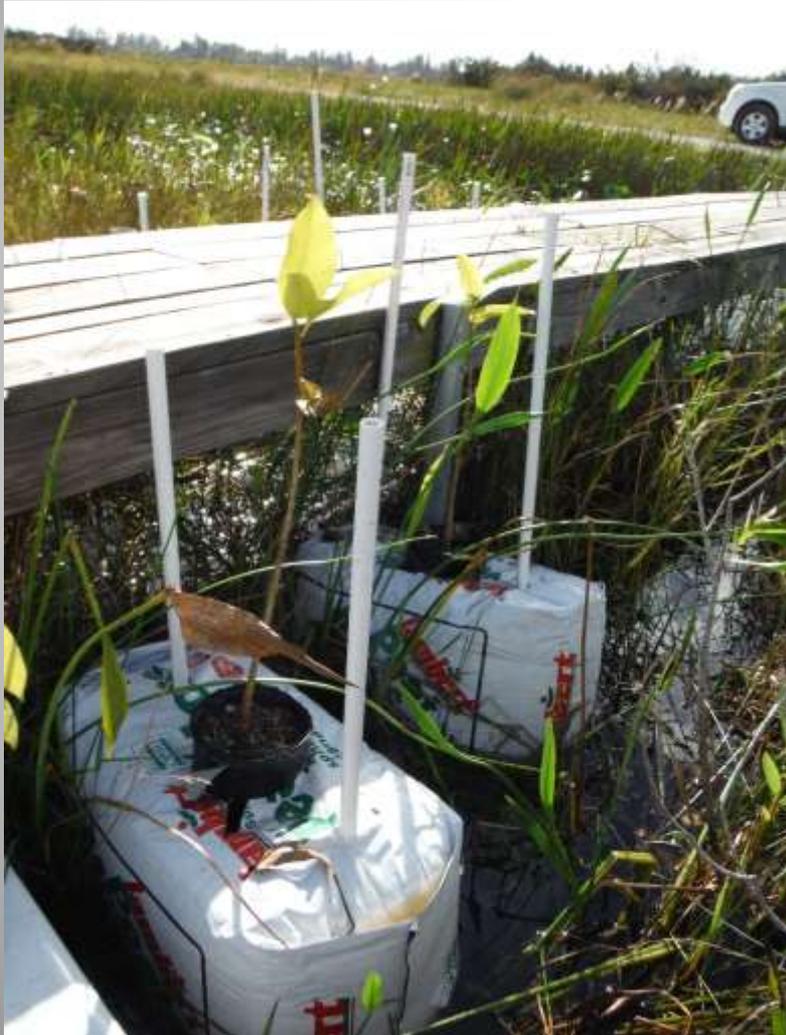
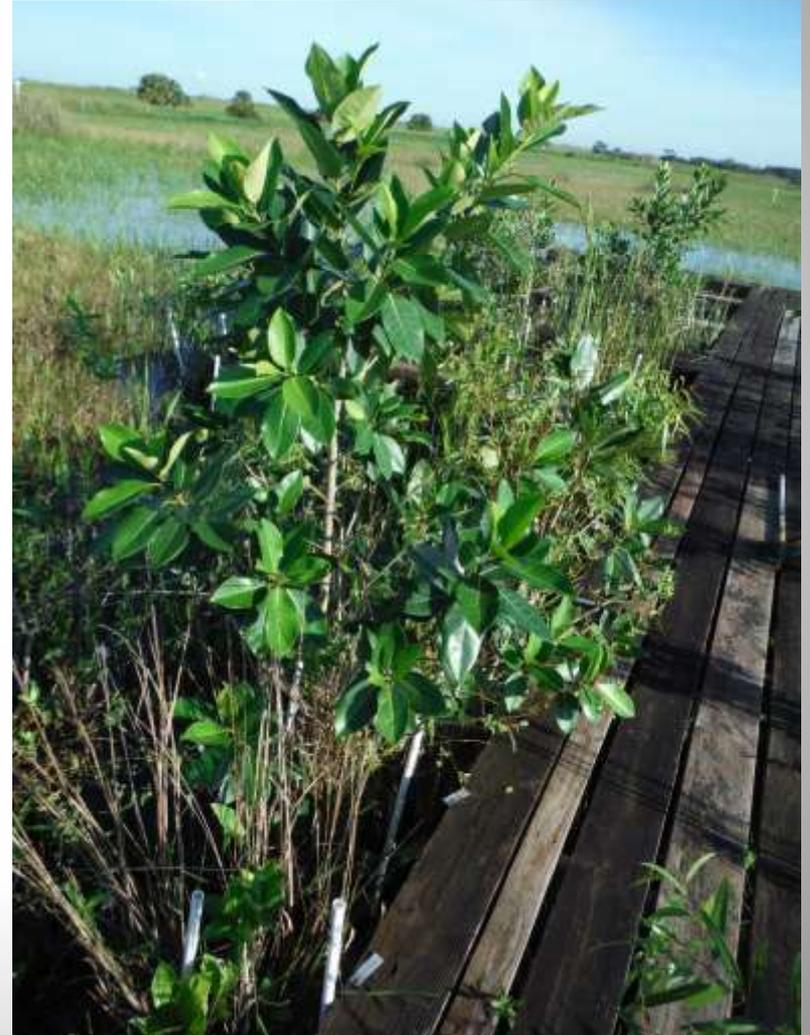
At planting and two years later (Strangler Fig)

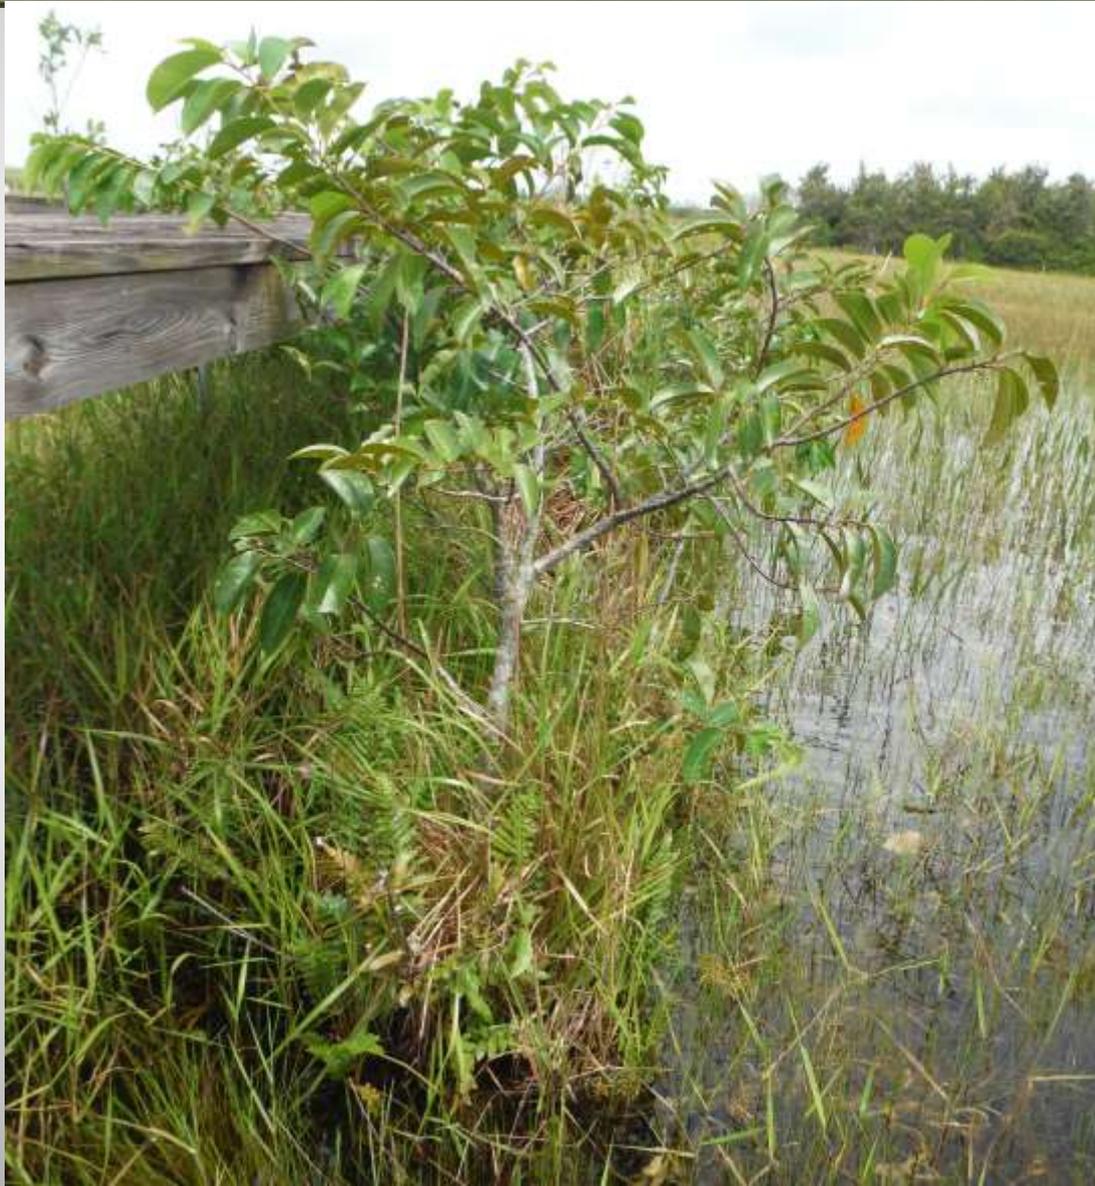
With pot and bag removed (Pond Apple)

The study concluded that the best design criterial for a successful pop-up would be:

- To provide the greatest elevation increase,
- To provide a small increase in nutrients (one fertilizer spike),
- Plant only a single sapling per peat bag.
