DROUGHT, WINTER RAINS AND HURRICANES: HYDROLOGIC OBSERVATIONS FROM 2014-2017 OF THE EASTERN PANHANDLE COASTAL MARSH AND NORTHEAST FLORIDA BAY, EVERGLADES NATIONAL PARK, FL, USA.

Gordon Anderson¹, Amy Renshaw² and Alexander Blochel³

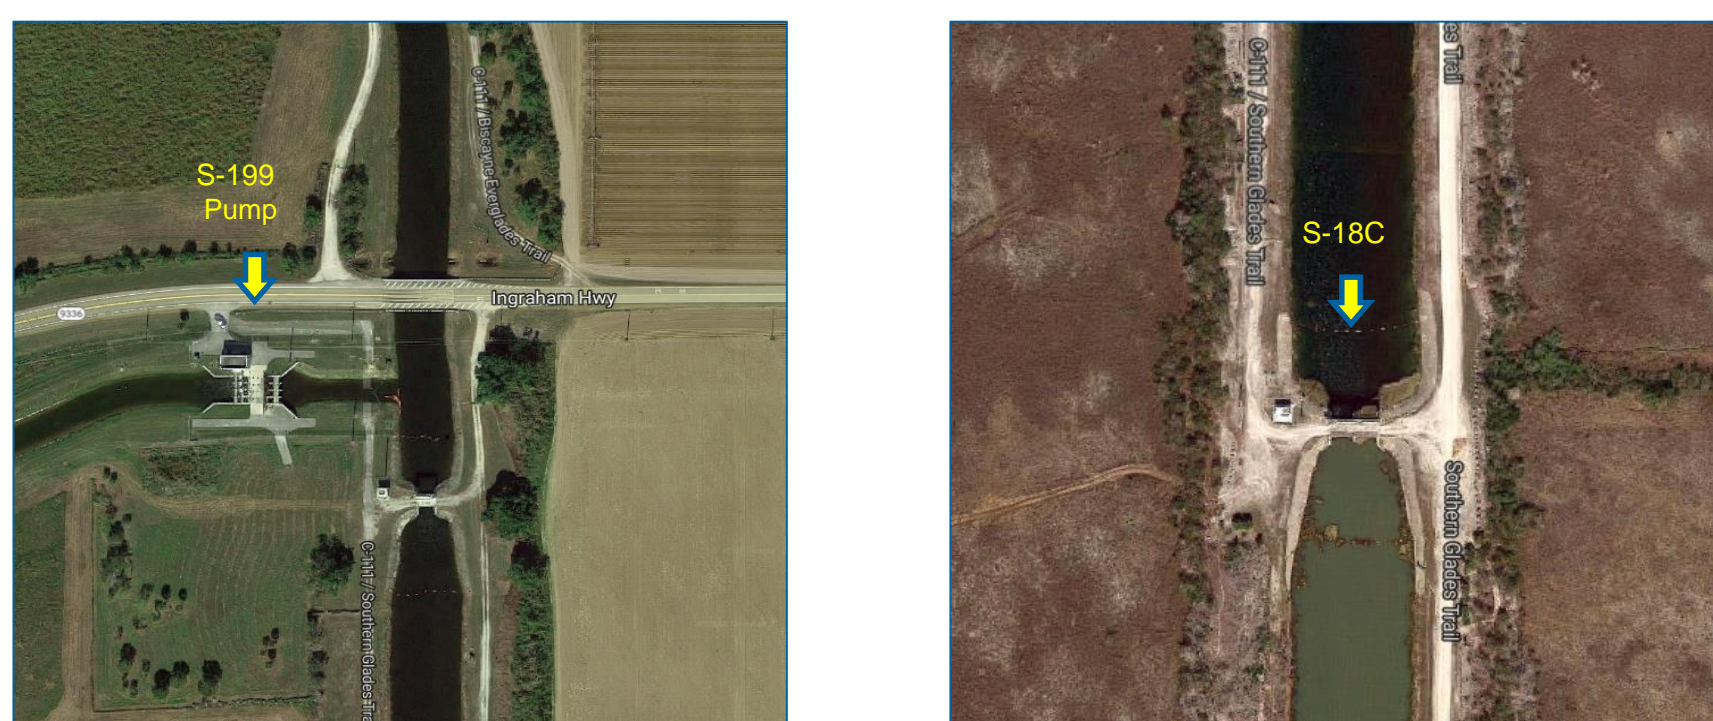
Figure 2. Left photo, Pump S-199, directs C-111 flows into Taylor Slough via secondary canal. S-199 has been operational since February 2012. Right photo, Spillway S18C with controls C-111 flows south to the EP and S-197 leading into Manatee Bay

C-111 Spreader Canal Western Project, Phase 1 (C111SCWP) was completed in February 2012 as a sub-part of the Comprehensive Everglades Restoration Project (USACE, 2014). Upstream retention ponds and canal modifications were constructed, directing more water flow (S-199) into Taylor Slough. Initially, the project was lauded (fig 1, fig 2). Audubon Florida reported Taylor Slough fresh water deliveries from C111SCWP reduced coastal mangrove salinity by 12.5 PSU from pre-C111SW levels in 2013 (Kline et al, 2017). However, in the EP marsh, fresh water availability has declined and salinities increased, due to topographic discontinuity (ridge) between Taylor Slough and EP and by diverting C-111 canal water below structure S18C (fig 2).

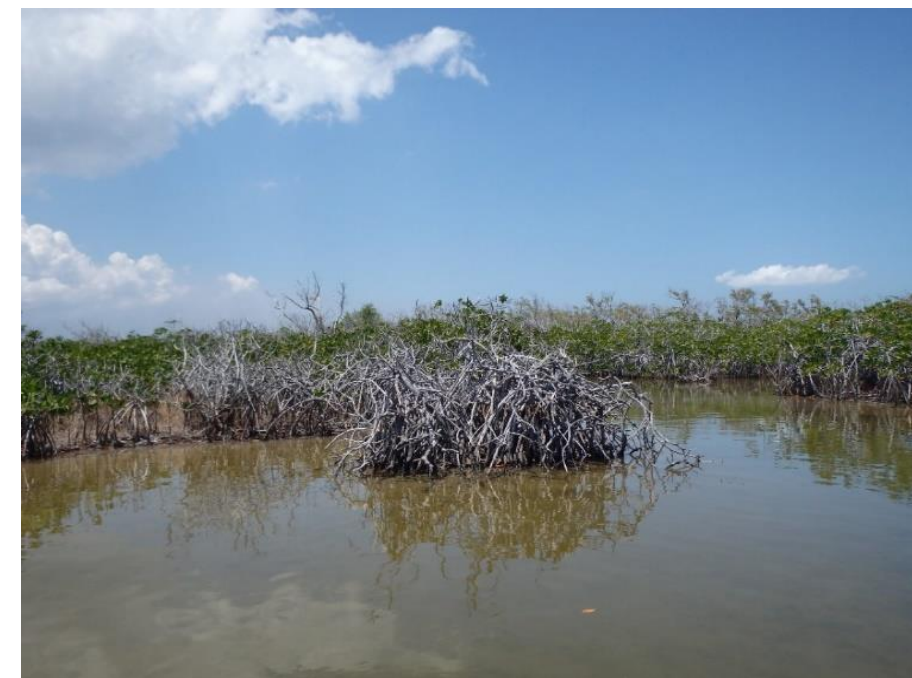
Figure 3. Top: Mangrove mortality from drought (fall 2015). Bottom: *Ruppia* *sp.* (Spring 2019)

Low rainfall and limited upstream freshwater discharge 2014-2015 led to drought conditions in the C-111 drainage and coastal marsh. The EP basin had its worst localized drought in over 25 years (1988-1990), creating prolonged hypersaline low-water marsh conditions that contributed to mortality of creek-lined red mangroves and reduction of freshwater marsh plants (fig 3).

However, the preceding drought lead to high marsh plant mortality and subsequent plant recruitment and recovery has been slow. *Ruppia* *sp.* (fig 3) was the first SAV to re-colonize after drought, followed by *Utricularia* *sp* and Emergent herbaceous vegetation (EHV). Dry season SAV growth observed during 2015-2016 was atypical to typical summer SAV growth, and suggests strong evidence that salinity, not higher summer temperatures nor longer day length is the key driver of SAV abundance in the transition (Kline et al, 2017).
