Tropical Storm Impacts to Everglades Stormwater Treatment Area Submerged Aquatic Vegetation Communities

INTECOL 9th International Wetlands Conference

June 7, 2012

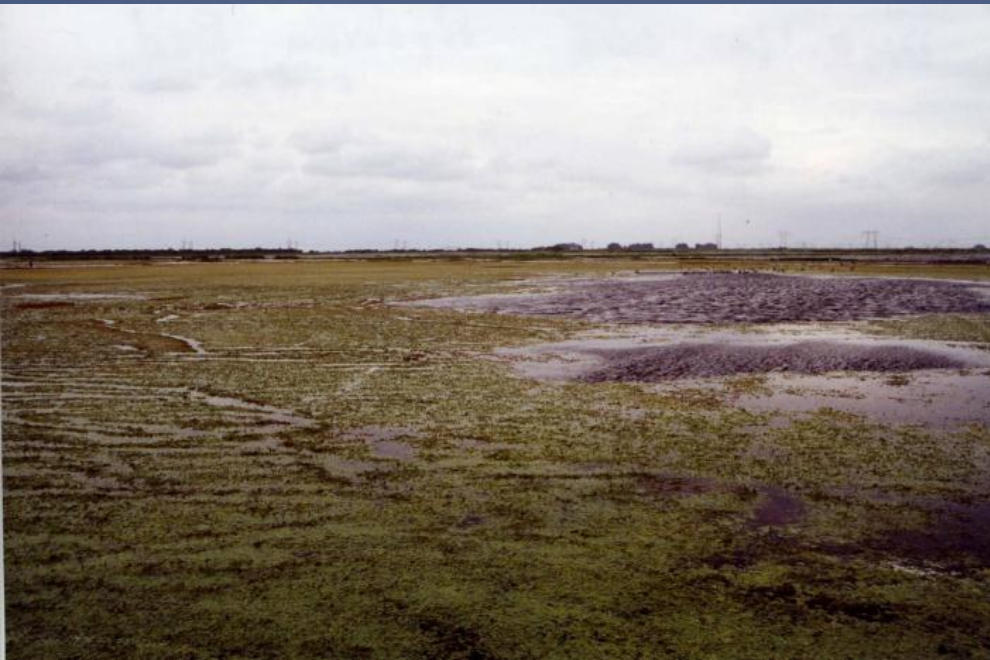
STA 1W Cell 5b,
outlined in red,
consisted of two
compartments
~ 500 ha in size

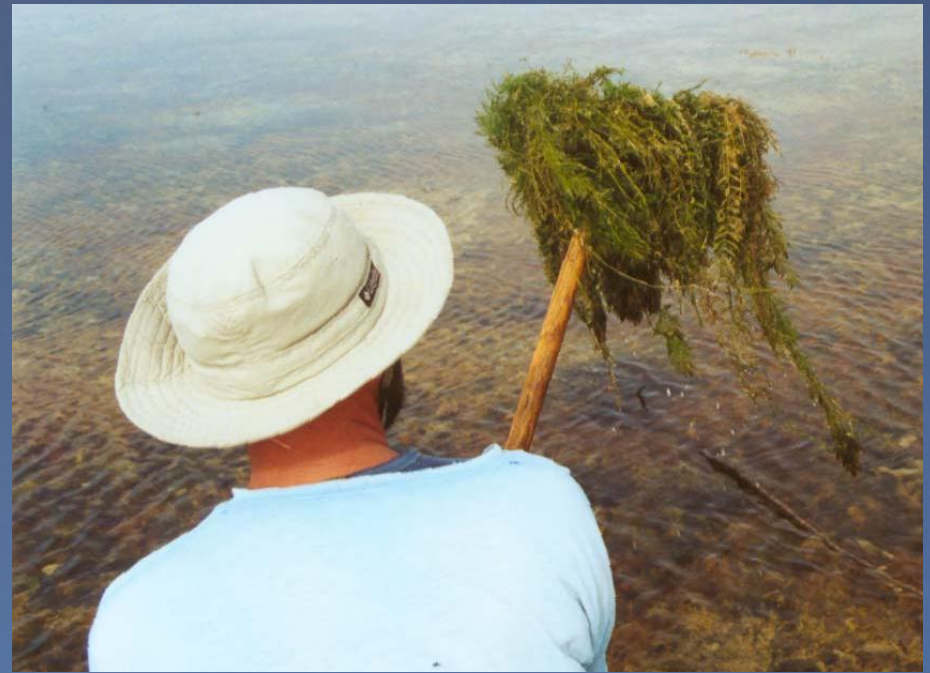
Plant cover assessed visually and with a rake, which is dragged three times on the bottom (~ 1 m distance) to capture vegetation.

- The rake is used to
 - Facilitate SAV detection under turbid water conditions.
 - Determine if other species are present underneath dense SAV beds
- The assigned cover category takes into account the SAV observed in the vicinity and the vegetation collected with the rake.

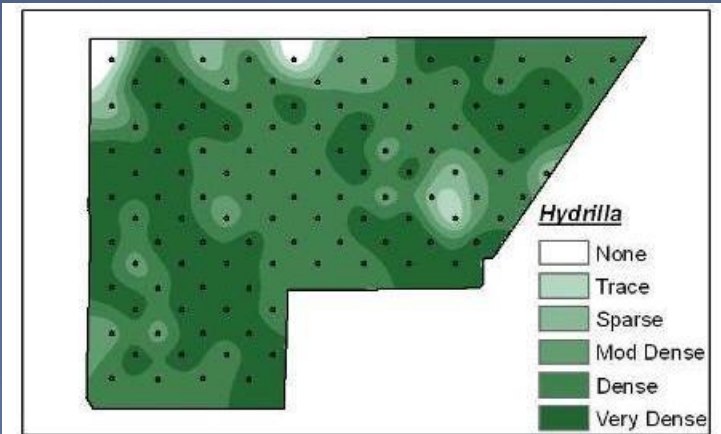
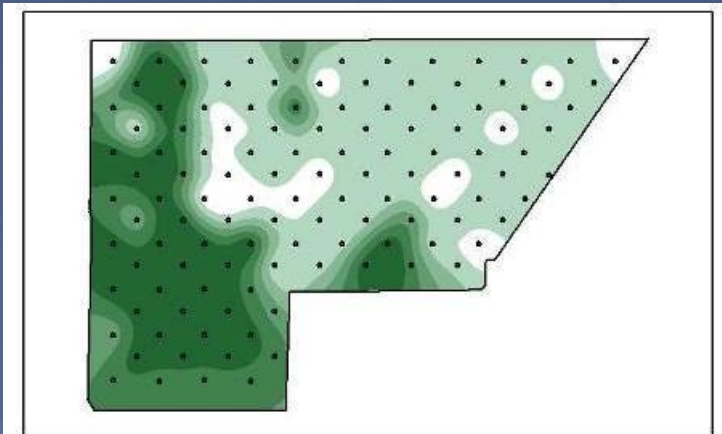
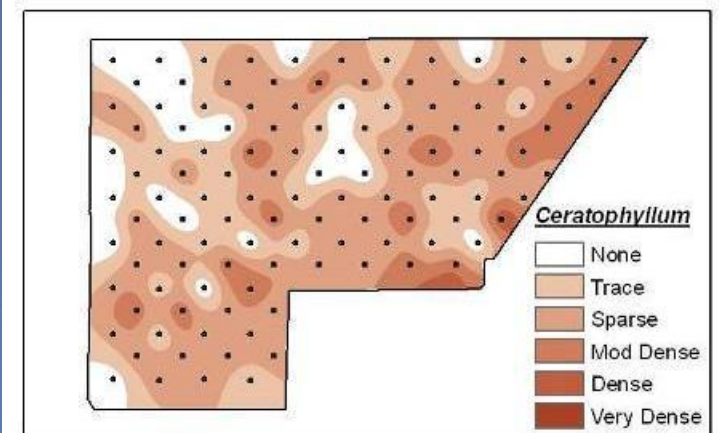
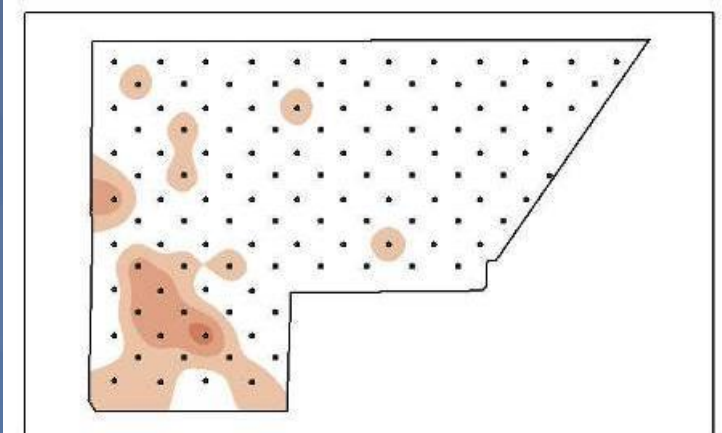
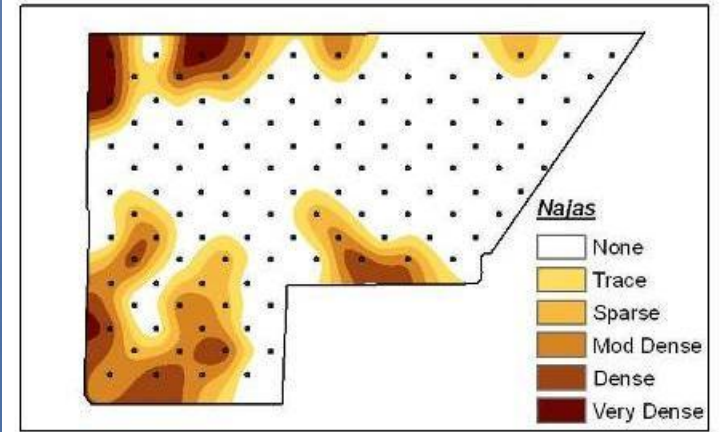
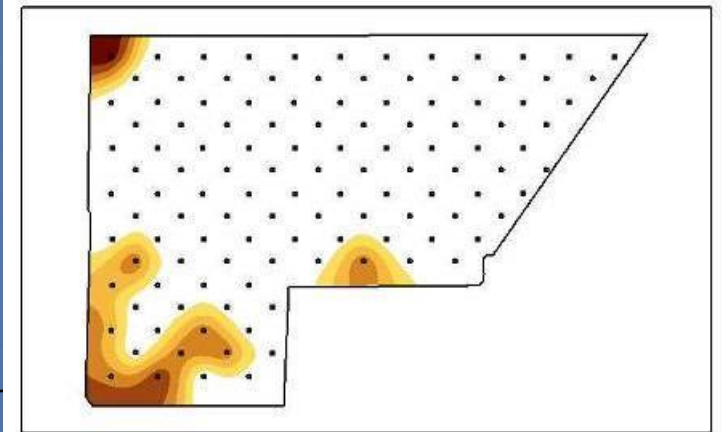
SAV before hurricanes: Aug. 2004

SAV after hurricanes: Oct. 2004

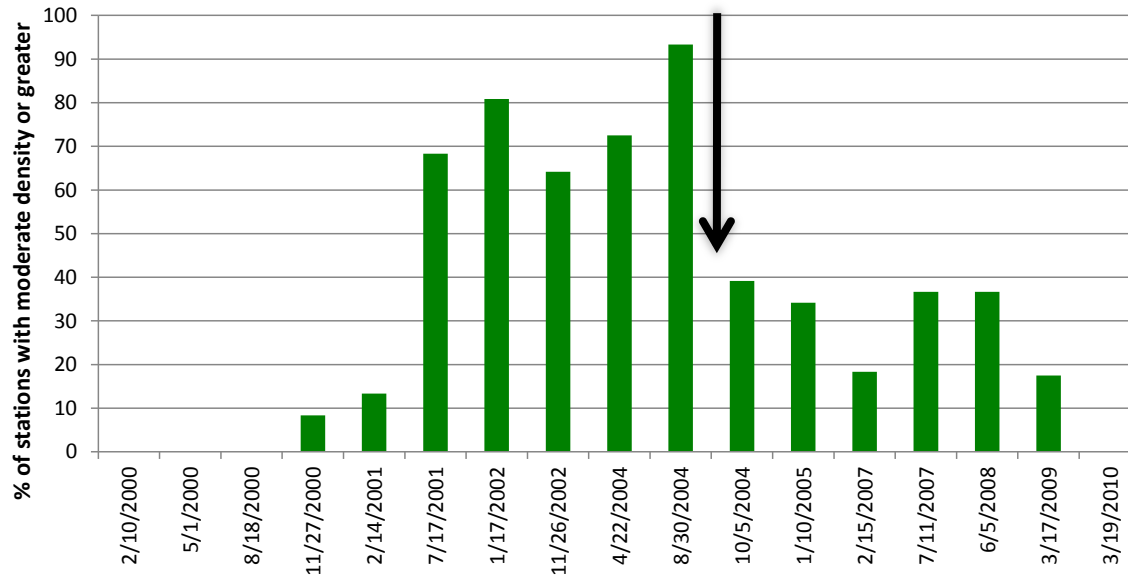
STA-1W Cell
5B: Feb 00 –
Mar 10
*Hydrilla Cover
Trends (arrow
depicts 2004
hurricanes)*

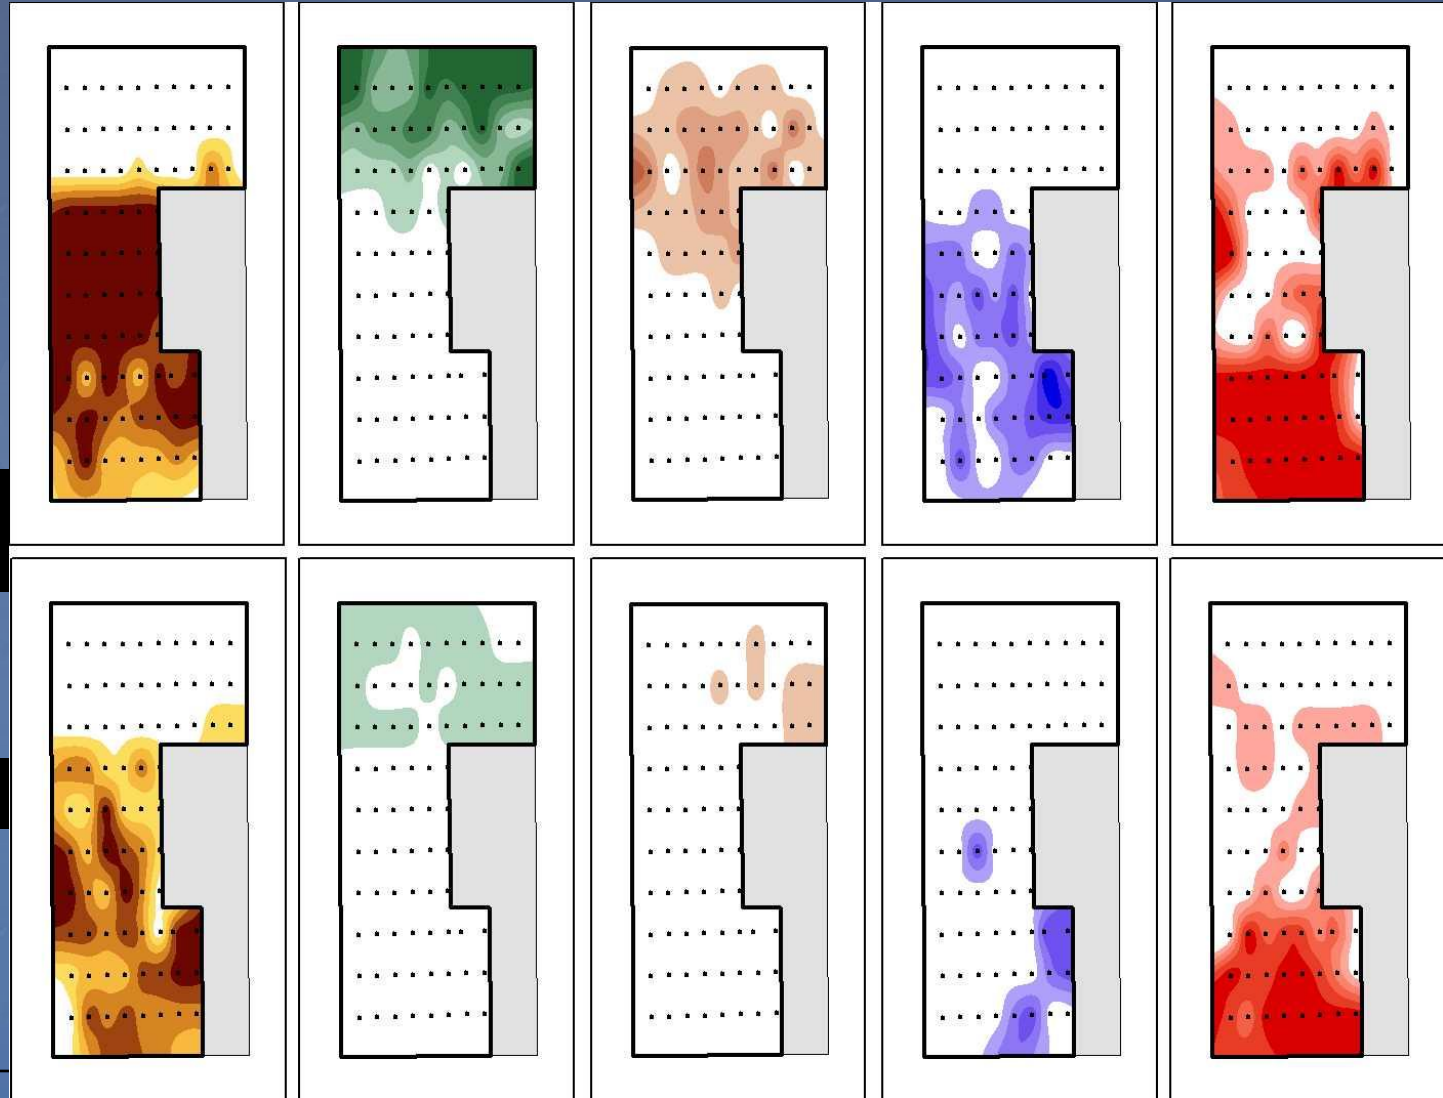
Hurricane Wilma Impacts on SAV in STA-2 Cell 3

August 2005

Hurricane Wilma:
October 24, 2005

November 2005

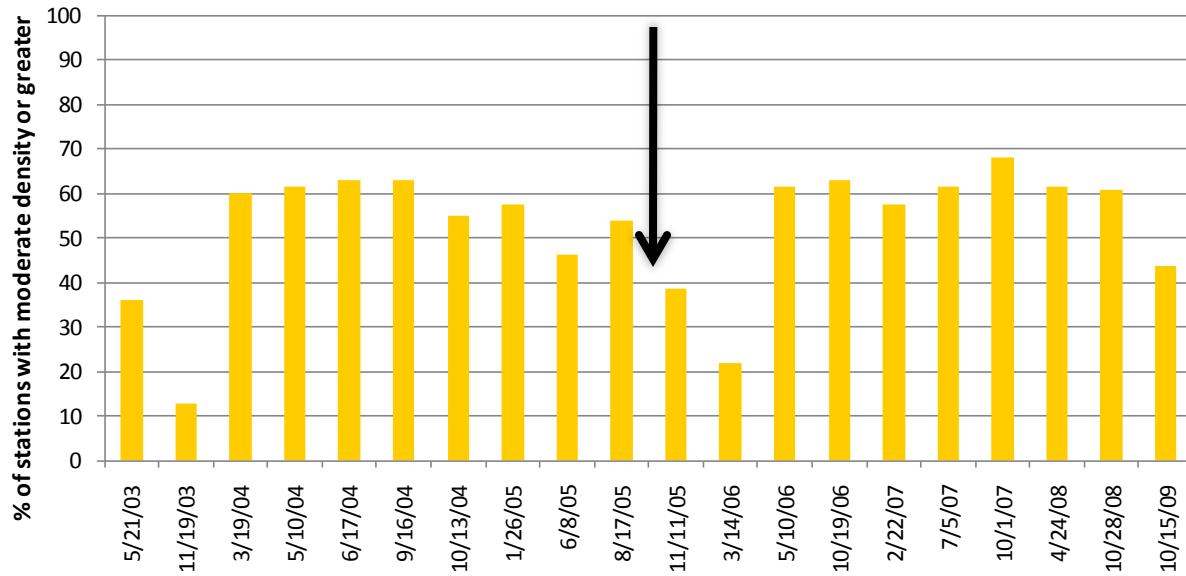
STA-2 Cell 3:
May 03 – Oct 09
Najas Cover
Trends (arrow depicts
2005 Hurricane Wilma)

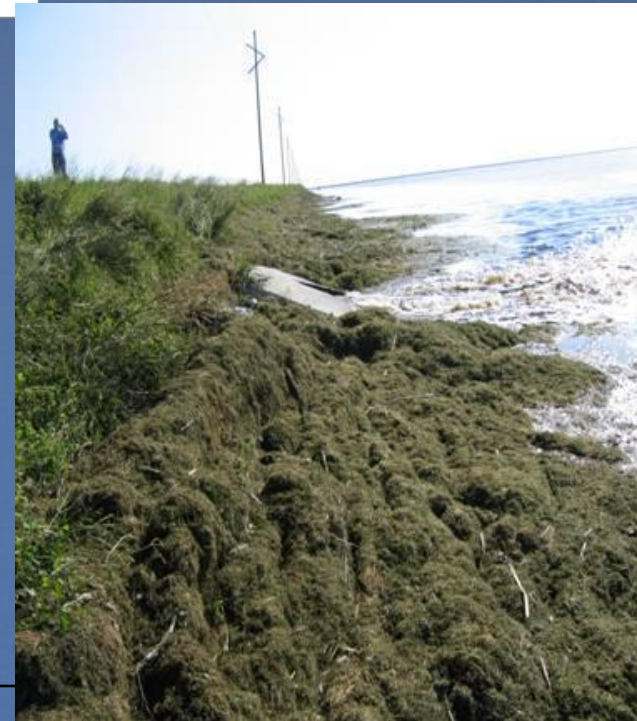
SAV swept onto the
levee in STA-2 Cell 3
after Hurricane Wilma

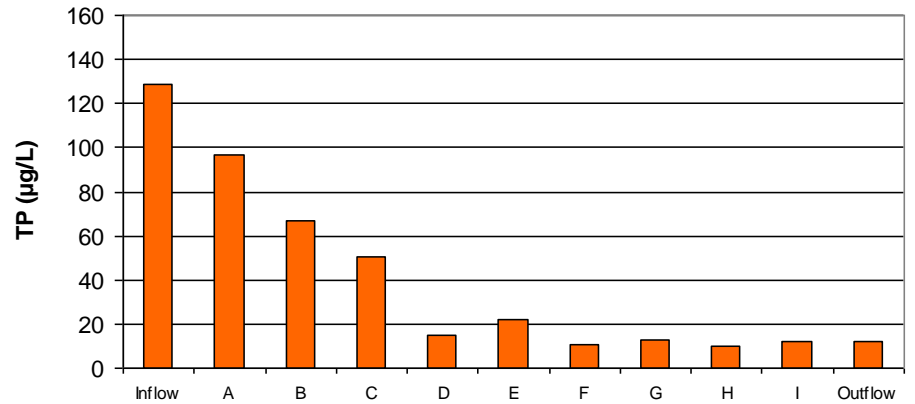
October 13, 2005

Spatial relationship between SAV cover and water quality, STA-2 Cell 3

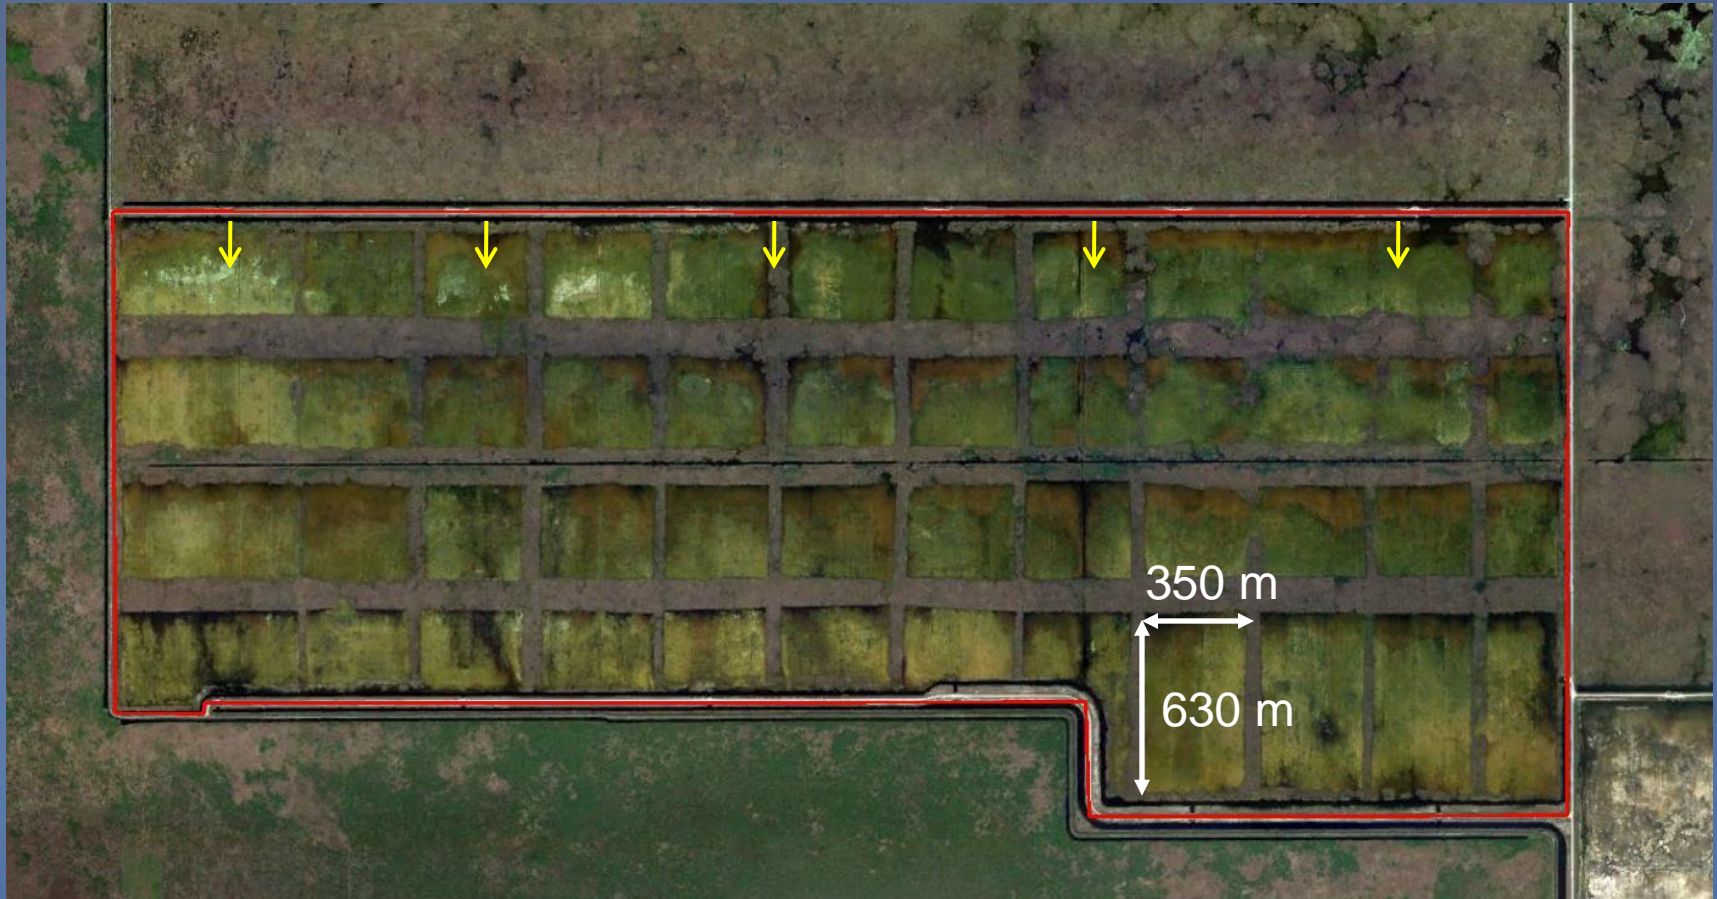
Currently, many back end STA cells are highly compartmentalized by bands of emergent macrophytes (STA-3/4 Cell 3B has sub-cells of ~ 20ha and smaller)
