Salinization of *Melaleuca*-dominated wetlands of the Gippsland Lakes, Australia

Paul Boon

Institute for Sustainability & Innovation

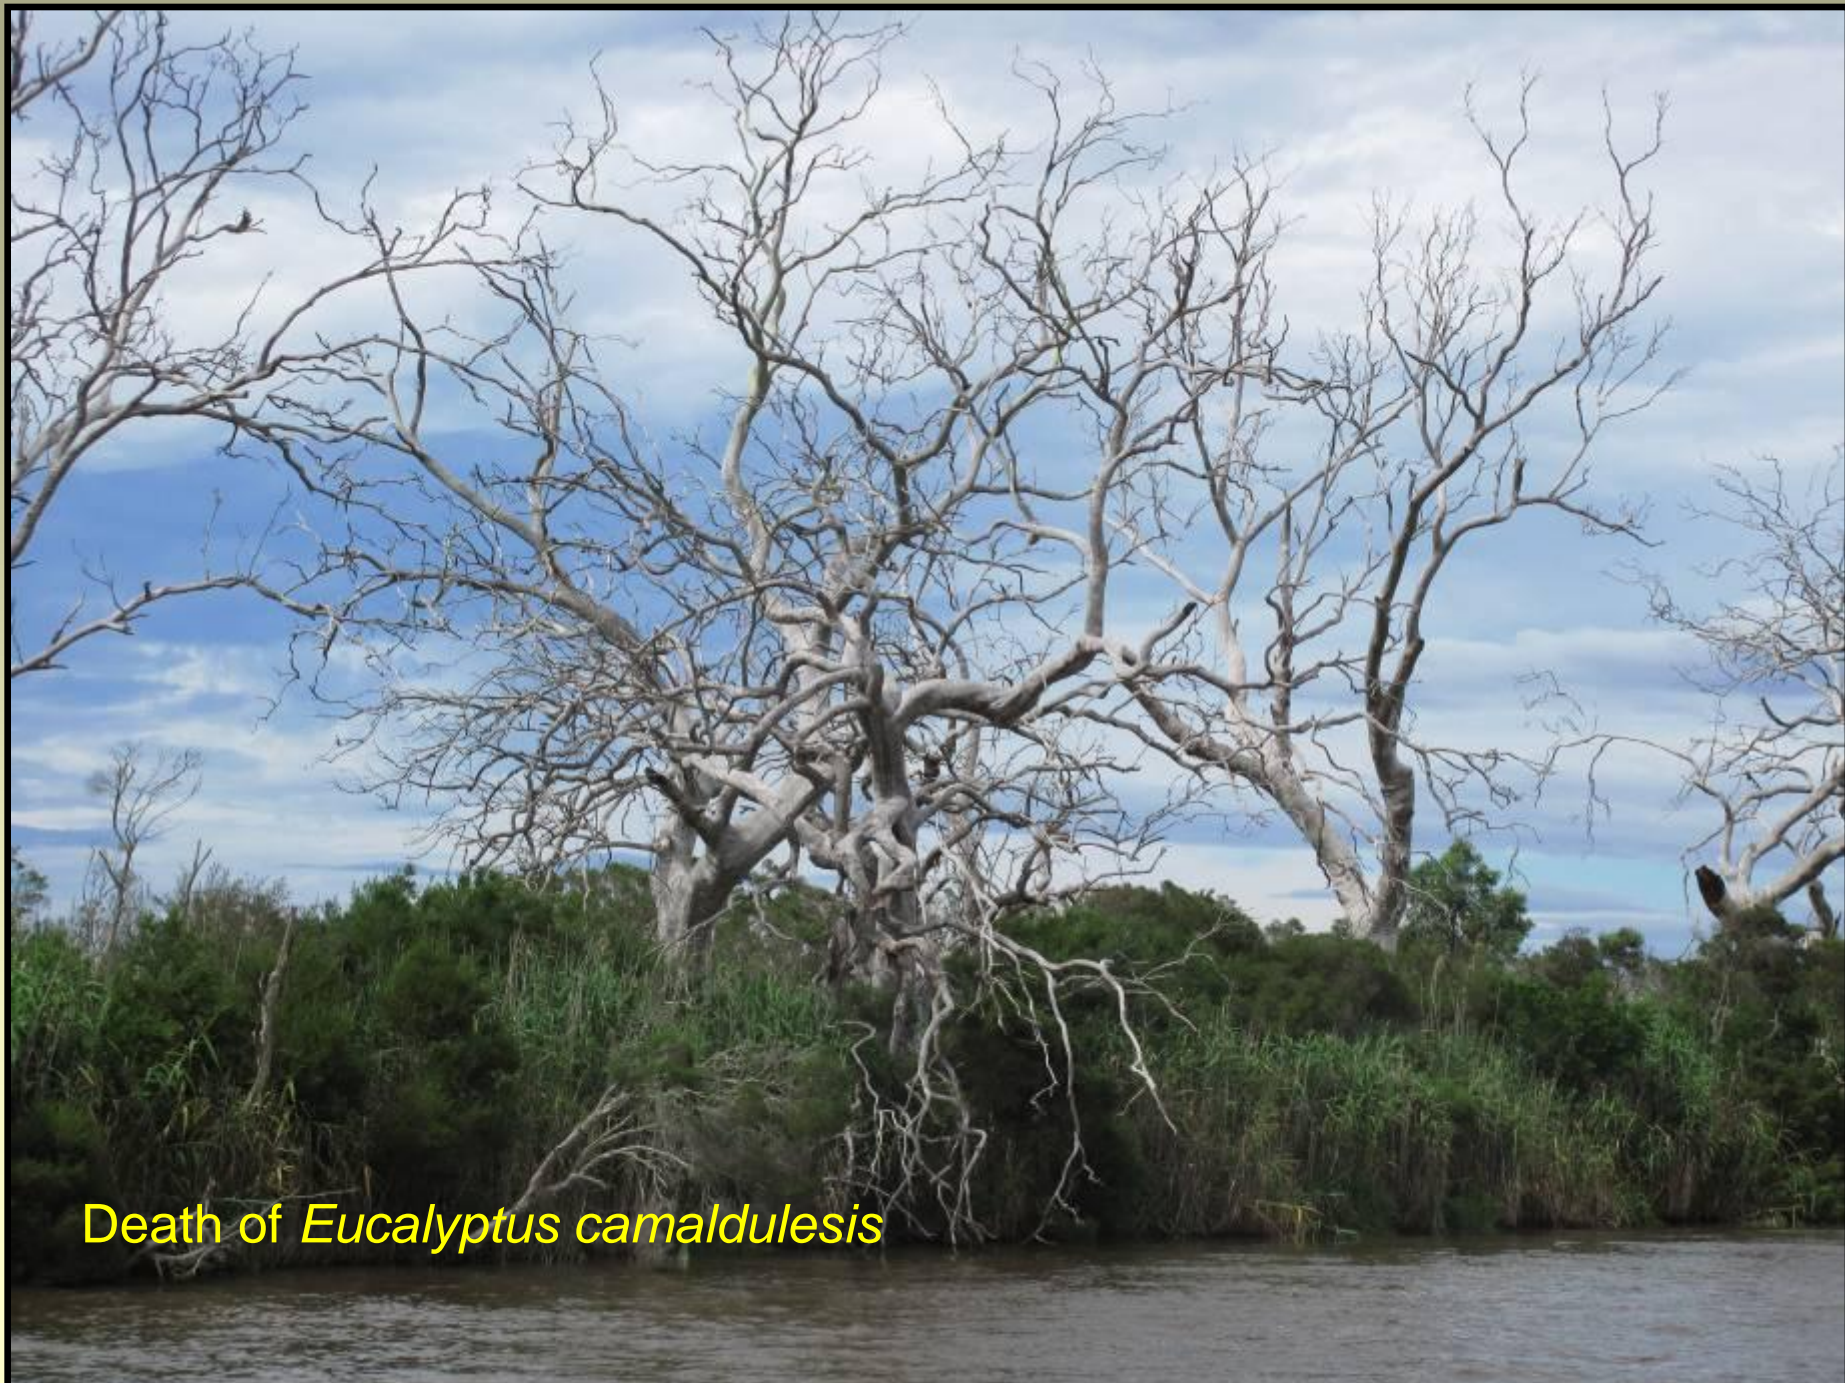
November 2010

Retreat of *Phragmites australis*

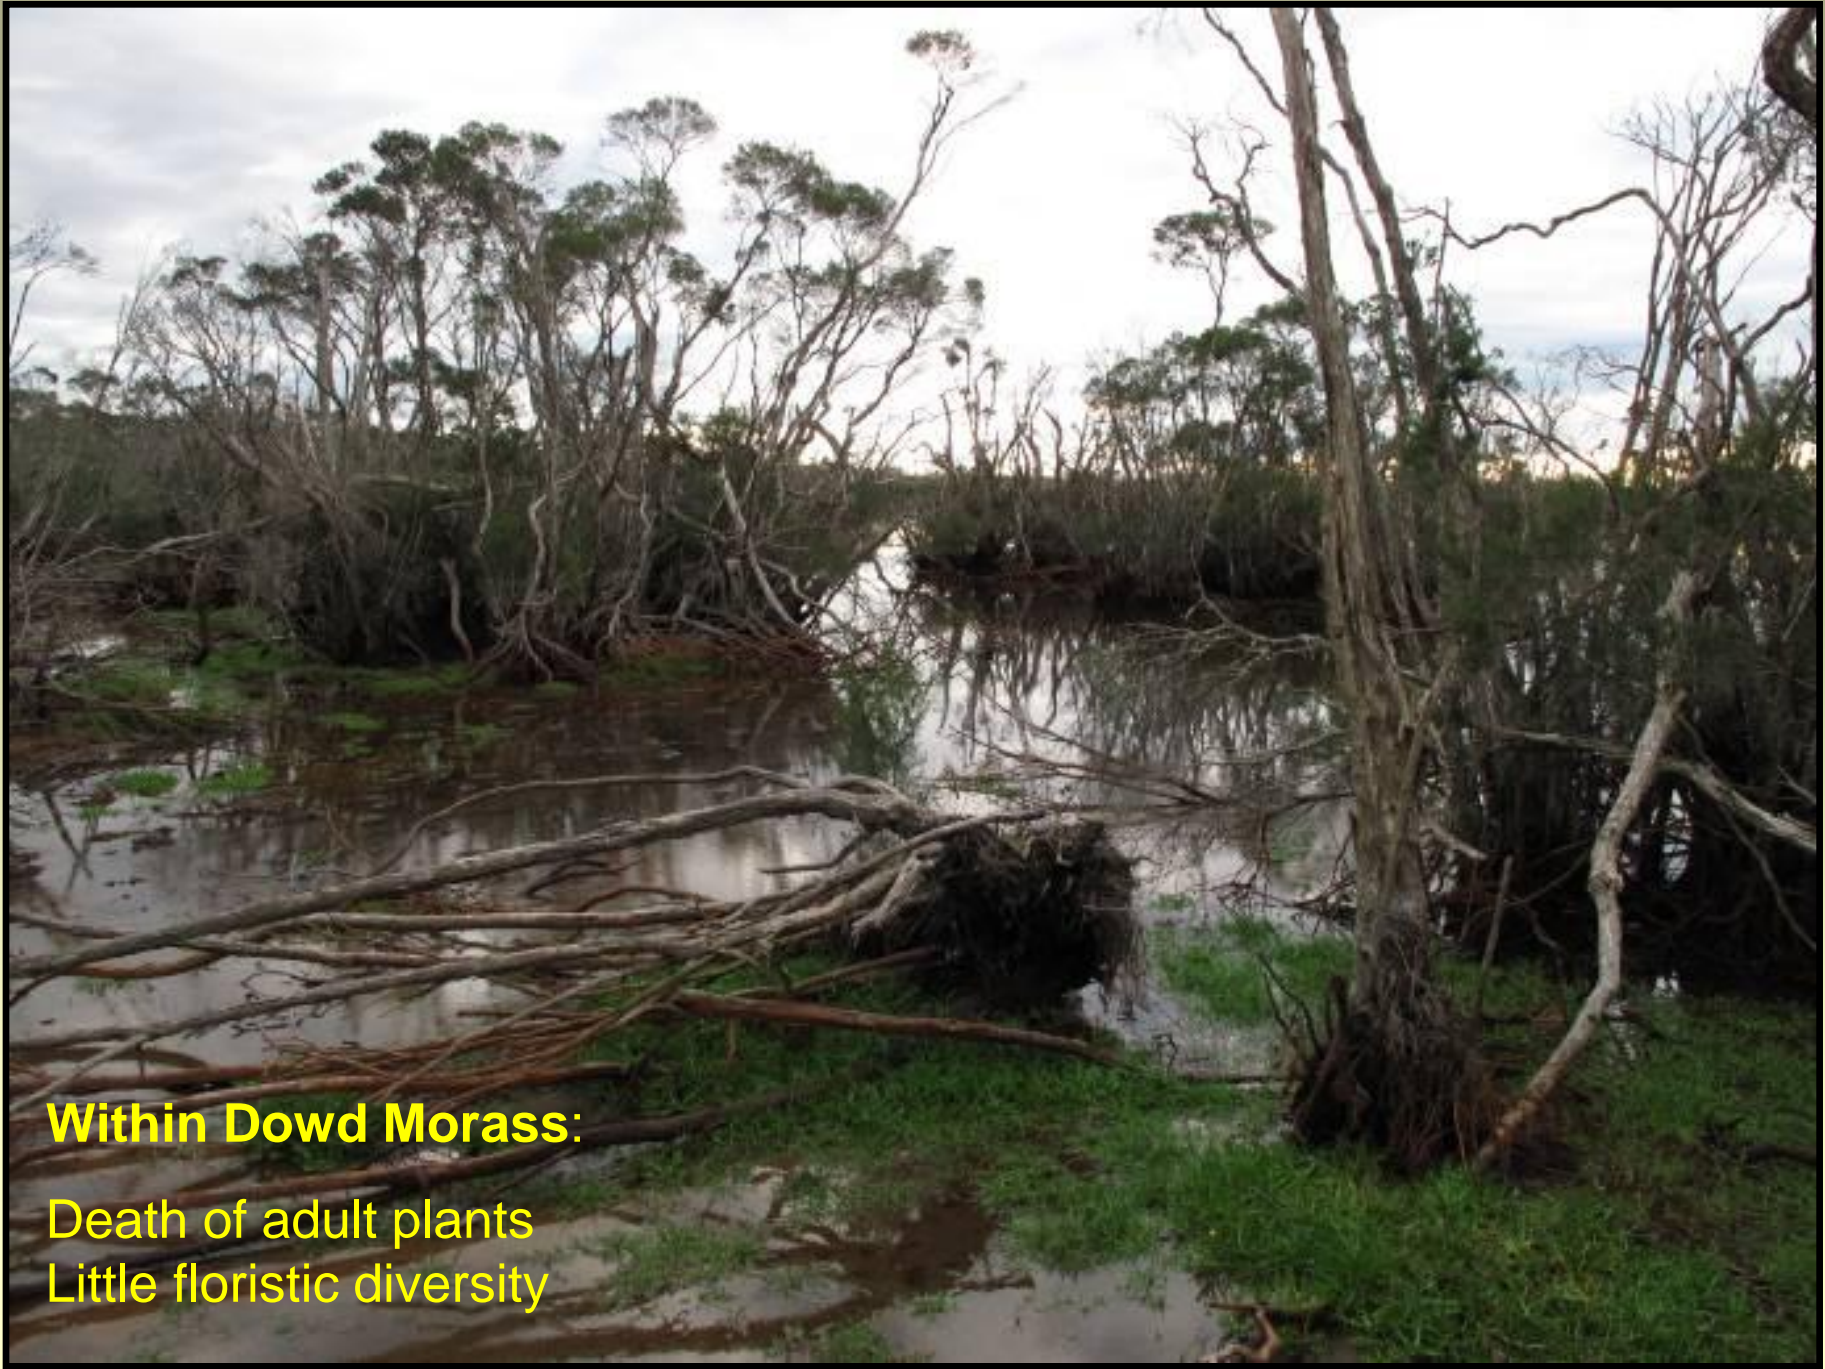
Death of *Melaleuca ericifolia*

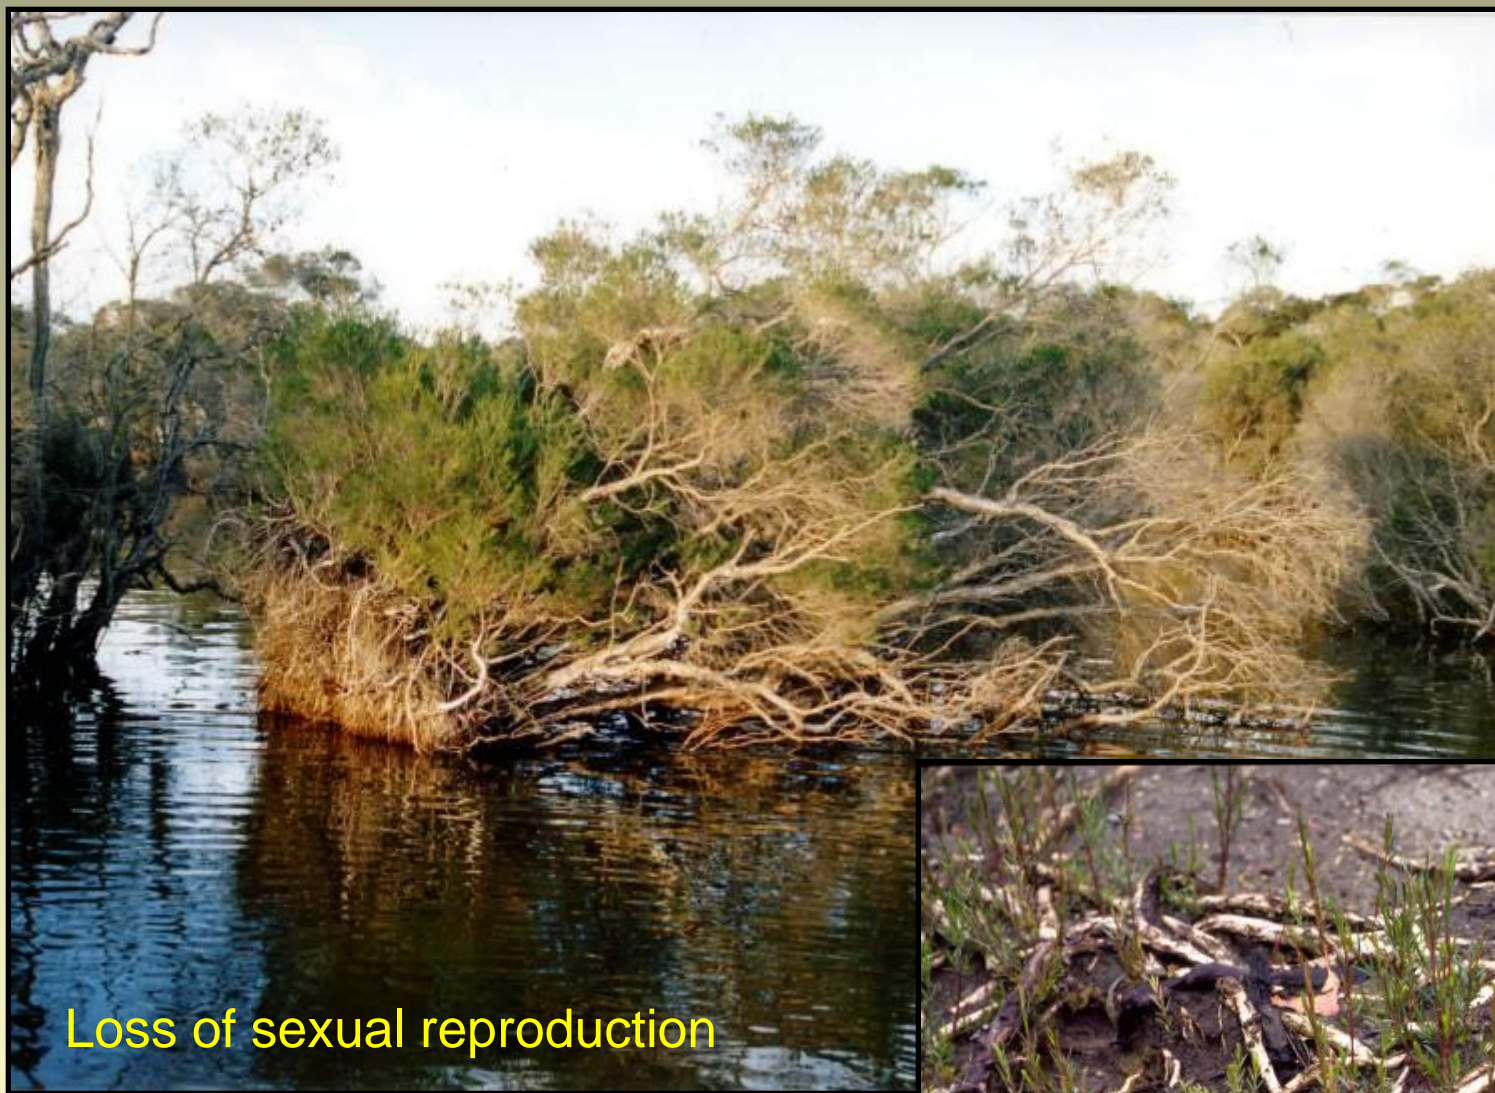
Within Dowd Morass:

Death of adult plants
Little floristic diversity

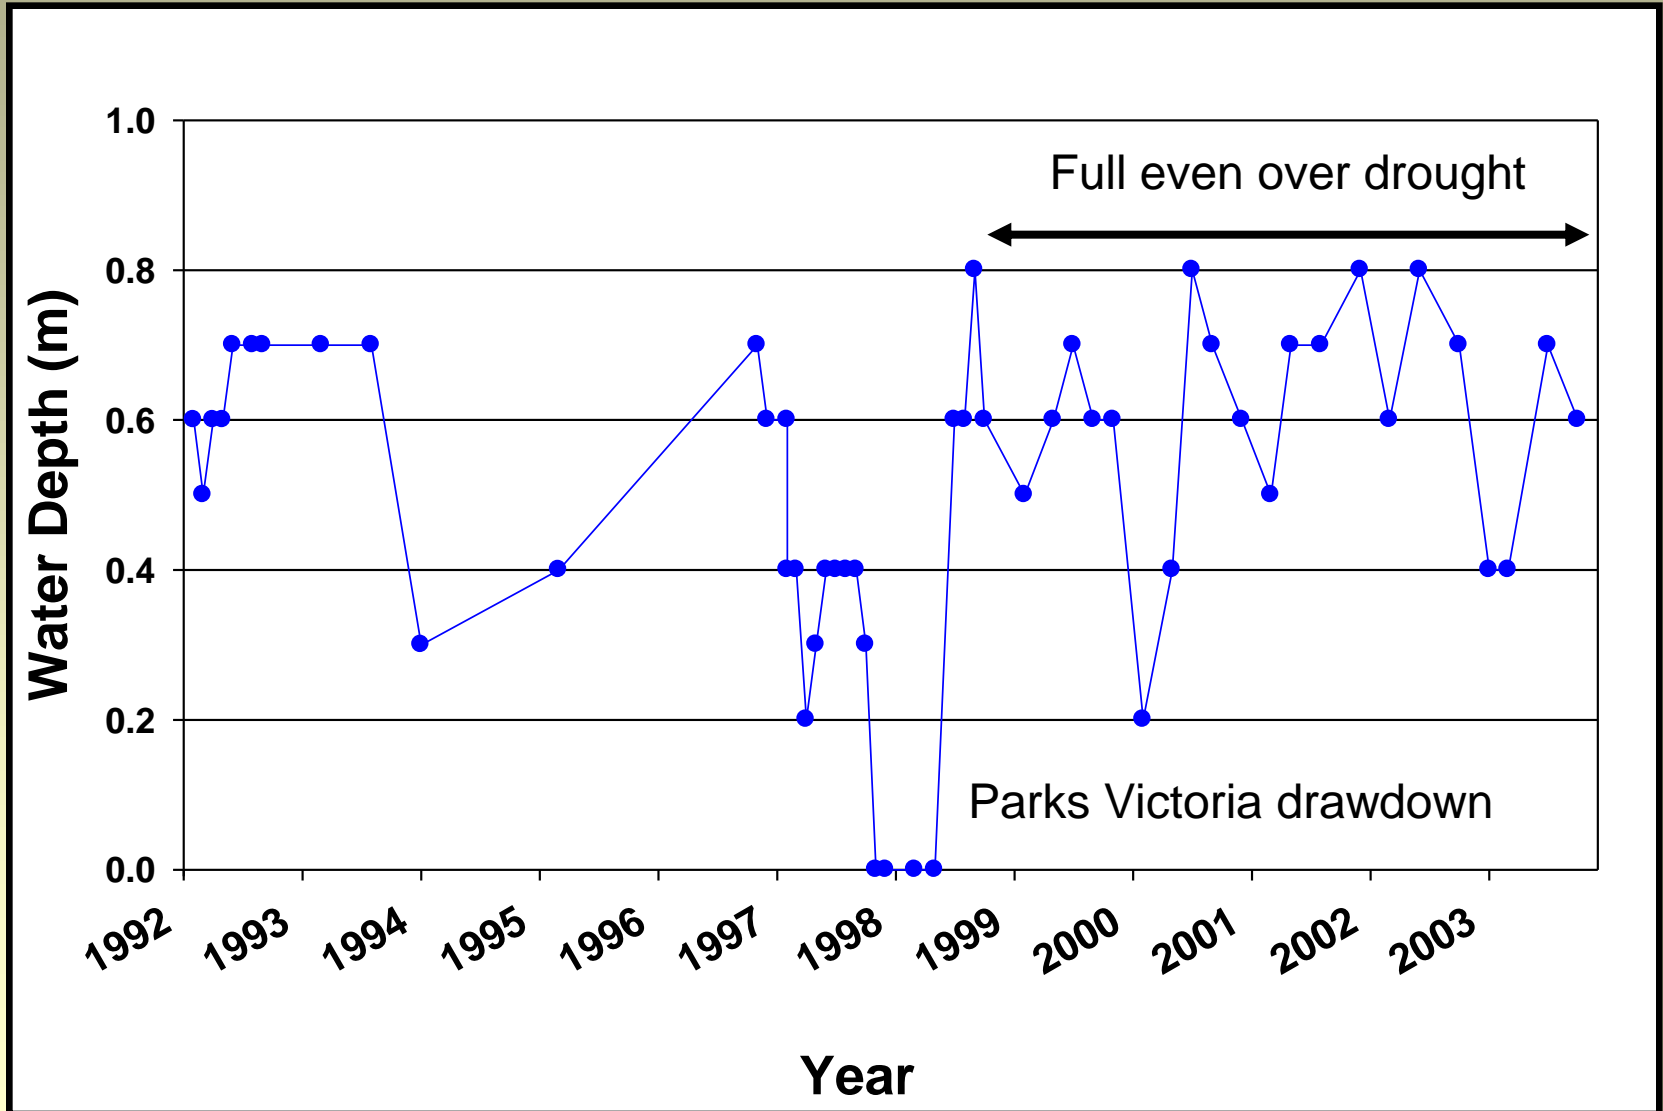
Morass kept full to prevent saline intrusions since 1992

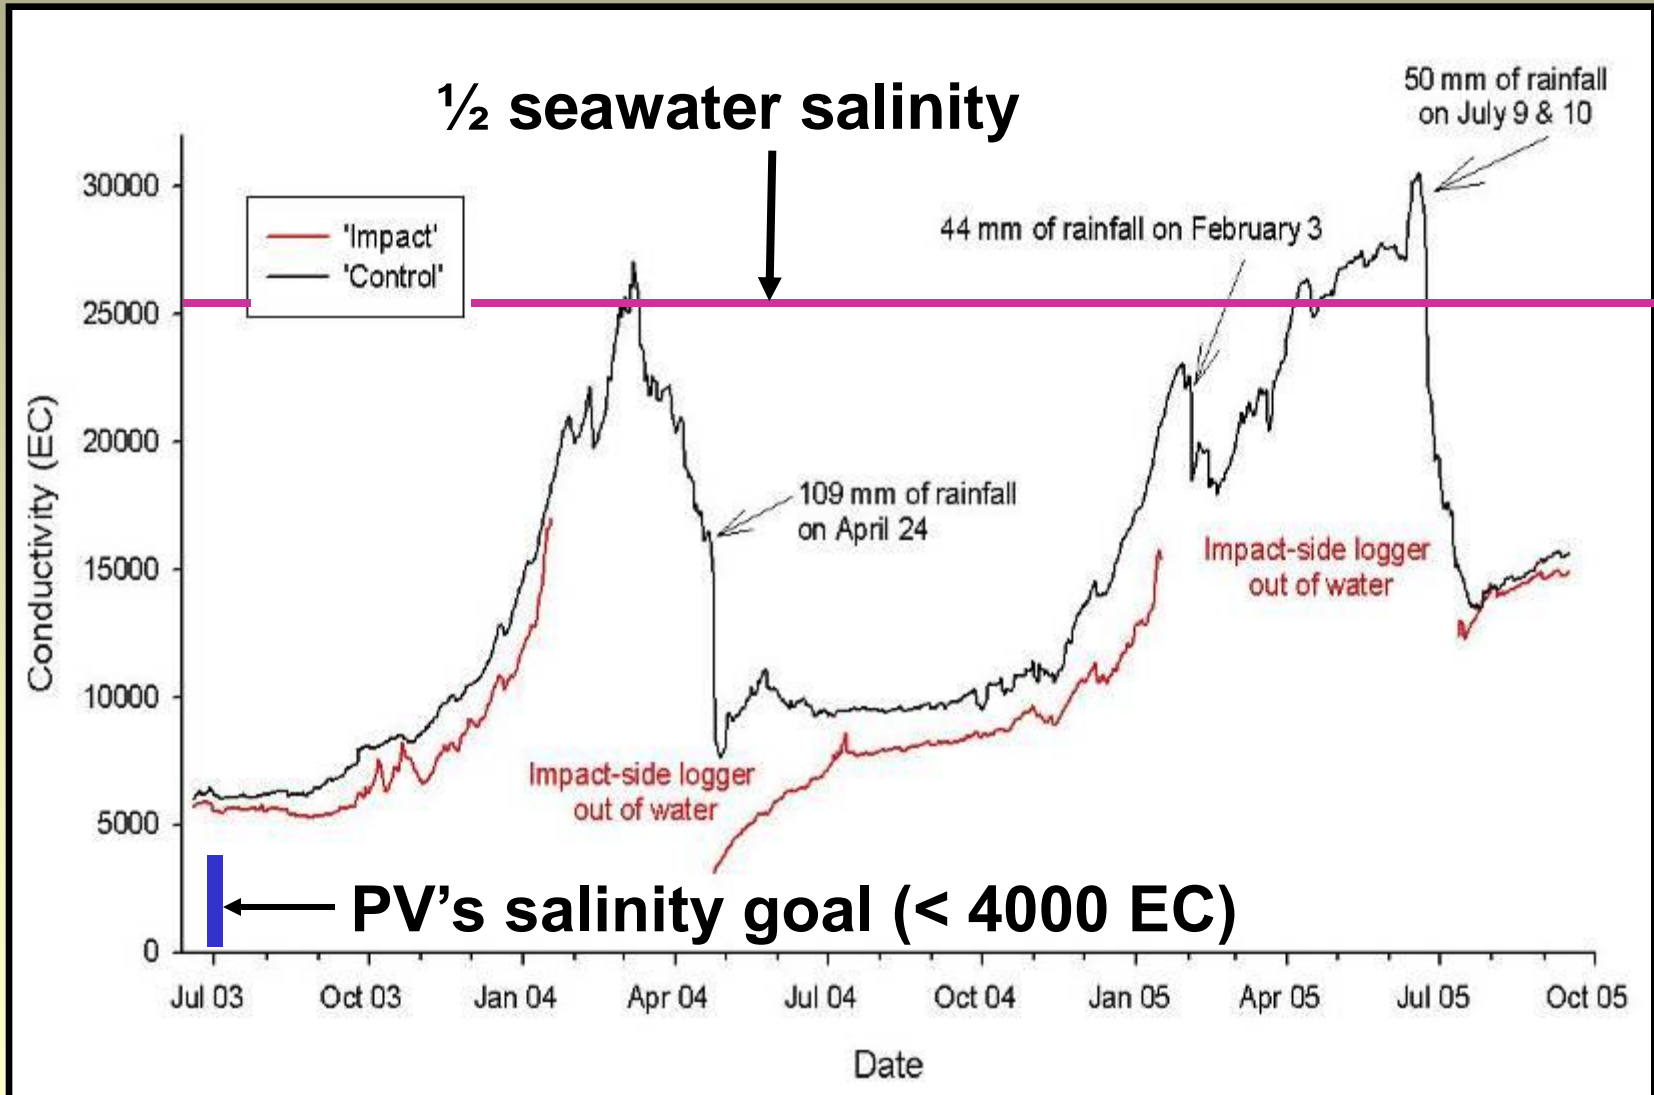
But salinity is still very high

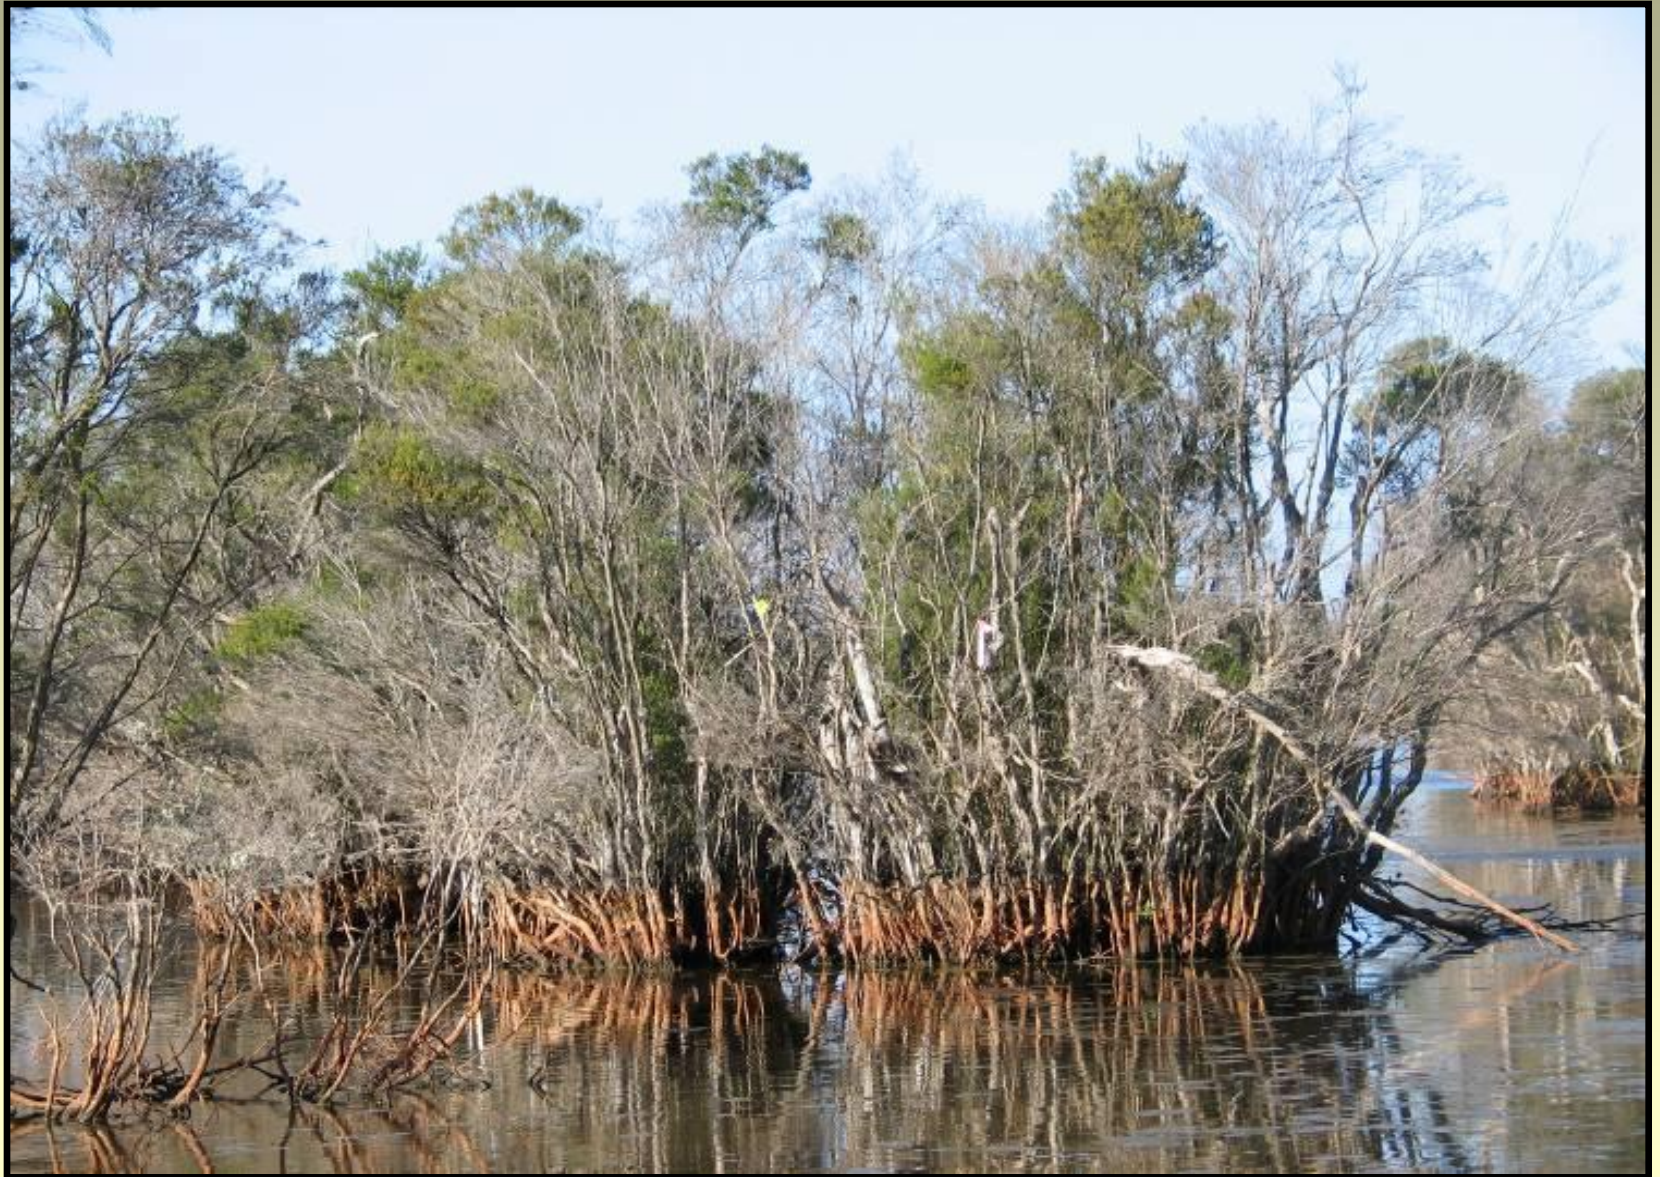
Passive draw-down 2003-2004

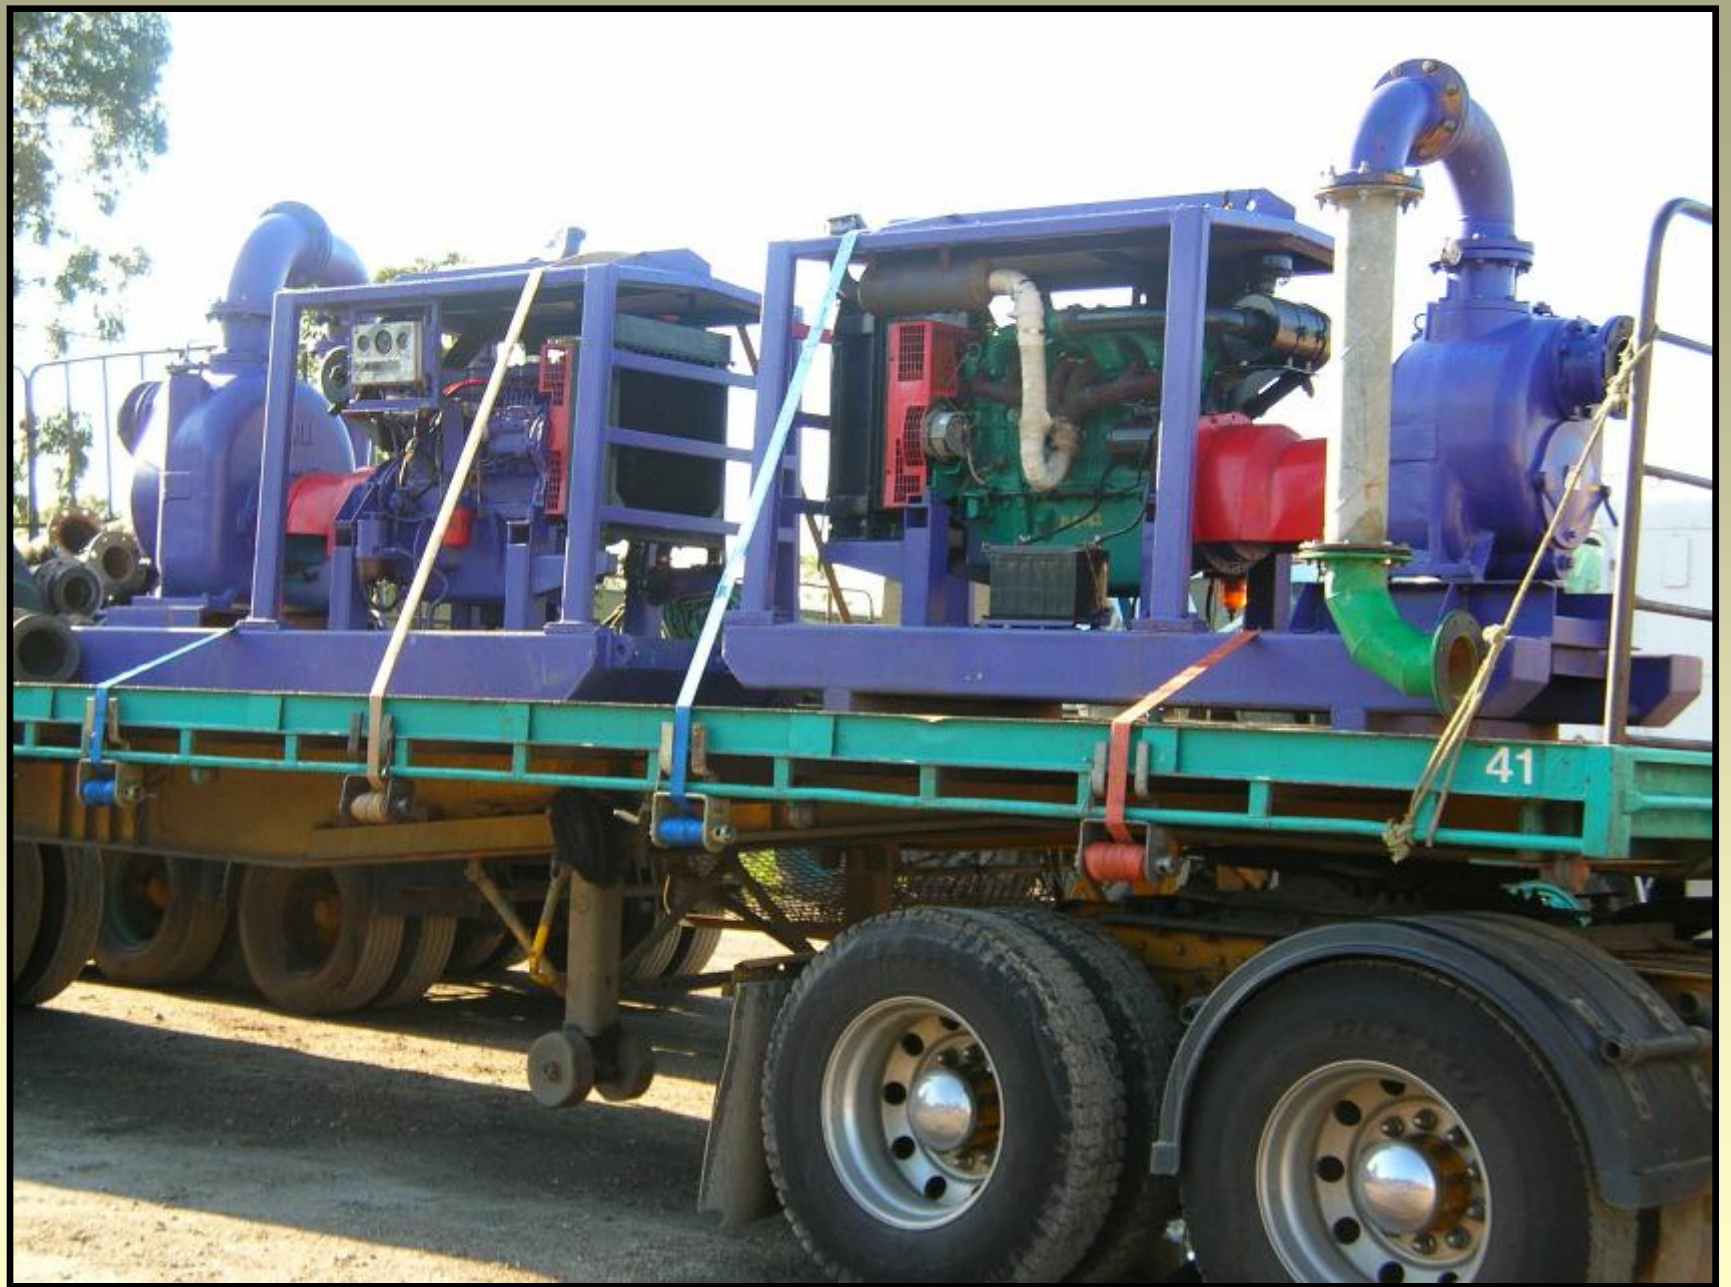
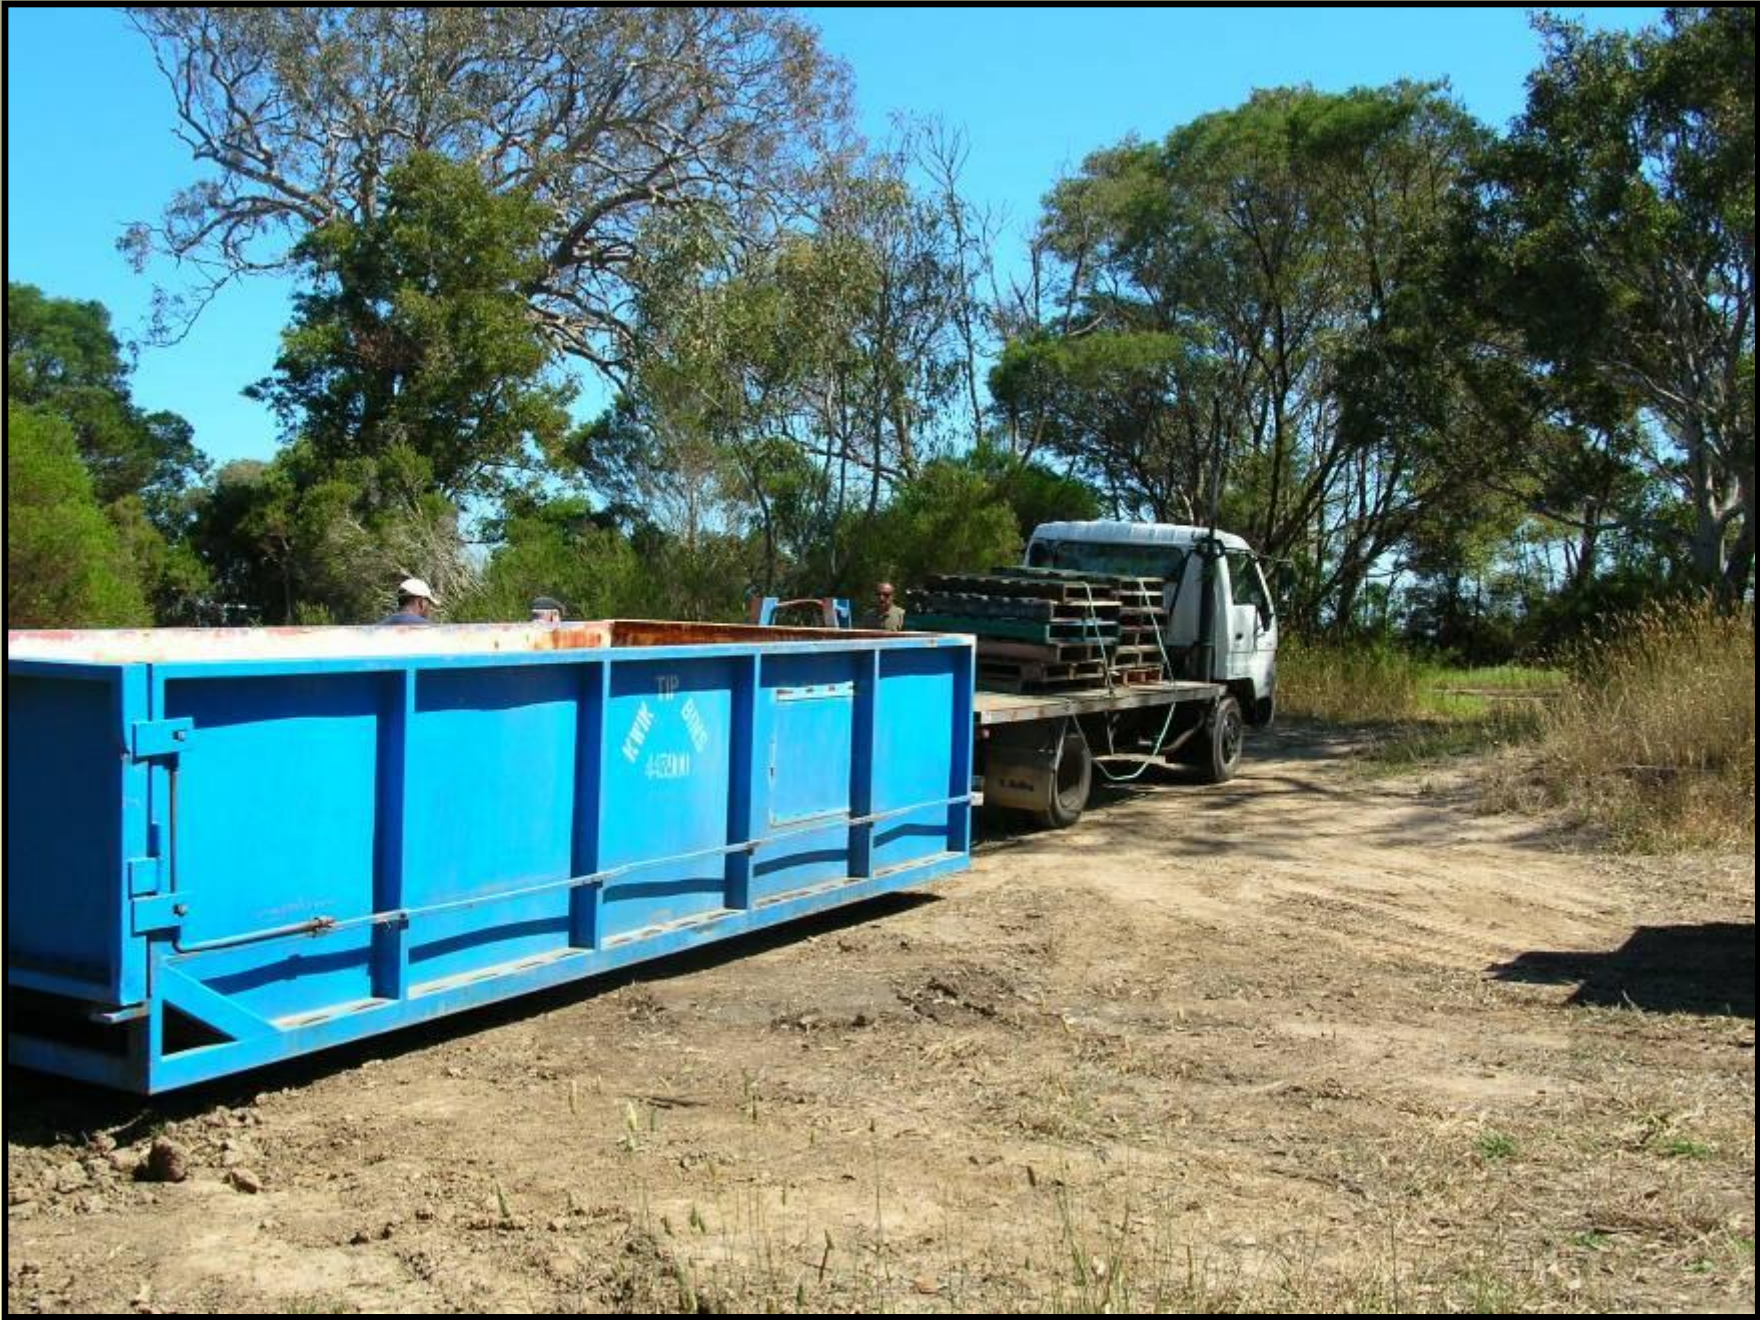
2nd intervention: active draw-down 2005

**Response to
2004 vandalism
in 2005:**

Pumping!

- 1 x 12" pump
- 1 x 10" pump

**Pumped
continuously for 28
days in early 2005**

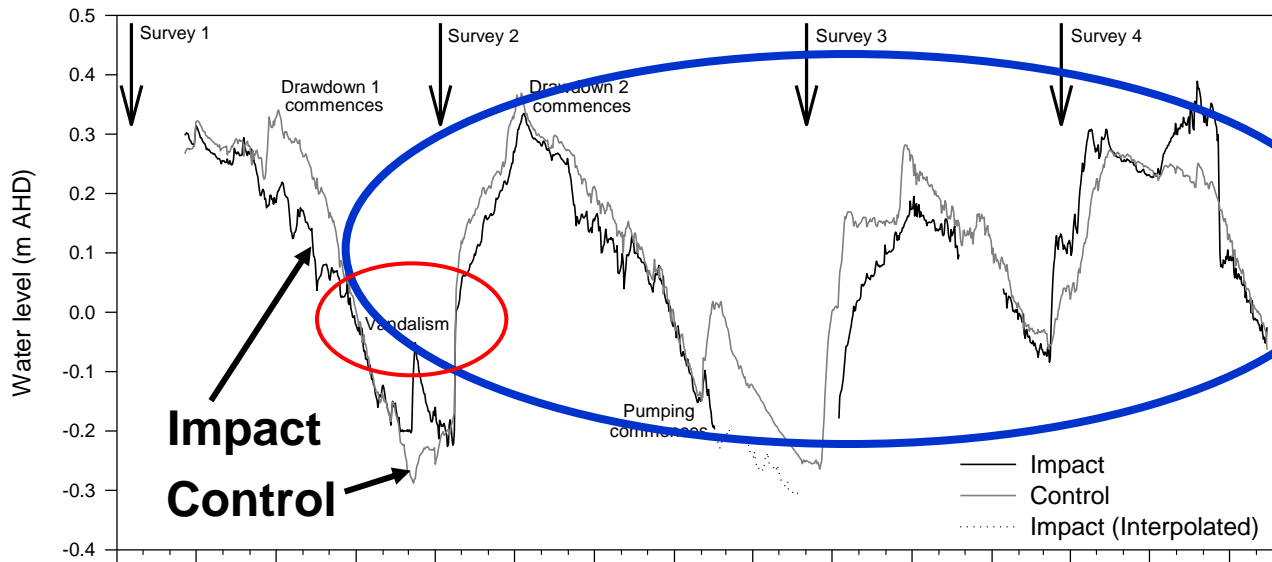
A) Water level

No big difference between Control and Impact water levels

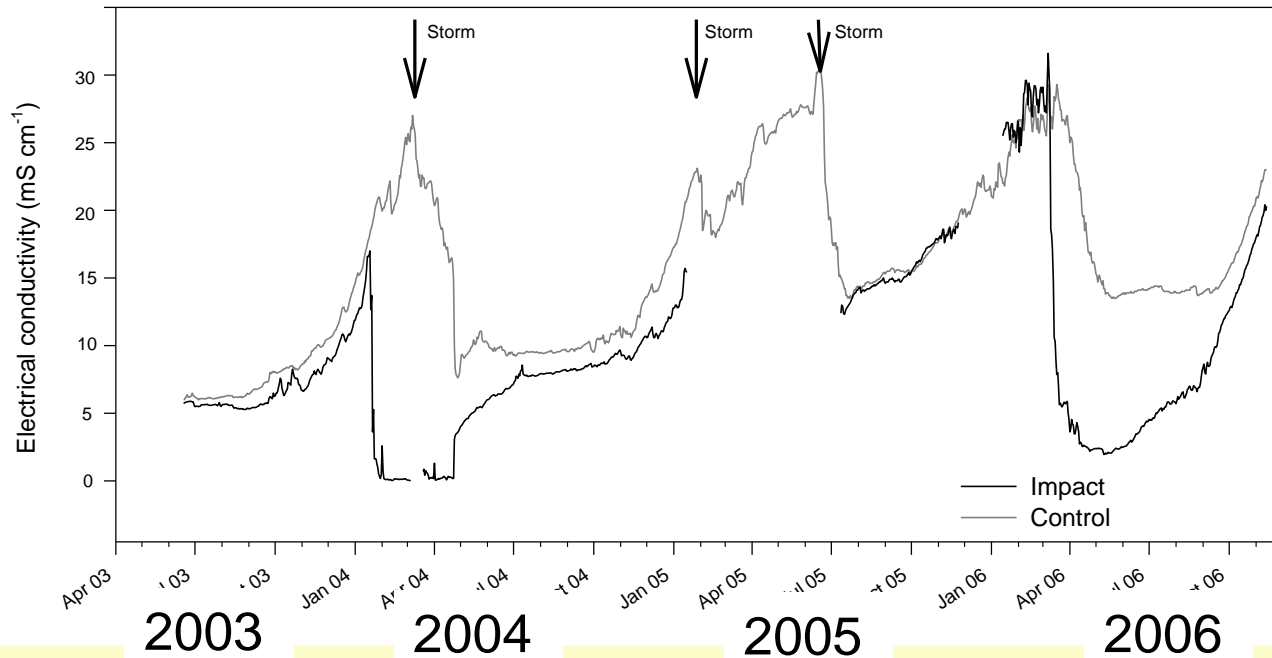
B) Salinity

Confounding variability in salinity between Control and Impact sites

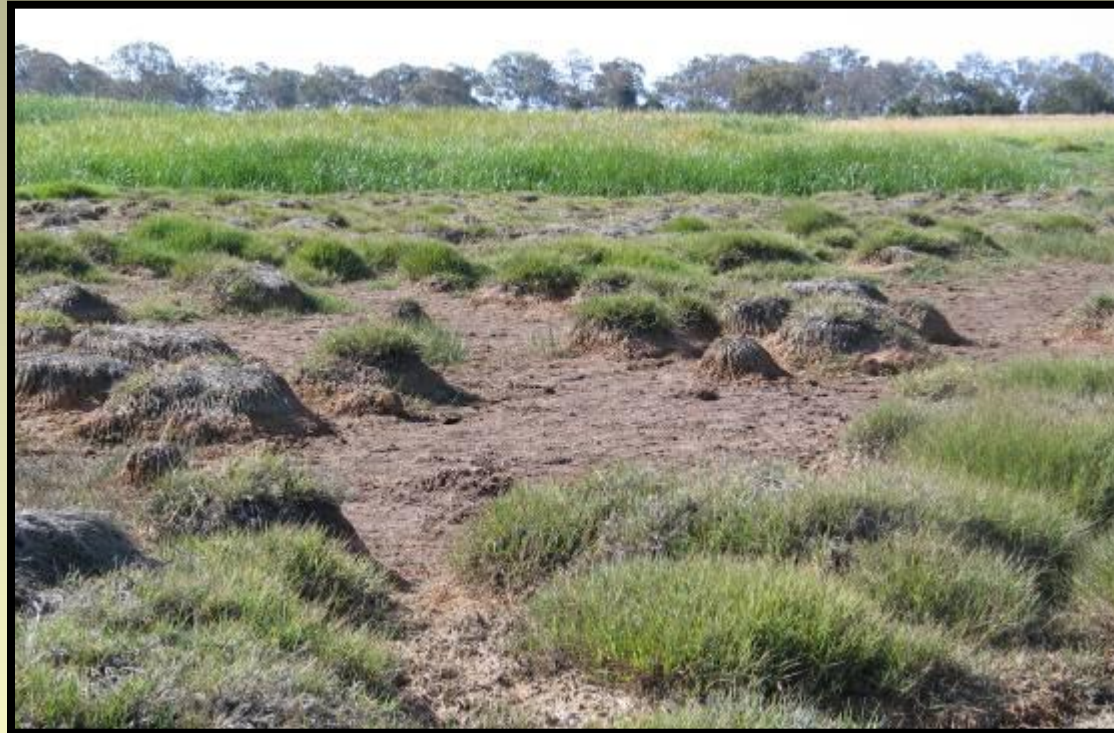
What causes the diversity of hydrologies? Microtopographic relief

Caused by *Melaleuca*, *Phragmites* and *Paspalum* humps

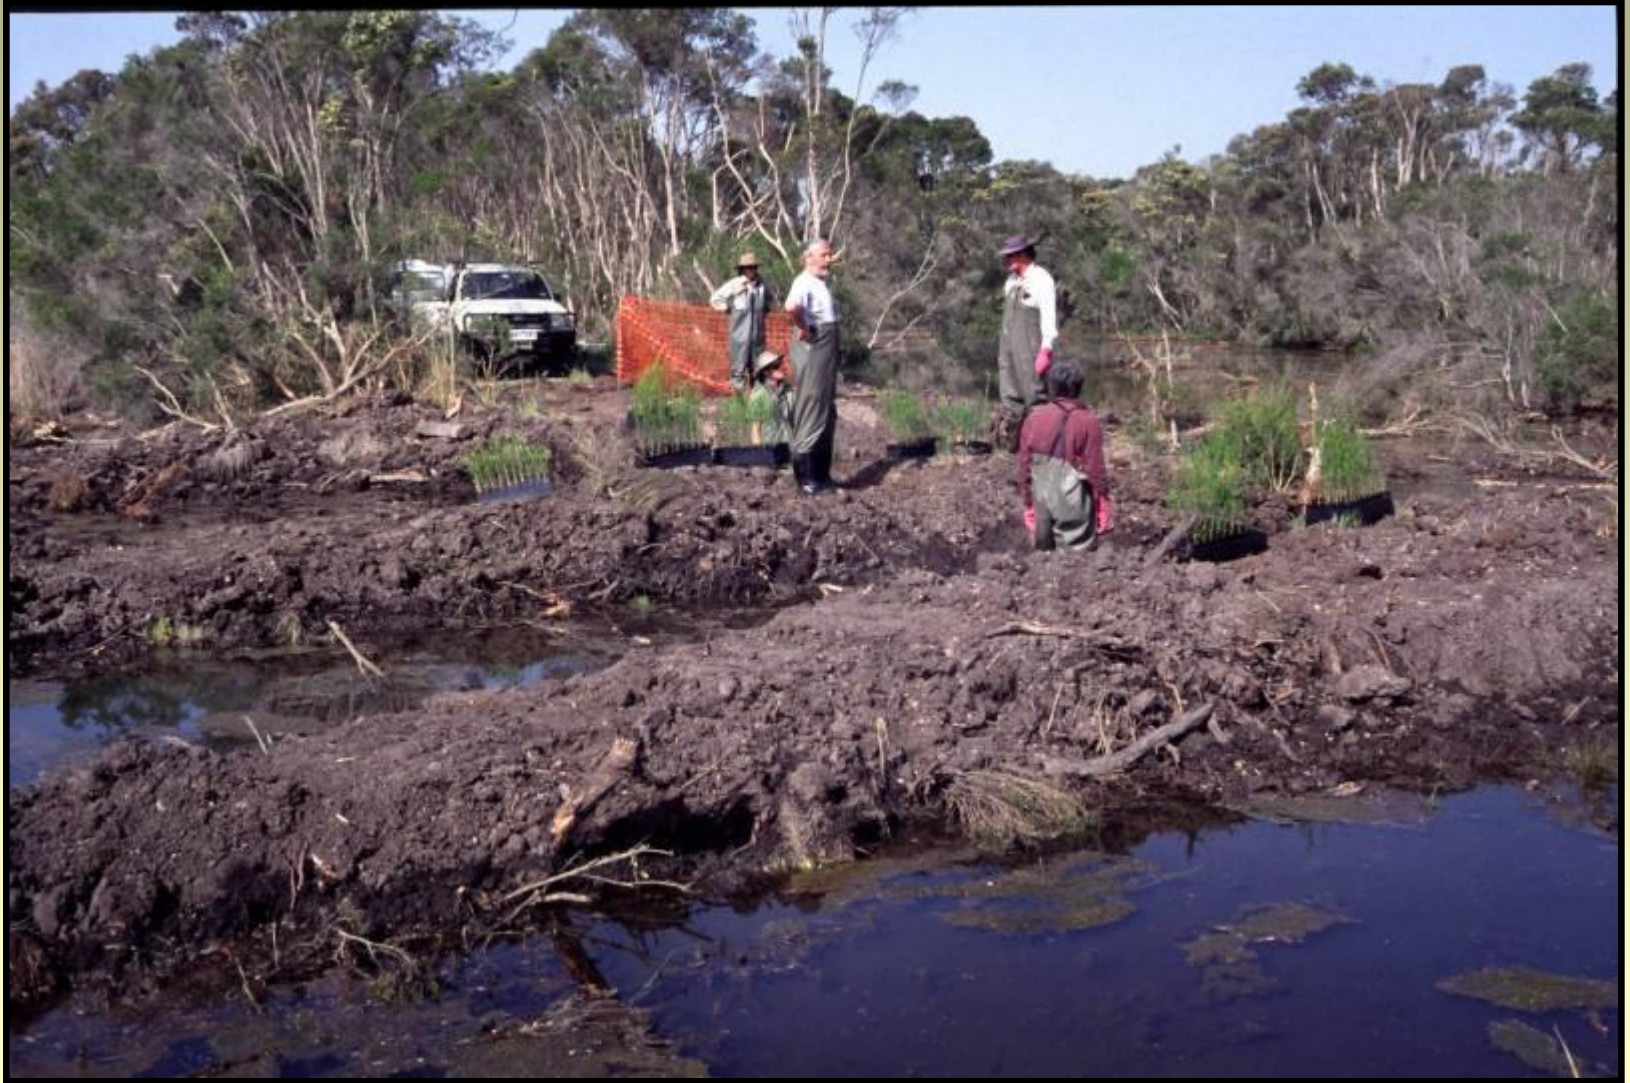
Large-scale hummock creation, 2006

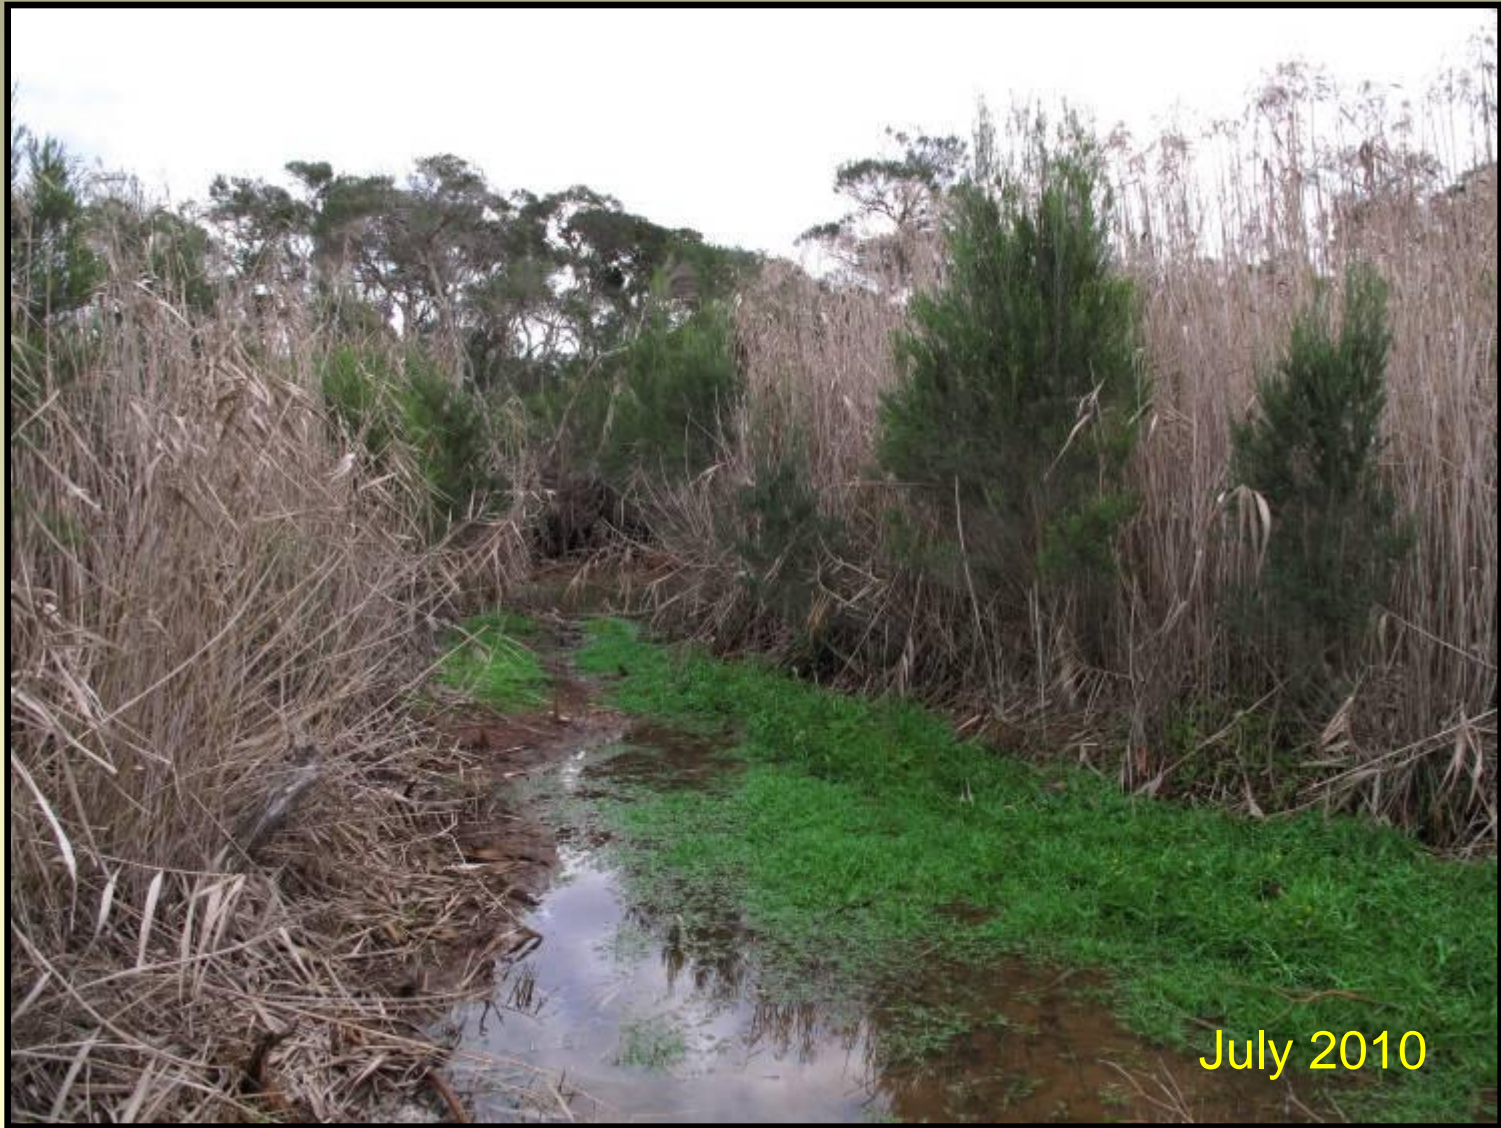
July 2010

Results after 4 years
