Ecohydrologic Characterization as an Essential Tool for Successful Mangrove Forest Management and Restoration

Roy R. “Robin” Lewis III, PWS
Coastal Resources Group, Inc., Salt Springs, Florida
June 8, 2012

Rookery Bay Fruit Farm Creek Proposed Restoration Site – 90 ha of Dead and Stressed Mangroves – January 21, 2011

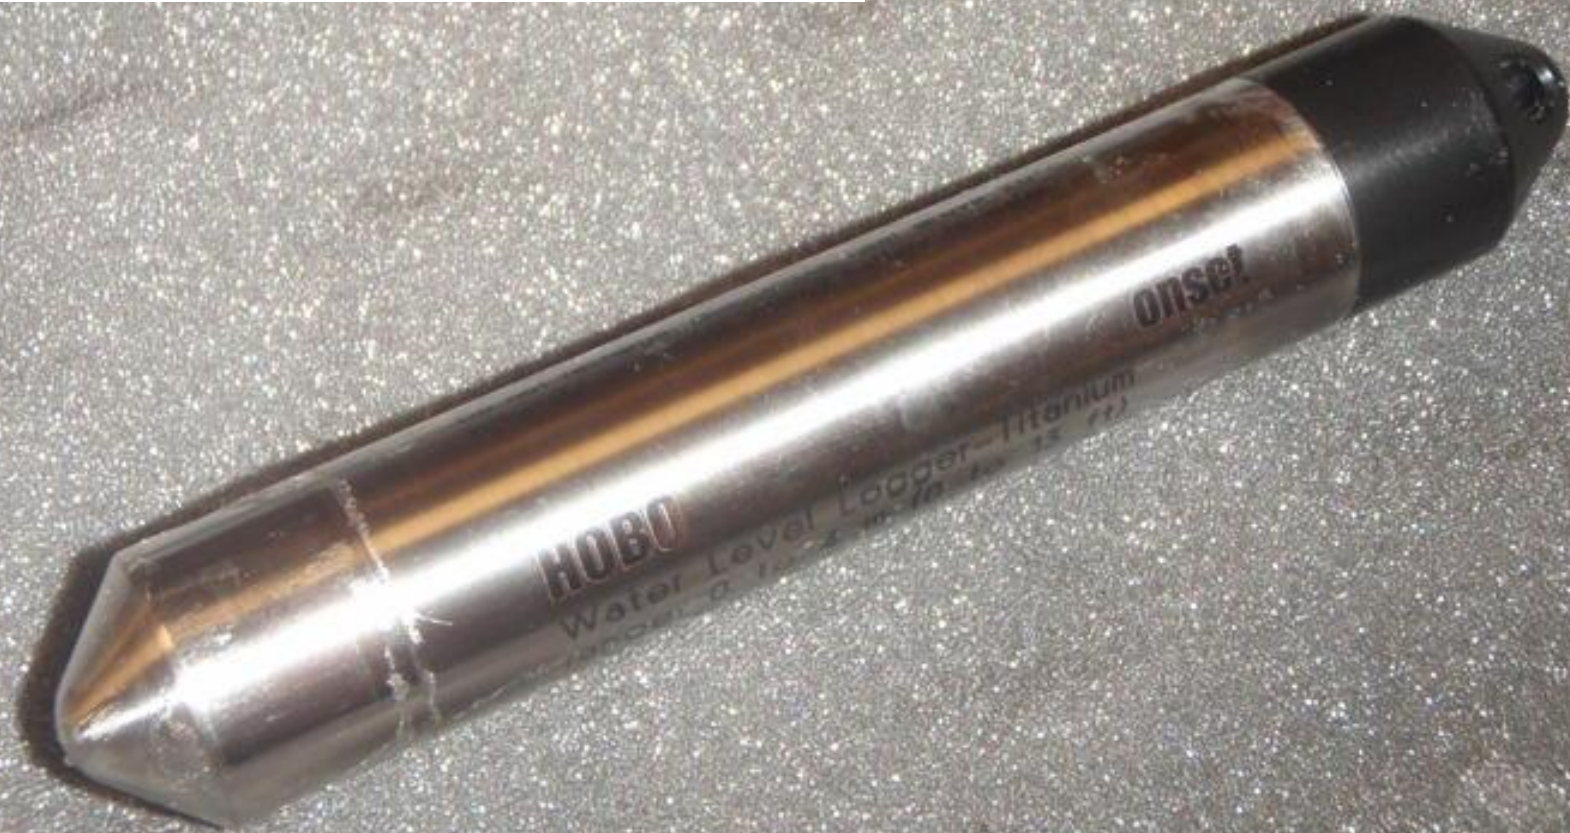
**HOBO Autonomous Water Level
Logger (1" X 6 ") – Titanium -
www.onsetcomp.com**

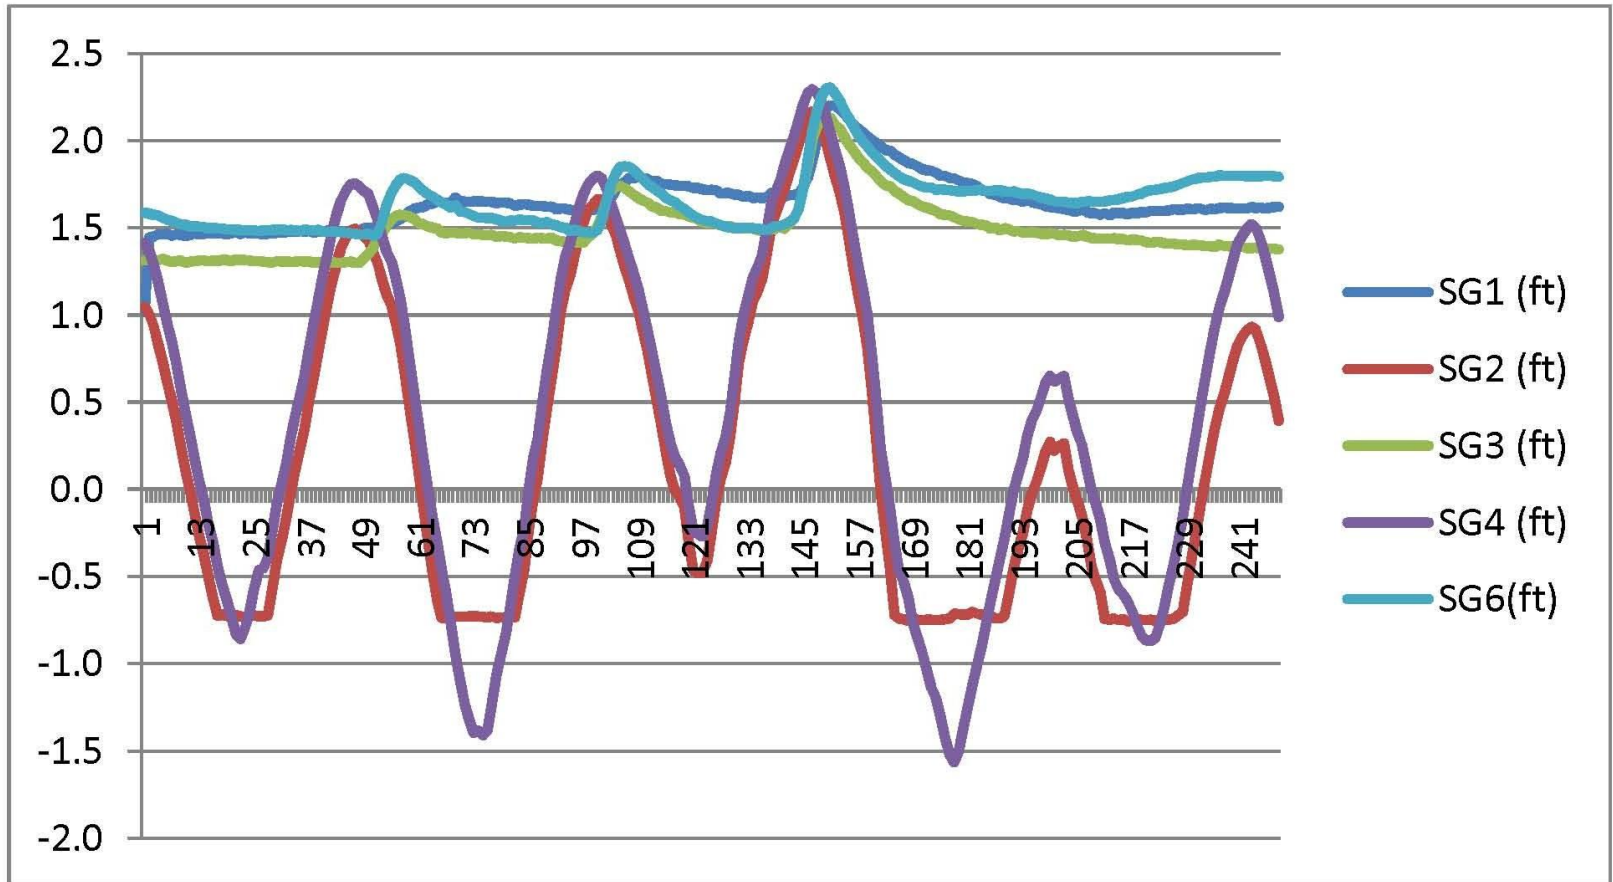
TIDE (FT NAVD 88) vs TIME (HOURS)

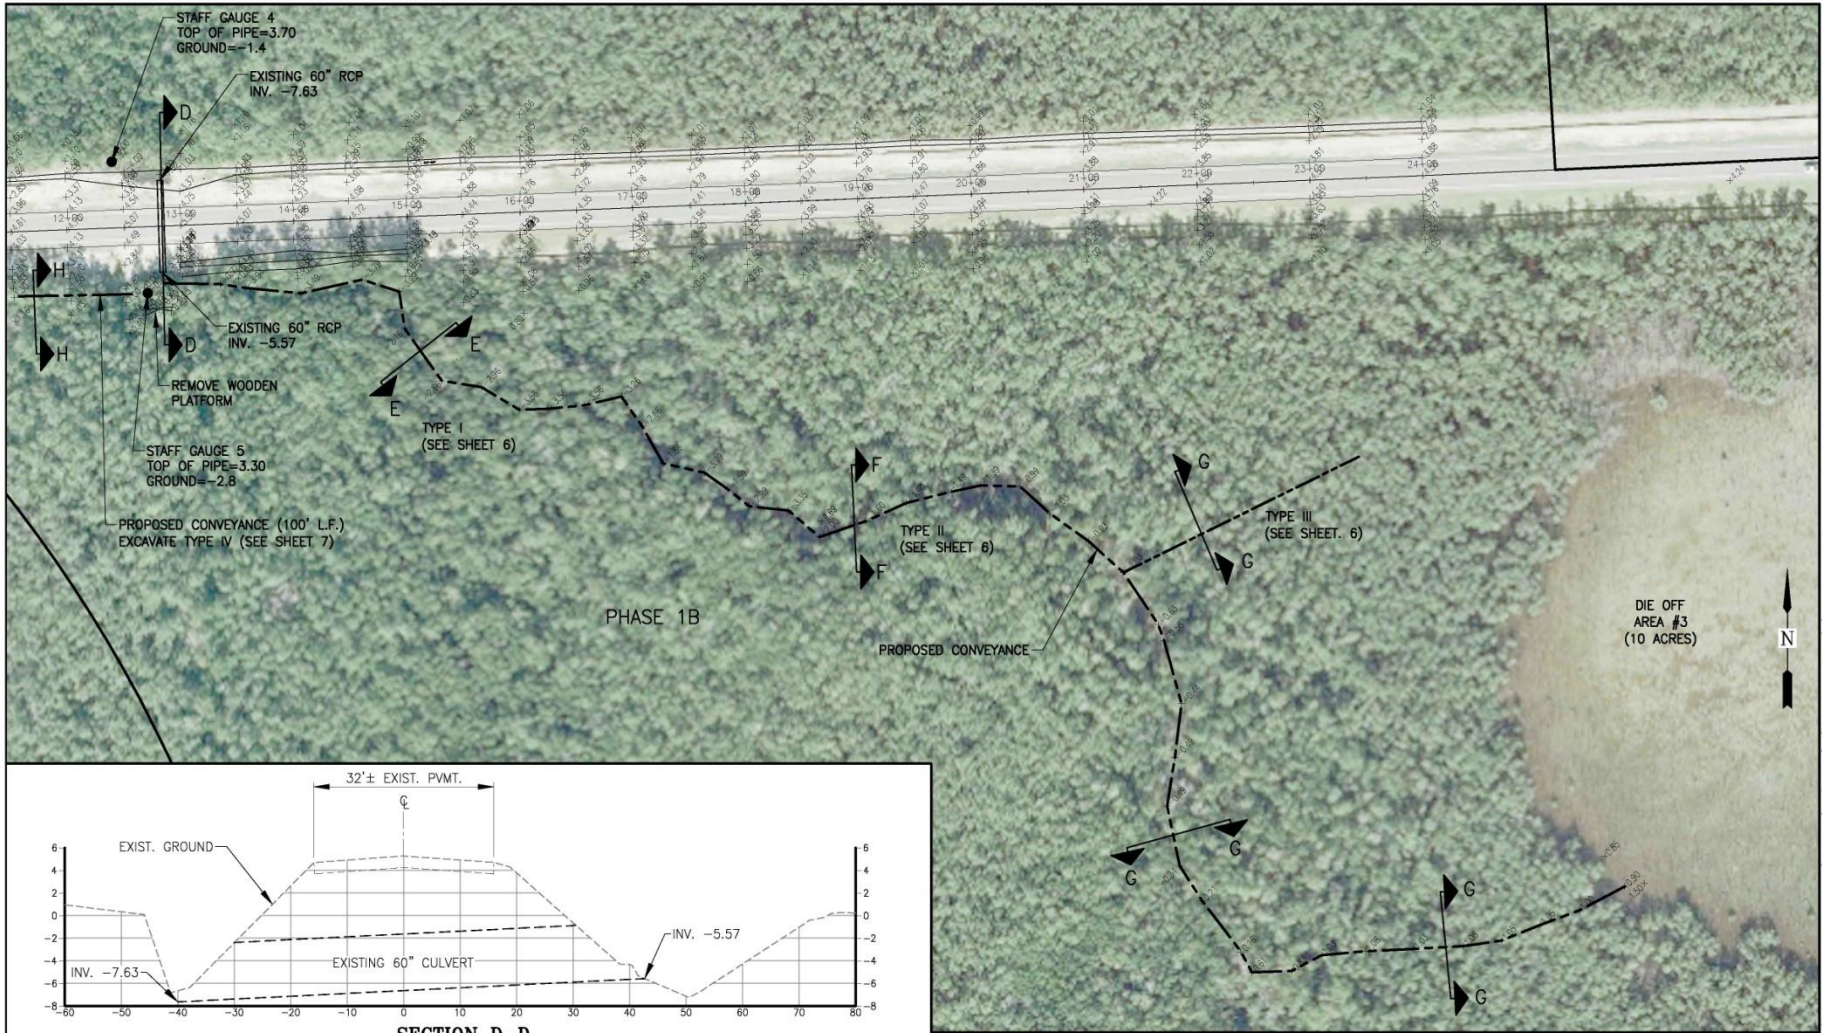
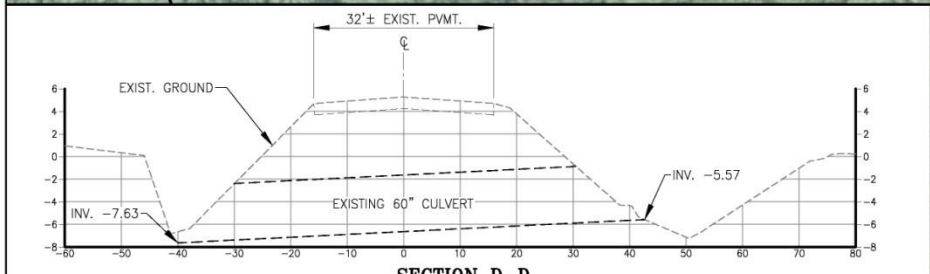
**RESTORATION OF MANGROVES
 AT FRUIT FARM CREEK**
 PHASE 1 B - RESTORATION PLAN
 DIE OFF #3

NOTE: ALL REFERENCE TO GRADE ARE IN NAVD88 (FT.)

Phase 1B (SG4) - 1 x 48" Culverts (proposed)
Phase 1B (SG4) - 1 x 60" Culvert (existing)
Phase 2 (SG2) - 3 x 48" Culverts (proposed)

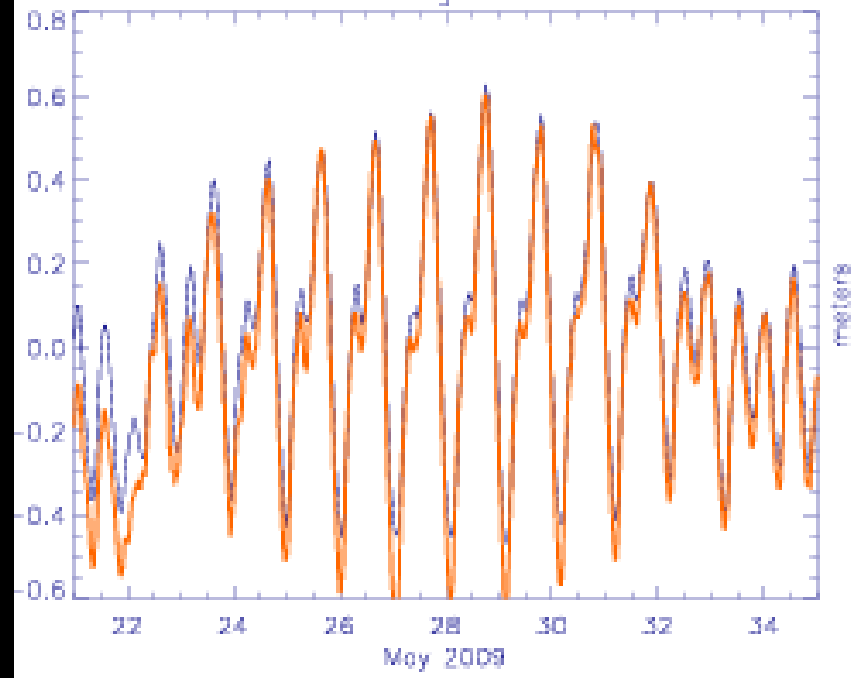
sg 1

Water Elevation at HOB0 Locations: _poc
