# Evolution of Self-designed Wetlands in the Snohomish River Estuary, Washington, USA

Scott Luchessa and Tina Bradley, ENVIRON International Corporation, Seattle, WA.

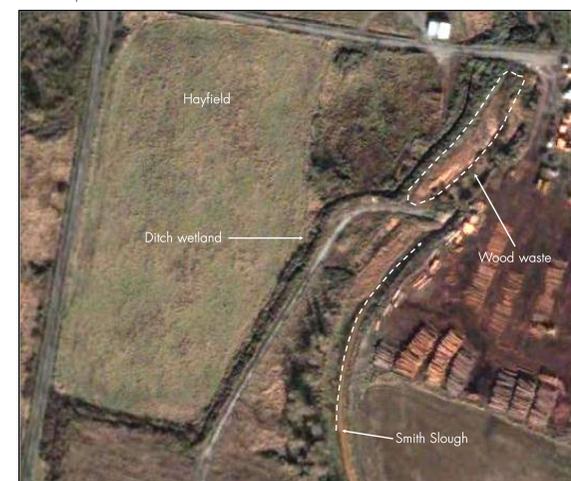
Figure 4. South parcel buffer enhancement and wetland restoration area before construction.

In Figure 4, note the developed nature of the area and presence of multiple stressors and sources of disturbance. Agricultural activities (hayfield) and roads about the ditch wetlands. A large volume of wood waste placed in Smith Slough (a historical wetland fill) contributed to a loss of wetlands, high biological oxygen demand and adverse impacts to wetland water quality.

Similar patterns were observed for other native shrubs and trees in the enhanced forested buffers. Figure 4 shows the changes in vegetation structure in buffer enhancement and wetland restoration areas on the southern parcel restoration area.

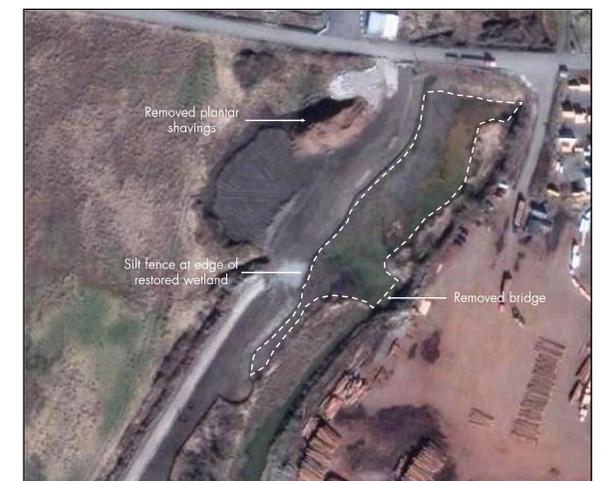
Figure 5. South parcel buffer enhancement and wetland restoration after completion of grading in 2005.

After construction, buffer enhancement and wetland restoration reduced the amount of habitat fragmentation and provide a more natural continuum of upland forest plant associations to riverine flow-through emergent wetlands. A bridge was removed over Smith Slough. In addition, approximately 2,800 cubic yards of wood waste in the form of planter shavings were removed from the riverine wetlands as part of the restoration (Figure 5).
