# Two Decades of Restoration on the Middle Rio Grande

Ondrea Hummel, CERP, Ecology Discipline Lead, Senior Ecologist

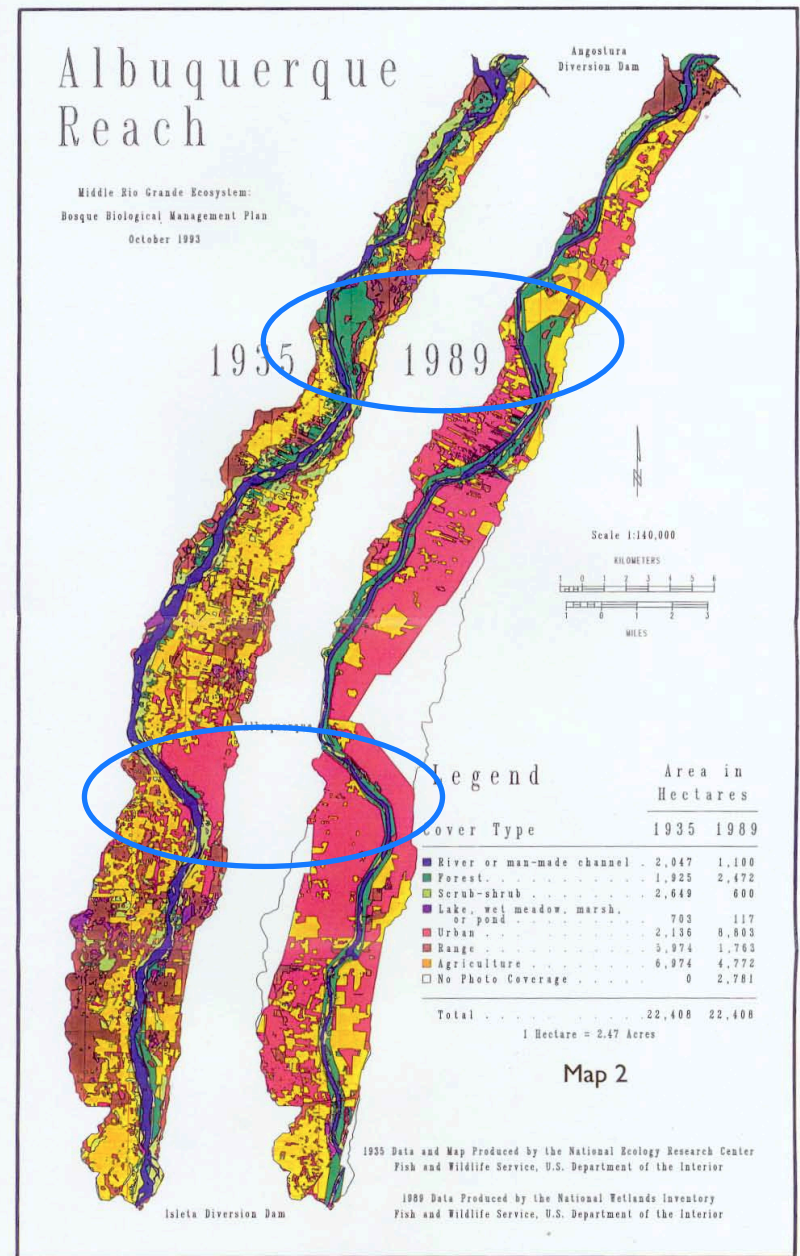
- **1935 -1989 channel changes**
  - Loss of ~1500 acres of river channel
  - Urban population doubled
  - Forest (bosque) decreased
  - Due to:
    - Albuquerque Levees mid 1950's
    - Jetty Jacks – 1960's
    - Cochiti Reservoir – 1972
  - *Current channel 'locked in'*
  - *Less availability of water to put into the system*

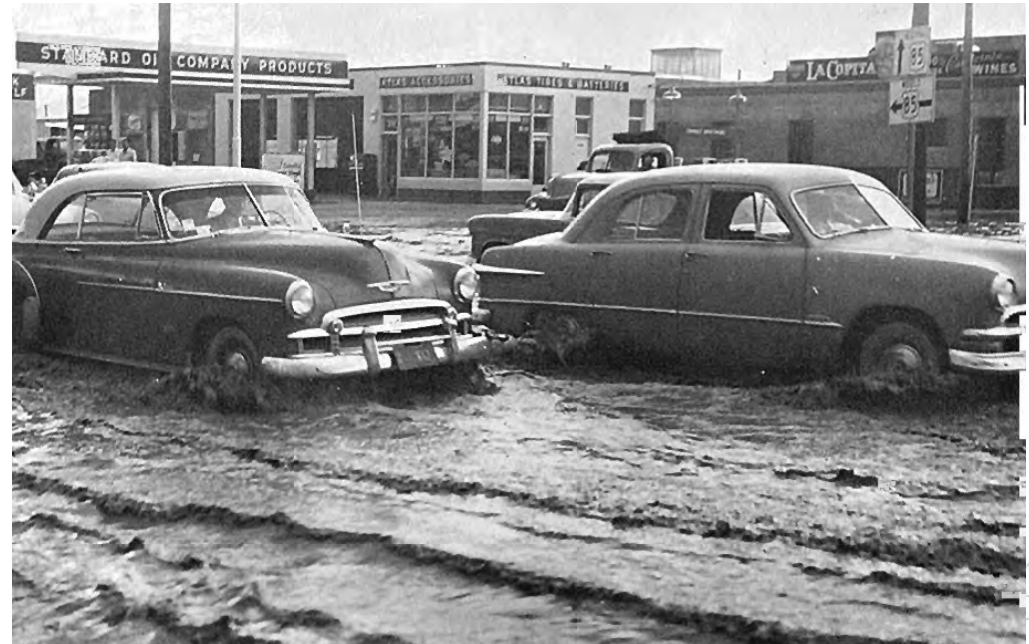
**1942 – Downtown Albuquerque**

**Cochiti Dam closed in 1972**

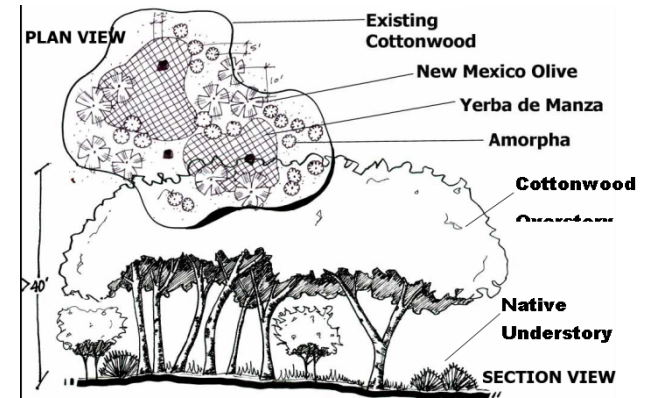
Figure 9. Schematic of a bosque forest

~ 50 % tree community (with  
25% tree/grass;  
25% tree/shrub),  
~30% shrub community,  
~16% grassland/ herbaceous,  
~4% wet meadow/wetland  
community

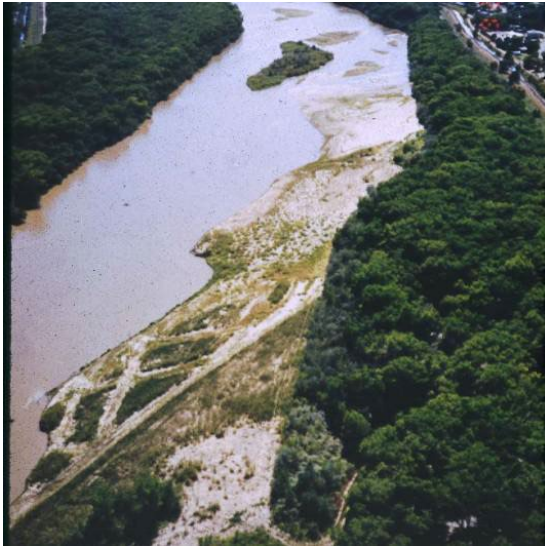
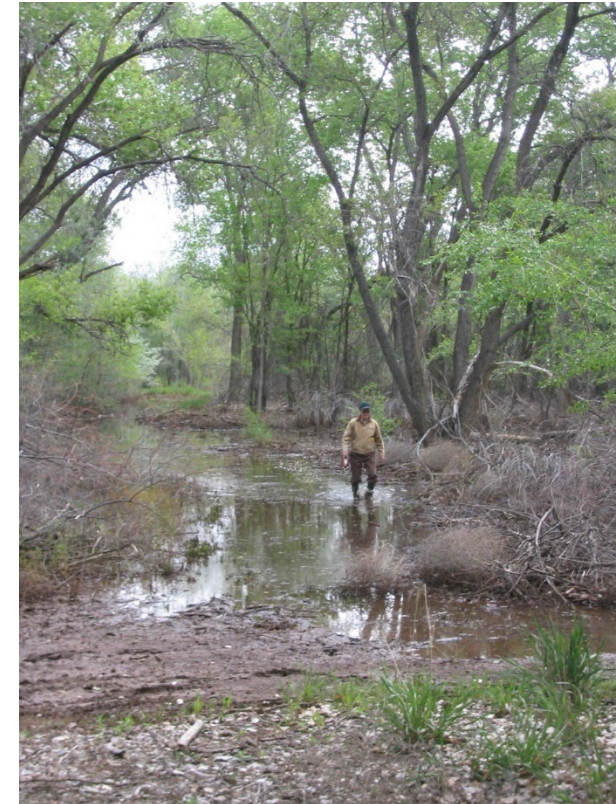
# Albuquerque Overbank Project - 1998

*First floodplain connection project,  
and with monitoring component*

Peak flows: 1998 – 4,060 cfs; 1999 – 4,920  
COA Open Space Division, Reclamation, NHPM  
Long-term monitoring reporting; Muldavin et al.

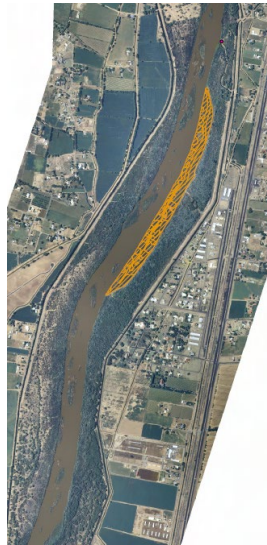
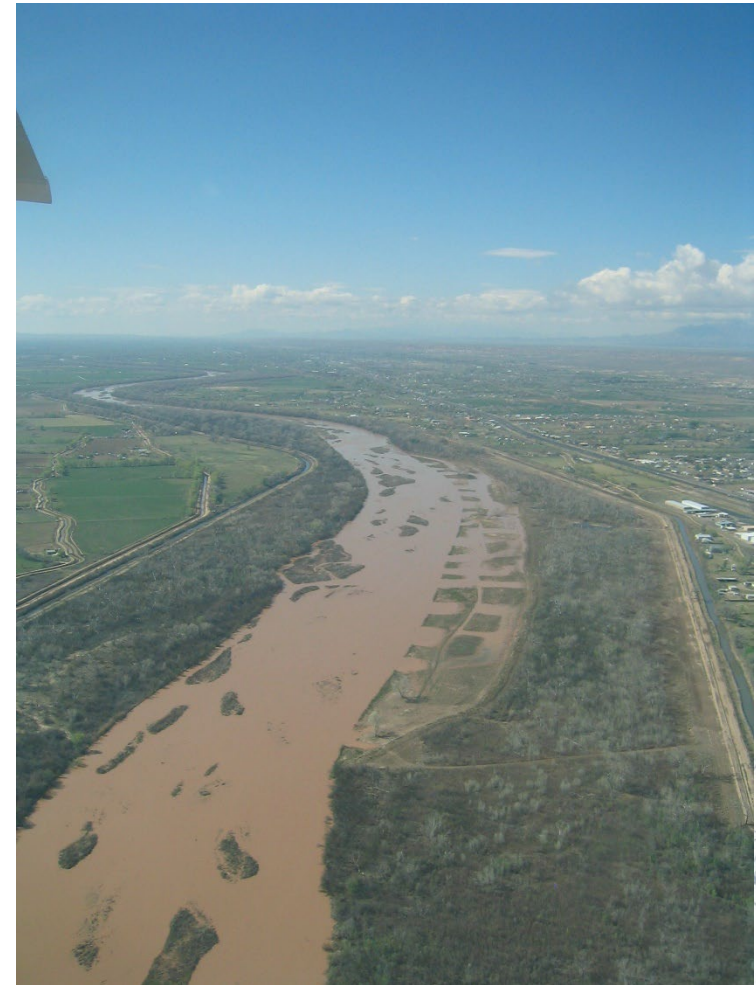
# Los Lunas Habitat Restoration Project – 2002-2003

- April 2000 fire
- MRGESCP – *Reclamation/USACE* leads
- Floodplain connection project
  - Terraces
  - High flow and backwater channels
  - Swales
- Annual monitoring of vegetation, birds, groundwater

2002	2002-09-10	1,770
2003	2003-03-21	1,880
2004	2004-04-03	3,590
2005	2005-06-03	6,780

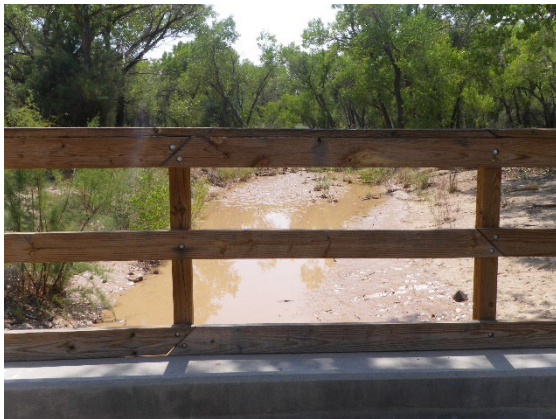
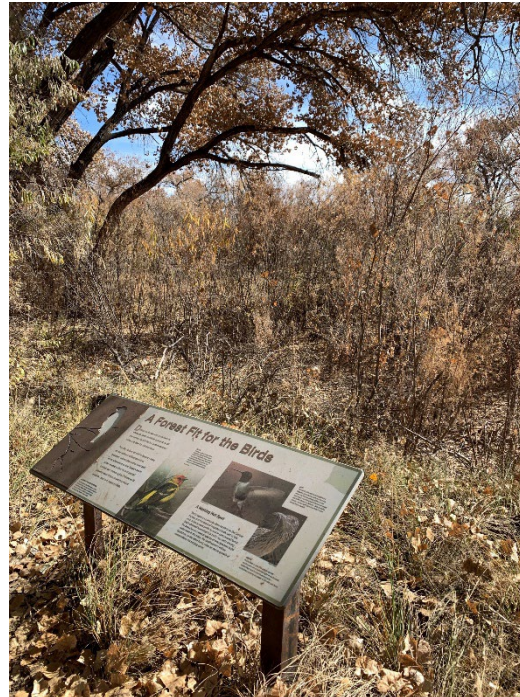
# Rio Grande Nature Center Habitat Restoration Project - 2008

Finished construction before high flow

Peak flow:

2008 – 5,400

2009 – 4,940

2010 – 5,140

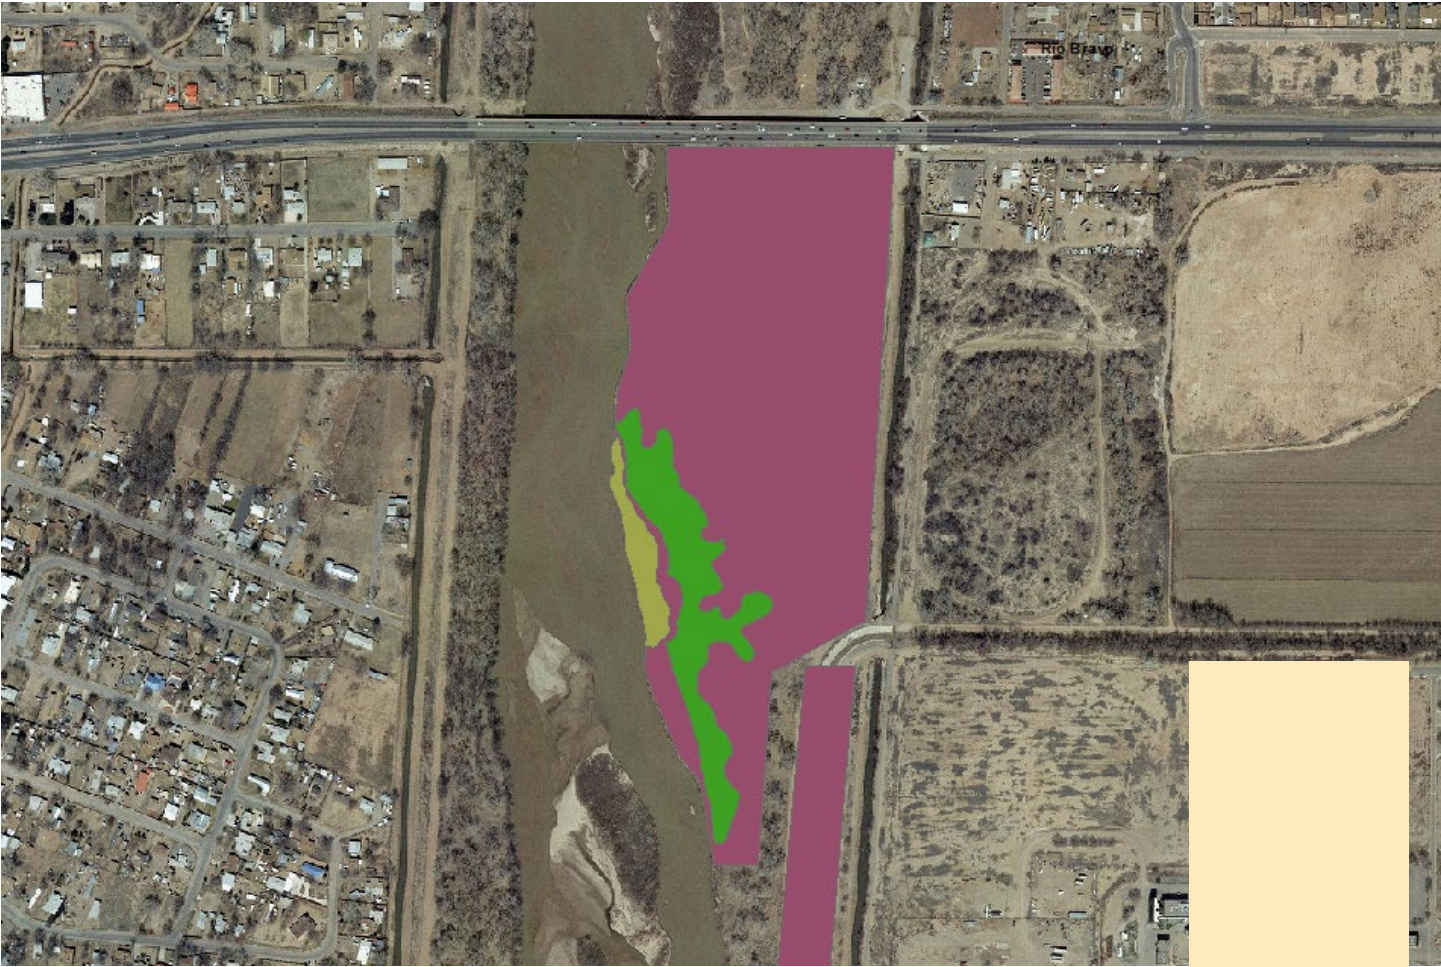
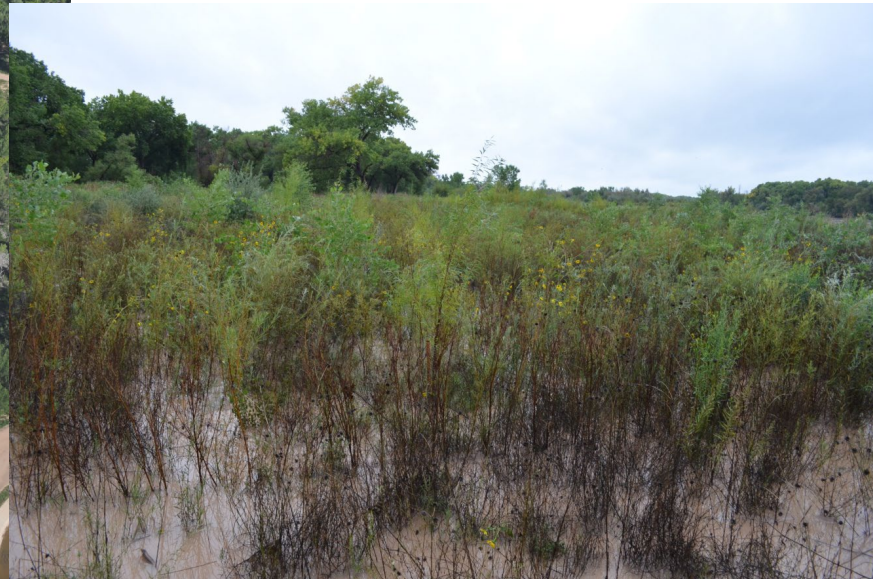
# 4B – Rio Bravo SE

Peak flow:  
2011 – 2,710,  
2012 – 2,510,  
**2013 – 4,250**

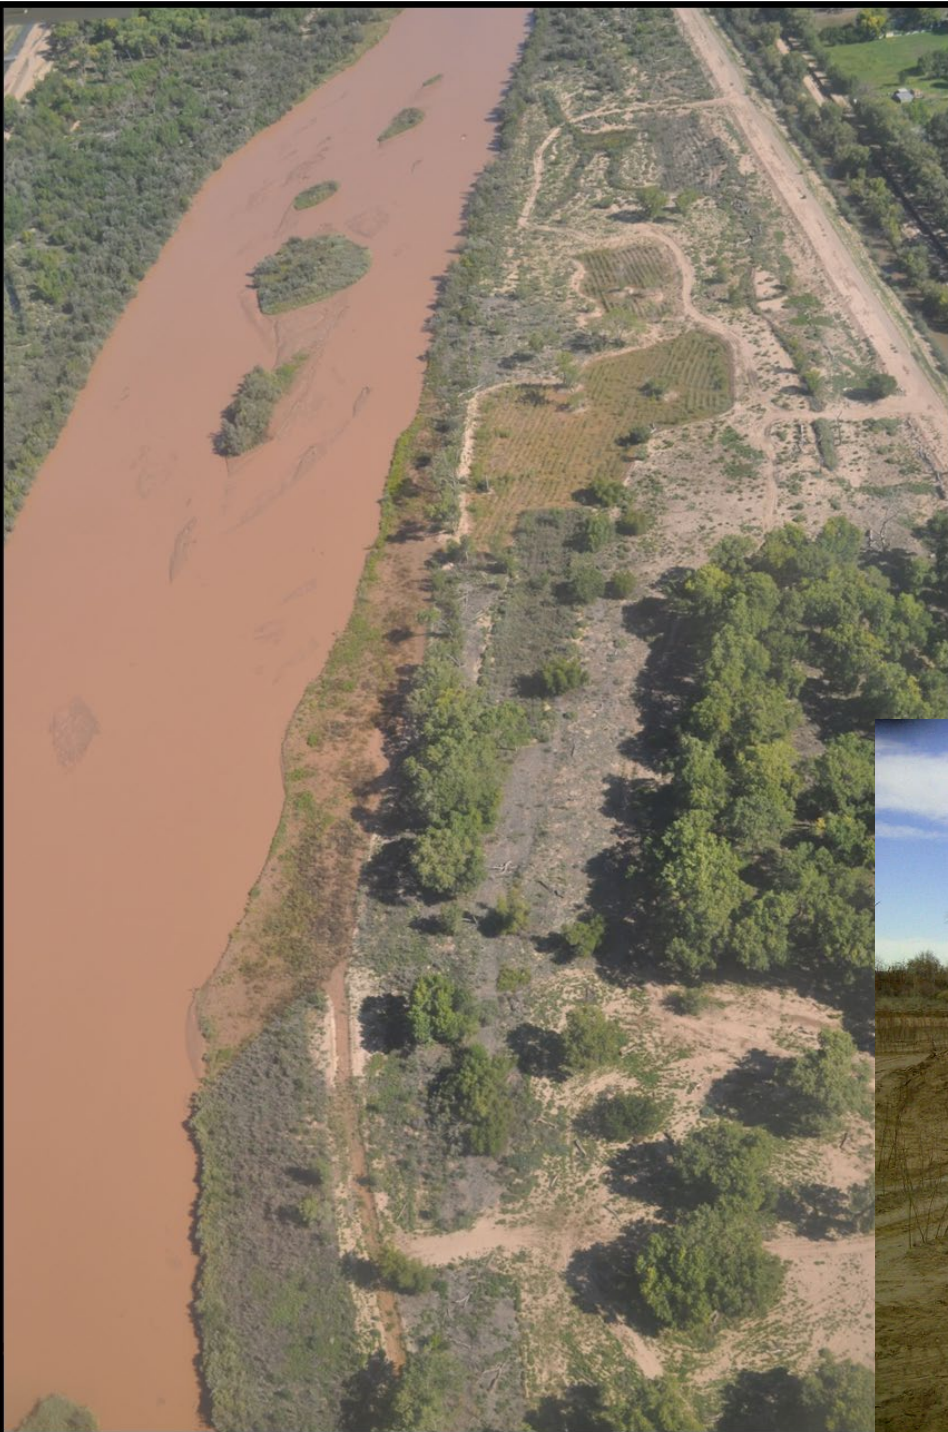
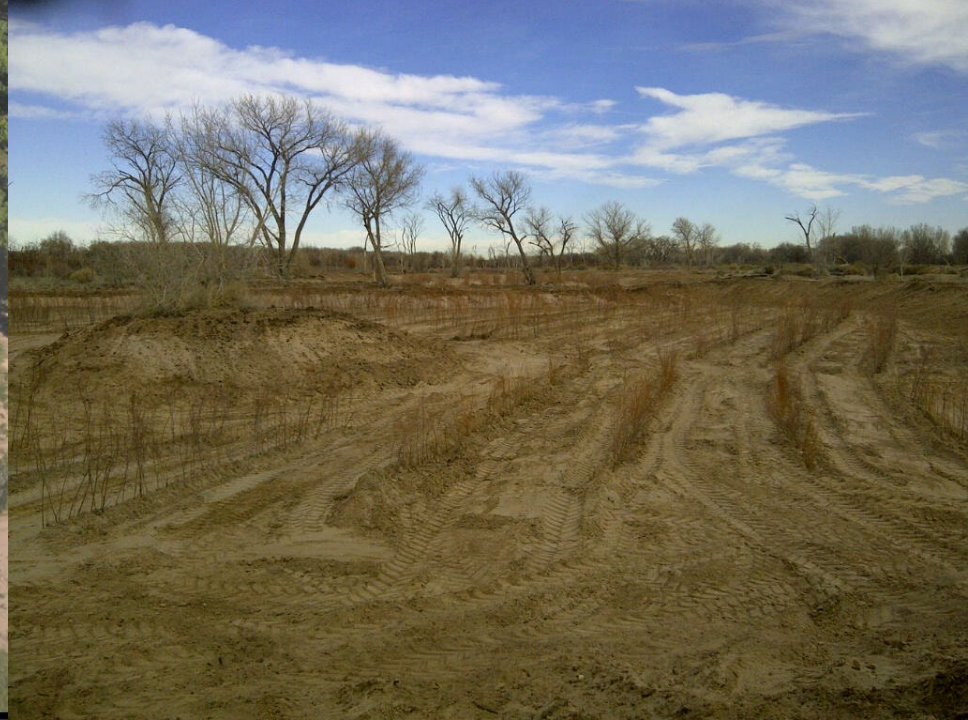
# 5C – adjacent to Valle de Oro

Peak flow:  
2011 – 2,710,  
2012 – 2,510,  
**2013 – 4,250**

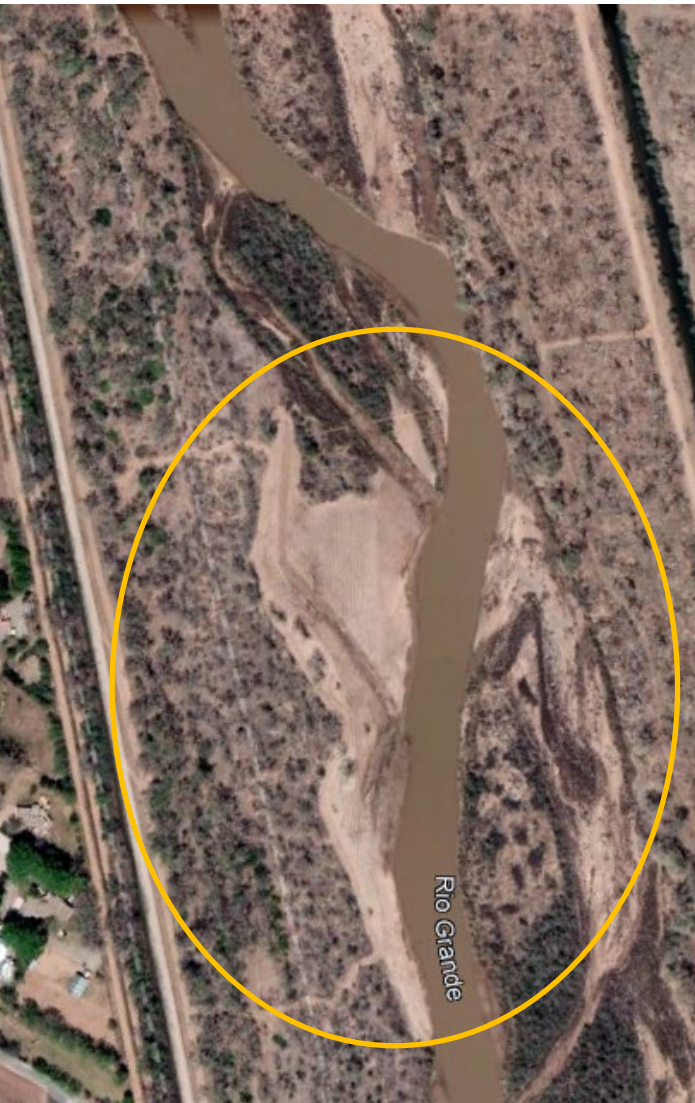
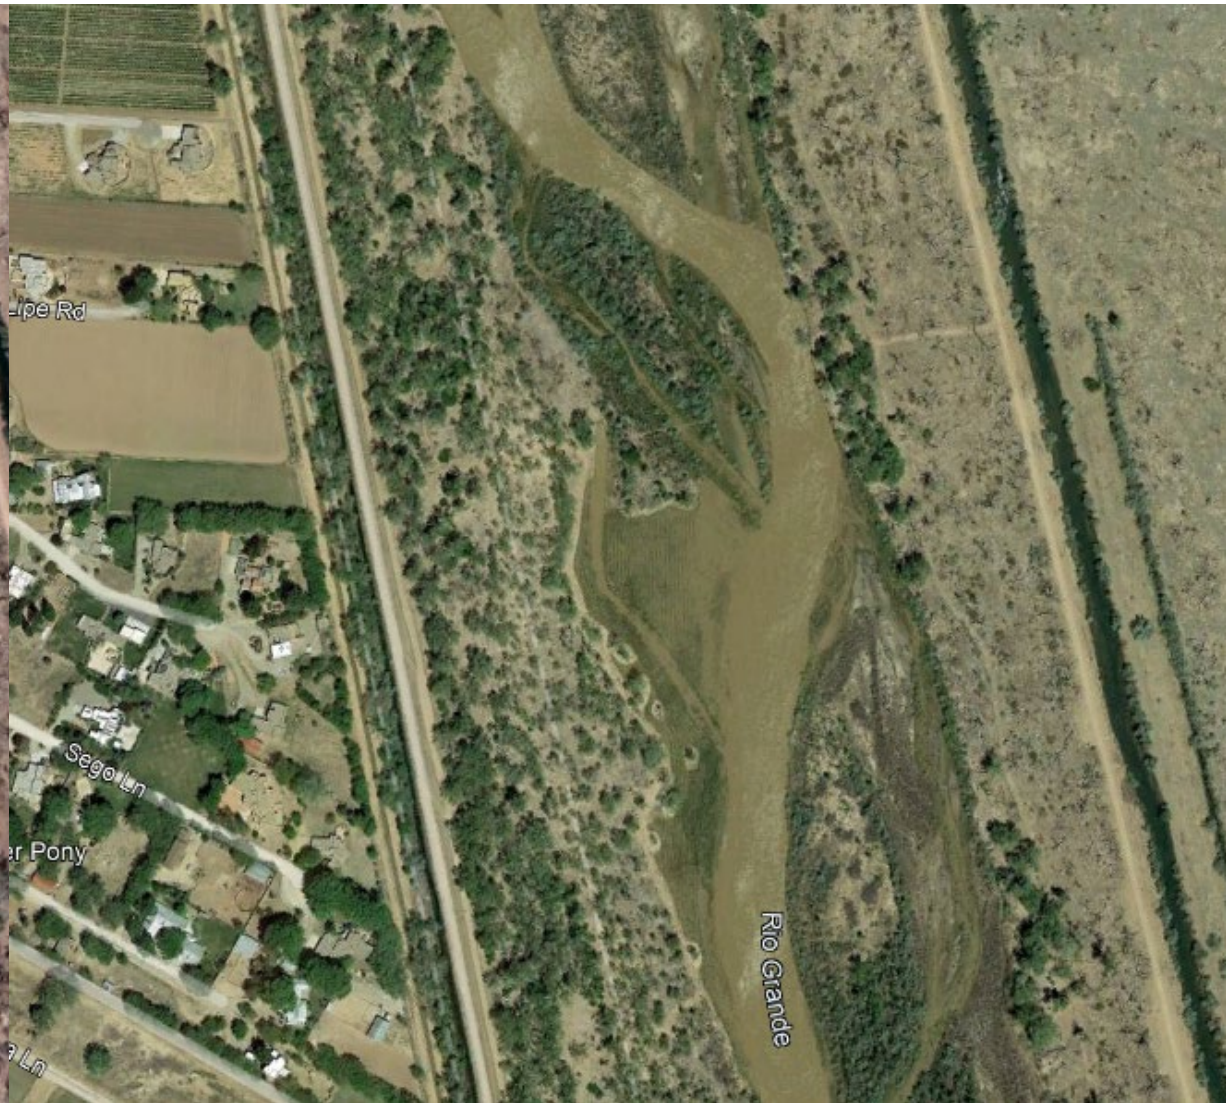
# Corrales 1A

April 2016 (June 2016 3,950 cfs)  
cfs

April 2017 - (May 10, 2016 - 5,660)

Excavation quantity - field design change
