Island Construction: Rebuilding Natural Levees to Restore Hydrologic Connectivity in the Northern Reaches of the Upper Mississippi River (UMRS)

*U.S. Army Corps of Engineers, St. Paul
District*

01 August 2011

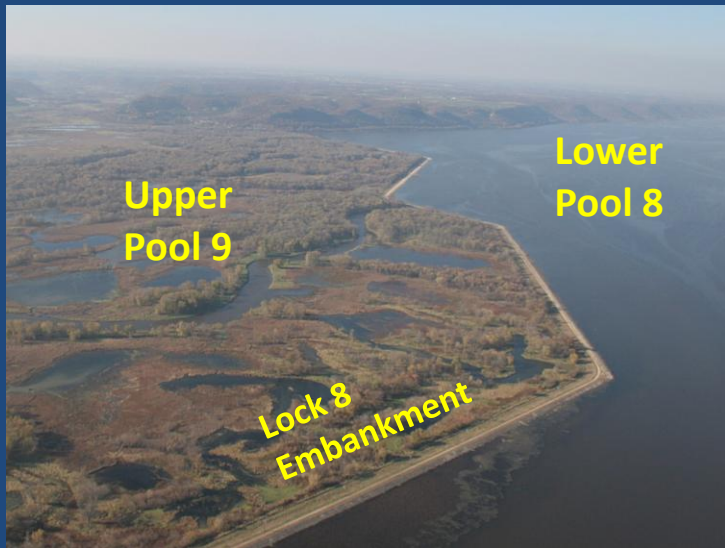
The most significant stressor was the construction of the Locks and Dams

23 miles

In lower pool 8, water levels were raised 10 feet submerging the floodplain upstream of the lock

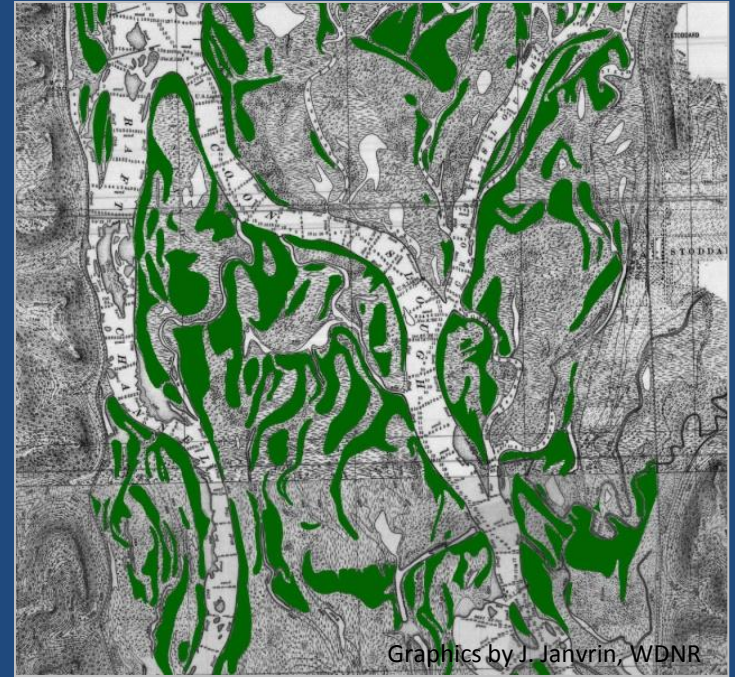
Natural levees (Islands)

Definition: The high banks (green shaded areas on adjacent map) along channels where sediment deposits during flood events. They separate channel from off-channel habitat.

These natural levees were, and still are called islands

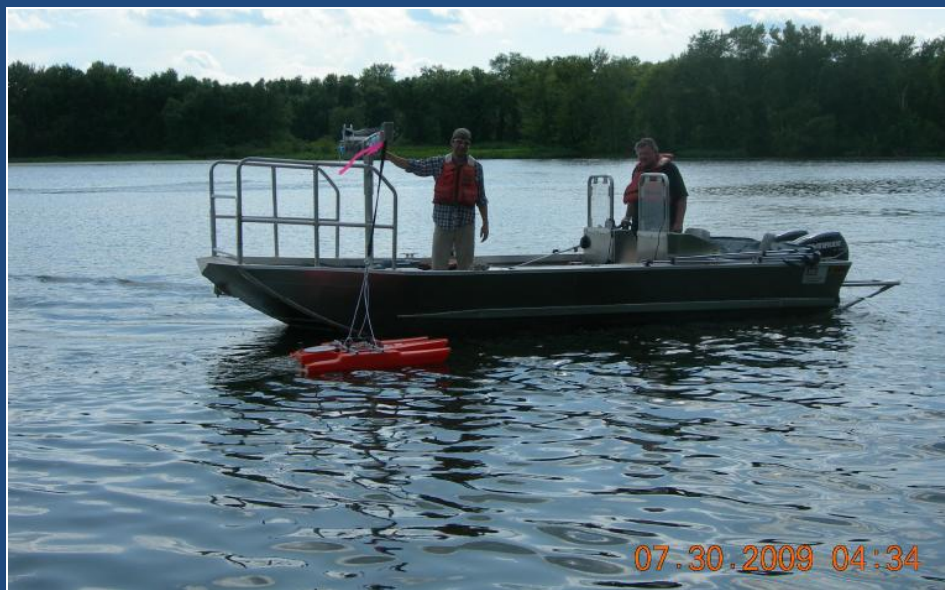
Monitoring and modeling needs were established

Discharge measurements to quantify hydrologic connectivity

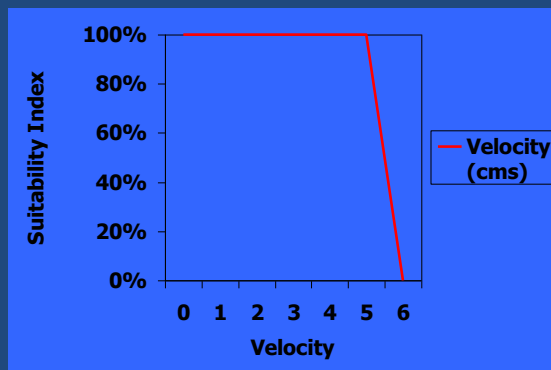
Two-dimensional hydraulic models based on LTRMP bathymetry and calibrated to discharge measurements

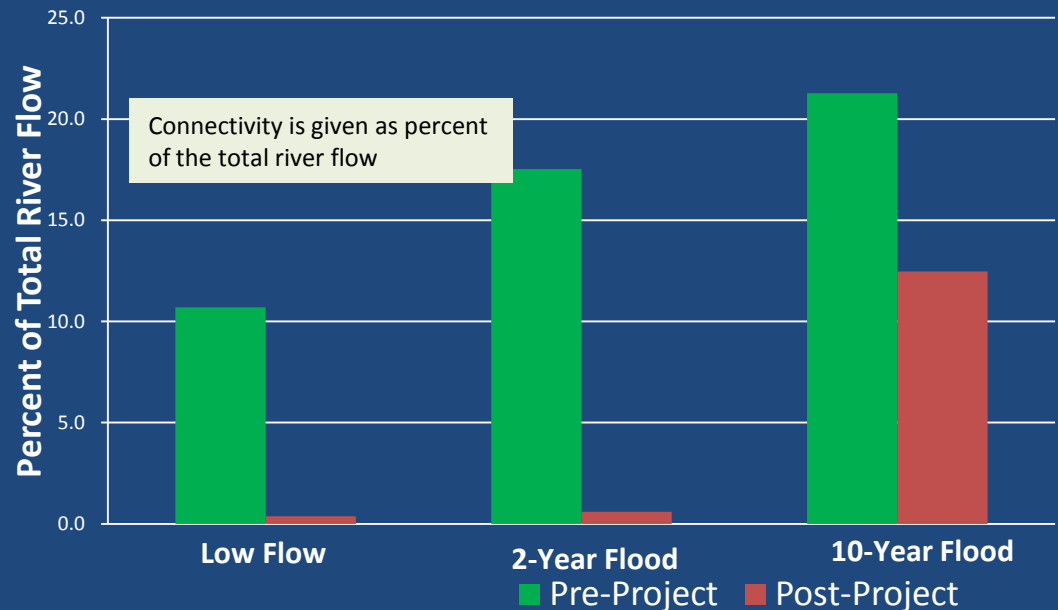
For post-project conditions the seasonal variation in hydrologic connectivity was increased significantly with low connectivity for low flow to bankfull conditions and then increasing connectivity for floods.

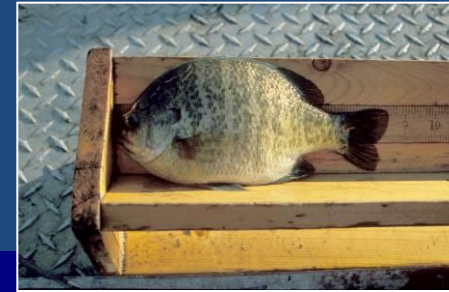
Fall electro-fishing indicates continual increases in fish over time.

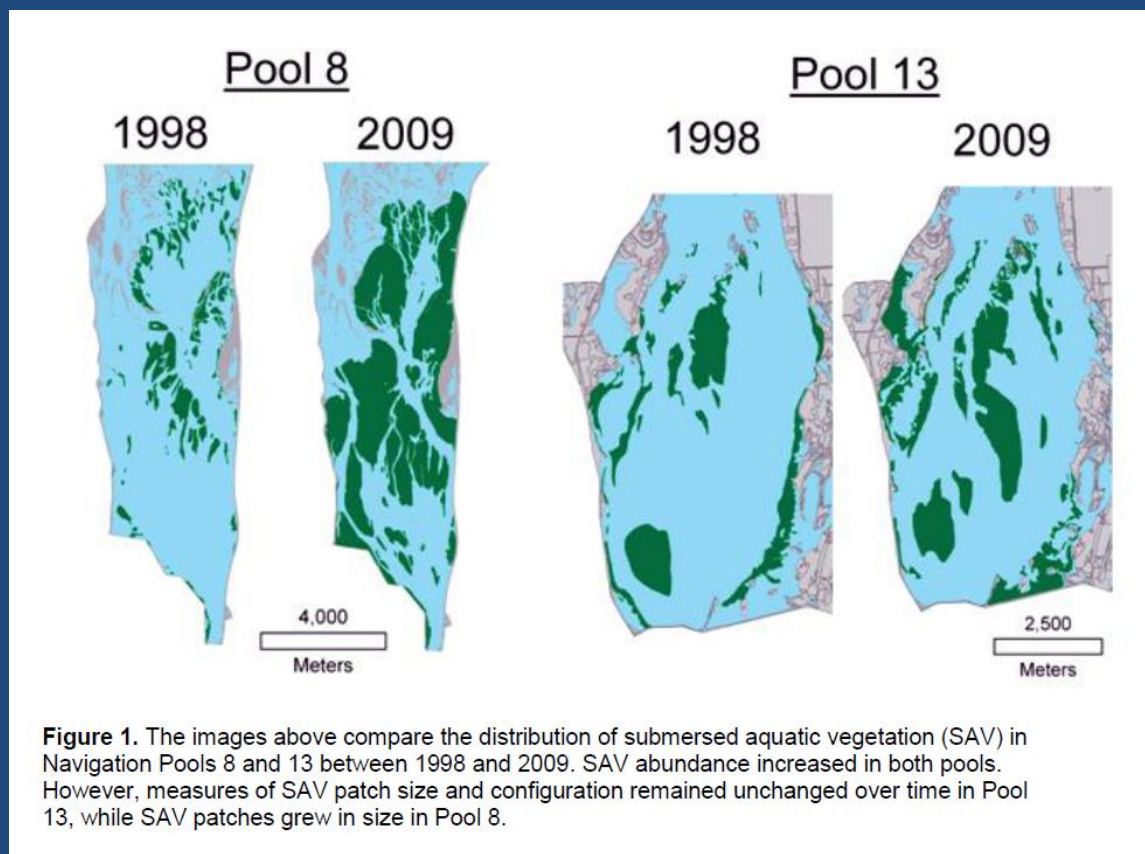
Graphic from 2011 UMRCC News Letter

Submerged Aquatic Vegetation (SAV) has improved due to regional factors and local management measures

In a comparison between Pools 8 and 13:

SAV abundance increased in both pools because of regional reductions in turbidity.

But patch size of SAV in Pool 8 was much more substantial.

These changes indicate that local modifications to water flow and wind fetch led to larger patches of SAV.
