Designing and Implementing Dam Removal Projects in the Context of the Regulatory Climate: Patapsco River Dam Removal Case Study

*Mary Andrews, P.E.
NOAA Restoration Center*

Patapsco River Restoration

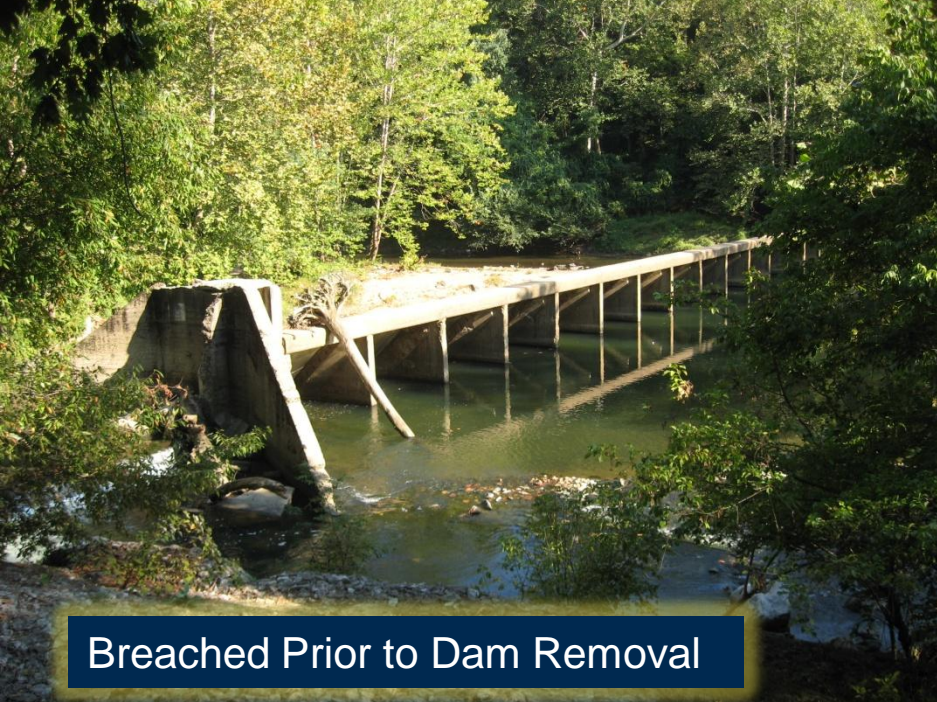
Breached Prior to Dam Removal

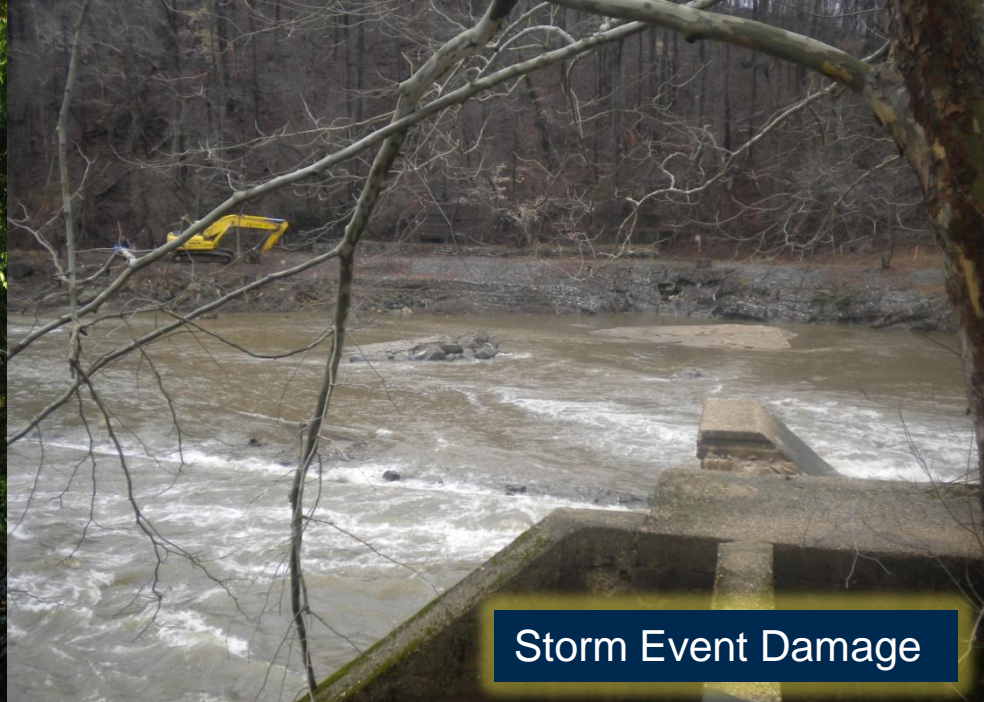
Storm Event Damage

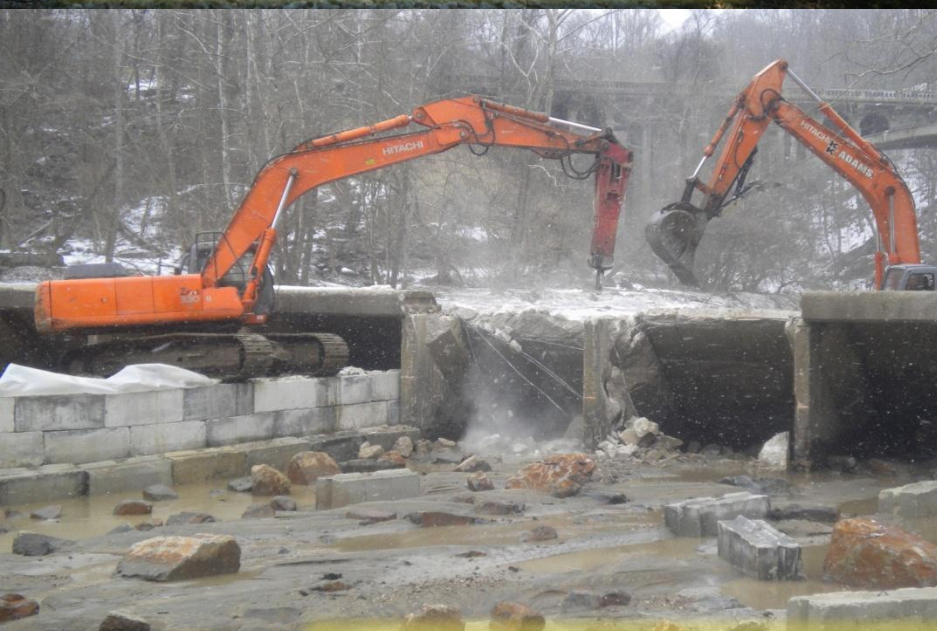
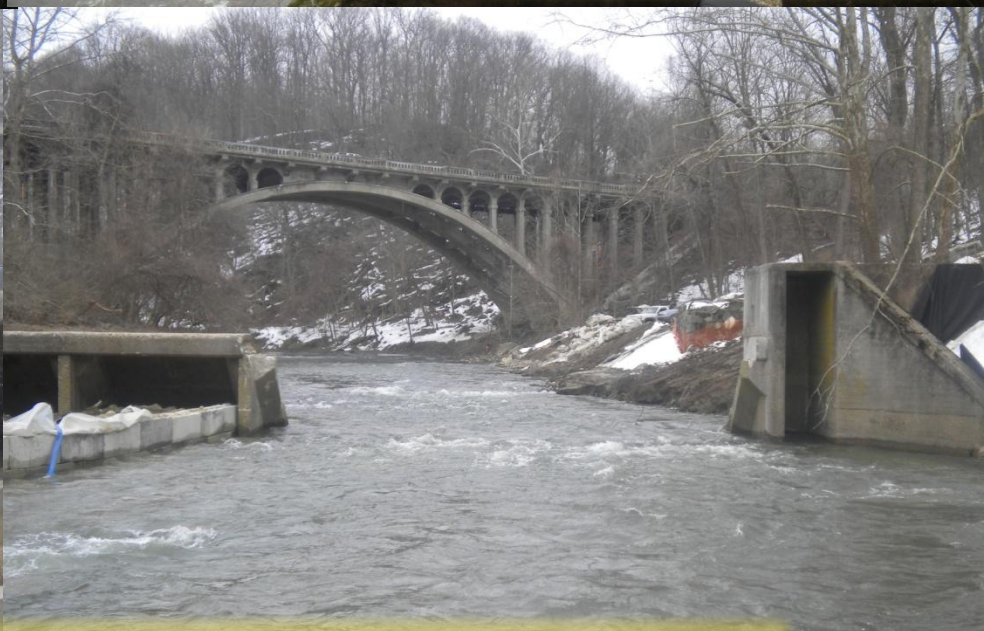
Diversion Channel (fabric lined) to Divert Water through Breached Dam

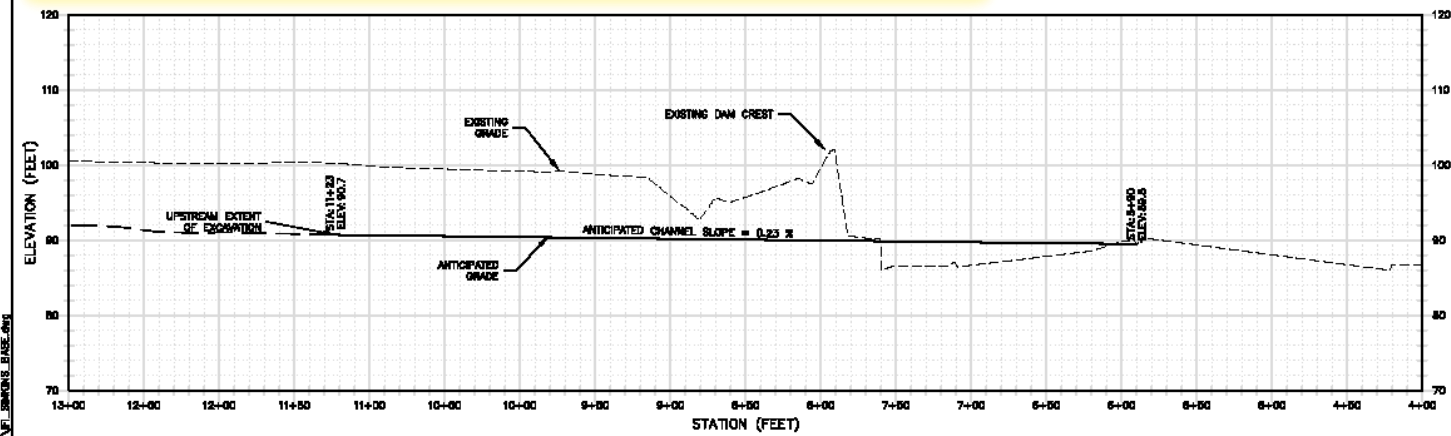
Longitudinal Profile

Impoundment: ~95 acre-feet
Normal pool length: 3,500 ft

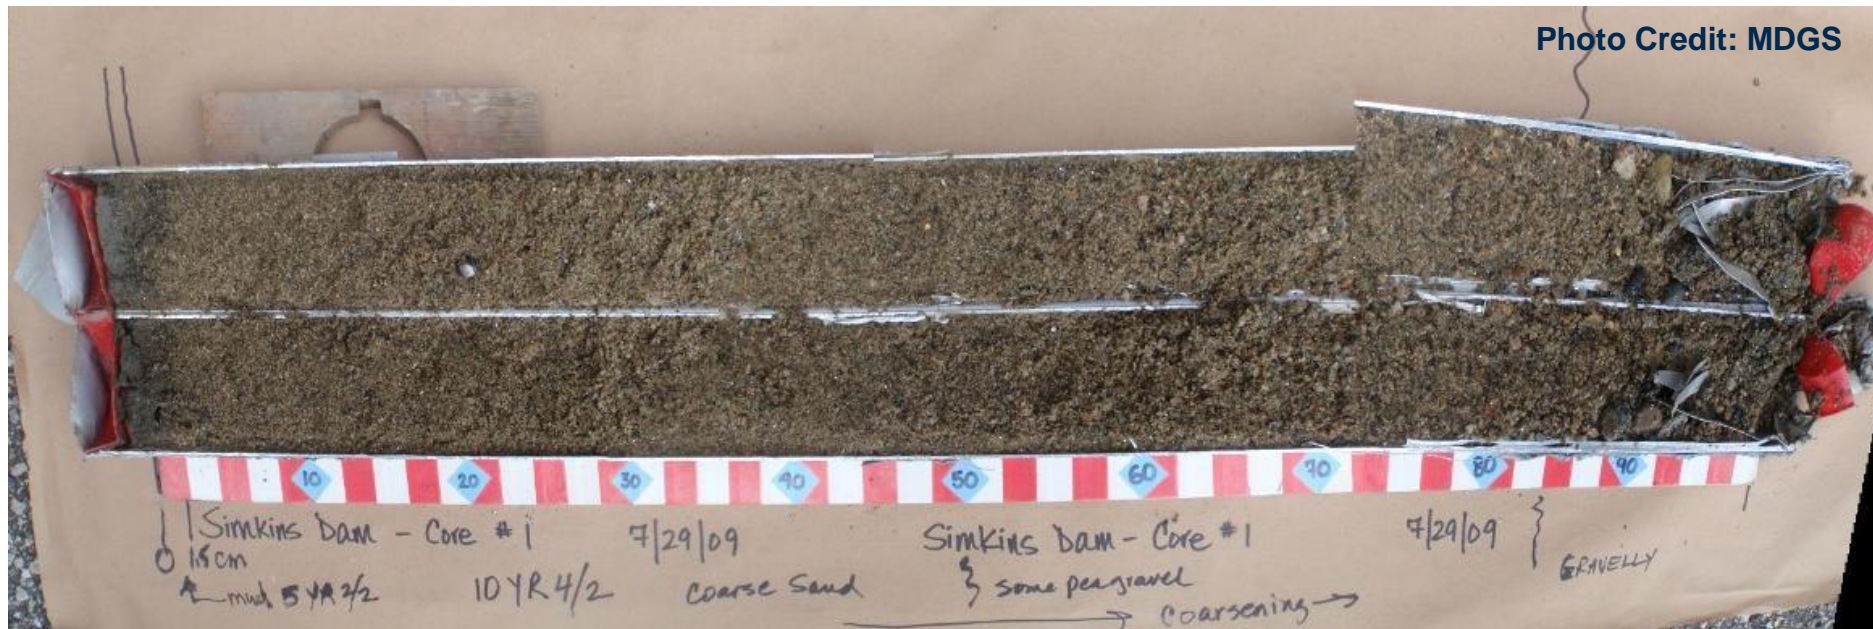
Sediment Character

- Grain size - 10 cores (Interfluve) + 4 cores (MDGS)
- 94% primarily coarse sand with some gravel; ~ 6% finer sand and silt

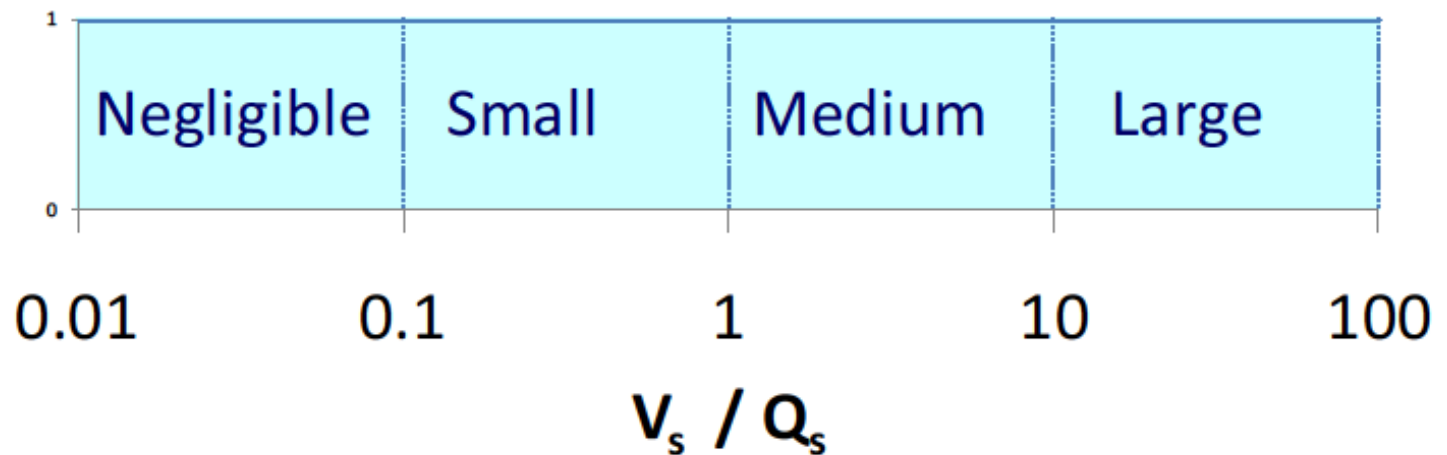
Reservoir Sediment Volume (V_s) Relative to the Average Annual Sediment Load (Q_s)

- Average annual sediment load based on
 - downstream transport capacity for coarse sediment
 - upstream supply for fine sediment

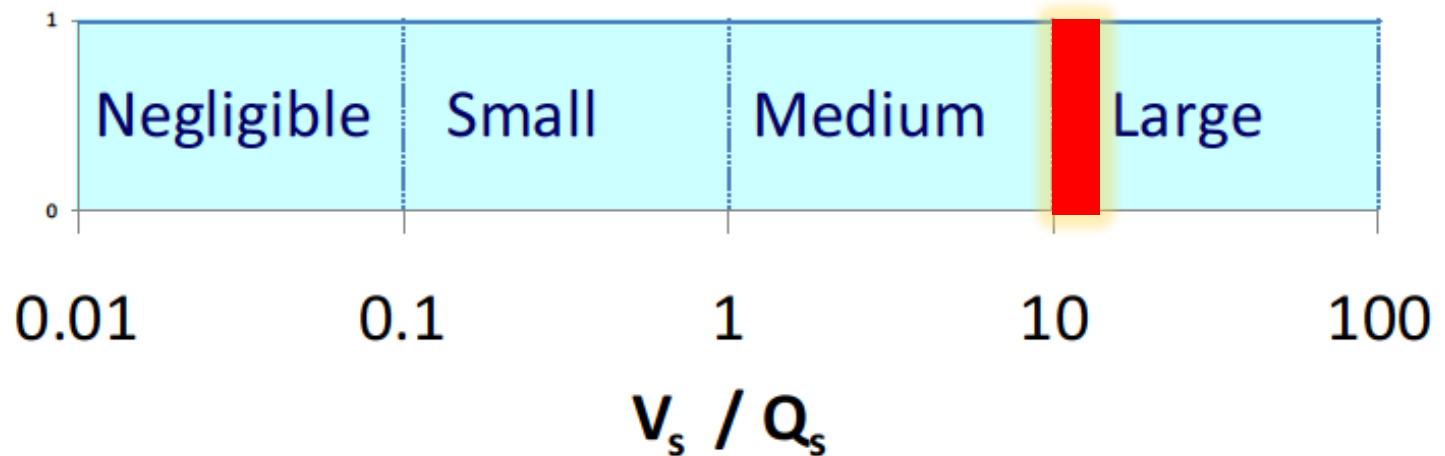
Reservoir Sediment Volume (V_s) Relative to the Average Annual Sediment Load (Q_s)

- Average annual sediment load based on
 - downstream transport capacity for coarse sediment
 - upstream supply for fine sediment

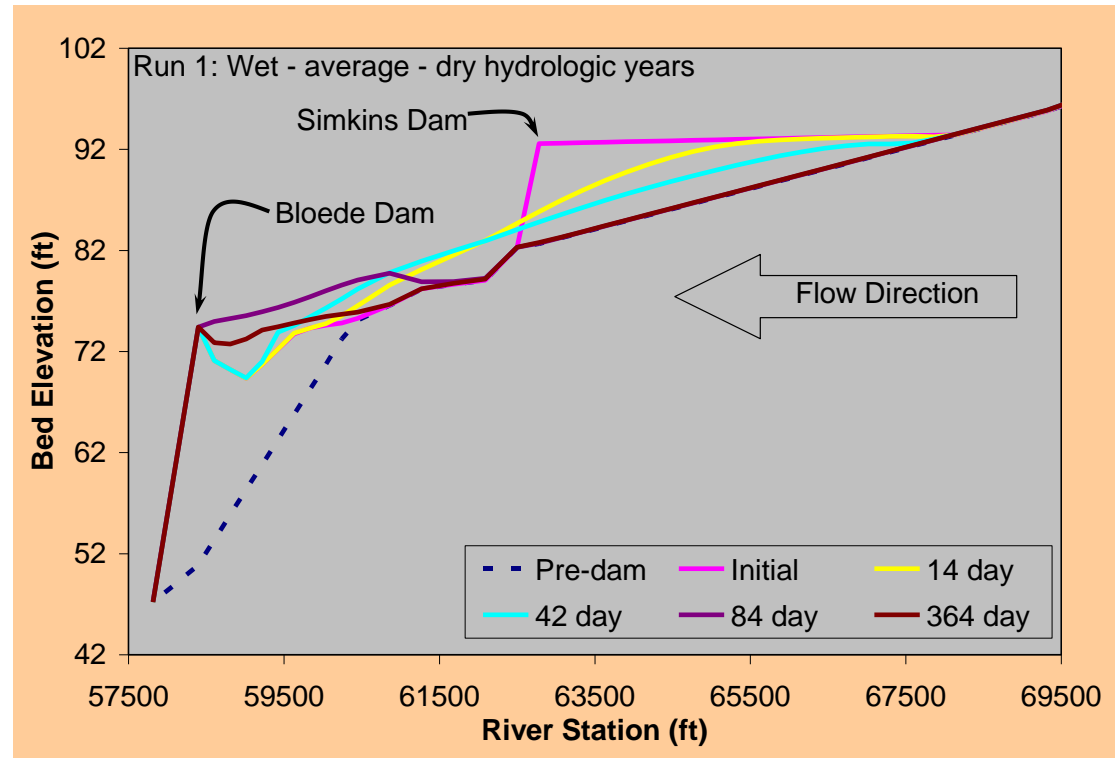
DREAM Model

- Dam Removal Express Assessment Model-1 – Stillwater Sciences
- Peer-reviewed and tested with both flume and field data
- 1D model simulates cross-sectionally and reach averaged sediment aggradation and degradation
- Three basic runs
 - Run 1: wet – average – dry
 - Run 2: average – average – dry
 - Run 3: dry – average – wet

- Release 88,000 – 104,000 cubic yards of sediment, depending on channel geometry following dam removal
- Complete evacuation of reservoir deposit in 3 months to 2 years, depending on hydrologic conditions
- Up to 4 ft deposition upstream of Bloede Dam that dissipates quickly, return to pre-dam removal condition soon after Simkins deposit is emptied
- Less than 2 ft deposition downstream of Bloede Dam that dissipates slowly in time

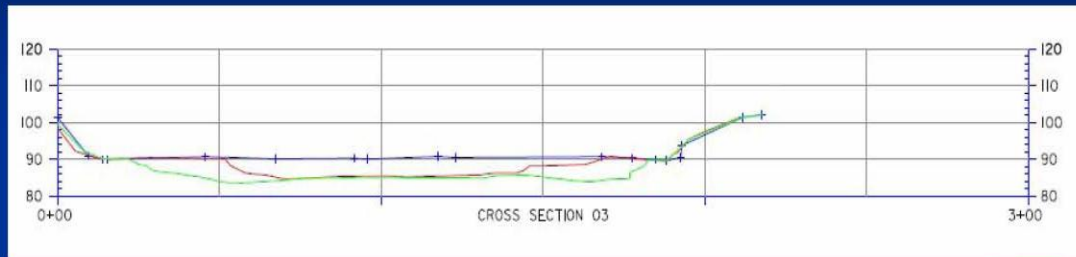
RS 63600- 1000' US of Simkins Dam

Cross Sections US Simkins

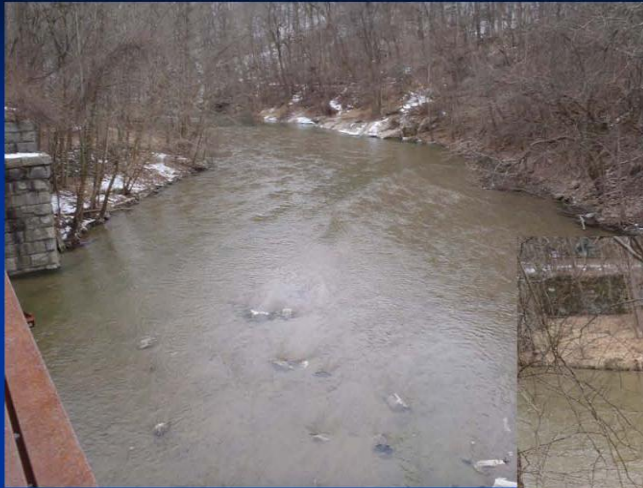
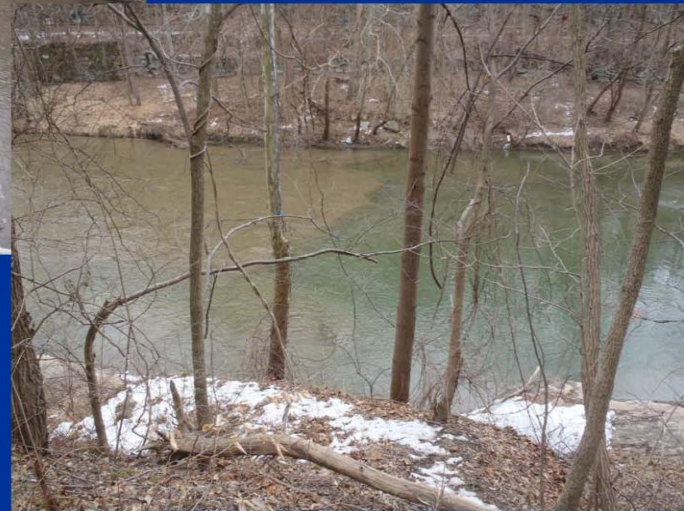
Post Removal 2/13/11

Sediment Transport Post Removal

Sediment Dispersal

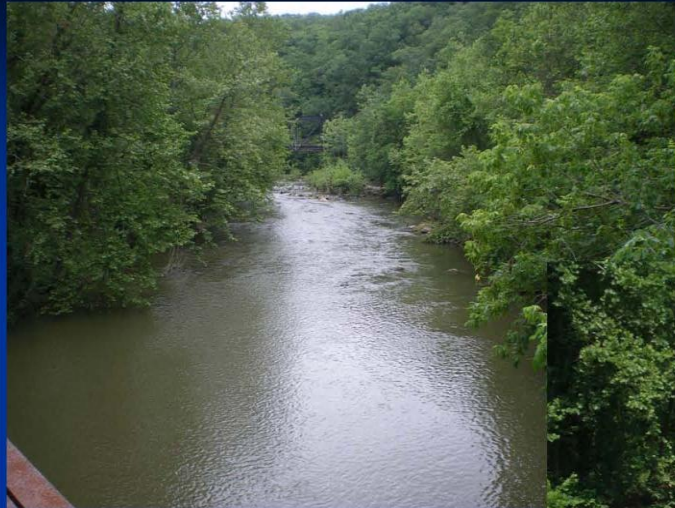
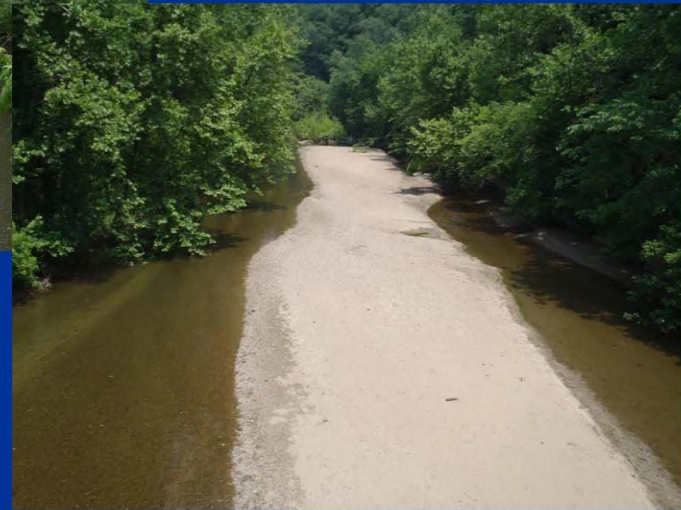
Post Removal 6/10/11

Sediment Transport Post Removal

Sediment Wedge
