# Sullivan Branch Stream Restoration

**STRAUGHAN  
ENVIRONMENTAL**

# Sullivan Branch

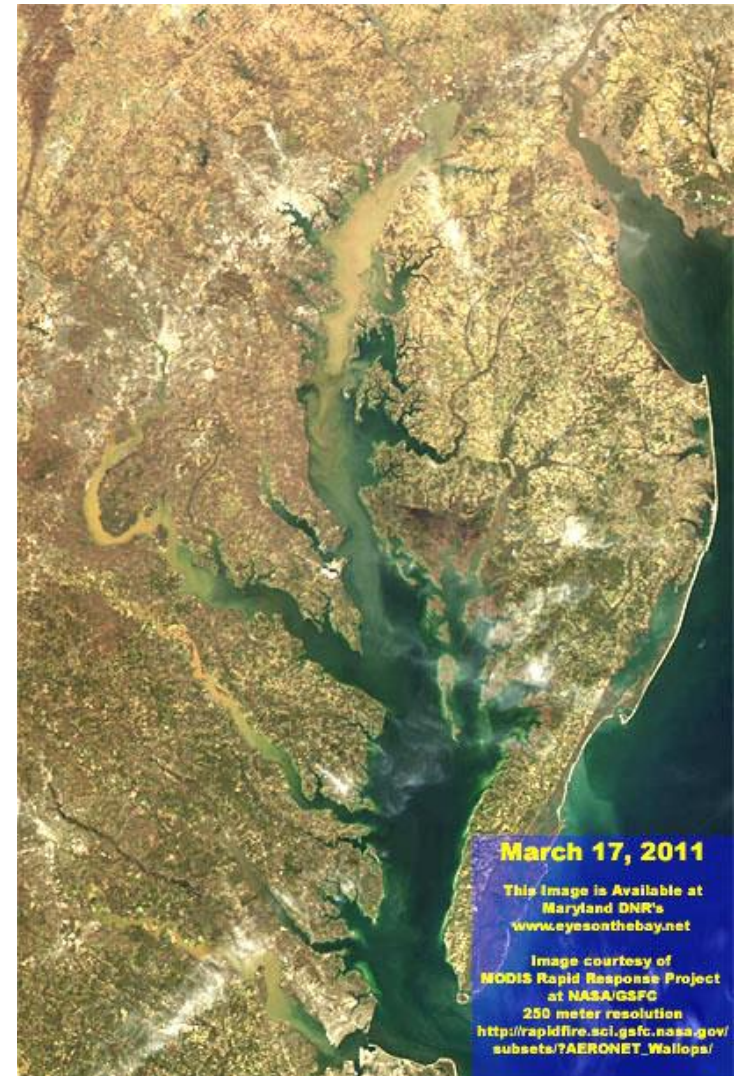
# Urbanization of Chesapeake Bay watershed has resulted in

- Increase in impervious surface
- Excess erosion
- Sediment plumes
- Stream degradation
- Disconnected floodplains

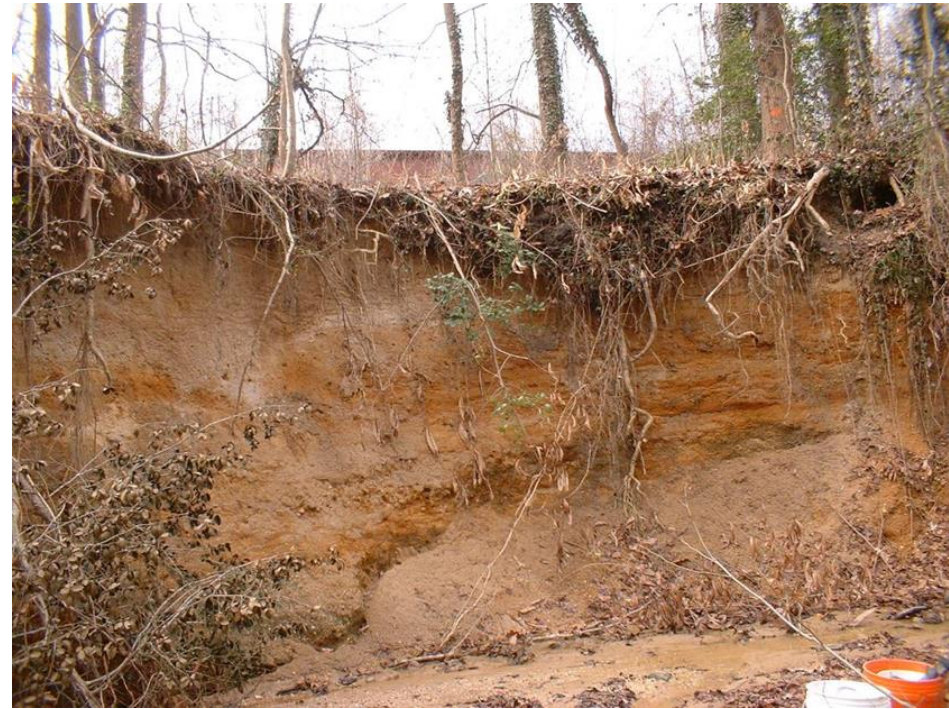
# Increased development changes the hydrology ; natural channels essentially unravel...

- Bed erosion
- Bank erosion
- Tree loss
- Channel incision
- Disconnected floodplains
- Water Quality degradation
- Sediment loads
- Undermining of outfall structures

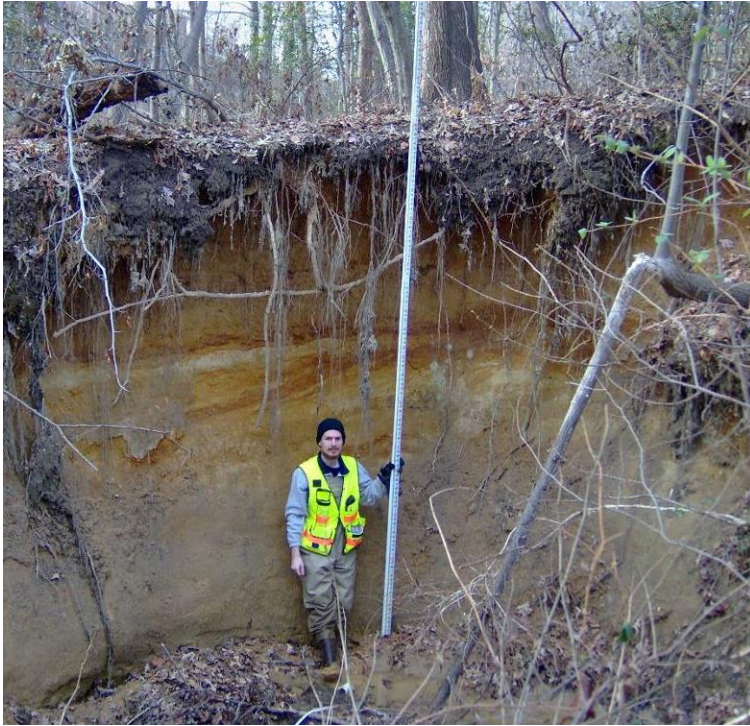
# Sullivan Branch Problems

- Failing/undersized outfalls
- Bank erosion
- Severe channel incision
- Sediment settling in wetland of Special State Concern
- Falling trees

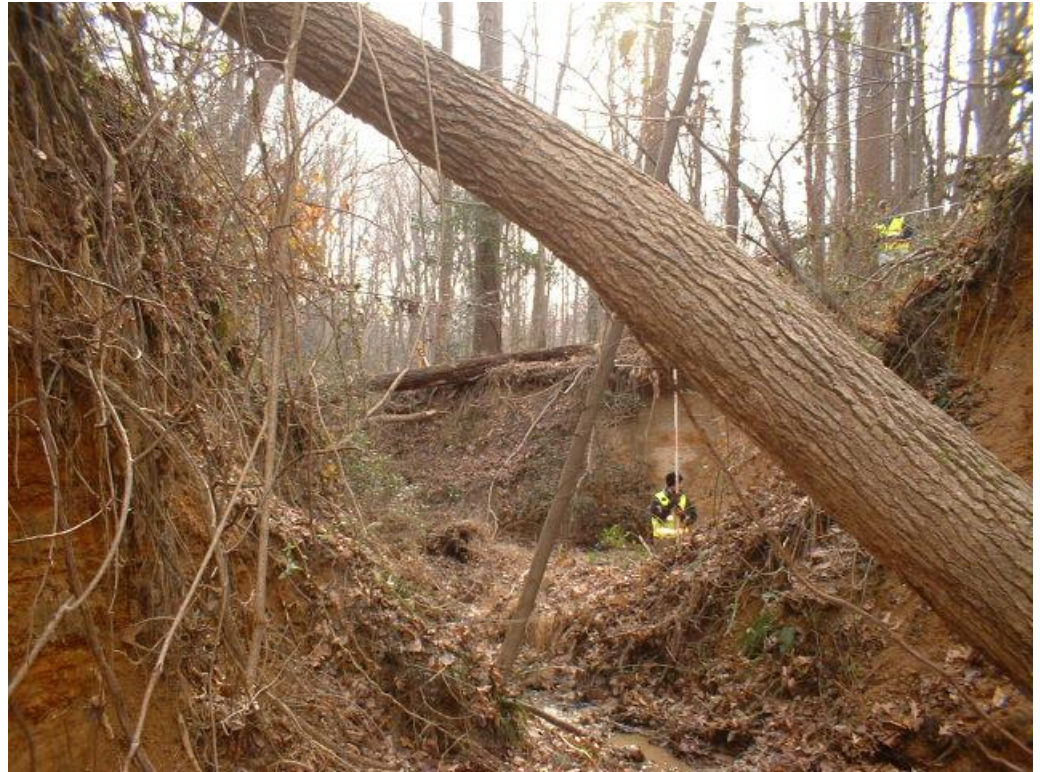
# Reach 1

- Laterally and vertically unstable
- Unable to access floodplain
- Steep slope
- Severe erosion
- Intermittent flow

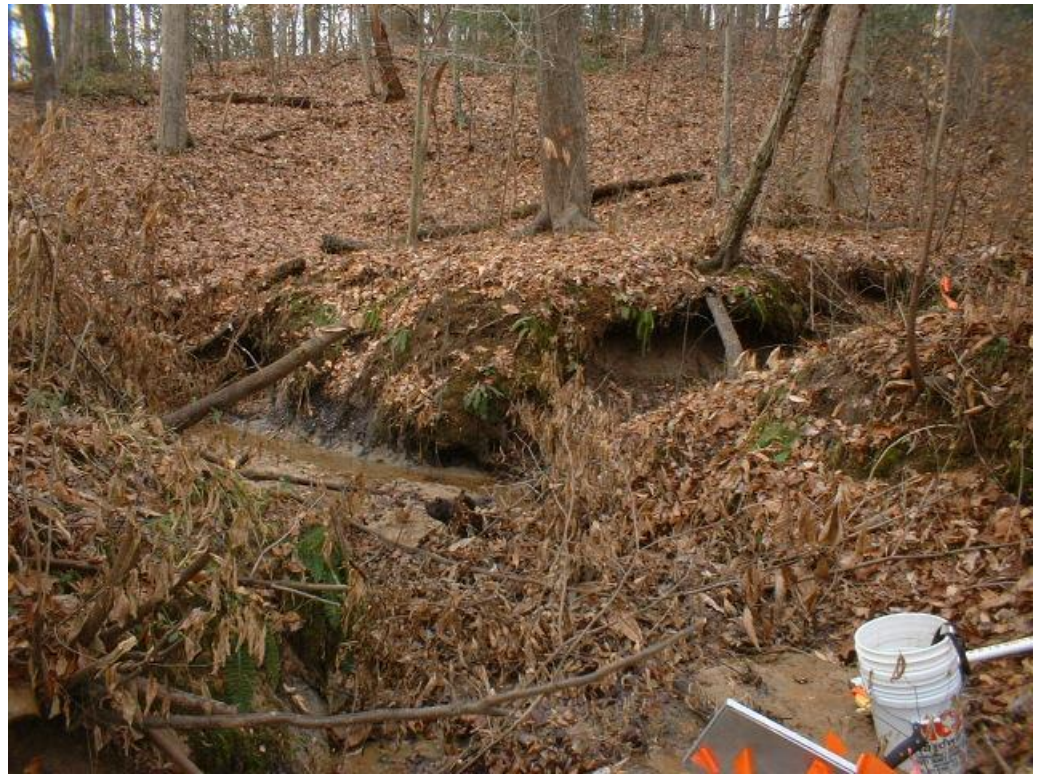
# Reach 2

- Moderately unstable
- Decrease in bank height
- Decrease in slope
- Transitional reach

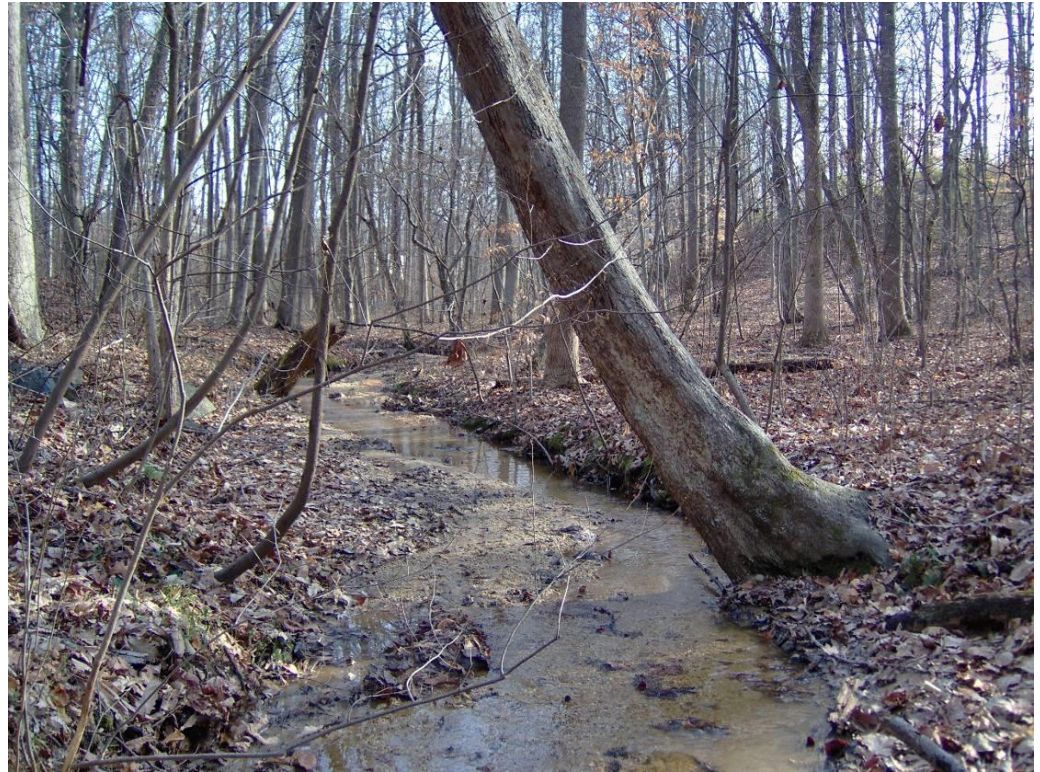
# Reach 3

- Vertically and laterally stable
- Dimensions consistent with regional curve
- Access to floodplain
- Reference reach

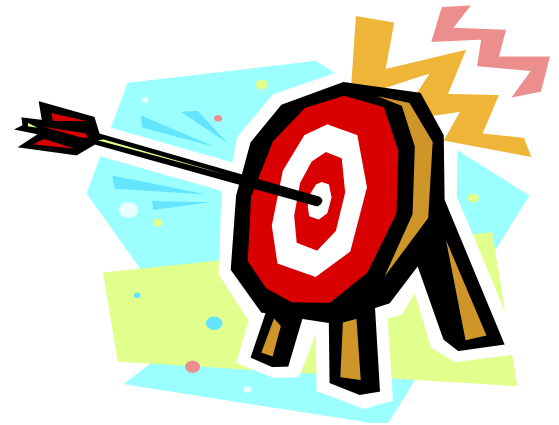
# Design Goals

- Reduce sediment/ bank erosion
- Allow access to floodplain
- Increase channel stability
- Stabilize outfalls
- Reduce tree impacts

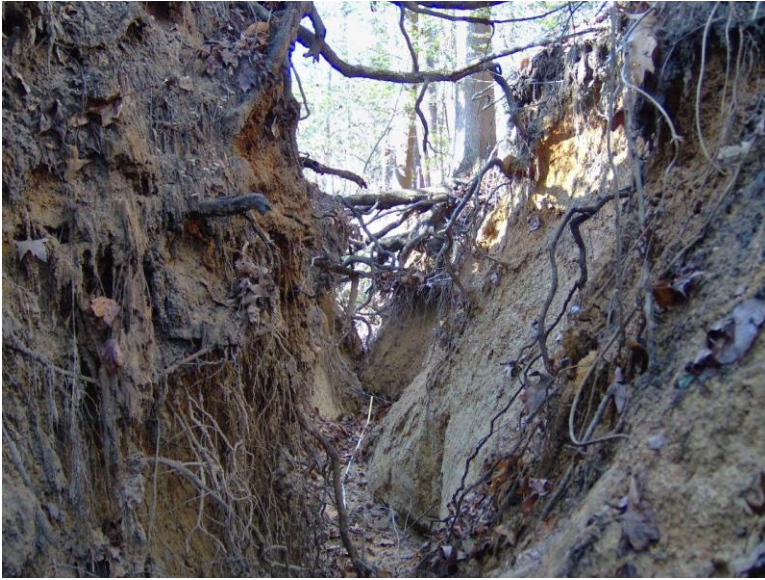
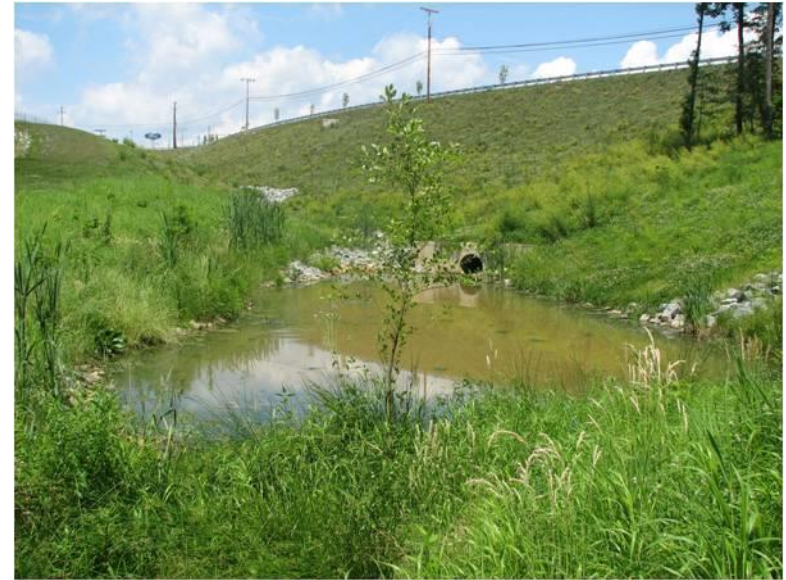
# Stormwater Management Practices

- Fill and re-vegetate tributaries
- Pipe upland runoff
- Create forebay to dissipate energy and improve water quality

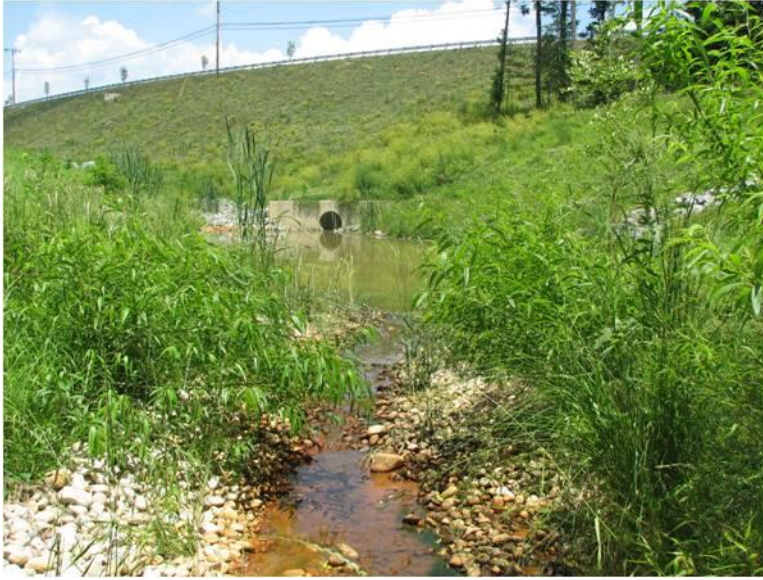
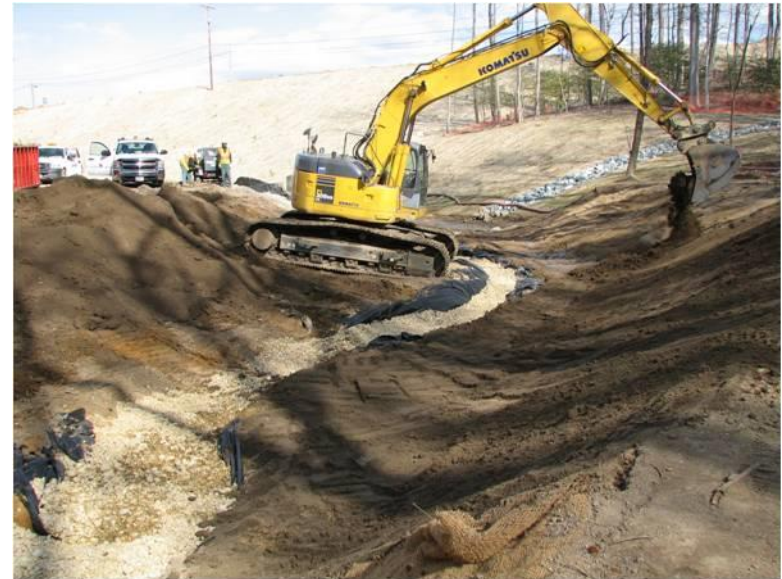
# Natural Channel Design

- Stream flows from forebay
- Grade back banks
- Create bankfull and 2-year floodplain benches

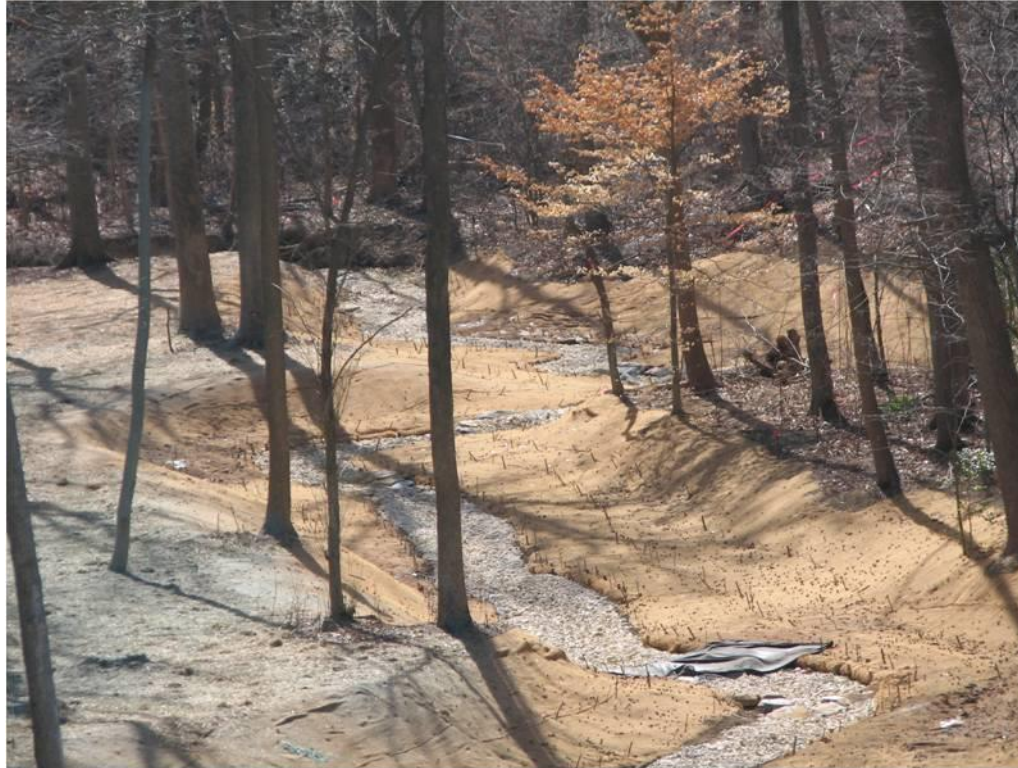
# Natural Channel Design

- Create meander geometry based on reference reach
- Keeping a majority of the restored channel within the existing channel to decrease tree impacts

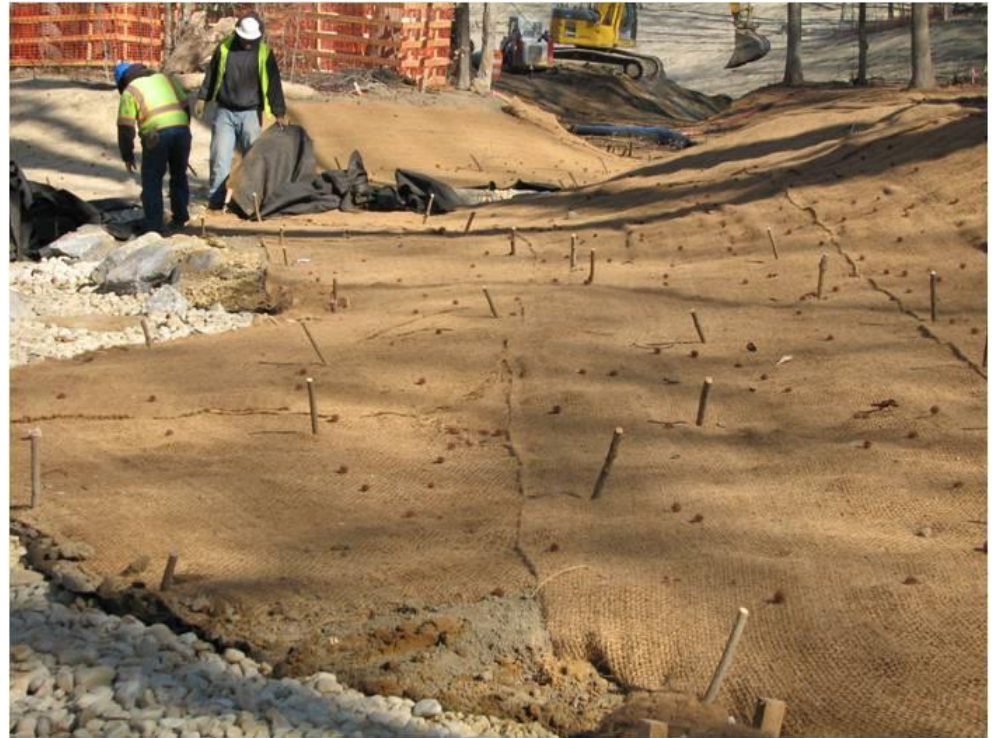
# Bio-Engineering

- Re-vegetate with native vegetation (including Bald Cypress)
- Coir fiber rolls along meander bends
- Woven coir mattress
- Live stake installation

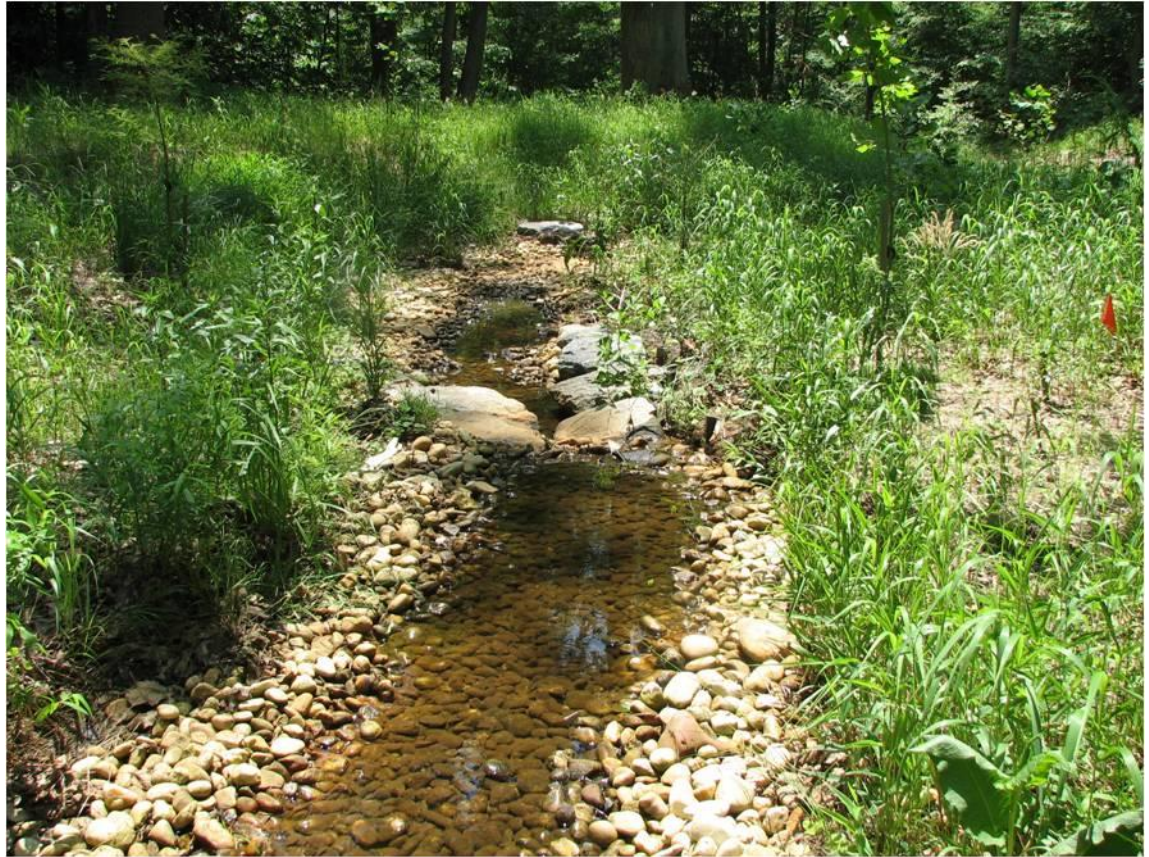
# Structures

- Rock cross vanes
- Step pools
- J-hook vanes

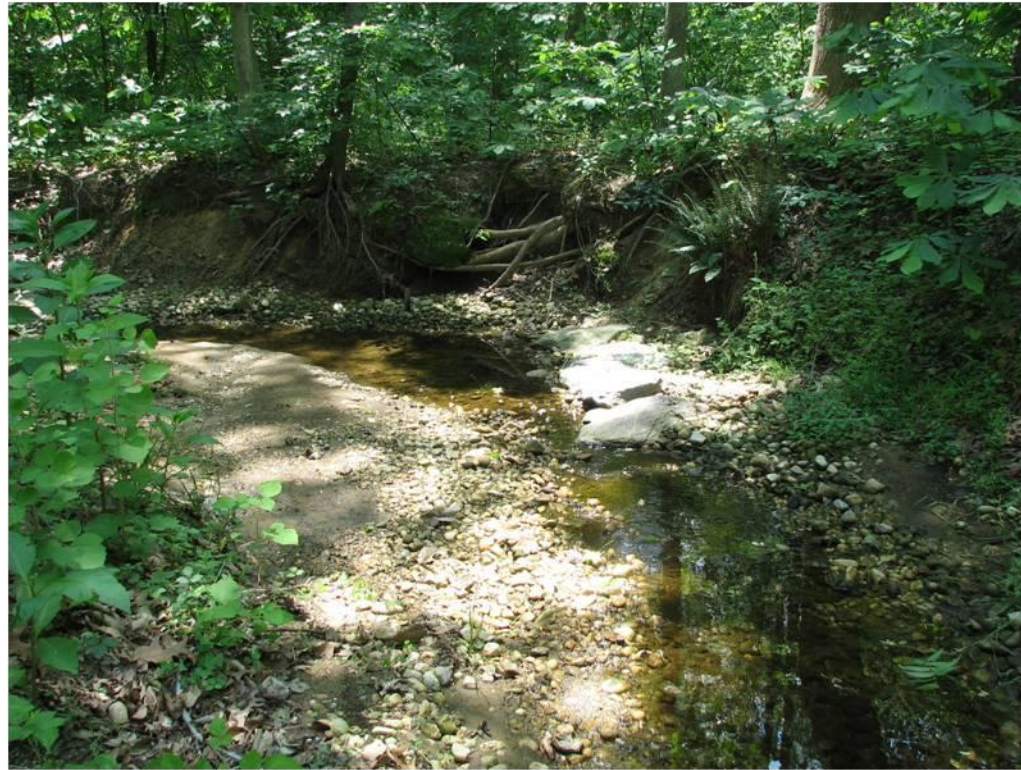
# Address localized erosion

- Bank erosion at meander bends downstream of grading
- Rock cross vanes & J-hook vanes installed to convey flow away from eroding banks

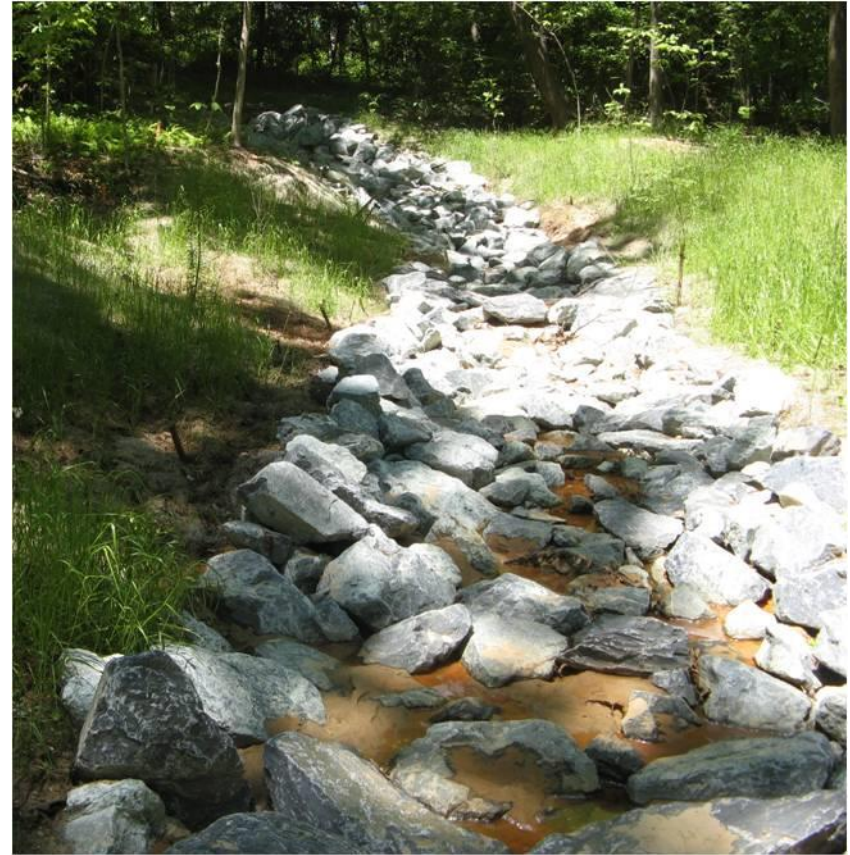
# Stabilize Tributary 5

- Receives drainage from SHA parking lot
- Replace failing riprap
- Create plunge pool
