The Los Angeles River and Large-Scale Urban Ecosystem Restoration

Los Angeles River Ecosystem Restoration
Feasibility Study

NCER 2013

Scott Estergard, Tetra Tech
Michael Affeldt, City of Los Angeles
Kathleen Bergmann, USACE
Ira Mark Artz, P.E., Tetra Tech

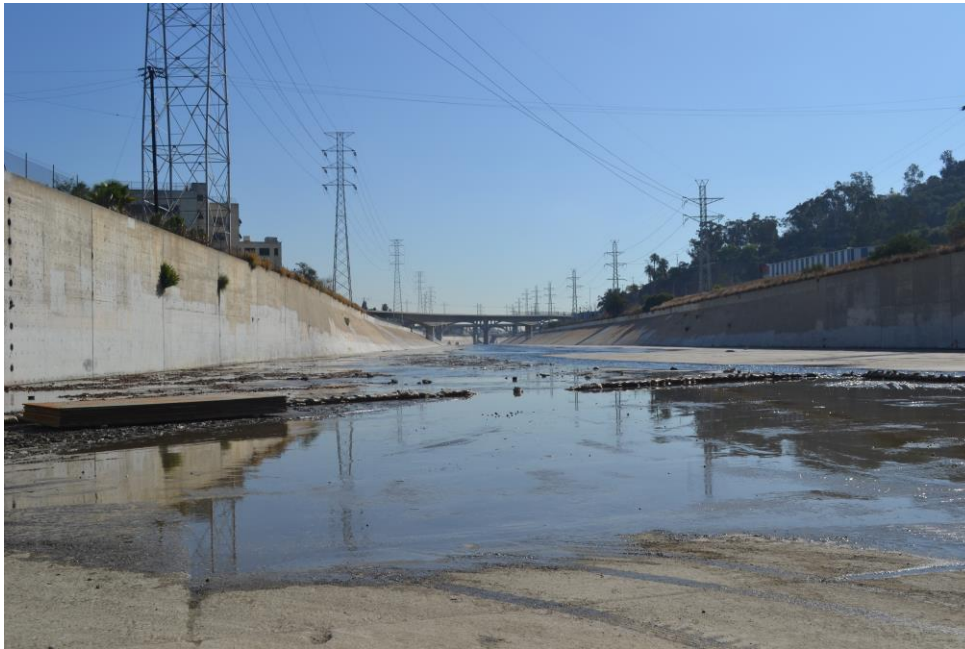
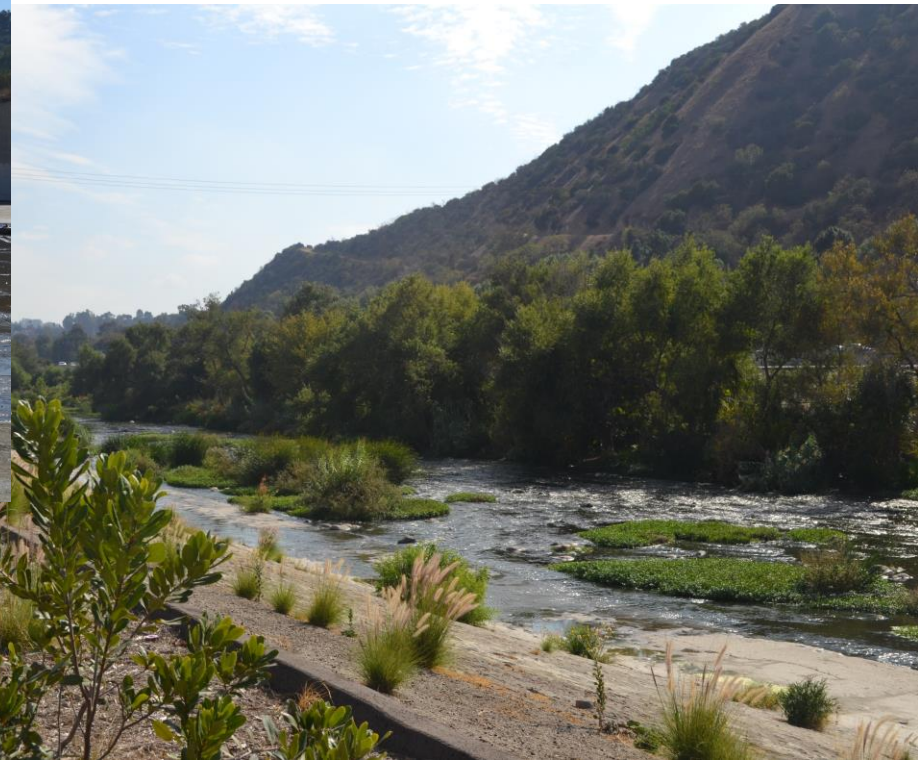
Study Area

Key Sites:

1. Headworks
2. River Glen-Verdugo Wash
3. Bowtie
4. Taylor-Yard-Rio de LA State Park
5. Arroyo Seco Confluence
6. Cornfields-LA Historic Park
7. Piggyback/Mission Yard

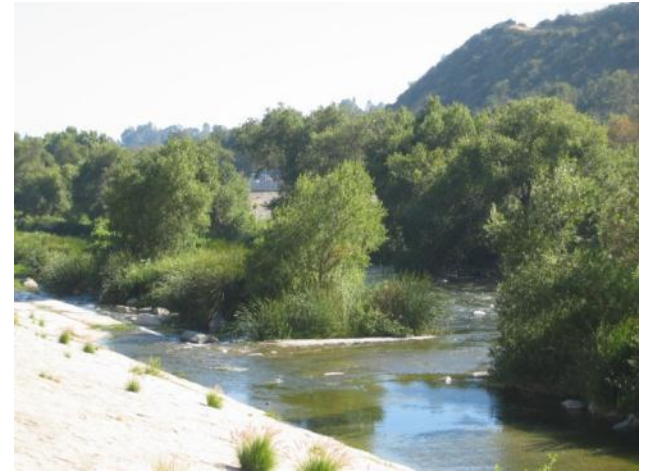
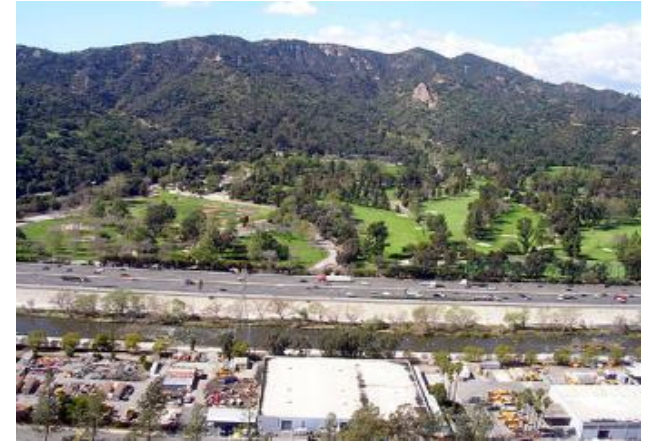
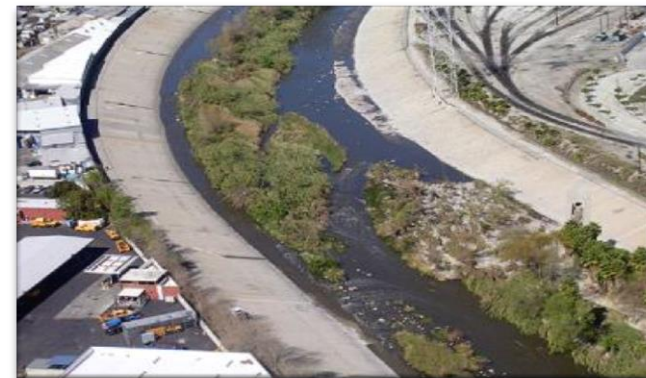
1. Loss of aquatic habitat
2. Lack of ecological processes necessary to support ecosystem
3. Lack of substrate
4. Lack of connectivity to floodplains and functioning ecological zones
5. Highly altered hydrologic regime
6. High velocity flows
7. Disruption of natural sedimentation processes
8. Impervious surfaces in the drainage area preventing infiltration and recharge
9. Poor water quality caused by urban runoff and pollution
10. Presence of non-native vegetation/ exotics and trash accumulation in the river
11. Lack of recreation and opportunities to interact with the natural environment

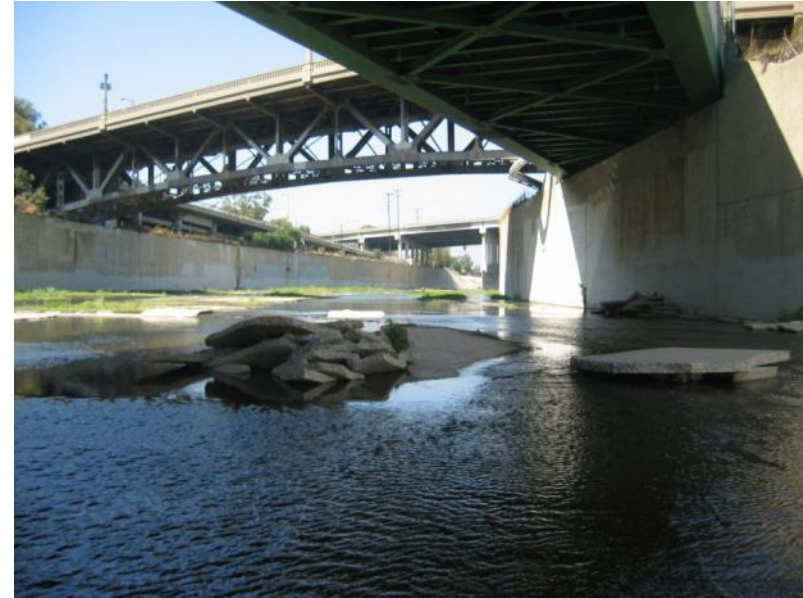
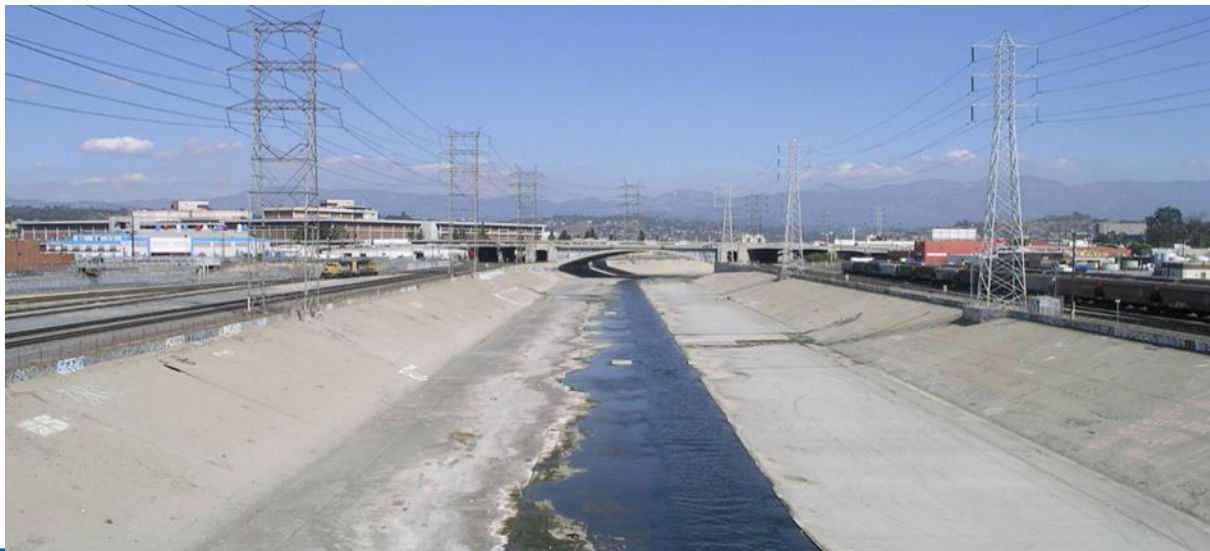
1. Hazardous waste sites
2. Potentially contaminated groundwater
3. Surrounding urbanization and infrastructure
4. Land availability in dense urban area
5. Maintain existing levels of flood protection

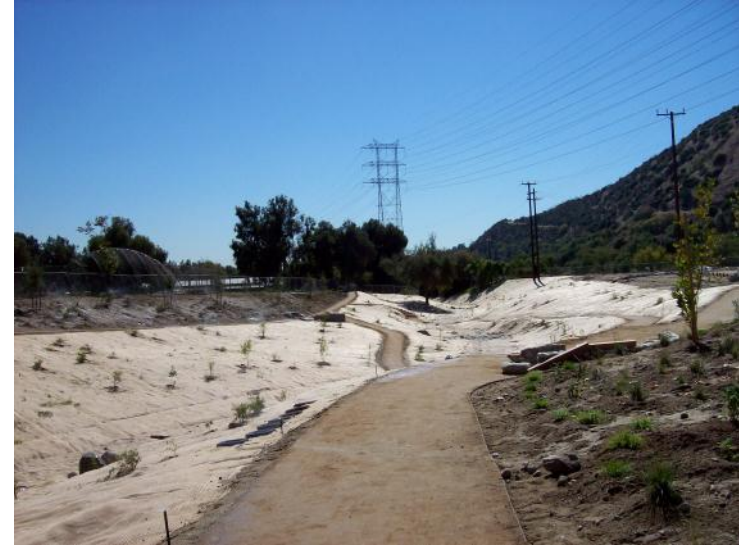
Atwater Park during construction
