Submerged Aquatic Vegetation Restoration in Florida Spring Systems

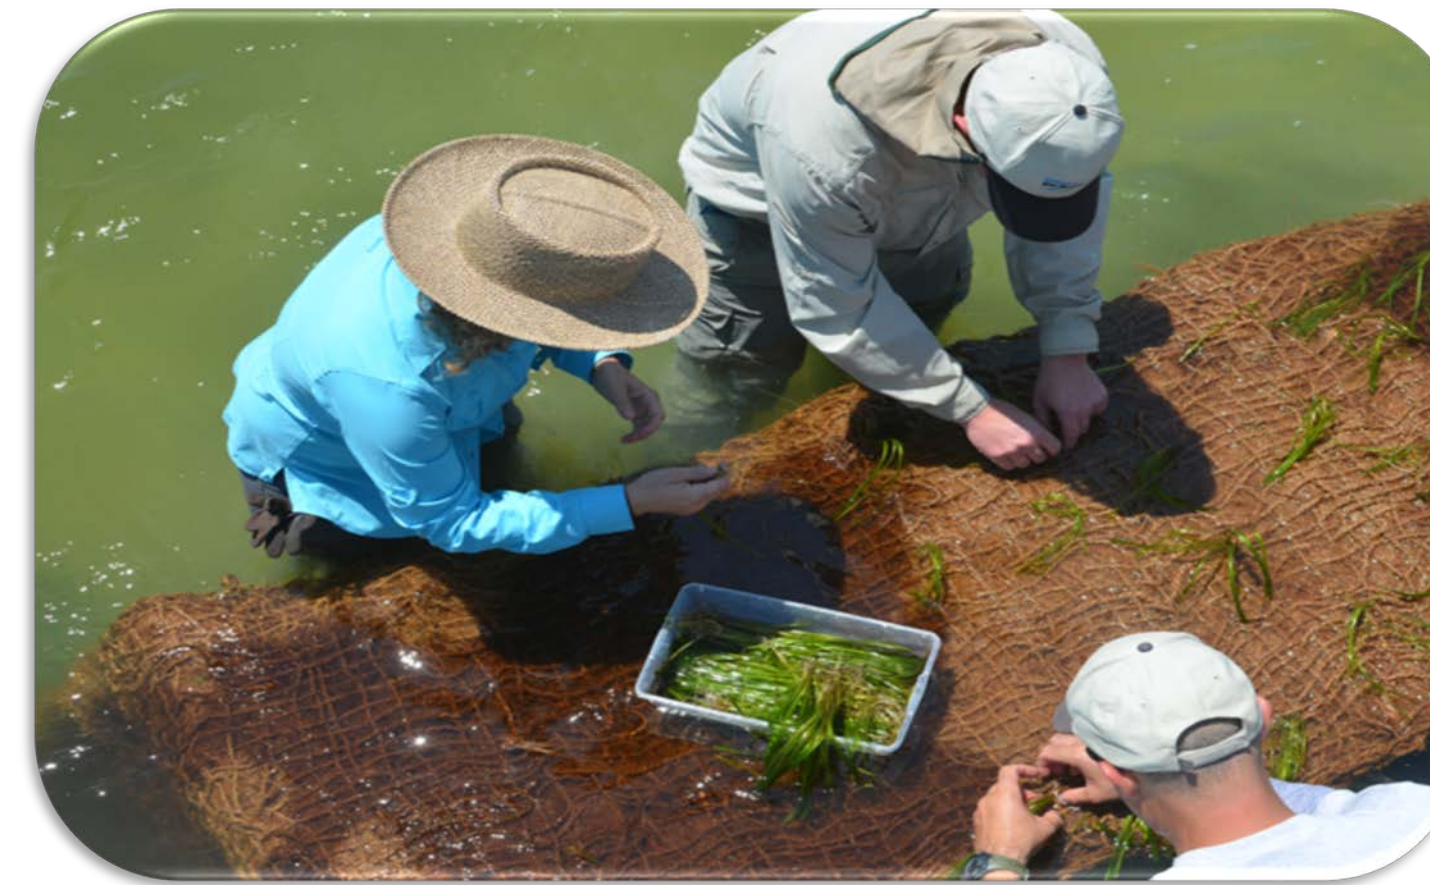
Eelgrass sod mats consisted of coconut coir fiber mats (15' x 3') planted on six inch centers with the 'Rockstar' variety of eelgrass (*Vallisneria americana*).

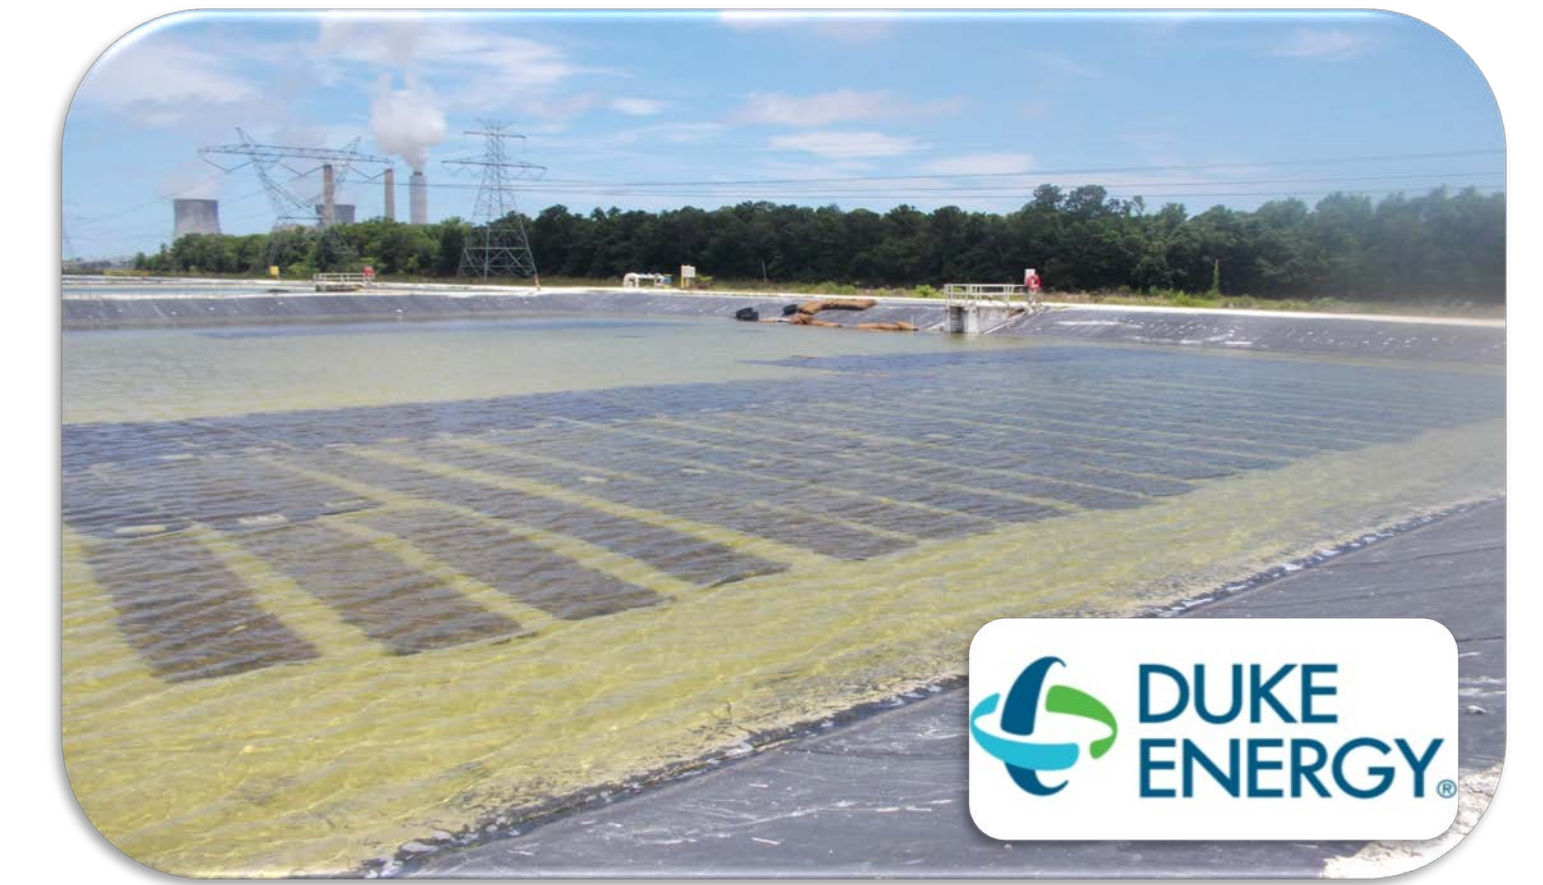
Several hundred eelgrass sod mats were cultivated in a one acre pond at the Duke Energy Mariculture Center in Crystal River.

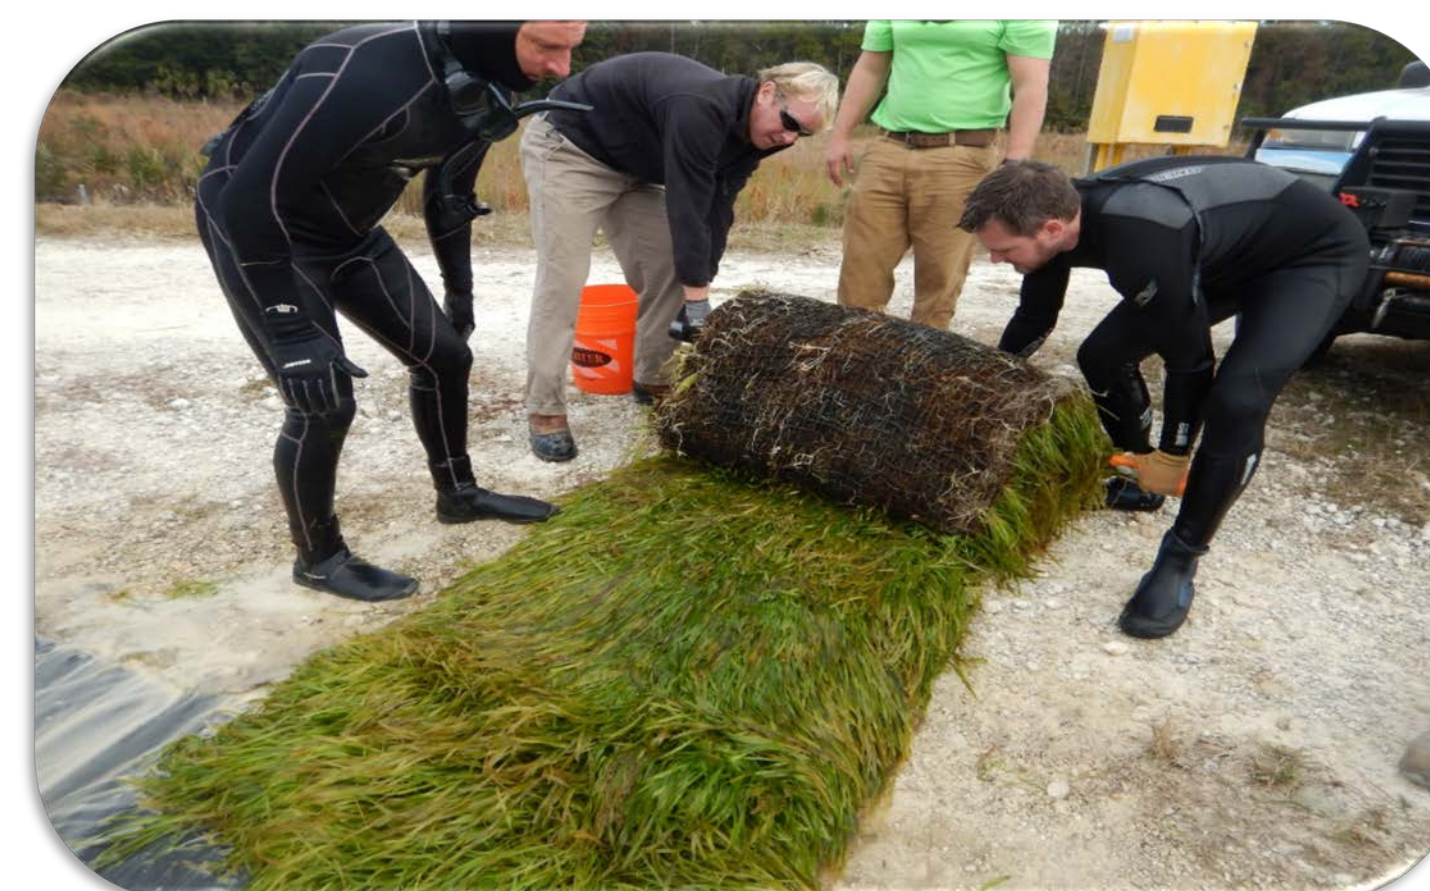
After four months the eelgrass sod mats were fully developed and were rolled up for transportation to the restoration site.

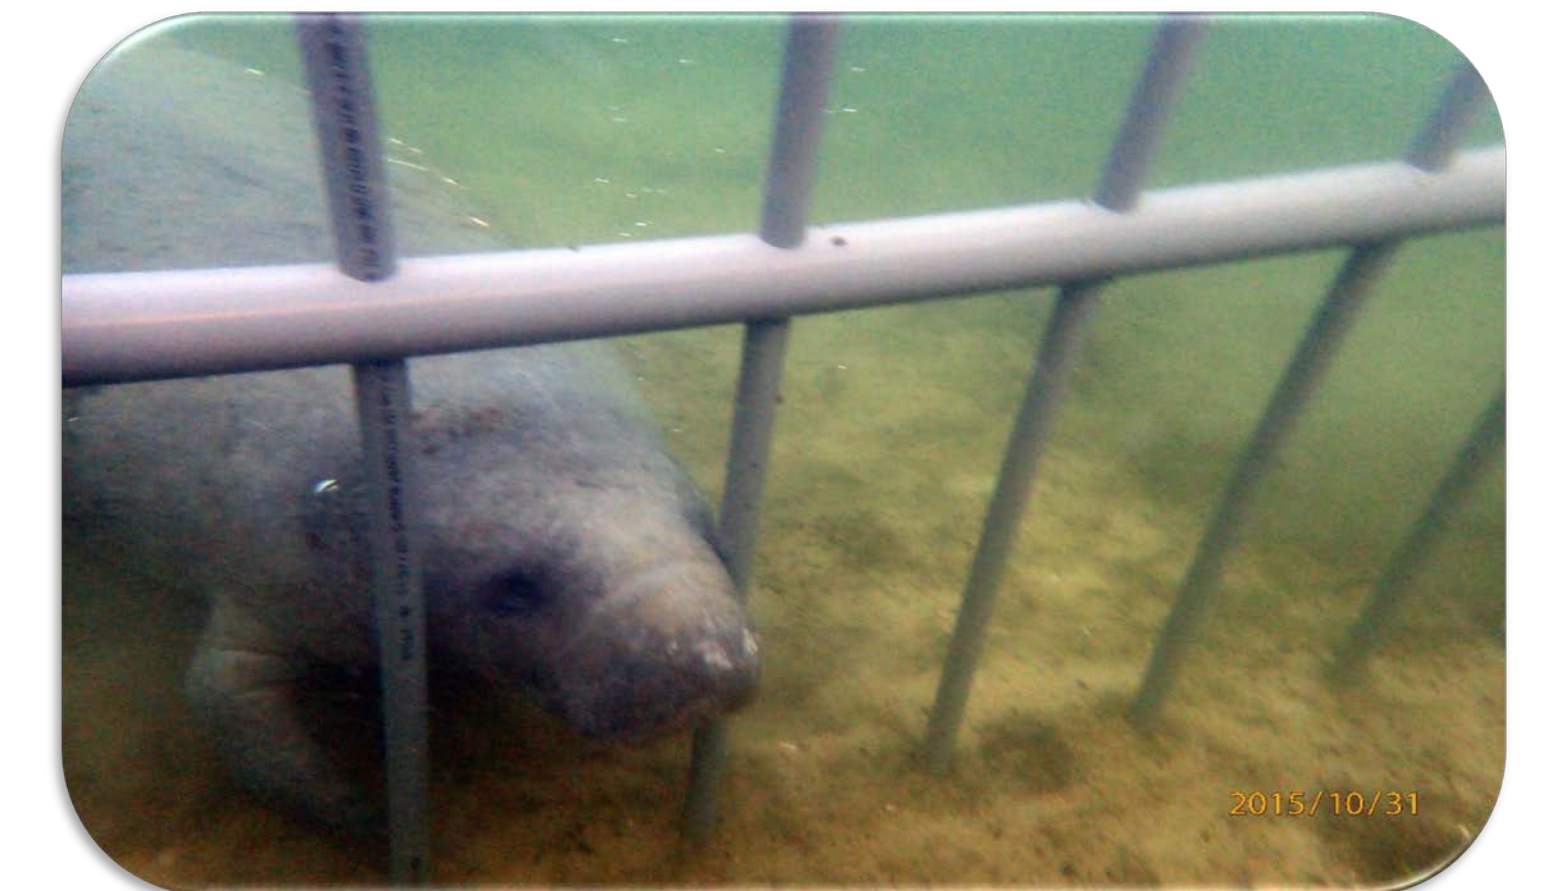
Herbivory exclusion barriers were specially designed to allow for maximum water circulation and wildlife usage while preventing manatee grazing.

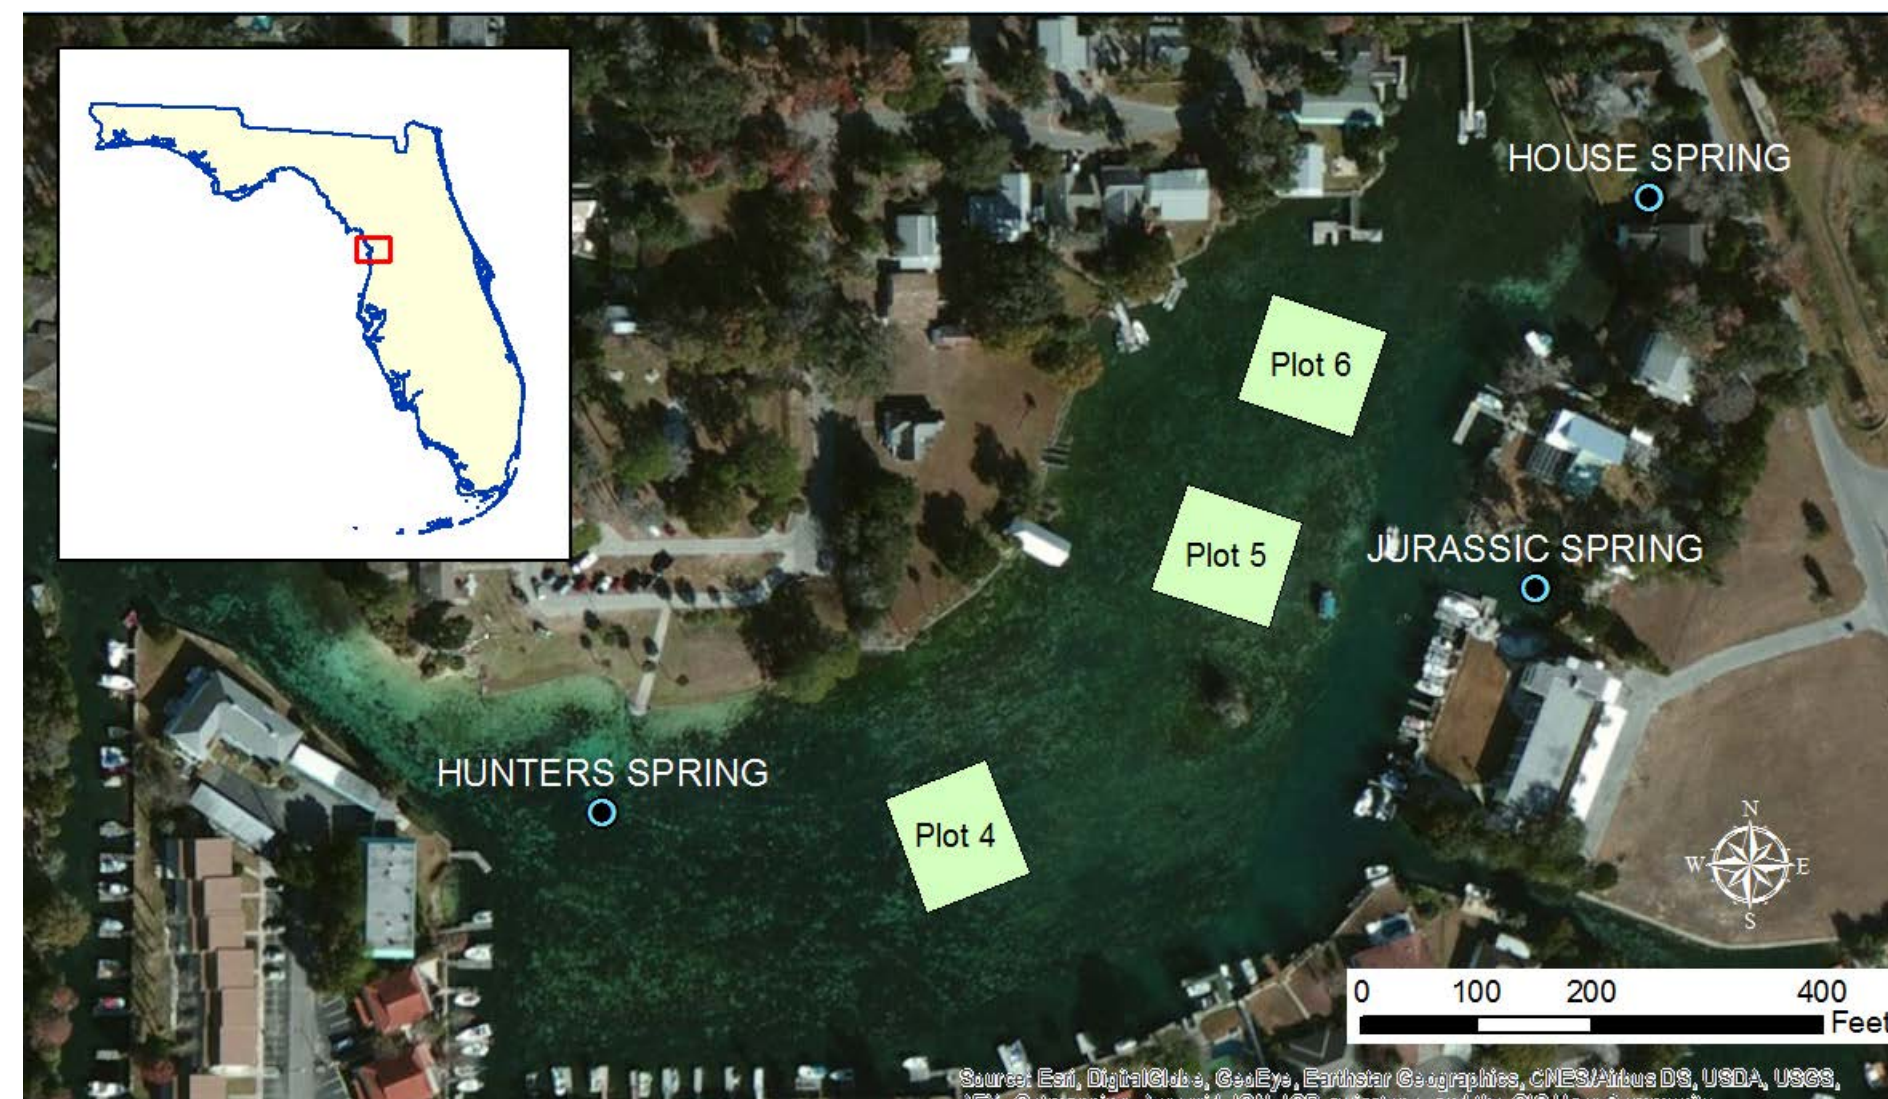
Herbivory exclusion barriers and eelgrass sod mats were installed at three quarter-acre plots in the Hunters Cove area within the Crystal River/Kings Bay spring system in the Fall of 2015. The long-term goal is to rotate the restoration plots until the entire six acre area is planted with eelgrass.

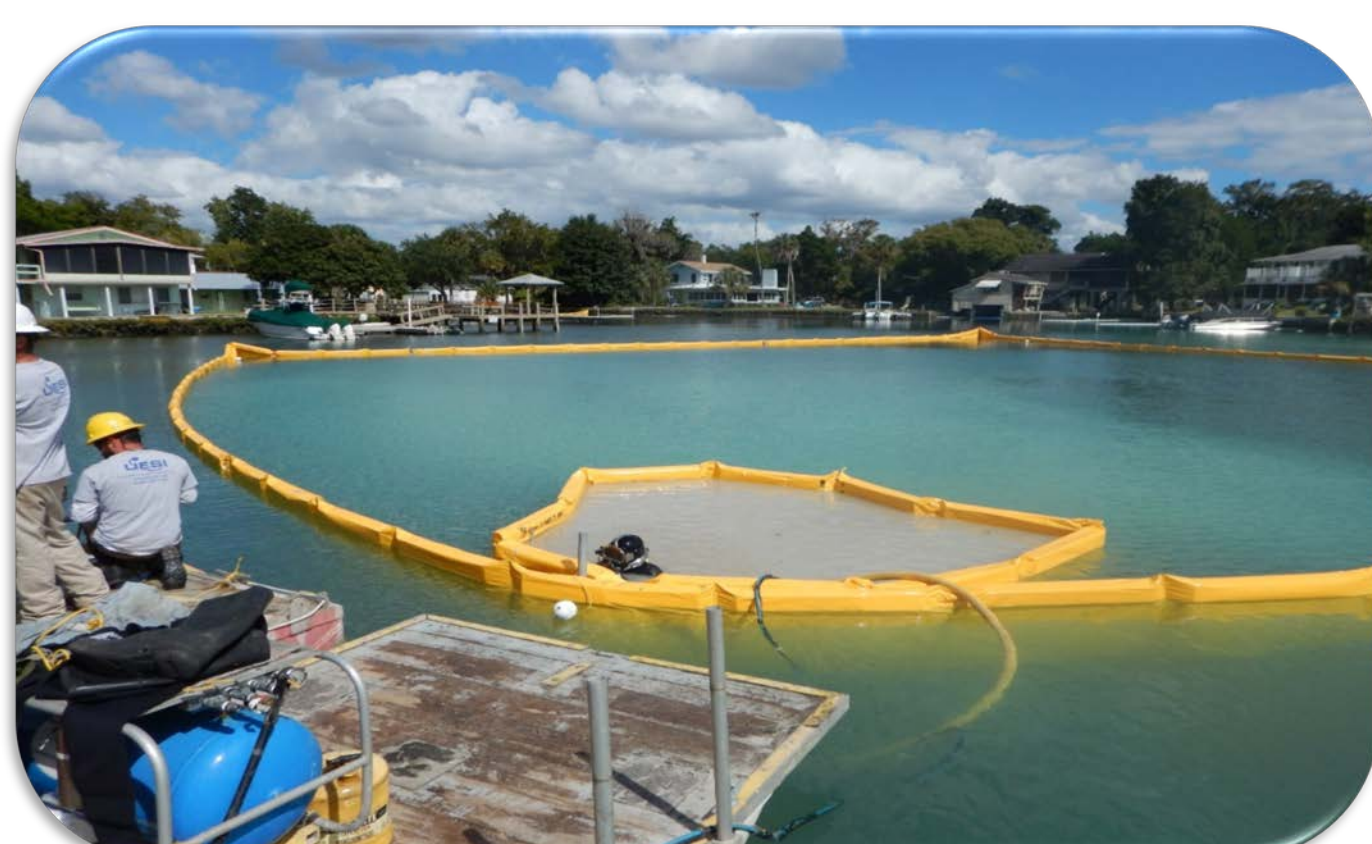
Underwater Engineering Services, Inc. (UESI) was hired to install the herbivory exclusion barriers using a team of SCUBA divers.

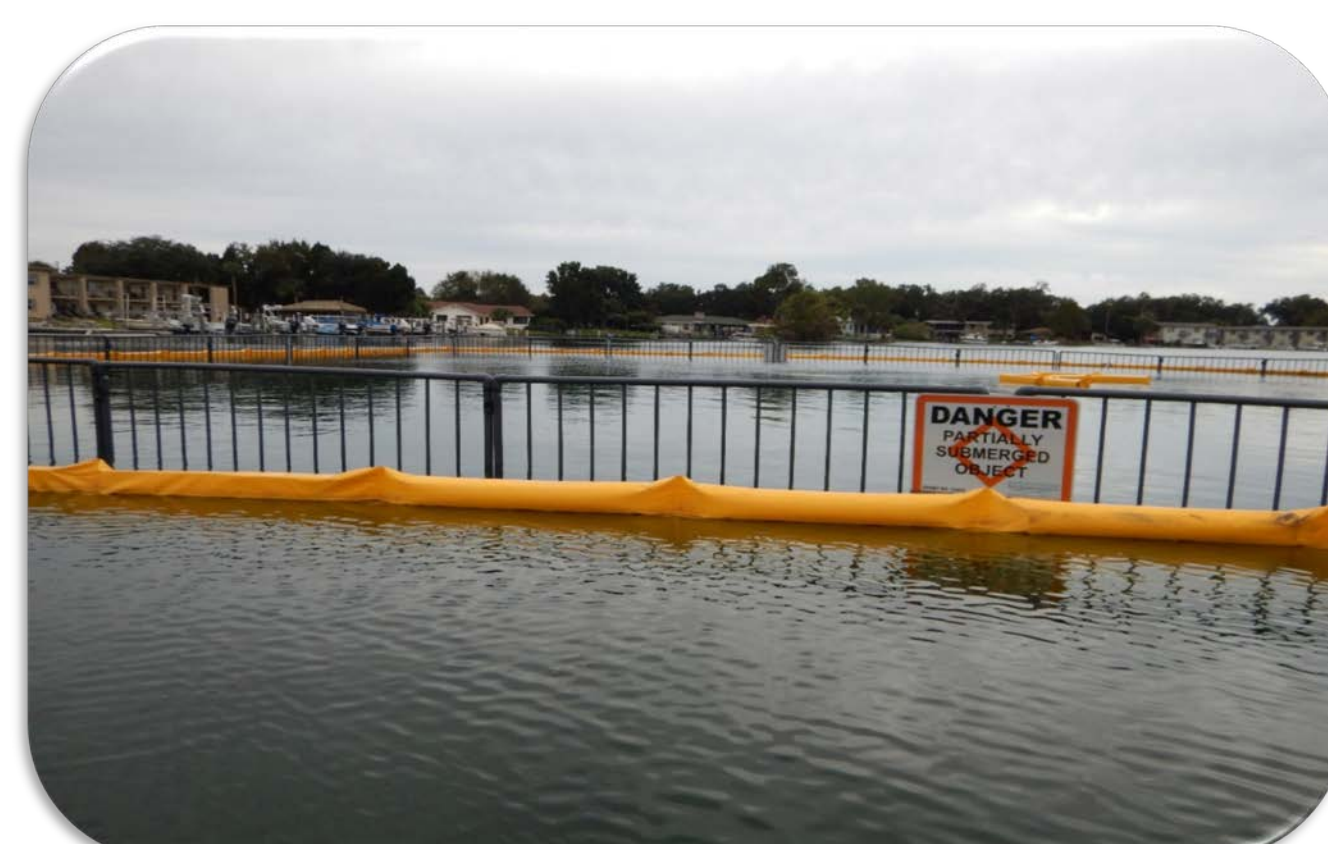
The PVC exclusion barriers were designed to conform to the bottom topography and extend >2' above mean high water to prevent manatees from accessing the restoration plots.

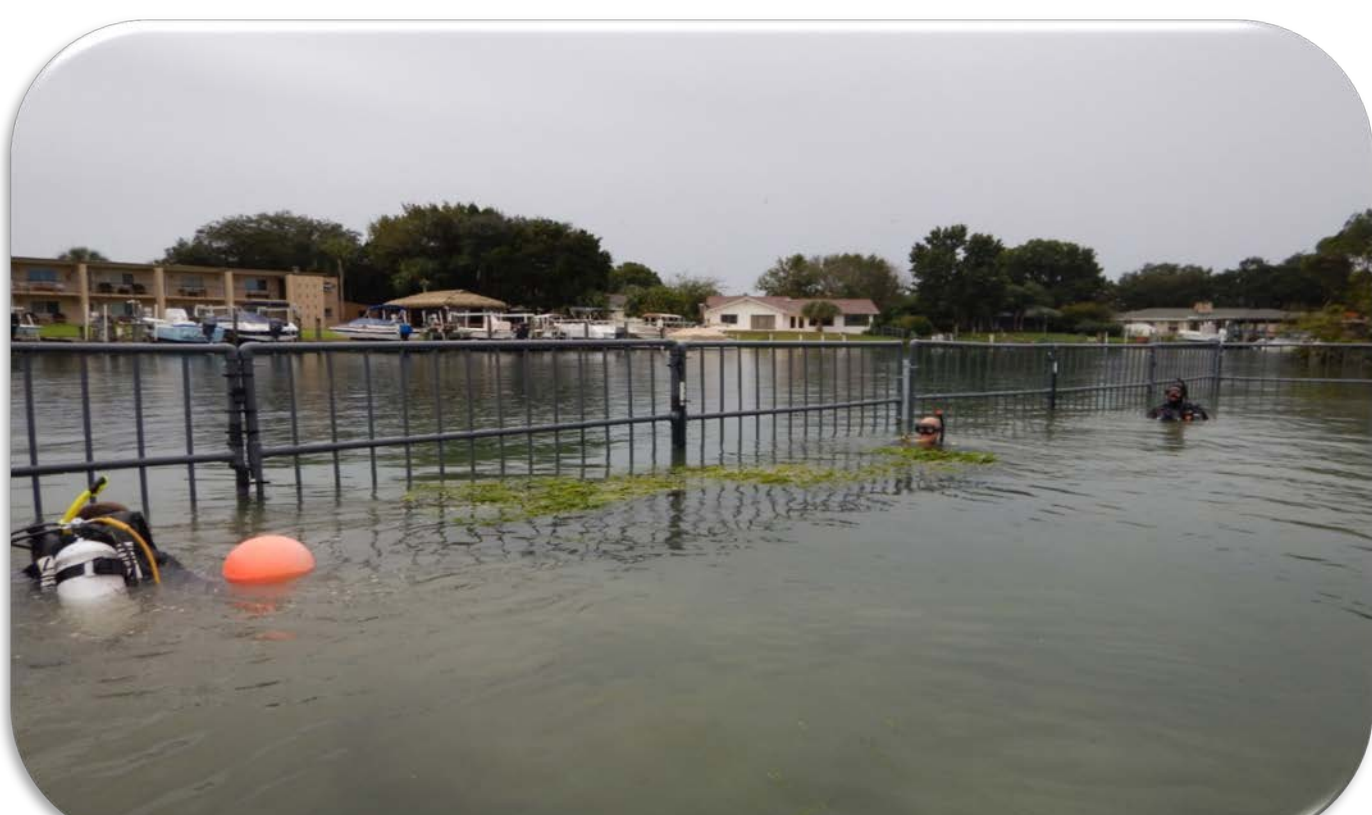
Eelgrass sod mats were installed within a quarter of each plot directly onto the existing substrate in rows with approximately 3' spacing between mats. In April 2016, additional mats and peat pots were installed in each plot.

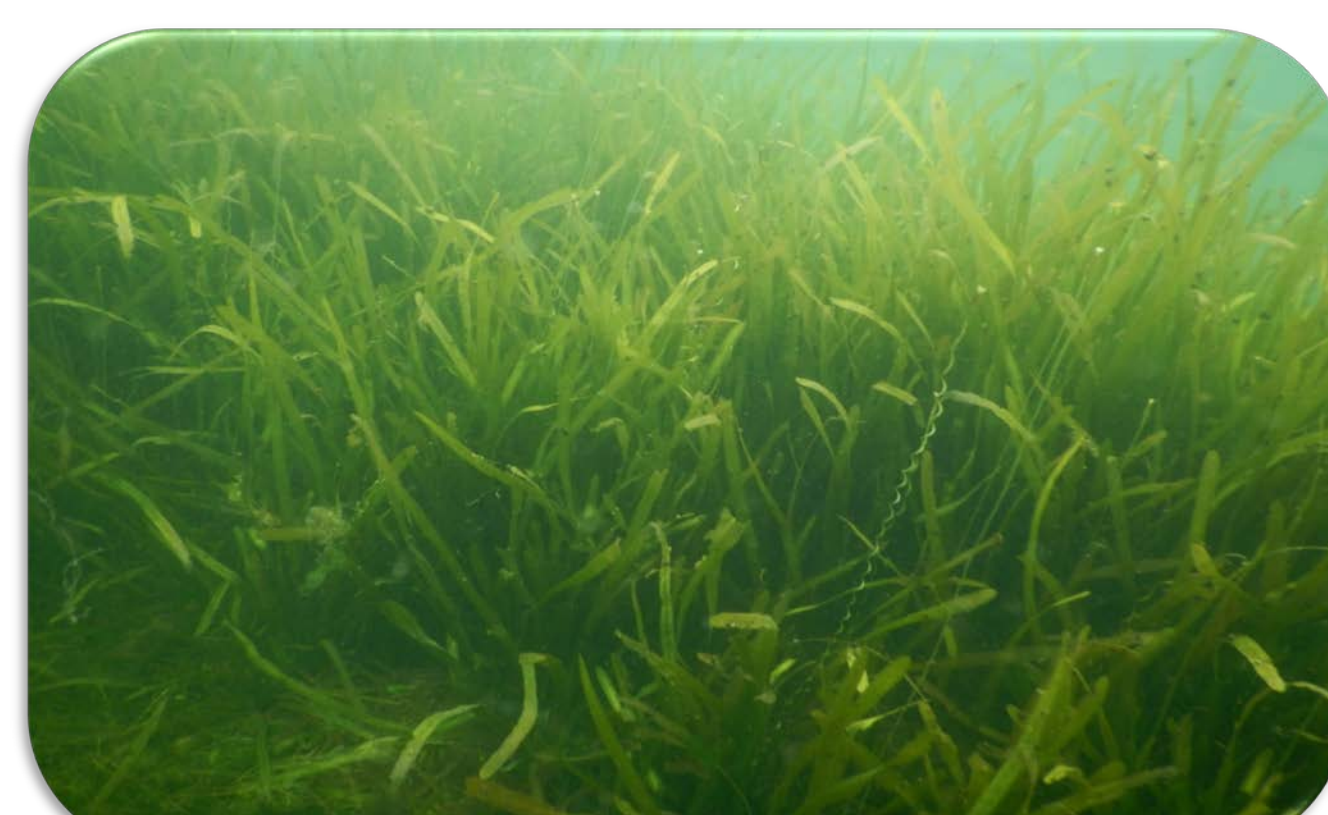
The eelgrass sod mats immediately created fish and wildlife habitat within a spring system dominated by filamentous algae.

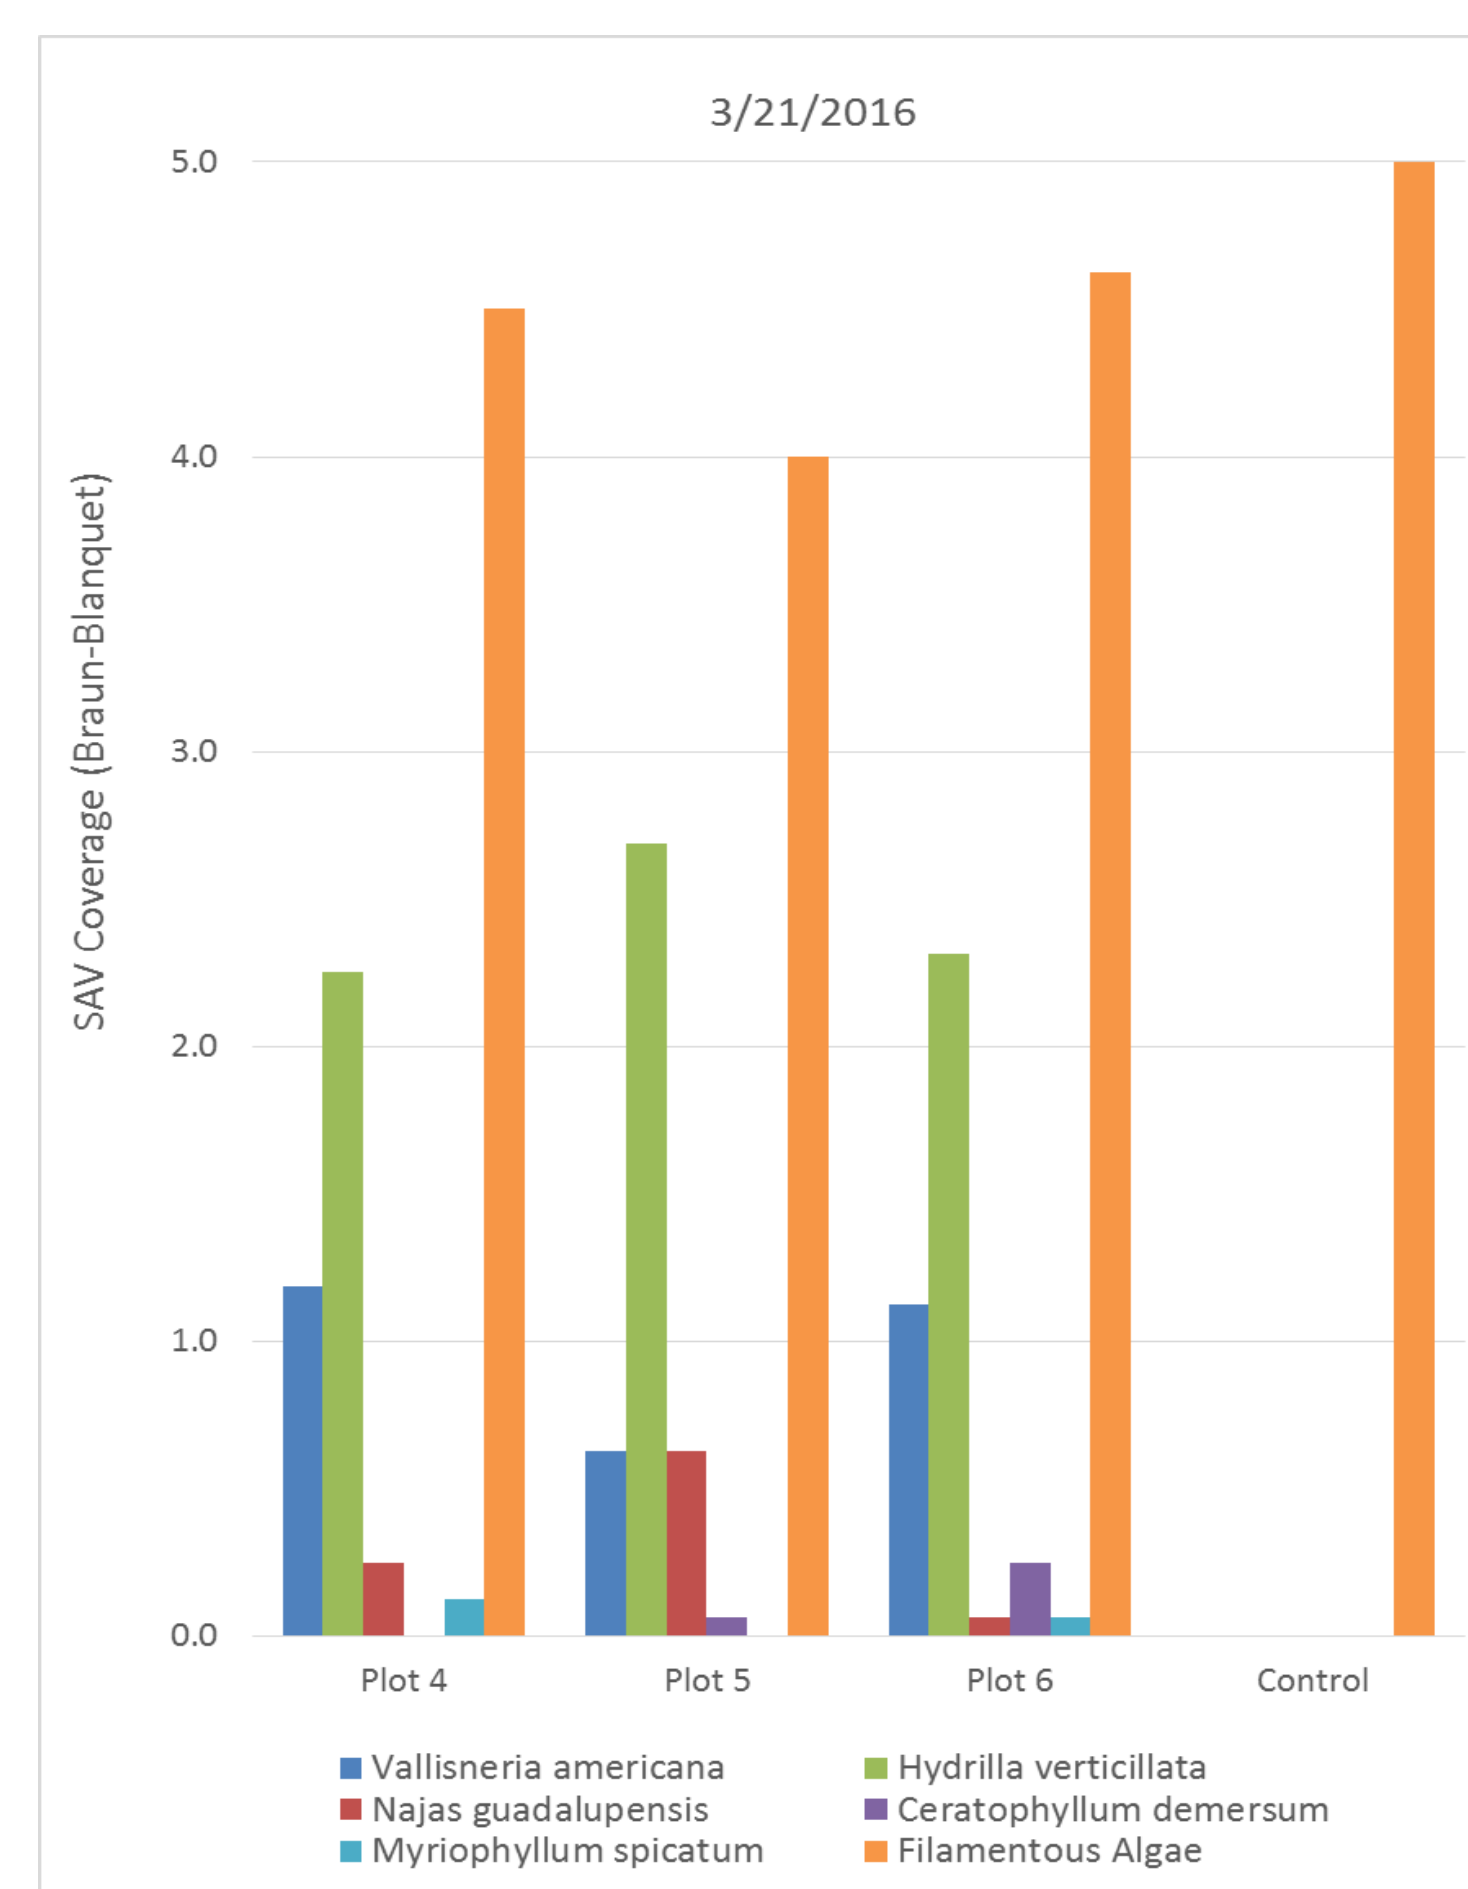
Four months later, eelgrass (*Vallisneria americana*) continues to expand where planted; however hydrilla and filamentous algae are abundant in the unplanted areas. Additional eelgrass installation and maintenance are expected to increase native SAV abundance.

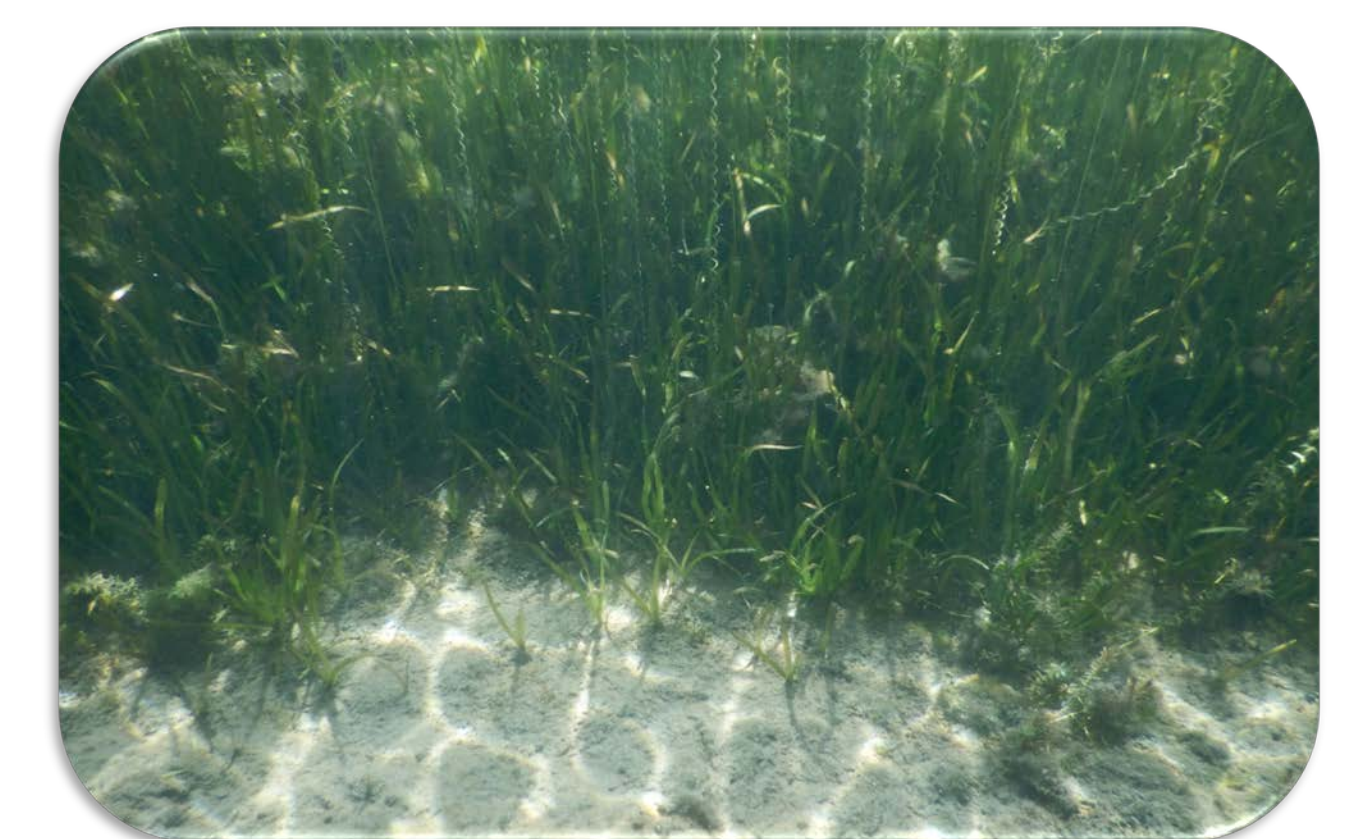
The eelgrass sod mats have expanded by over 2' on each side and are beginning to coalesce into larger eelgrass beds.

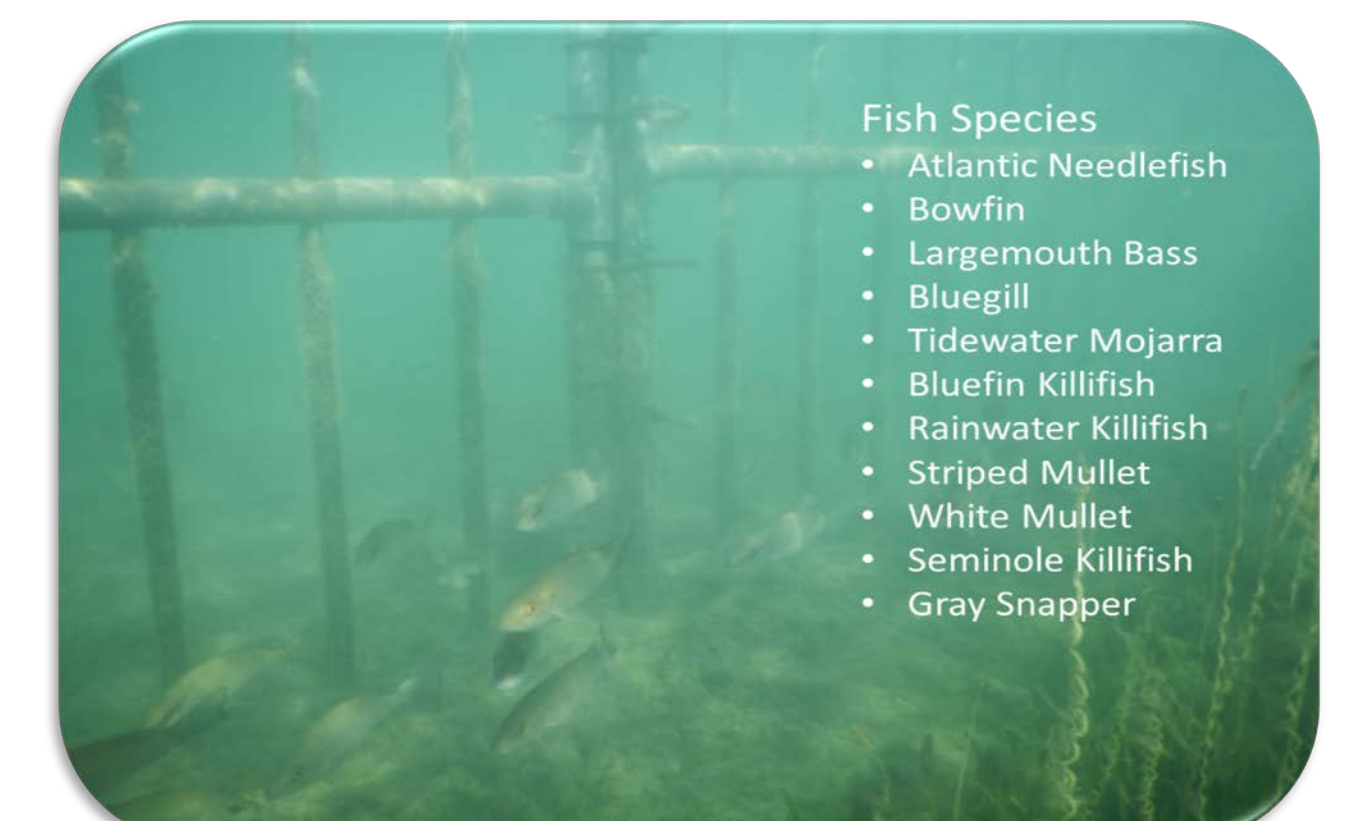
Fish Species

- Atlantic Needlefish
- Bowfin
- Largemouth Bass
- Bluegill
- Tidewater Mojarra
- Bluefin Killifish
- Rainwater Killifish
- Striped Mullet
- White Mullet
- Seminole Killifish
- Gray Snapper

FFWCC and SWFWMD staff sampled the fish community within the restoration plots and found 11 species, compared to only 2 species in the control area.
