Effectiveness of a Channel Habitat Reconnection in Tidal Freshwater of the Columbia River: Sandy River Delta

GARY E. JOHNSON AND NICHOLE K. SATHER

Pacific Northwest National Laboratory, Coastal Ecosystems Research Team

National Conference on Ecosystem Restoration, Coral Springs, Florida, April 2016

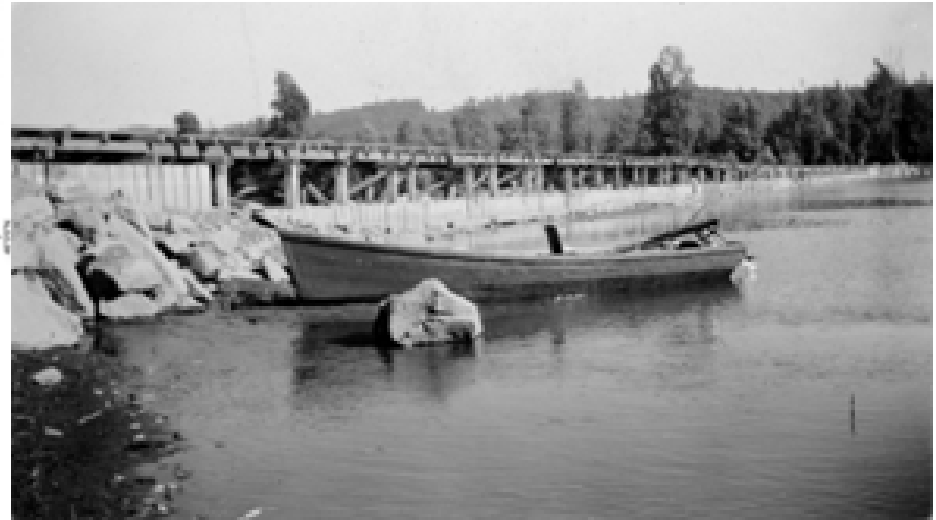
At the Sandy River delta, a dam was installed in the 1930s to concentrate flows of two main distributaries into one to enhance smelt and salmon migrations upstream into the Sandy River.

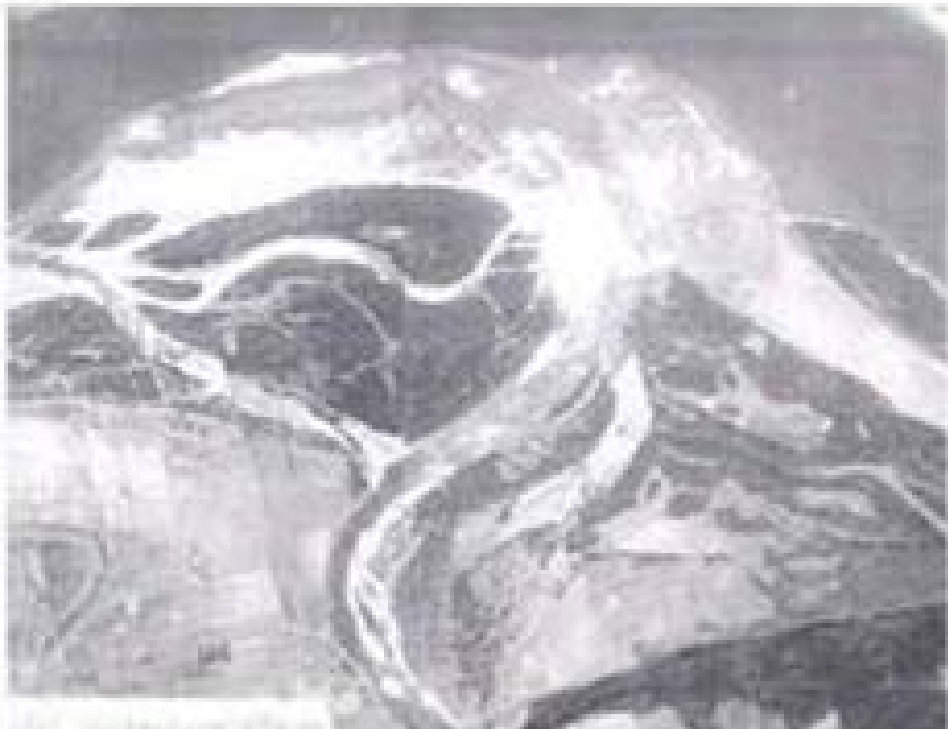
Aerial View -- Pre-Restoration

The dam altered the flow regime and reduced the quantity and quality of rearing habitat for juvenile salmon migrating down the Columbia and Sandy rivers to the ocean.

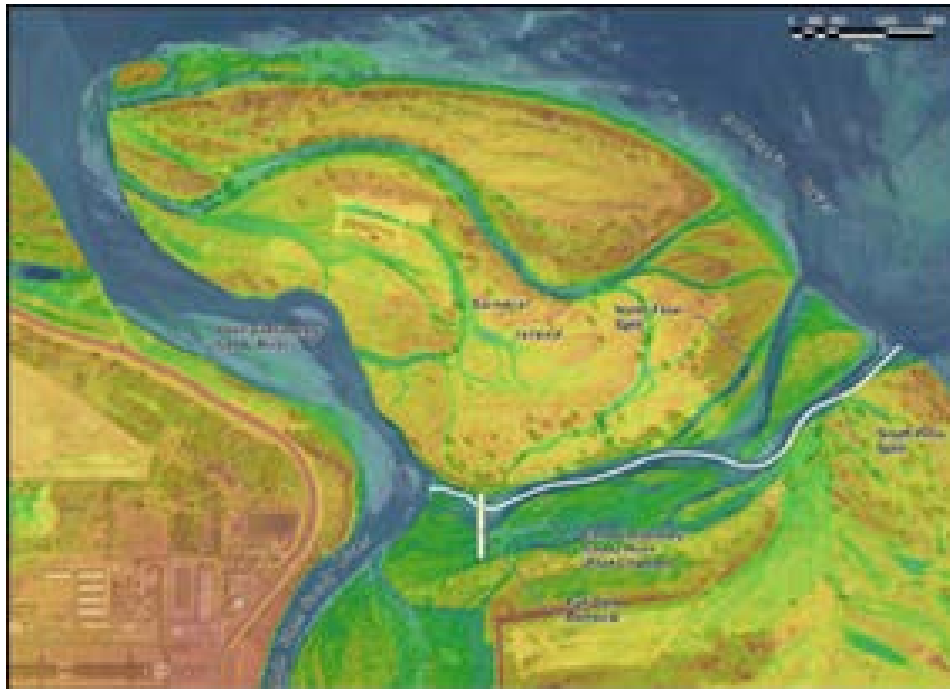
The restoration action involved removing the dam to return the river to its natural channel form, processes, and connection to the Columbia River.

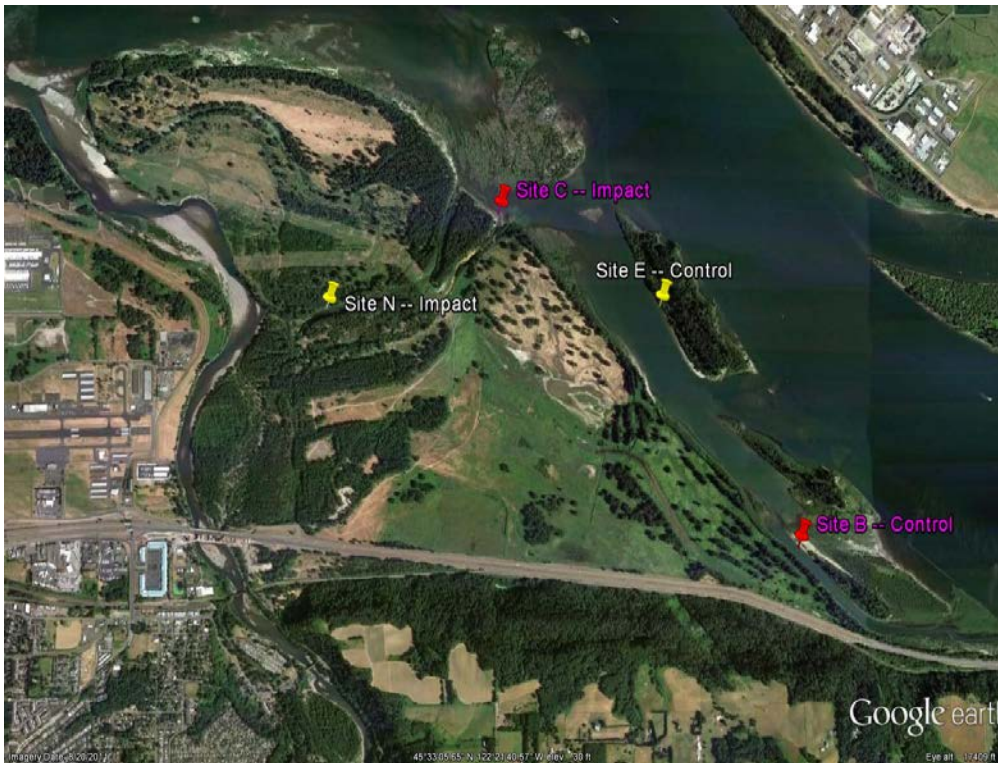
We implemented a before-after-control-impact design with two pairs of control/impact sampling sites.

This presentation includes data from **Sites C and N.**

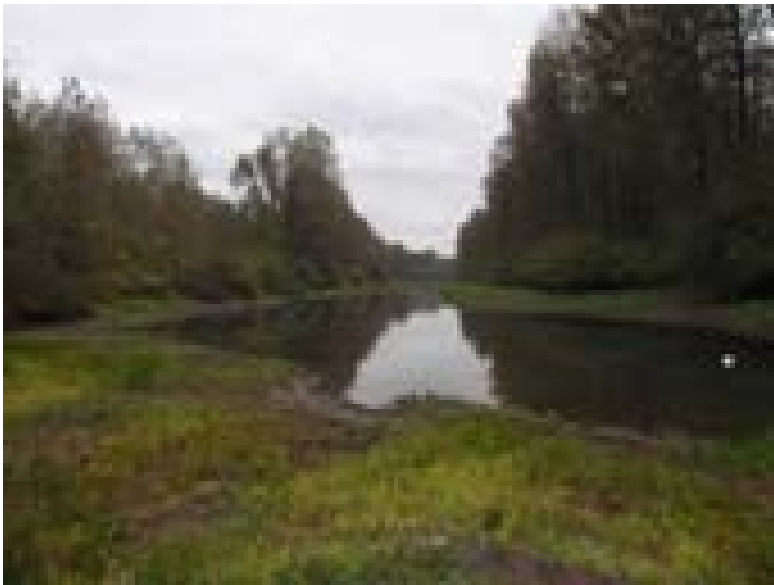
Pre-construction, Oct 2012

The rechannelization produced dramatic physical changes to the historical river channel at the confluence with the Columbia River, changing from backwater to riverine habitat.

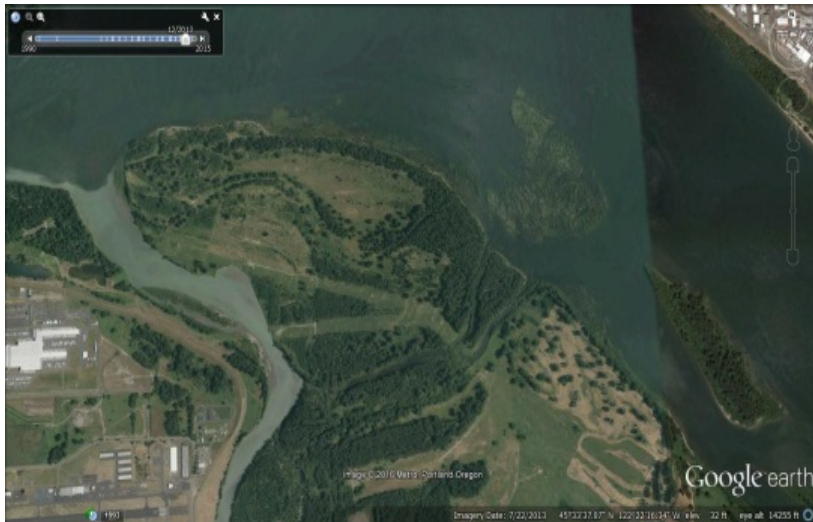
Pre-restoration July 2013

Physical changes caused by the dam removal are evident in satellite photos.

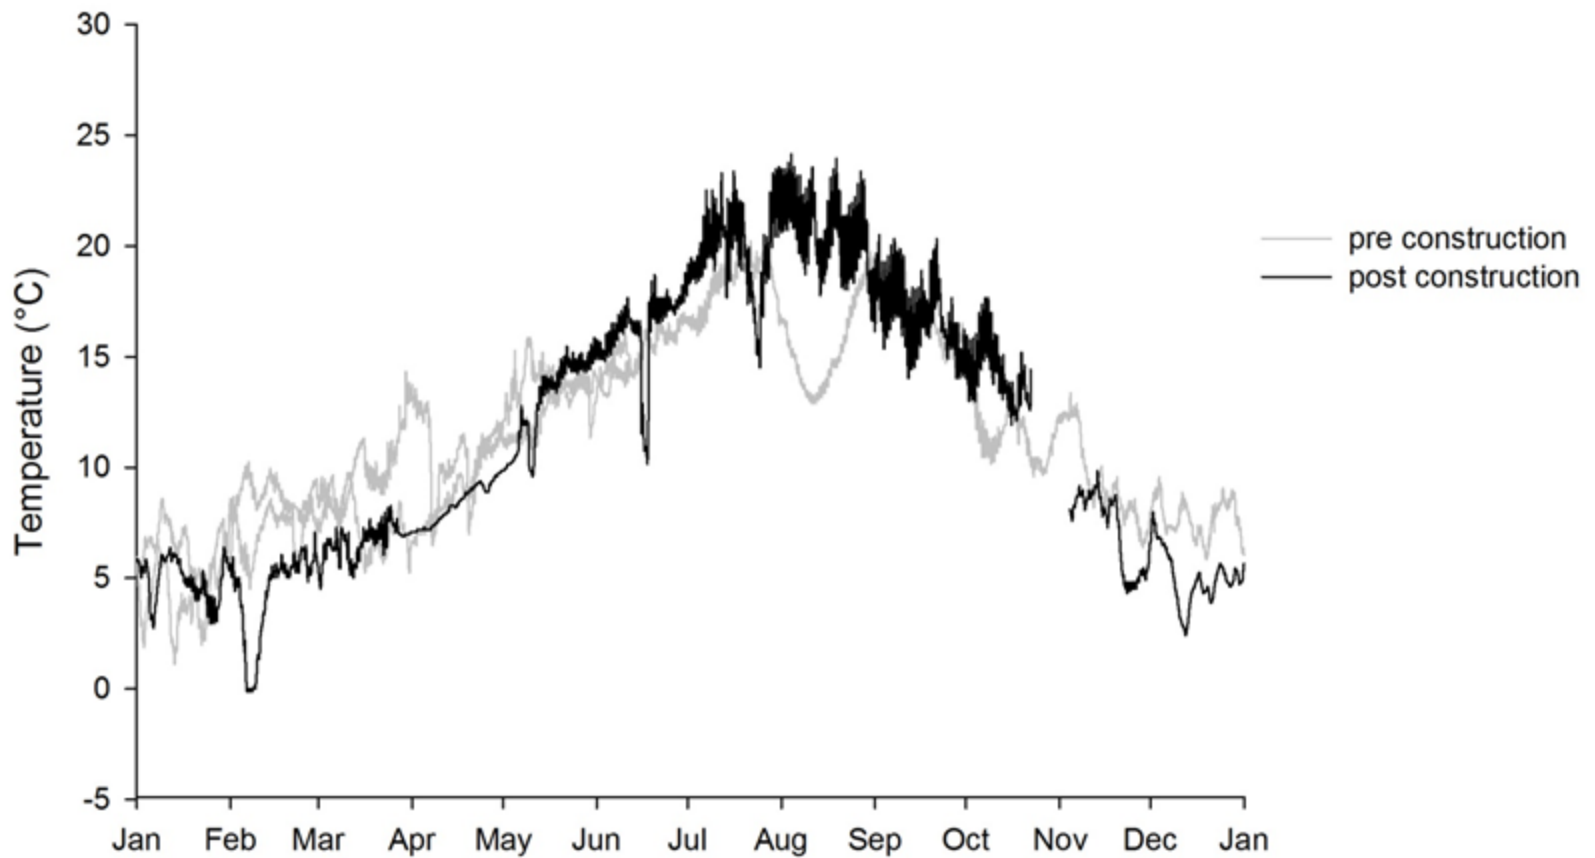
Site N Temperature

Water Temperature
