RIVERBANK STABILIZATION ON THE CONNECTICUT RIVER: LESSONS LEARNED FROM 25 YEARS OF RESTORATION

MICKEY MARCUS, TONY SOMERS AND CHRISTIN MCDONOUGH
SWCA ENVIRONMENTAL CONSULTANTS, AMHERST, MA, USA

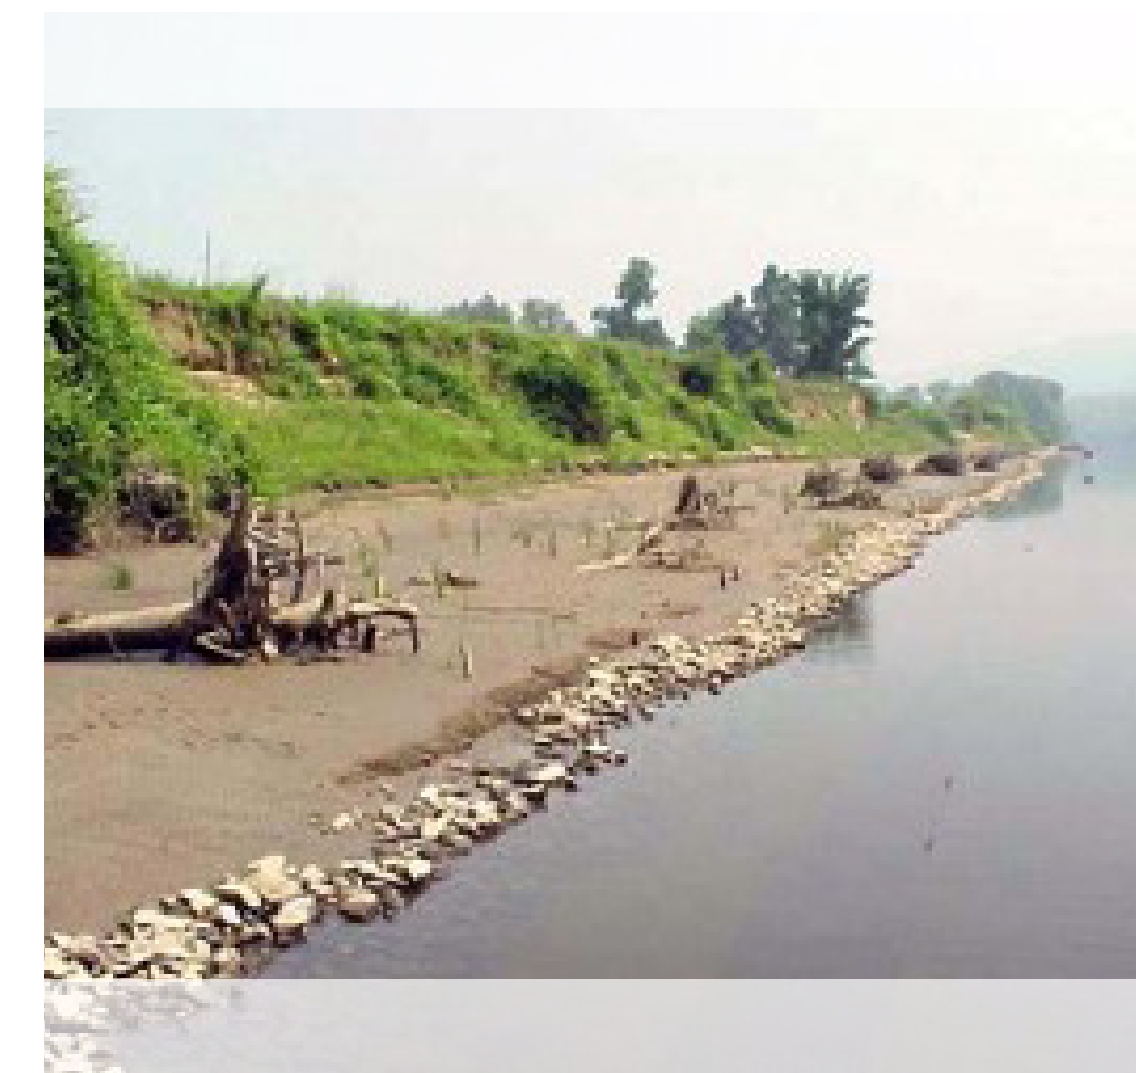
Building a new shoreline using stone, logs and plants - 1999

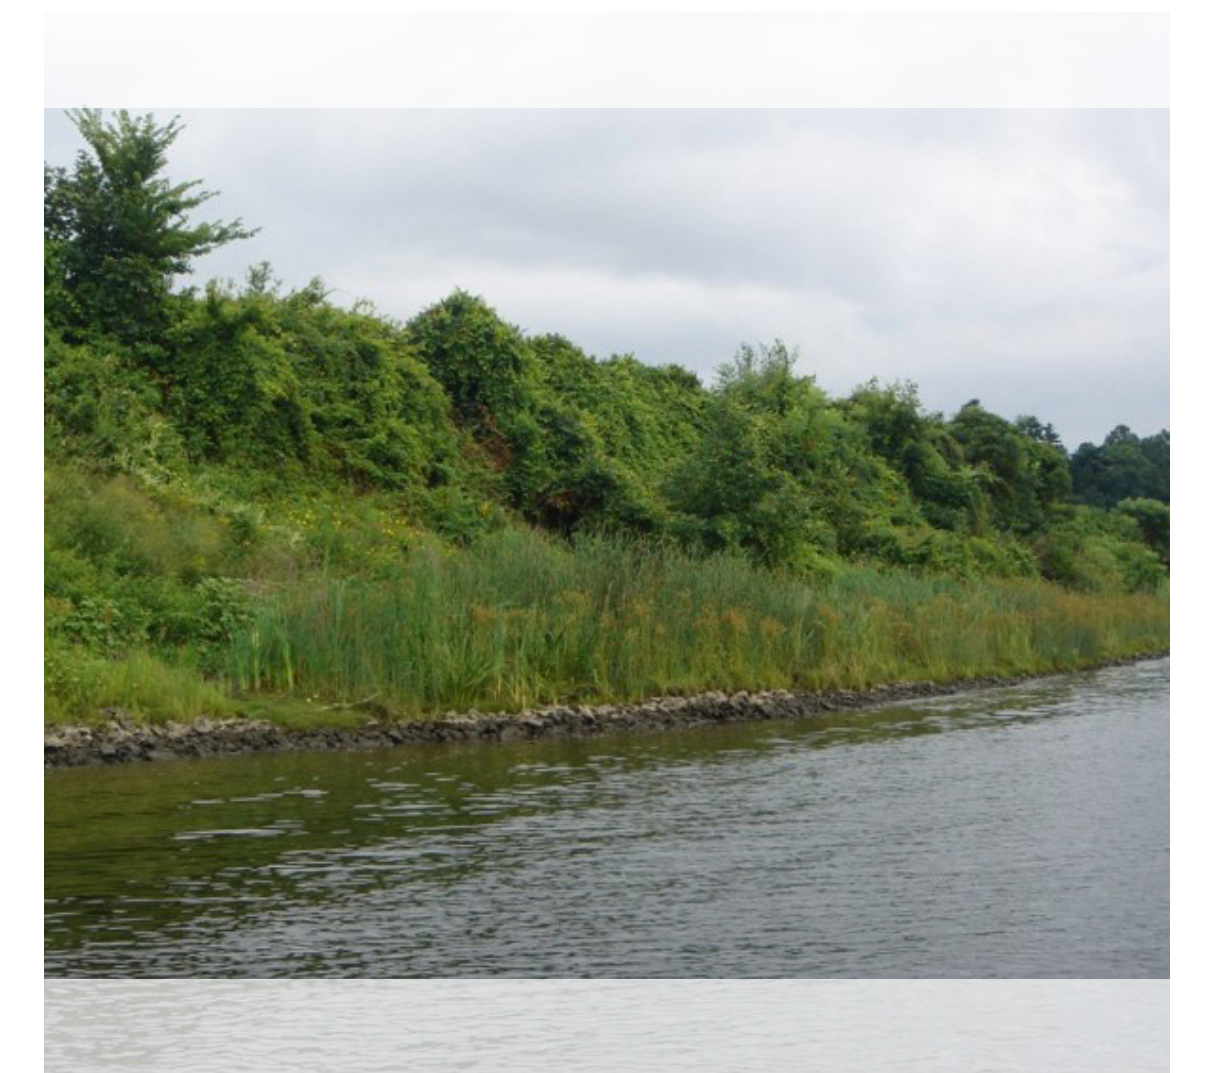
New shoreline - 2005 Post Construction

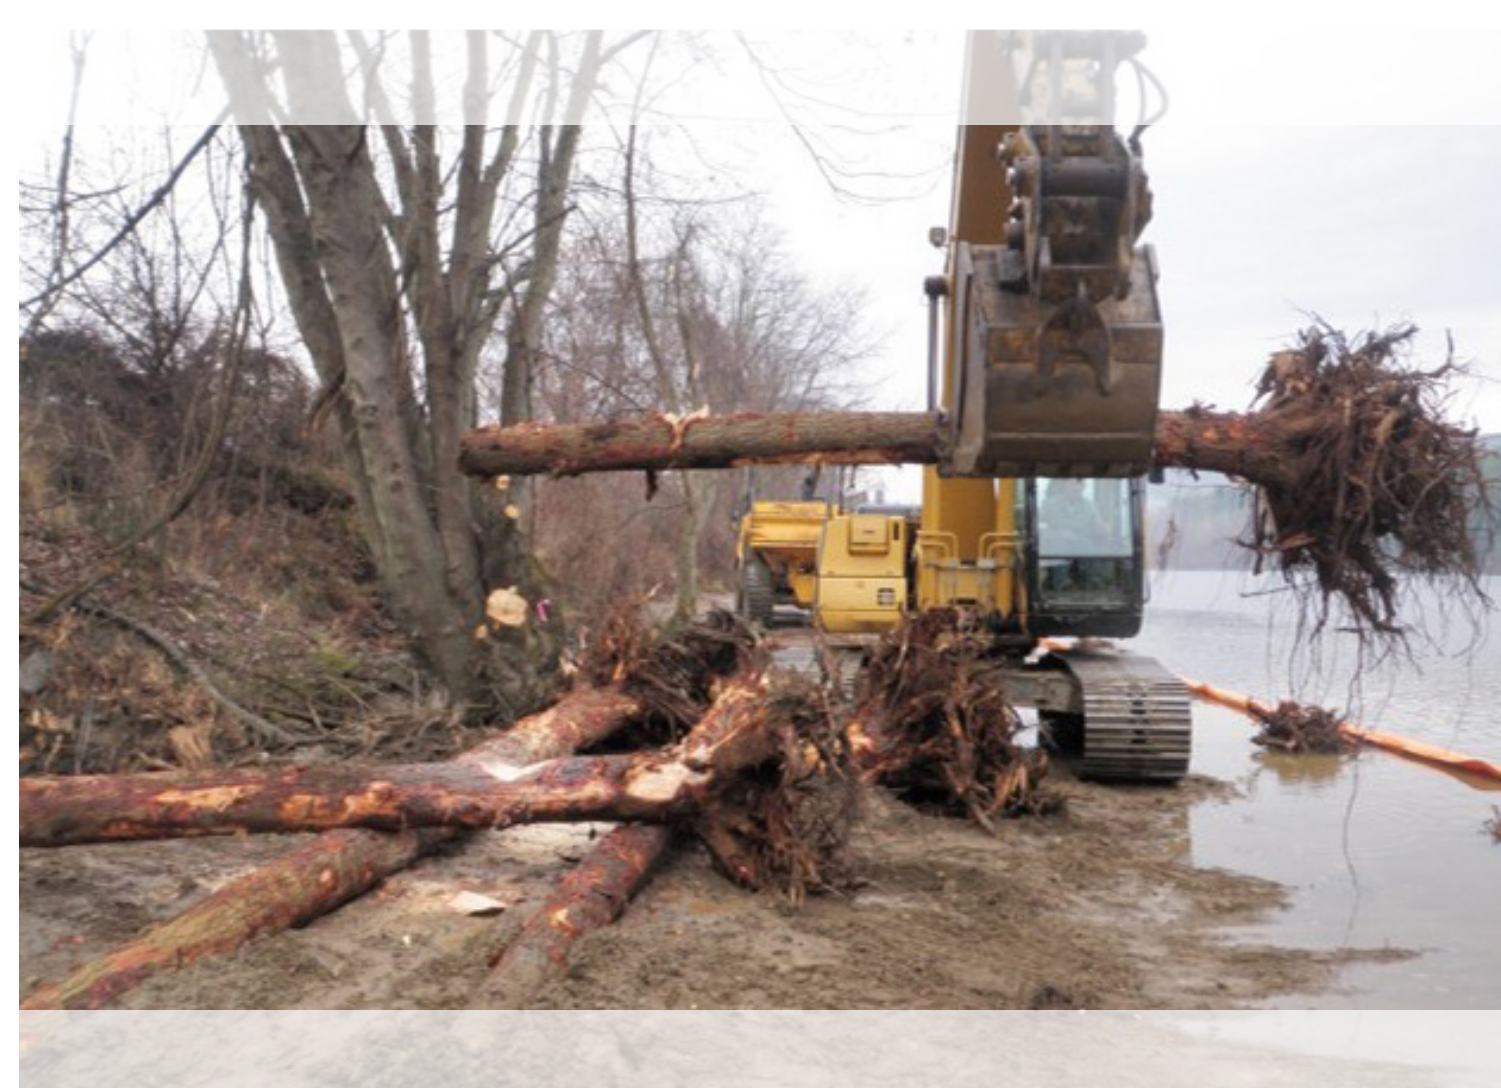
Building engineered logs

Engineered woody debris log jams were built at a spacing of approximately 120 feet (36.5 m) on center and secured into the banks to anchor the planned sediment accretion formations. Native willow shrubs and emergent and aquatic vegetation were planted between the log jams to help in the retention of sediment, and to provide wildlife and fisheries habitat. Staff gages, and scour chains were installed

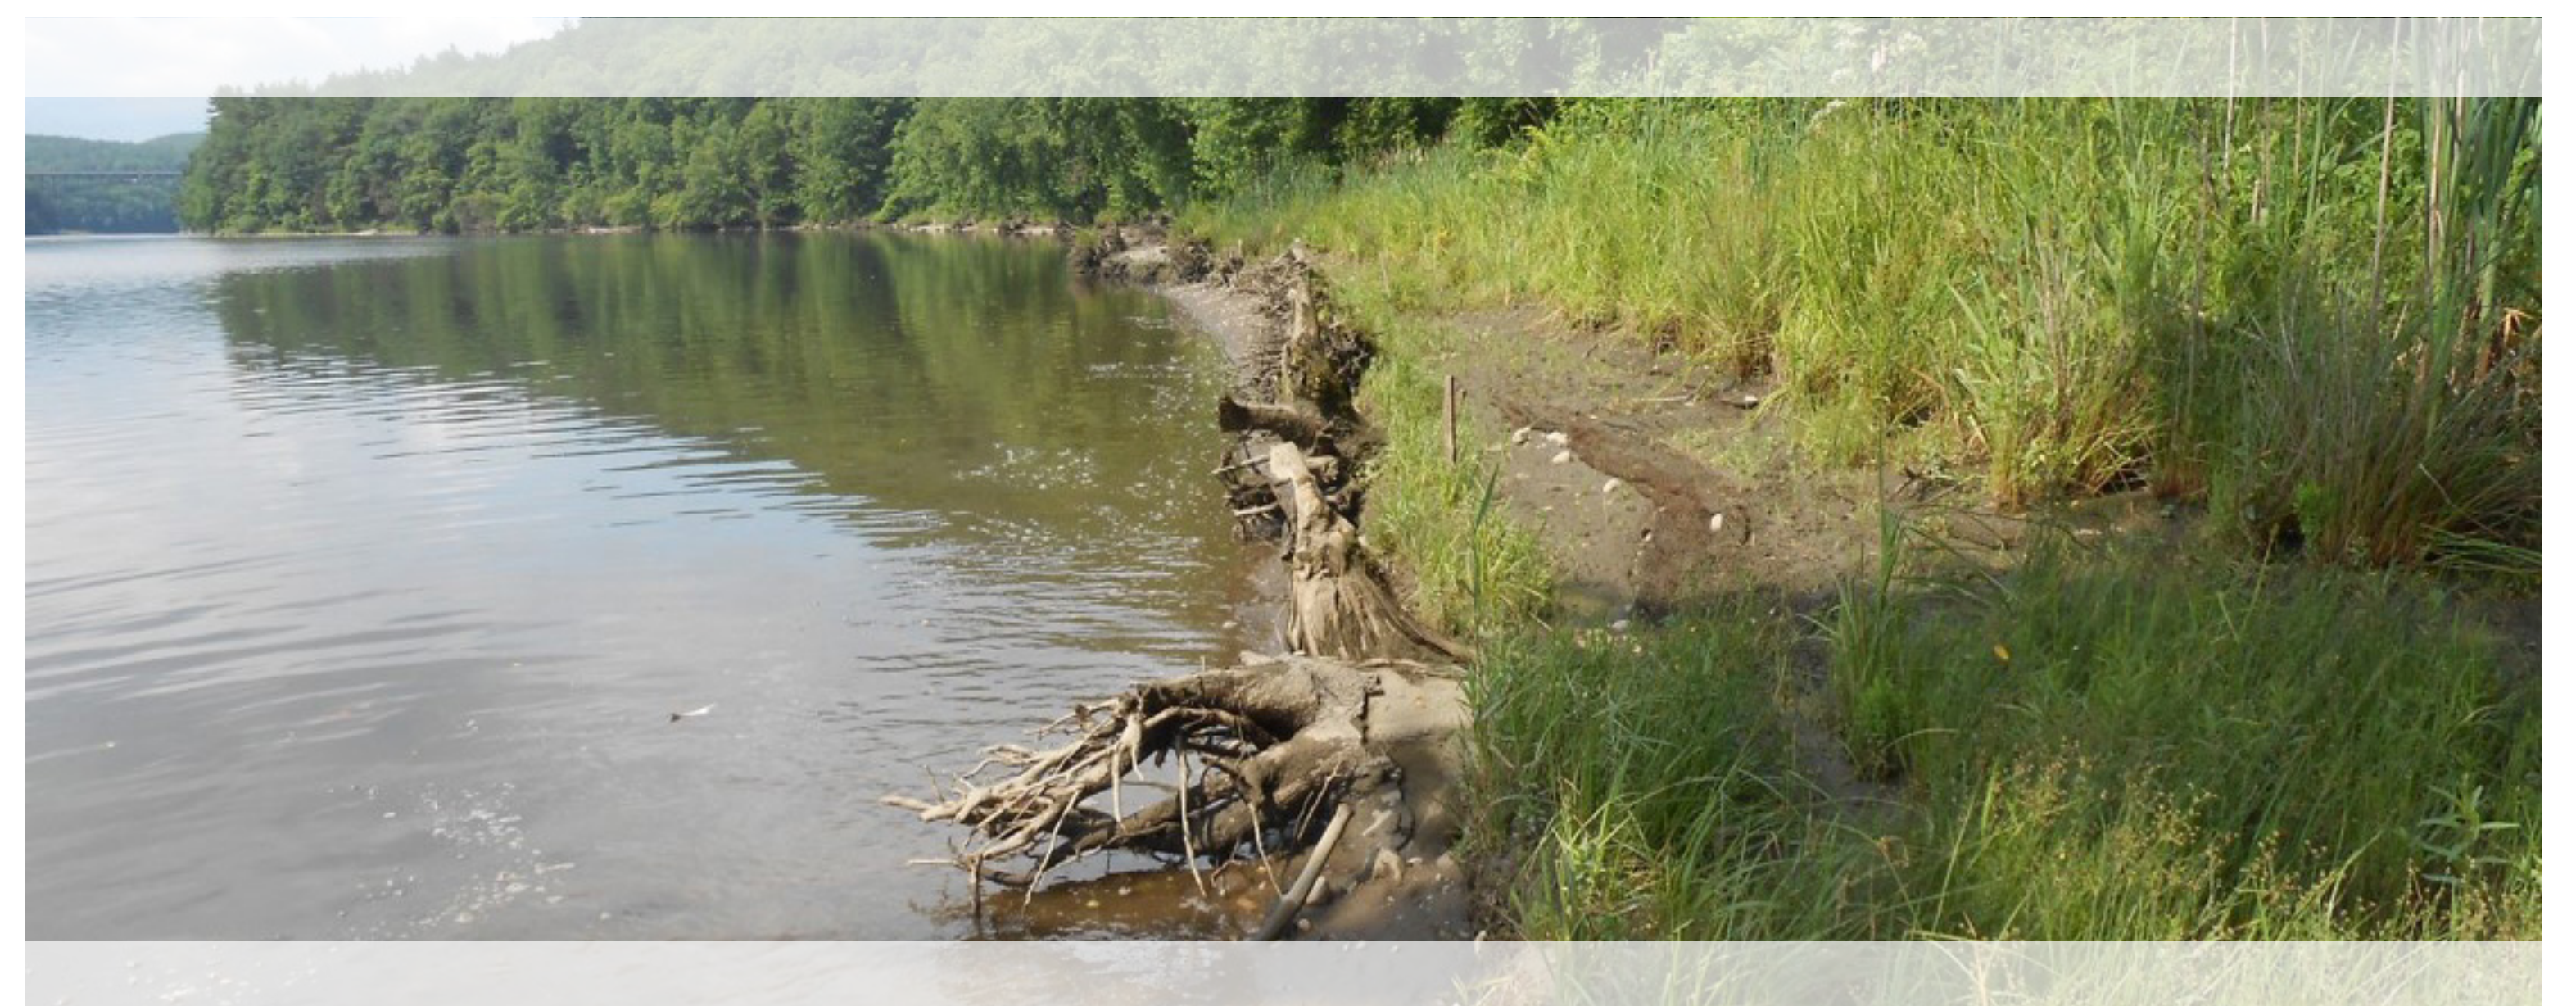
Site after four years

vertically along the project's aquatic bench to measure accretion or deposition. To measure bank erosion, bank pins consisting of metal welding rods were installed horizontally into the banks. During the first year of monitoring, the woody debris structures accumulated as much as 30 inches (76 cm) of new sediment by reducing water velocity along the shoreline during flood events. Tropical Storm Irene on August 28, 2011 was a bankfull event which exceeded 110,000 cfs (3,114,853 lps) and submerged the bank and woody structures for over two weeks. Following the storm significant sediment was deposited and retained by the wood structures; there was no measured horizontal bank erosion. The accumulated sediment has permitted emergent vegetation to become established, which further protects the adjacent river banks.

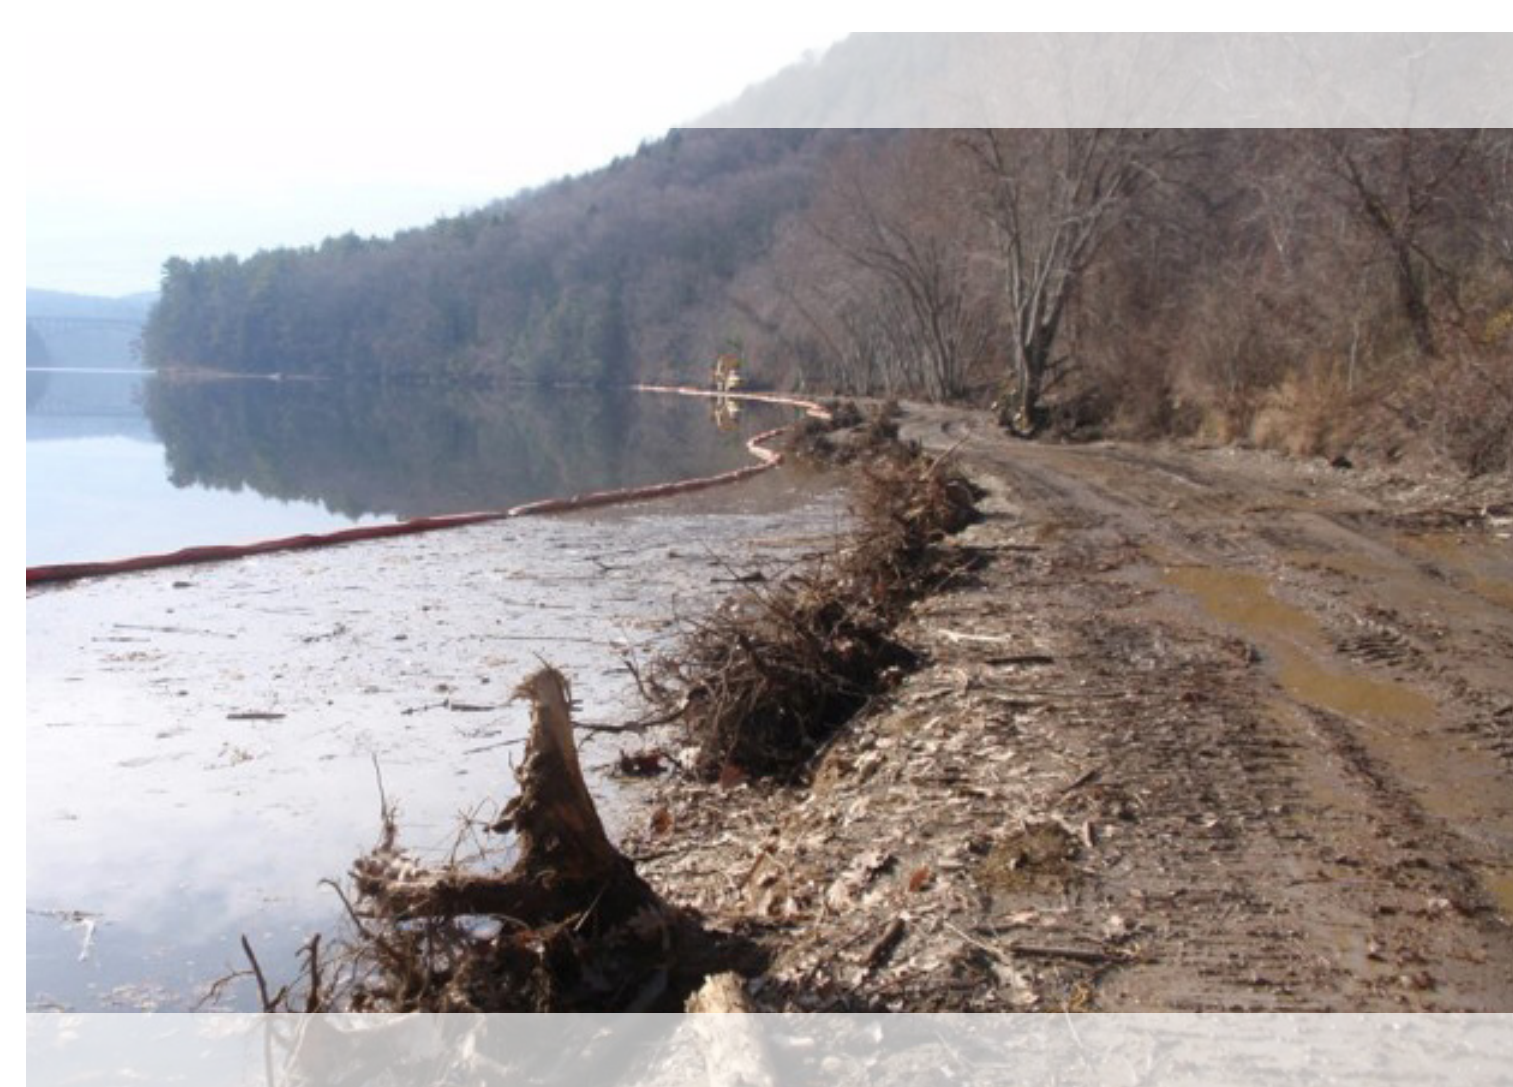
Log construction

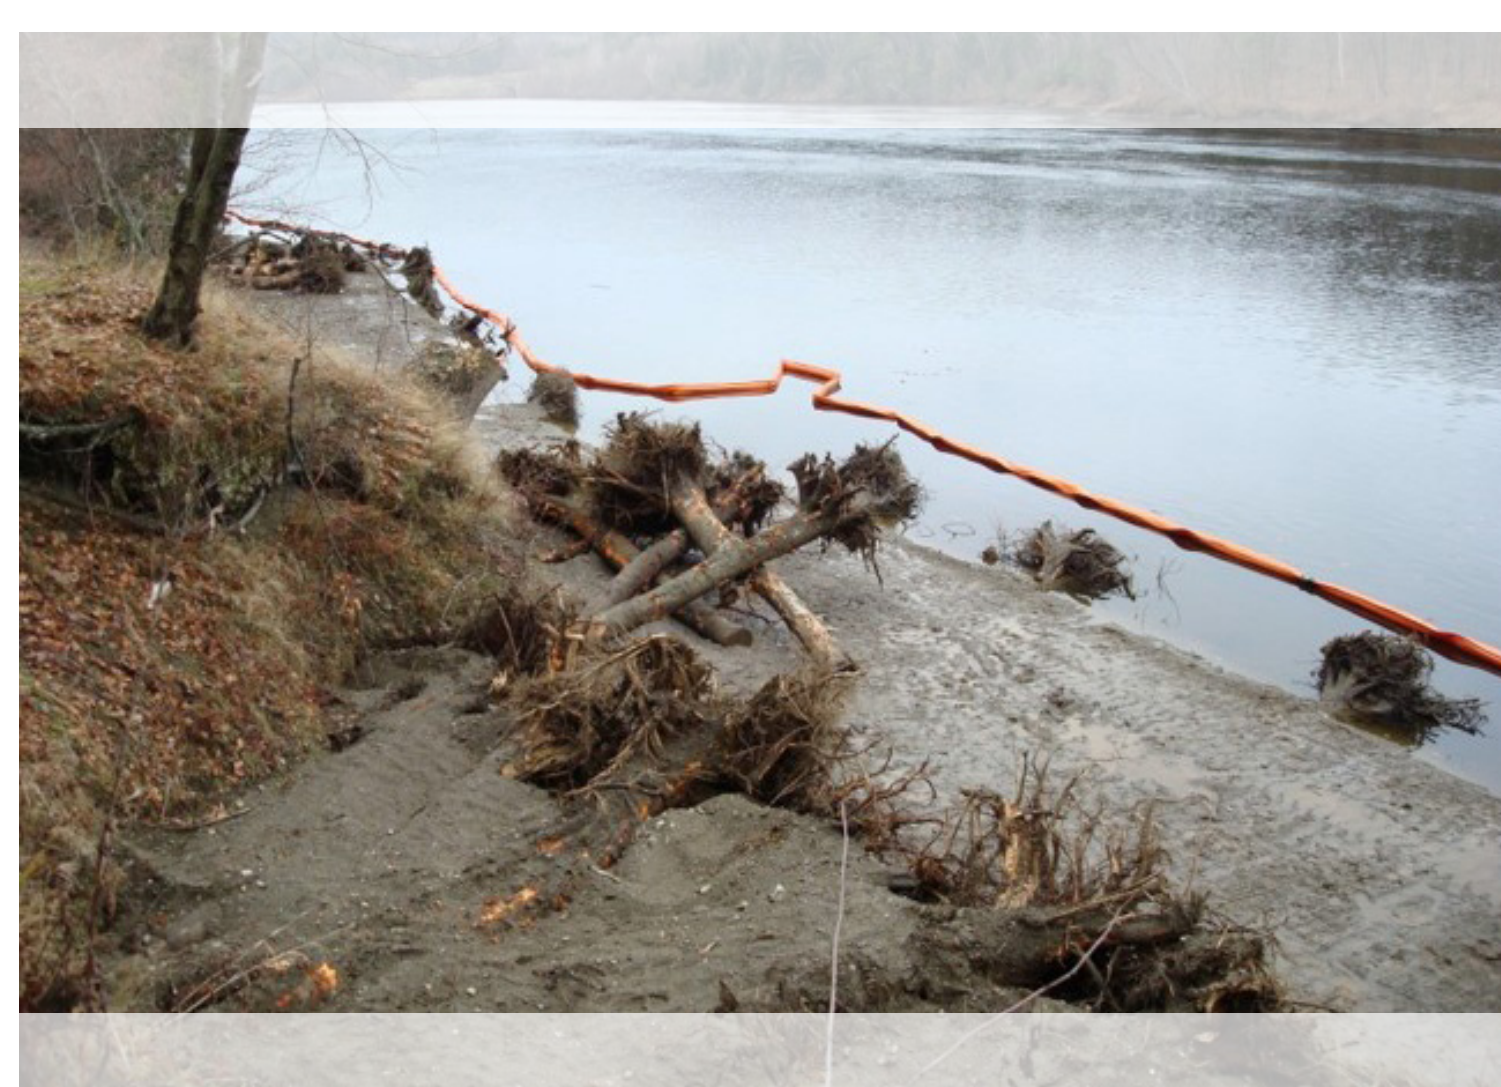
Log construction
