# Salt marsh sustainability in New England: progress and remaining challenges

Cathy Wigand & Stephen Balogh

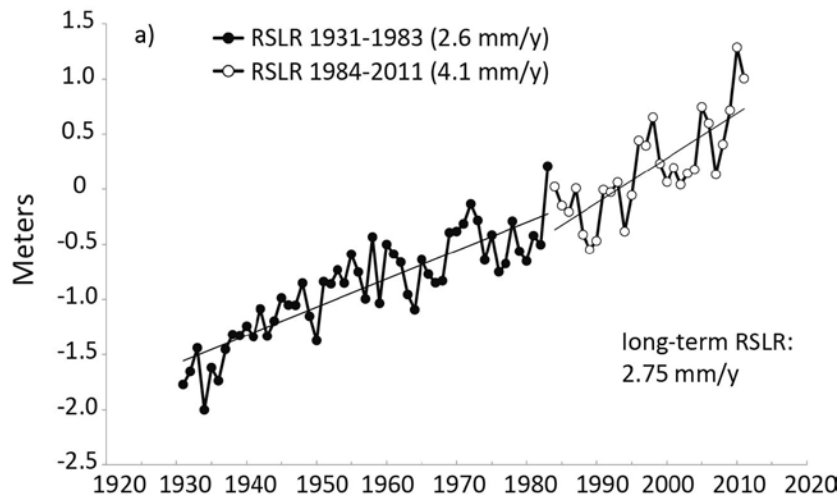
\*Relative sea level  
at Newport, RI

(\*Relative to the most recent MSL  
datum established by CO-OPS)

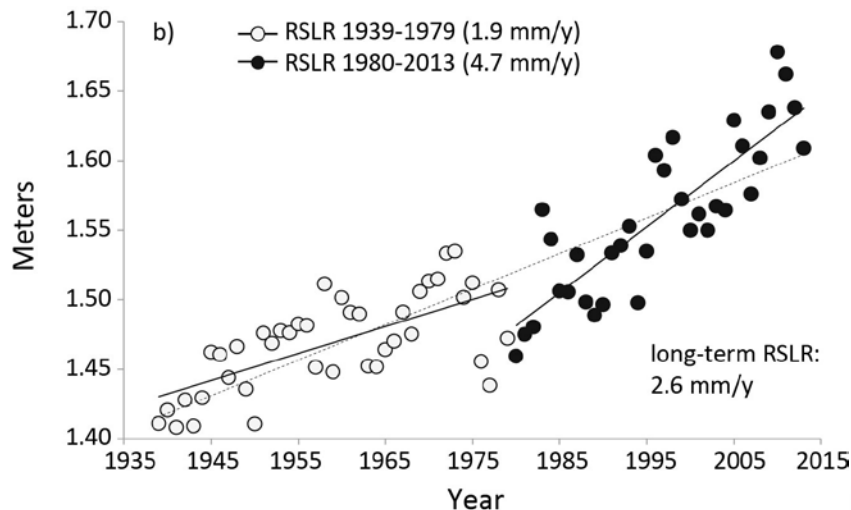
Mean annual sea level  
at New London, CT

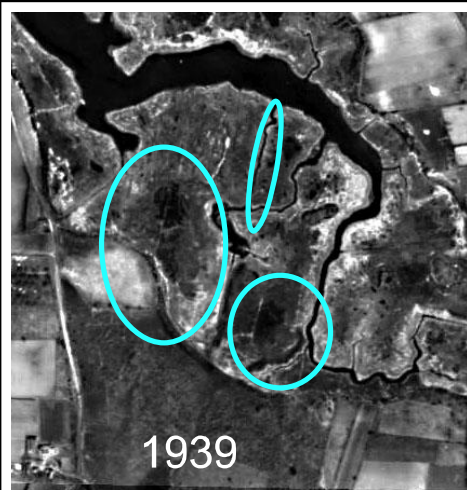
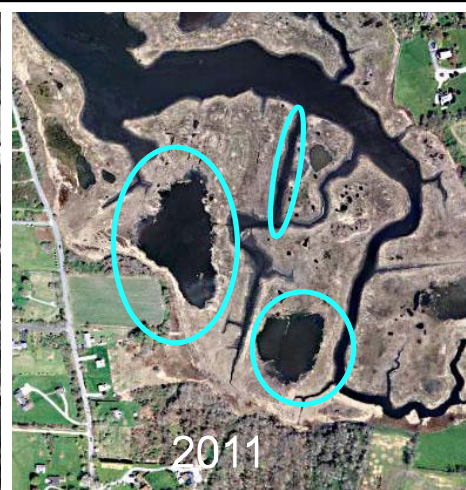
Sapowet

# Landscape spatial patterns linked with coastal marsh loss & SLR

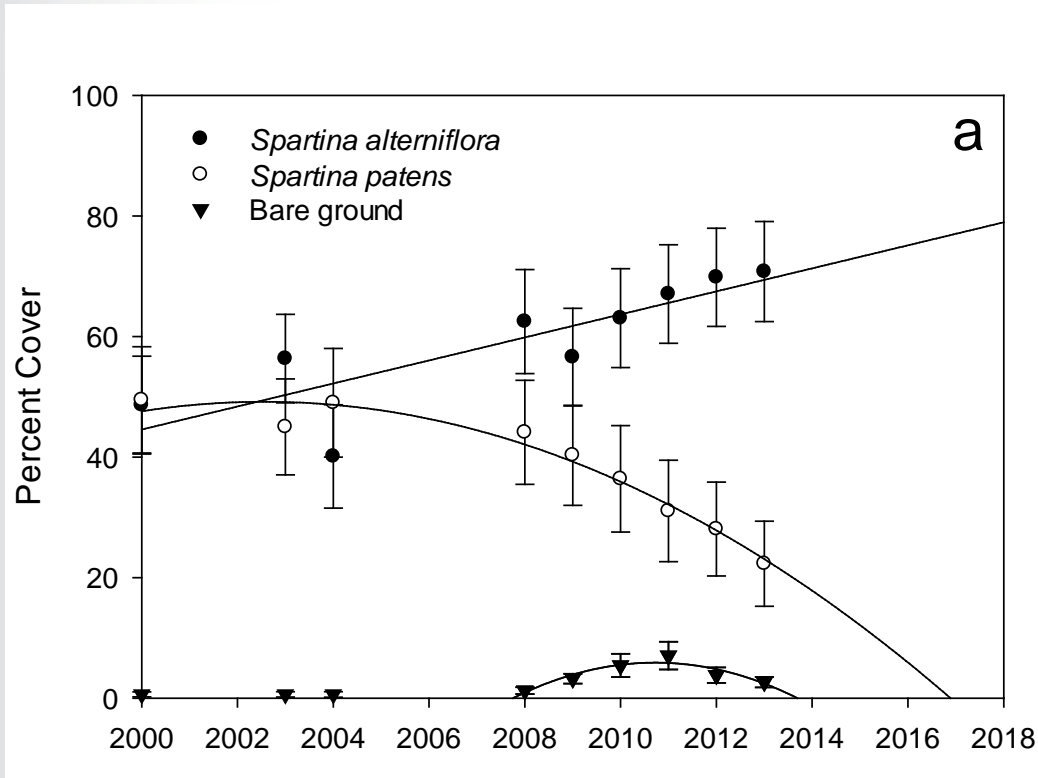
Changes in the cover of *S. alterniflora*, *S. patens*, and bare ground over time in marshes at the RI NERR. Error bars are  $\pm 1$  SE

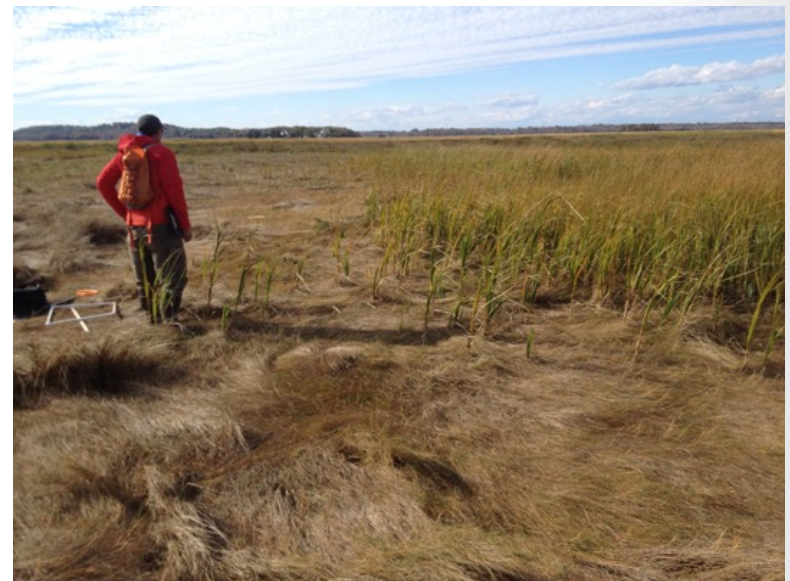
Advancement of the low marsh, *S. alterniflora* into the high marsh at Parker River NWR, MA

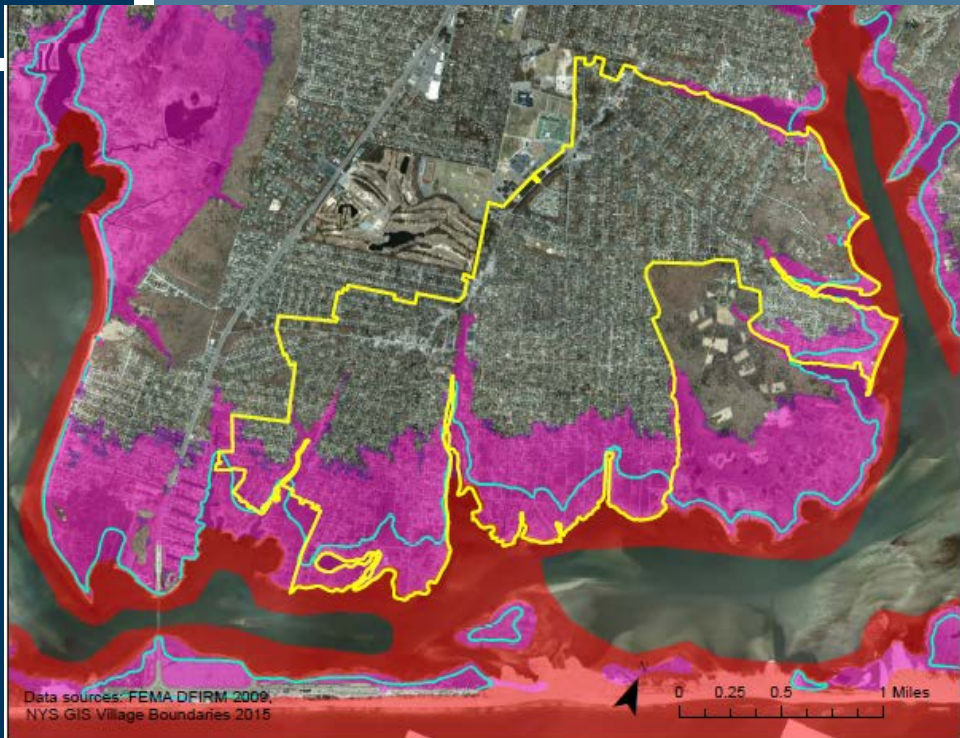
- Flood Hazard Areas (DFIRM)**
- 0.2 % Annual Chance Flood Hazard
  - A Zone (1% Annual Chance, Elev. Not Determined)
  - AE Zone (1% Annual Chance, Elev. Determined)
  - VE Zone (1% Annual Chance + Wave Action)
- Limit of Moderate Wave Action
- Village of Mastic Beach
- The Nature Conservancy  
Long Island

Coastal storm vulnerability

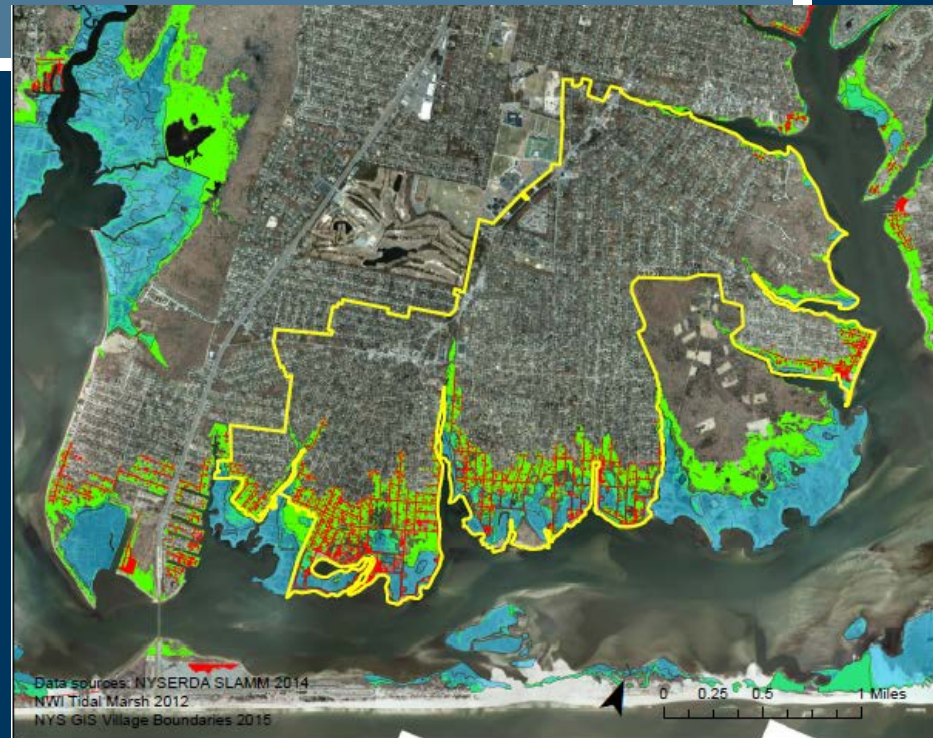
- Village of Mastic Beach
  - Current Tidal Marsh Extent (2012)
- Future SLAMM projection (RIM MIN - 2085)**
- Flooded Developed Dry Land
  - Tidal Marsh
- The Nature Conservancy  
Long Island

Marsh migration potential

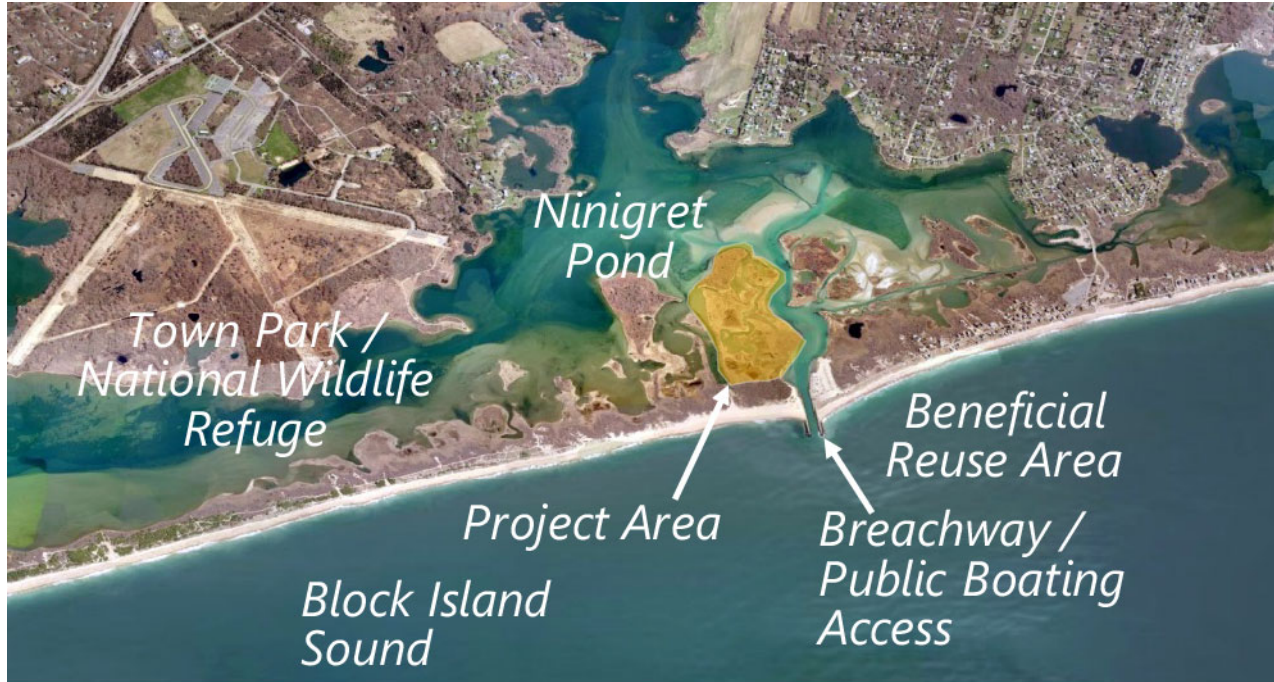
- Back-barrier marsh adjacent to manmade breachway, state-owned public access point, beach and campground
- Microtidal salt marsh habitat exhibiting areas of prolonged flooding, vegetative die-off, subsidence and marsh edge erosion
