THE ECOLOGY OF DAM  
REMOVAL – A NATIONAL  
LOOK AT ECOSYSTEM  
RESTORATION  
CHALLENGES AND  
OPPORTUNITIES FOR  
REMOVAL OF RIVER  
BARRIERS

September 21, 2018

Nick Nelson & Marty Melchior

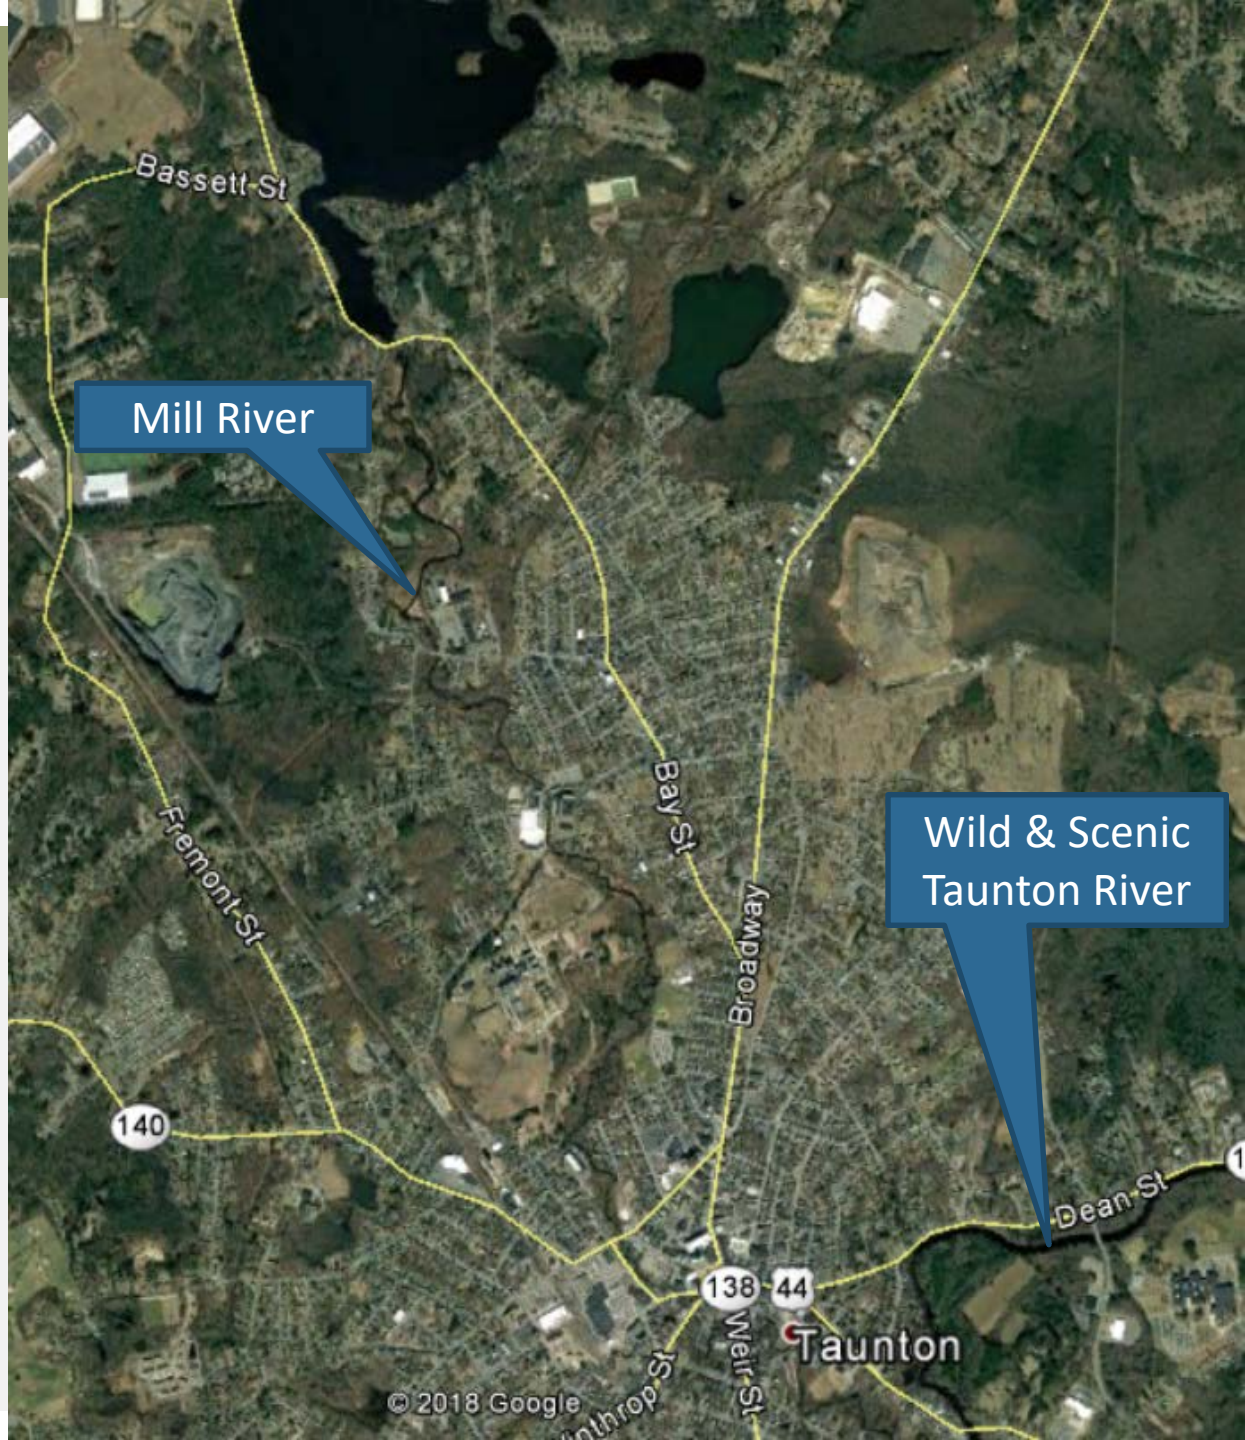
**~14,000 cubic yards of impounded sediment**

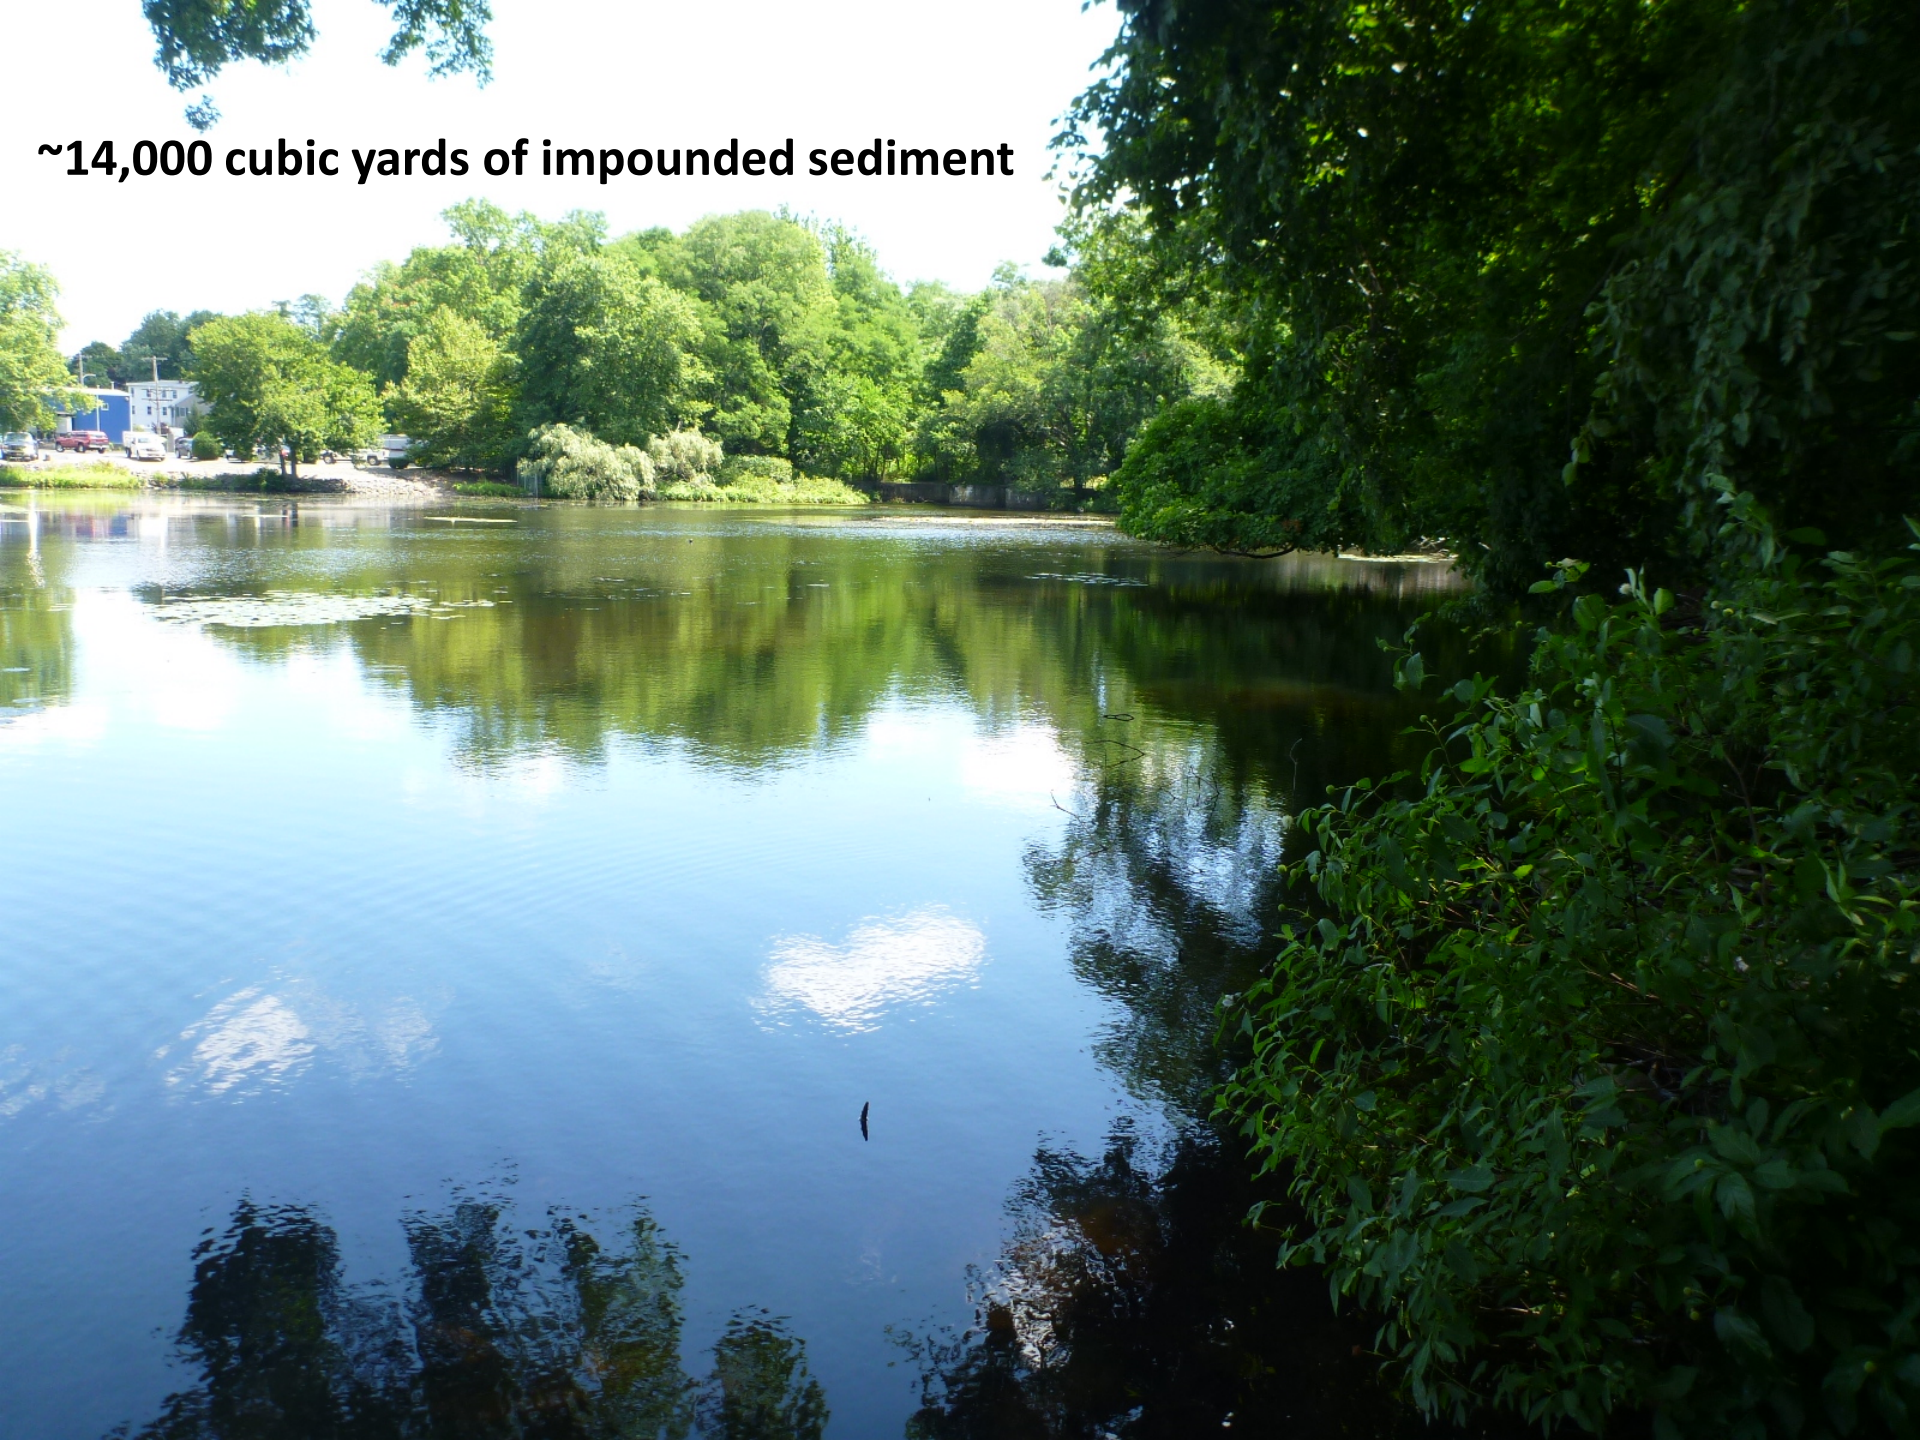
Active sediment removal and channel construction

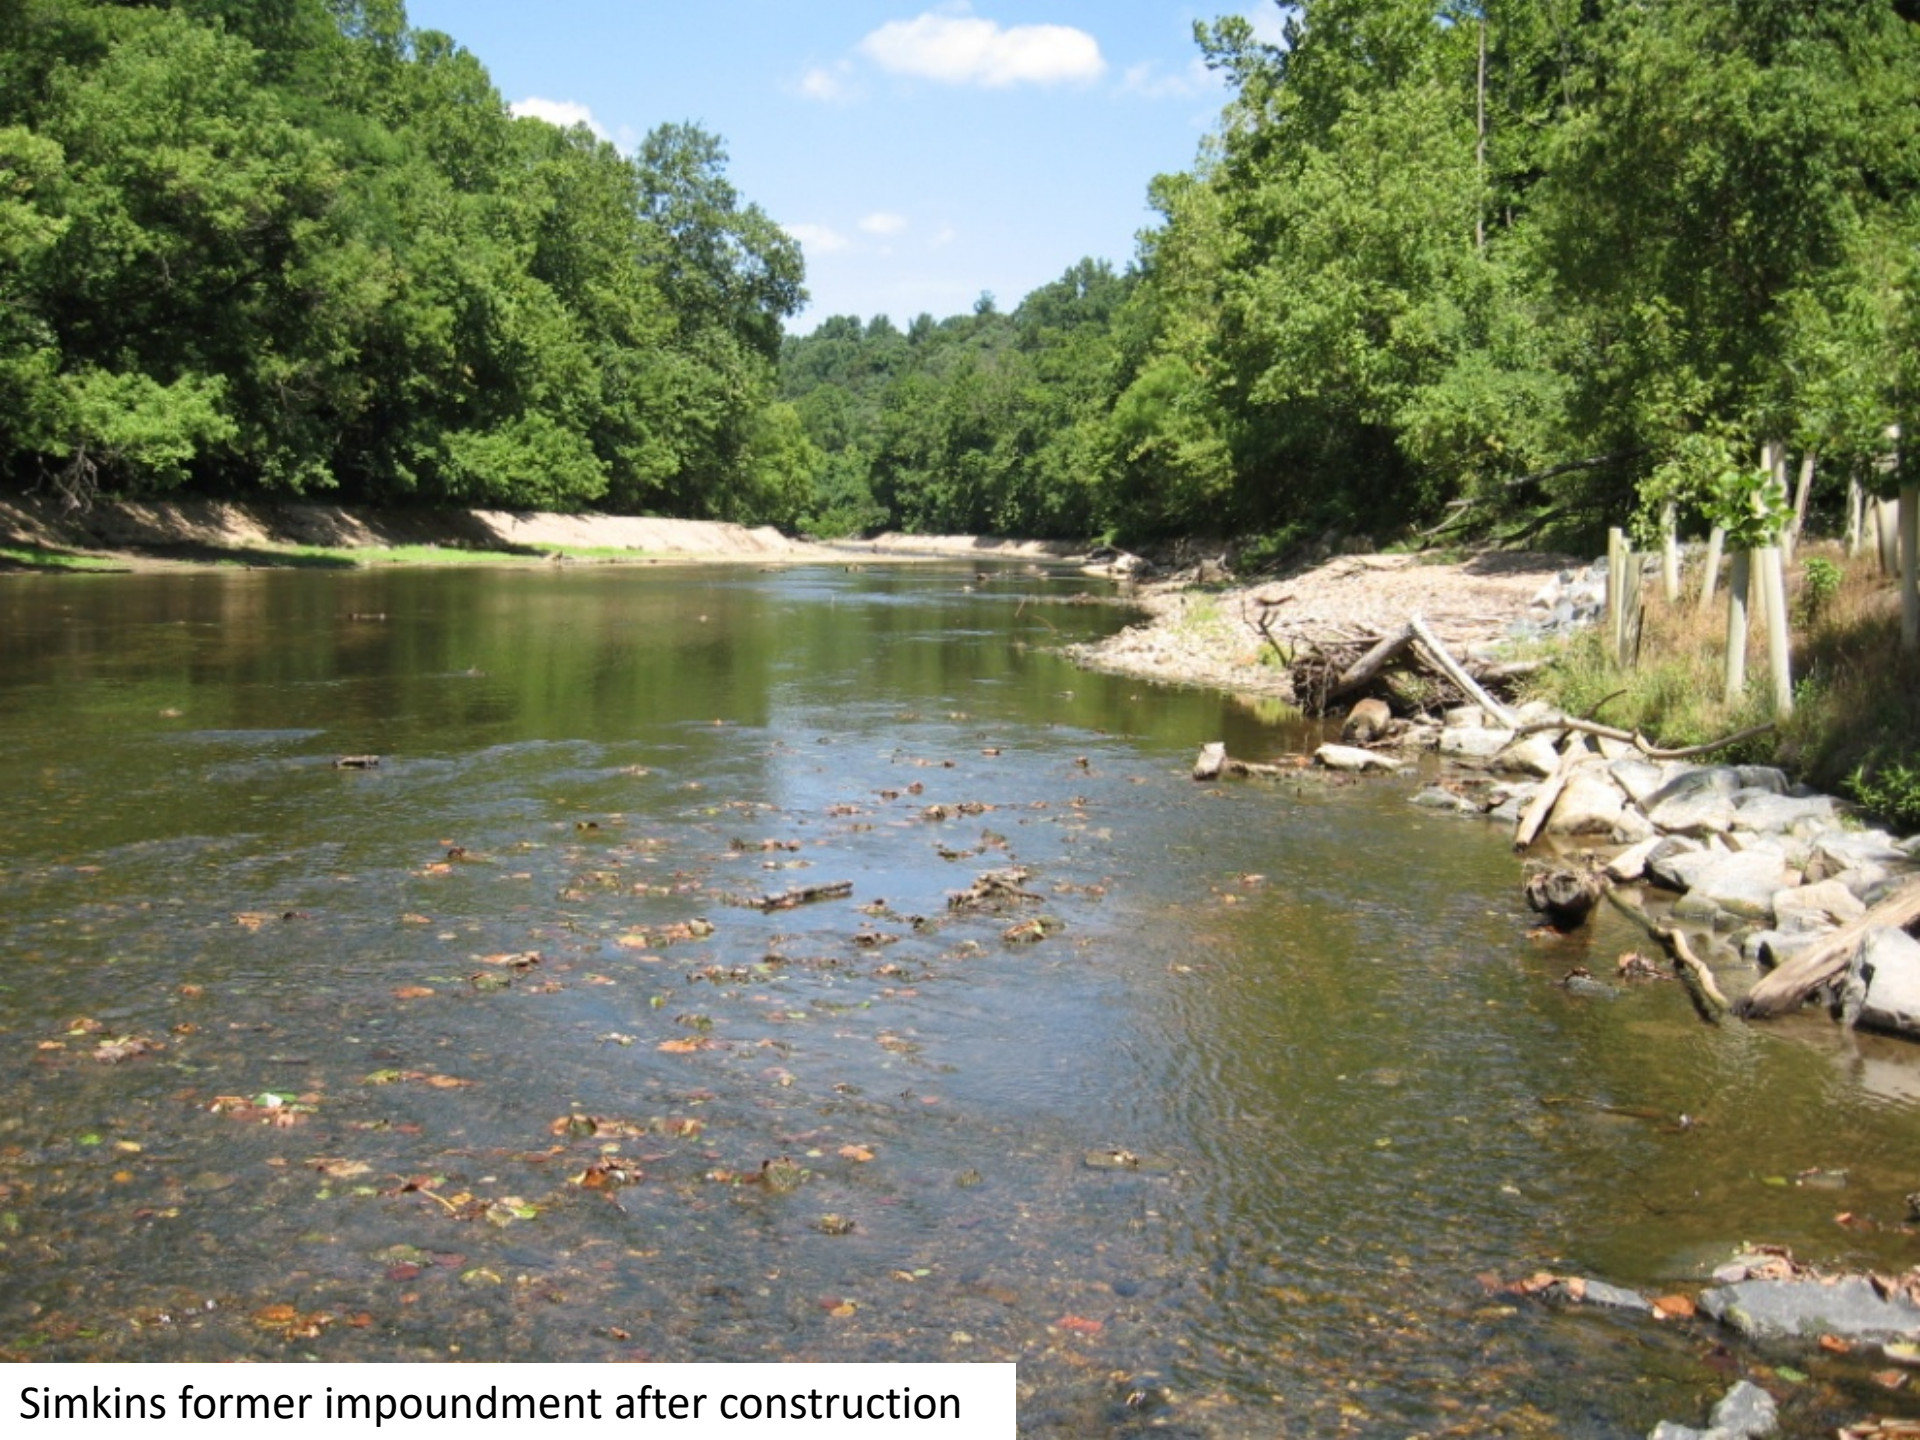
Simkins former impoundment after construction

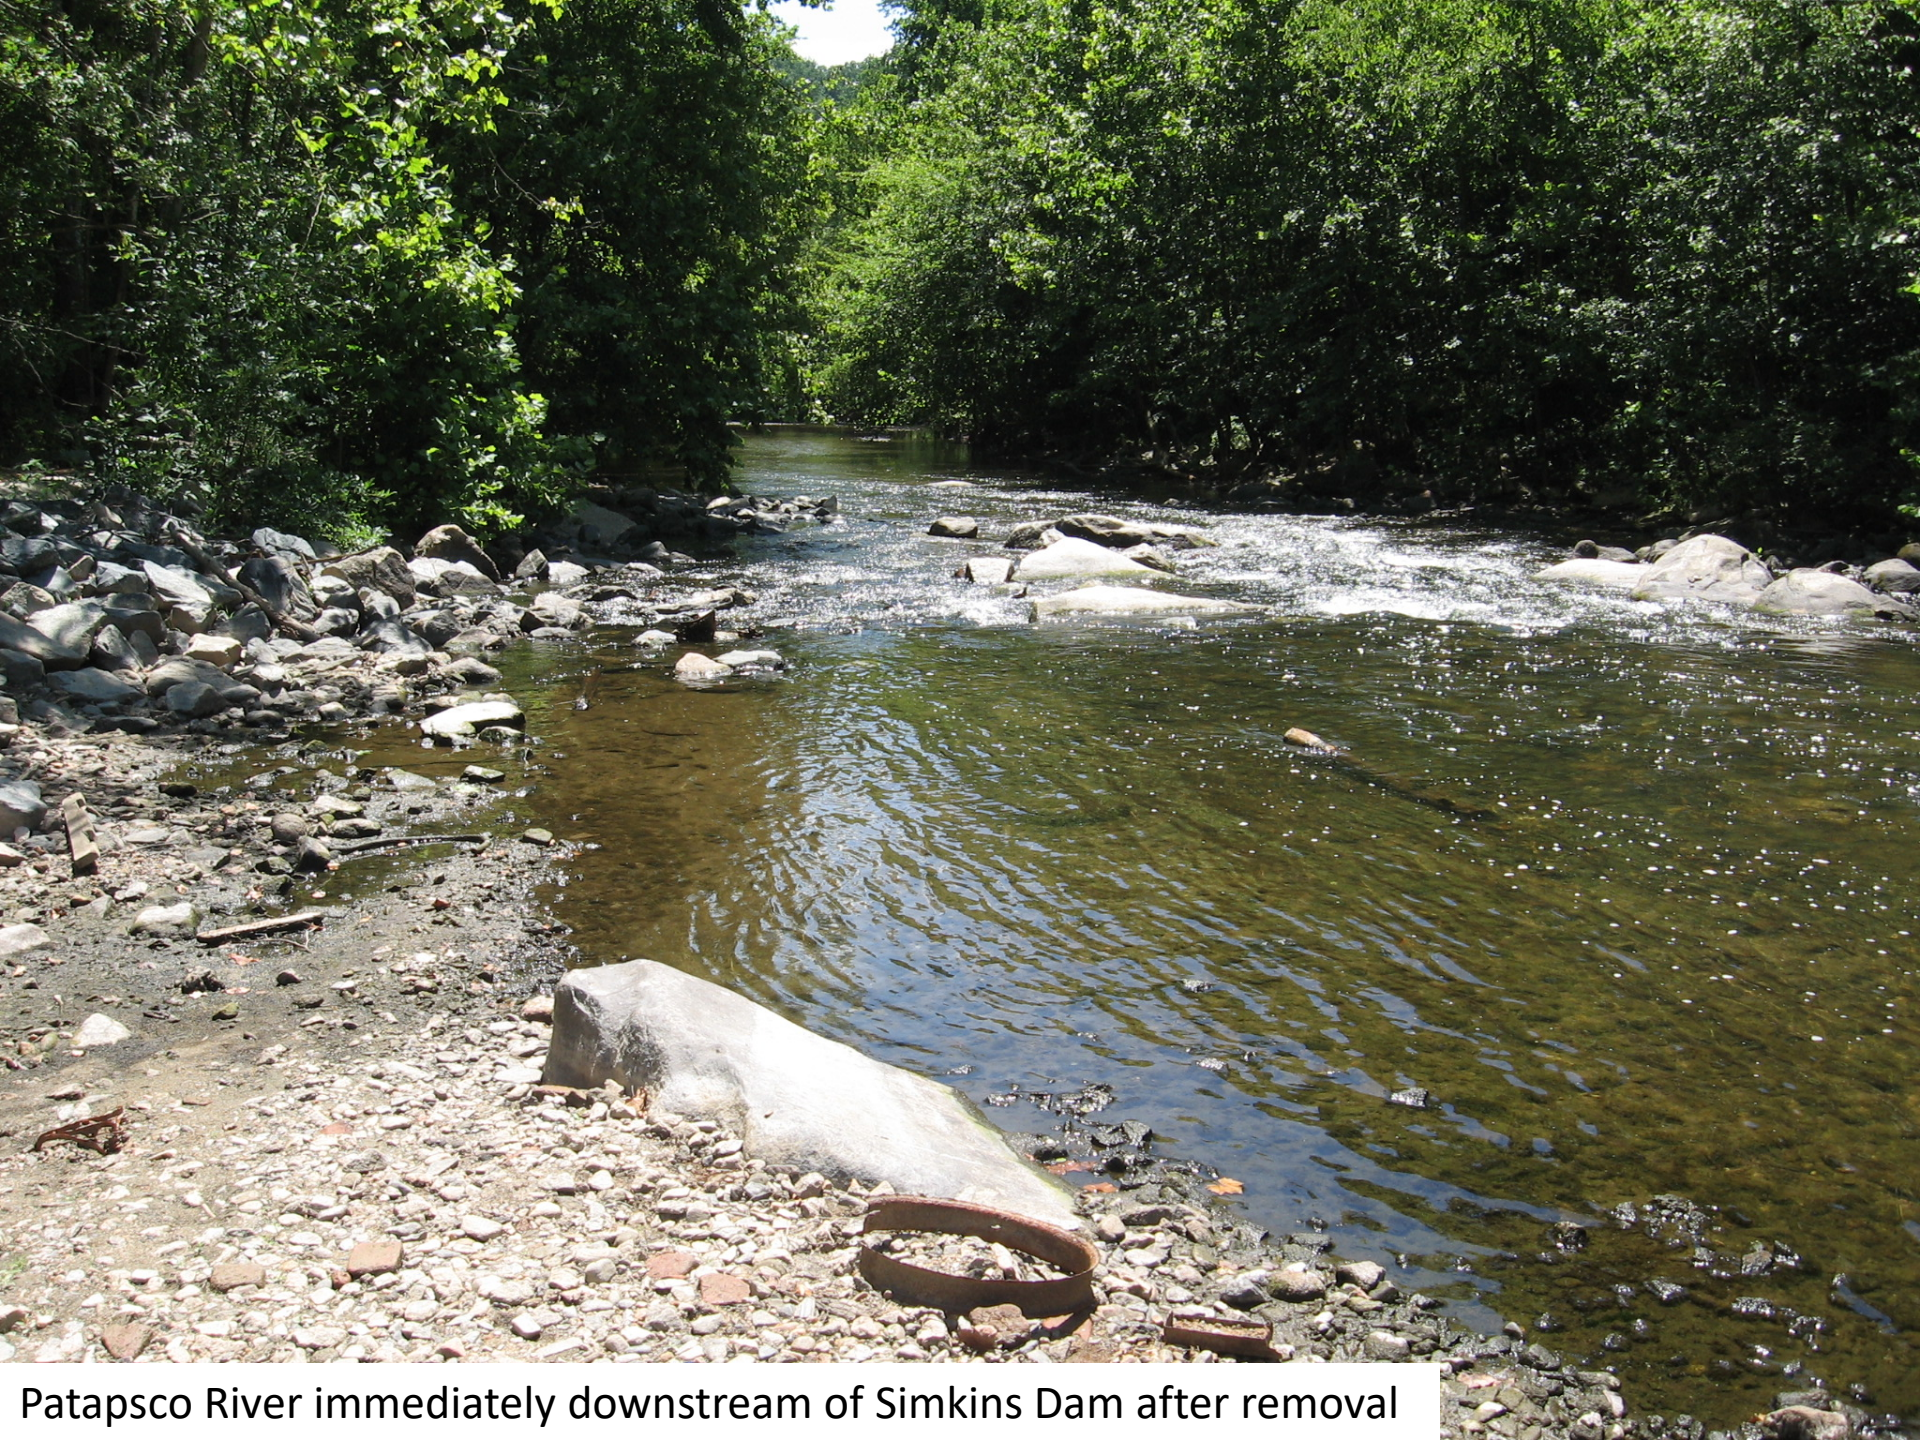
Patapsco River immediately downstream of Simkins Dam after removal

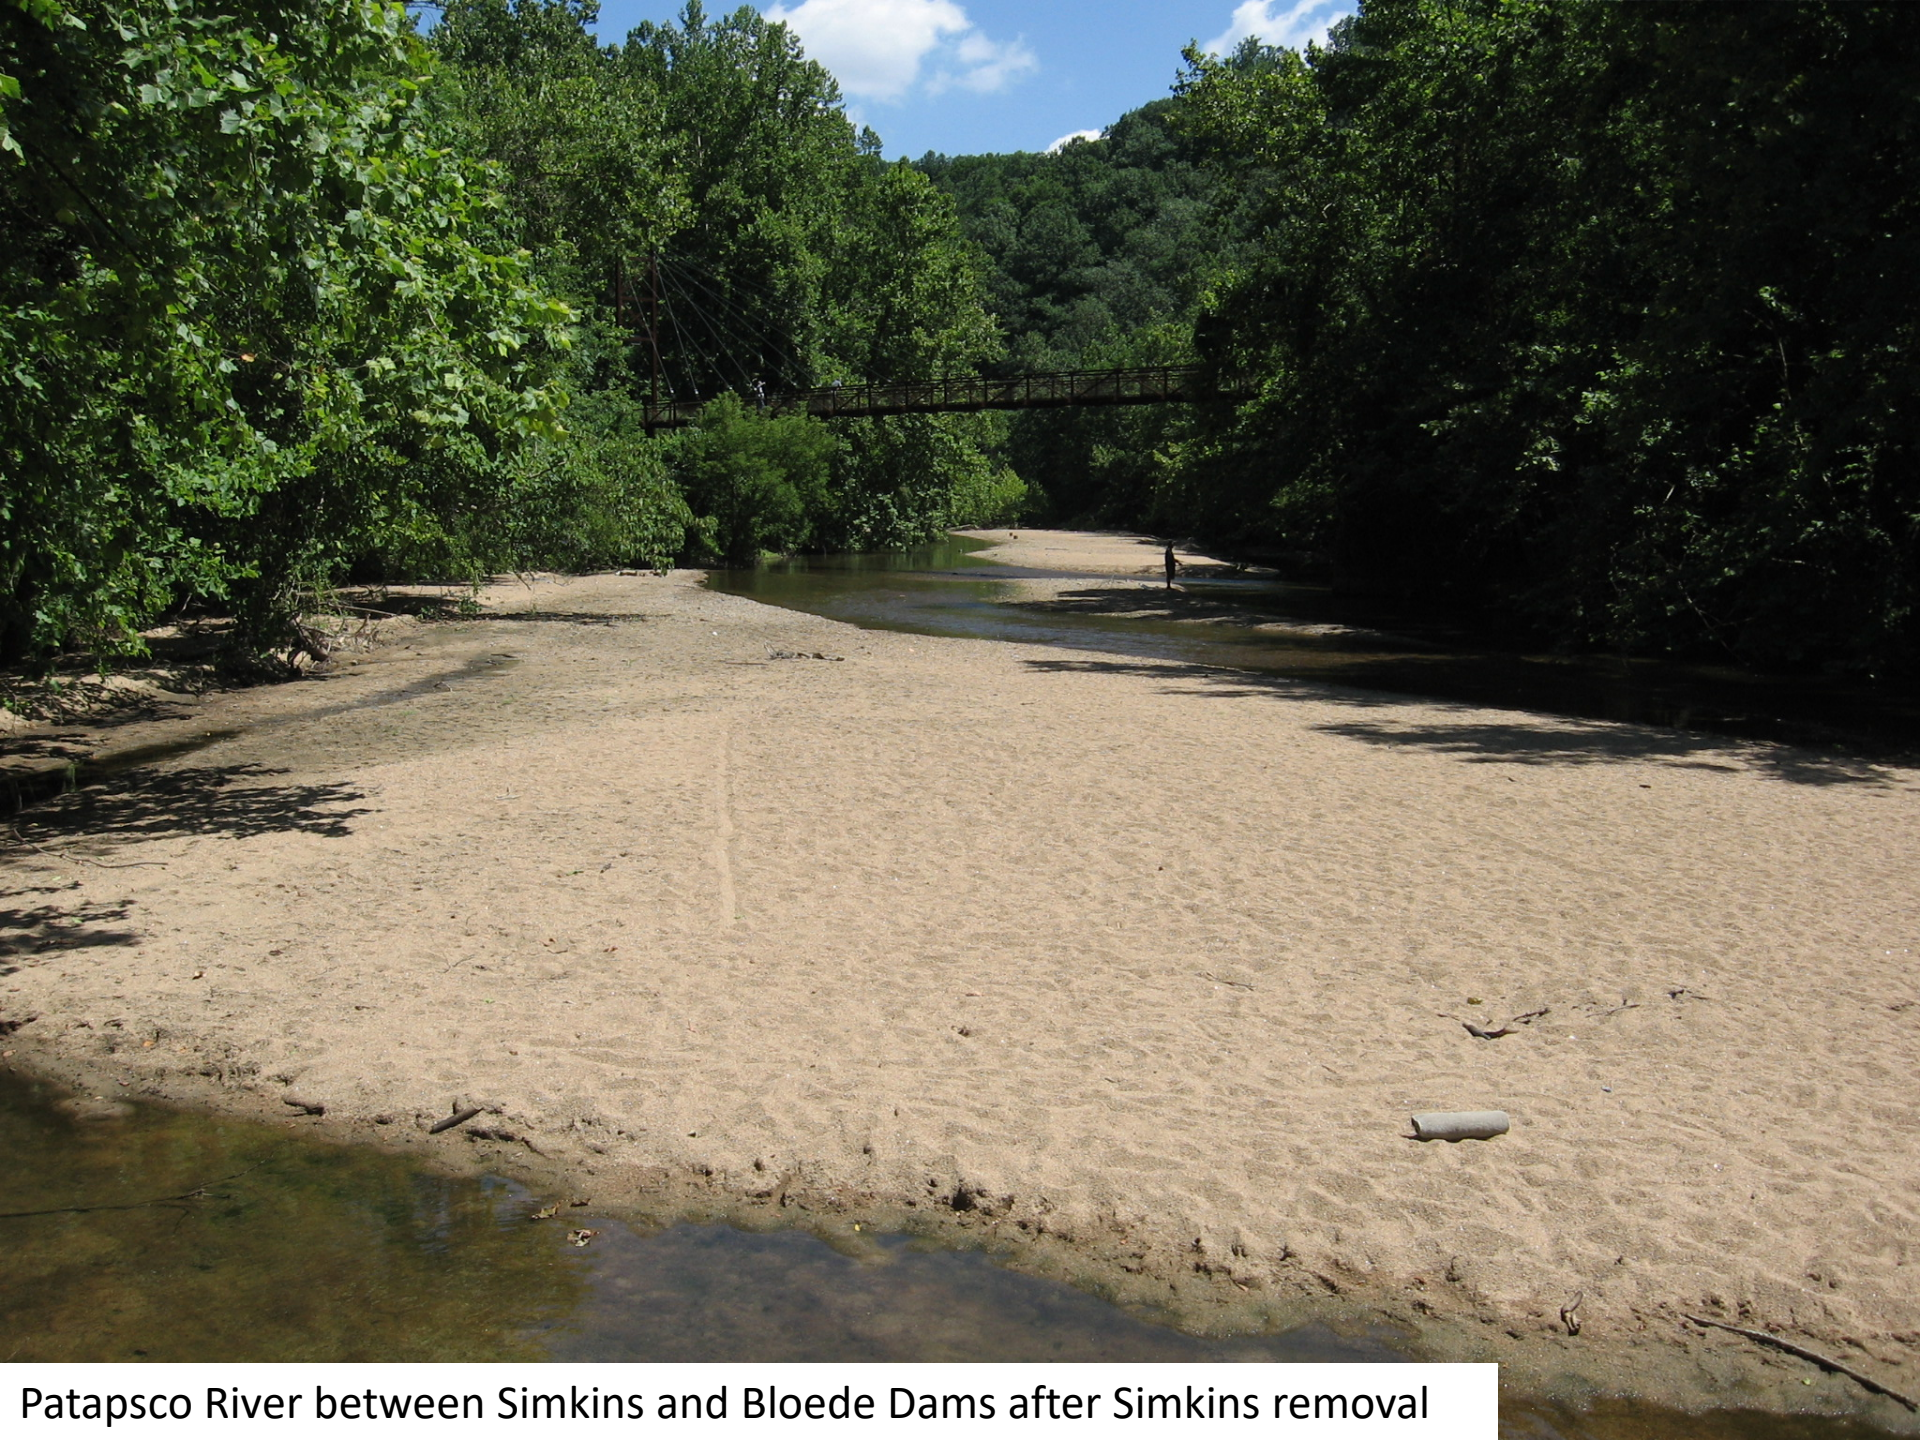
Patapsco River between Simkins and Bloede Dams after Simkins removal
