Developing and Using Ecological Resilience Metrics to Measure Project Performance after Hurricane Sandy

Tidal Marsh and Barrier Beach Restoration at Prime Hook NWR

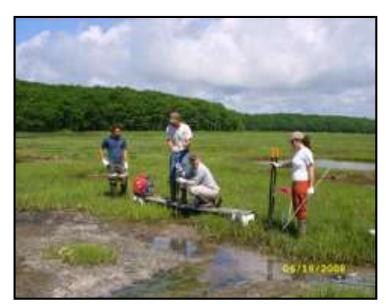
SET Installation

- Nekton abundance, species richness
- Salt marsh plant community monitoring
- Water Quality
- Marsh surface elevation change trend
- Marsh accretion and erosion
- Groundwater dynamics

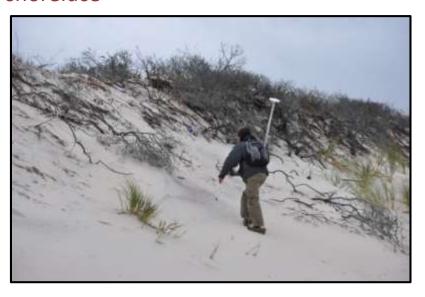
Beach and Dune Restoration

- Fish, wildlife population, recruitment, overwintering, stopover weight
- Vegetation cover of dunes, pre and post
- Dune characterization
- Beach width, elevation, volume, shoreline position
- Post-storm volume of sand in active shoreface

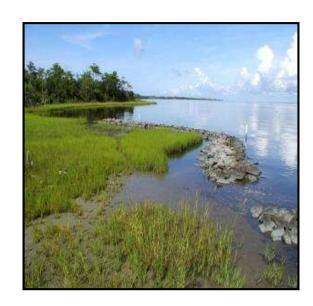
Living Shorelines

- Oyster length/frequency
- Oyster coverage & population
- Vegetation cover
- Water temperature, salinity
- Vertical accretion rates
- Shoreline position

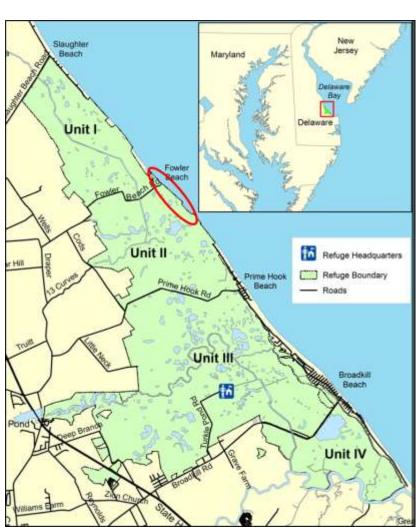
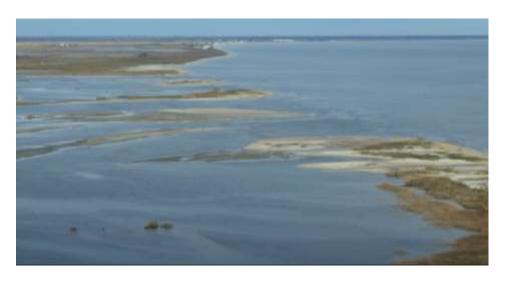
- On the western shore of the Delaware Bay, in southern DE
- Established in 1963
- 10,132 acres, primarily wetlands
- Refuge divided into management units
- Dune breaches are in Units I & II

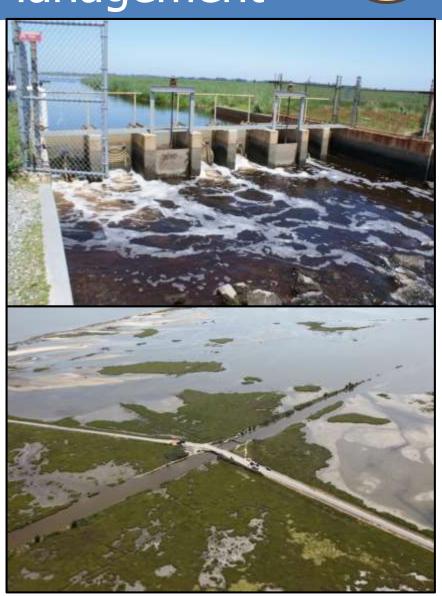
- ~4000 acres of freshwater impoundments
- Tidal water restricted by water control structures
- Culverts between Unit II and Unit III
- Successful freshwater impoundment management for 20+ years

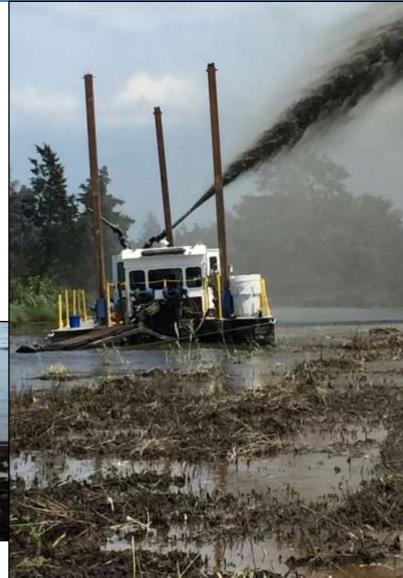
Prime Hook National Wildlife Refuge (Photos: USFWS)

- Close breaches
- Dredge a network of tidal channels
- Eliminate water control structures
- Remove road and alterations to roads and/or culverts
- Use dredge material to augment marsh

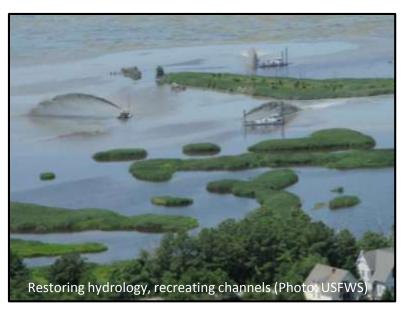
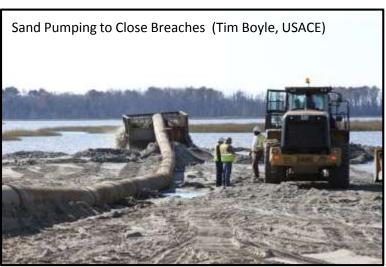
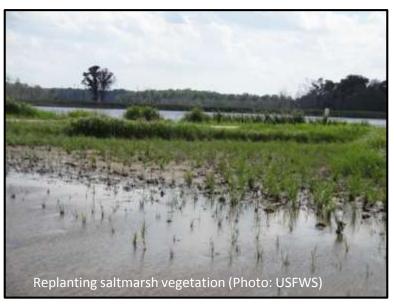
The Result

- Restored Hydrology
 - Establish tidal channels
- Restored ecosystem services
 - Storm surge and flood protection
 - Carbon Sequestration
 - Habitat
- Increased public support
