# Evaluating Alternative Oyster Garden Structures and Materials in Residential Canals

Adrian Sakr<sup>1</sup>, Logan Mazor<sup>1</sup>, Christine Angelini<sup>1</sup>, Eric Milbrandt<sup>2</sup>, & Andrew Altieri<sup>1</sup>  
<sup>1</sup>University of Florida ESSIE; <sup>2</sup>Sanibel Captiva Conservation Foundation | [adriansakr@ufl.edu](mailto:adriansakr@ufl.edu)

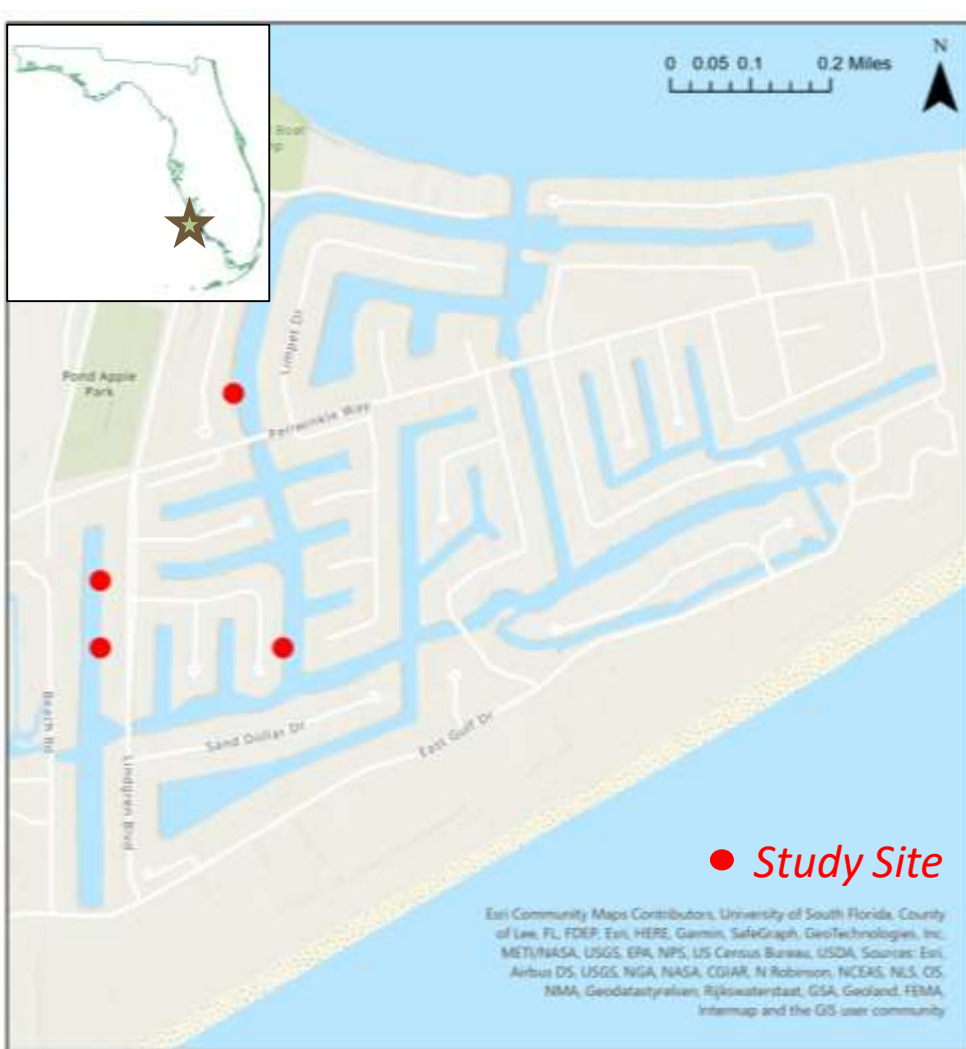
Deployed 2 of each garden at each of 4 houses in June 2022

Final data collection Oct. 2023; Hurricane Ian occurred late Sept. 2022

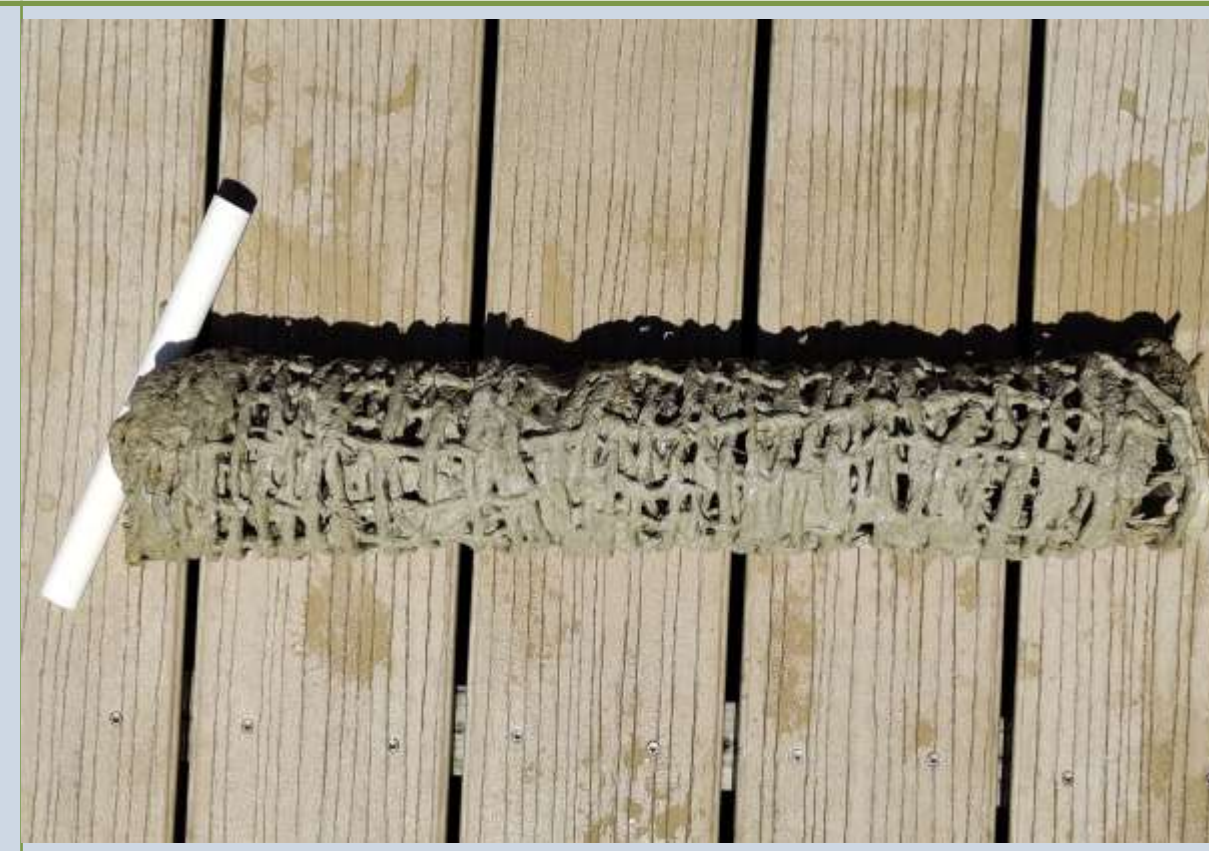
**Jute-Reinforced (JR) Calcium Sulfoaluminate Cement Cylinder**

Size: 3' x 6" x 6"

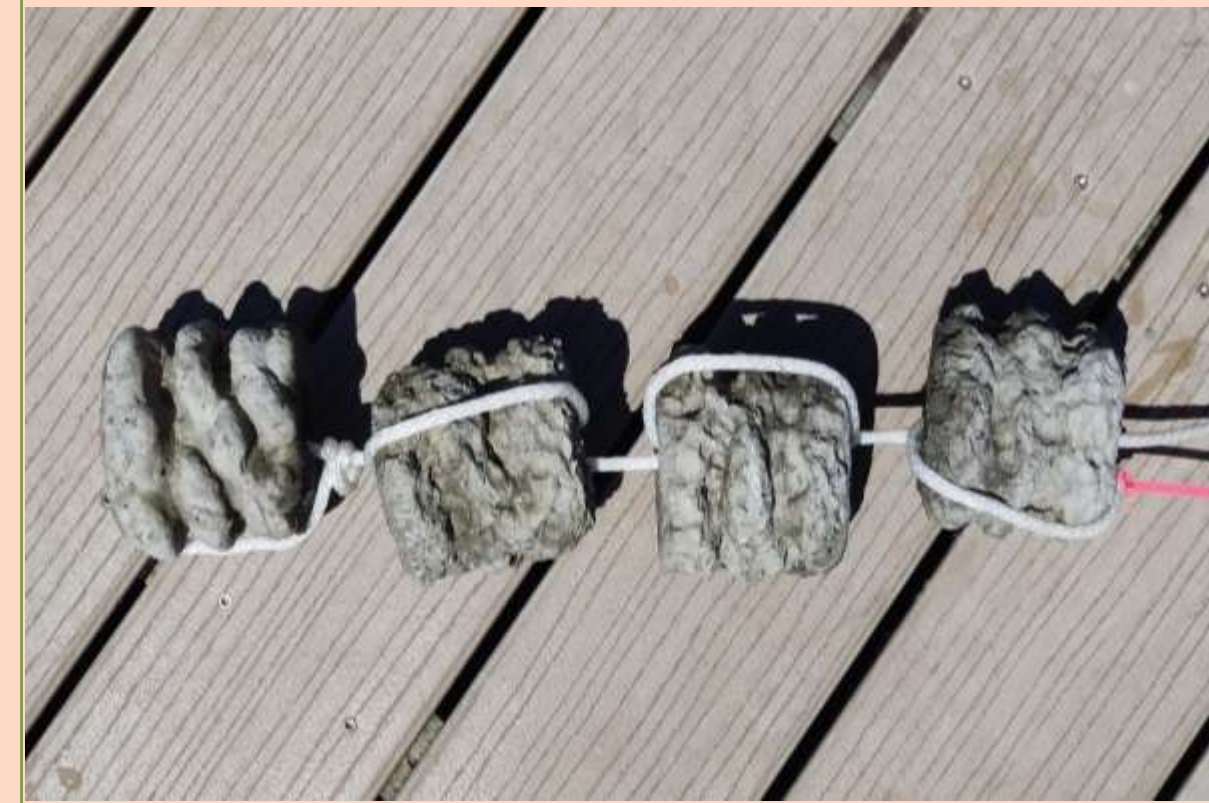
**GROW Oyster Reefs, LLC. Concrete Discs**

Size (per disc): 3.5" x 3.5" x 3.5"

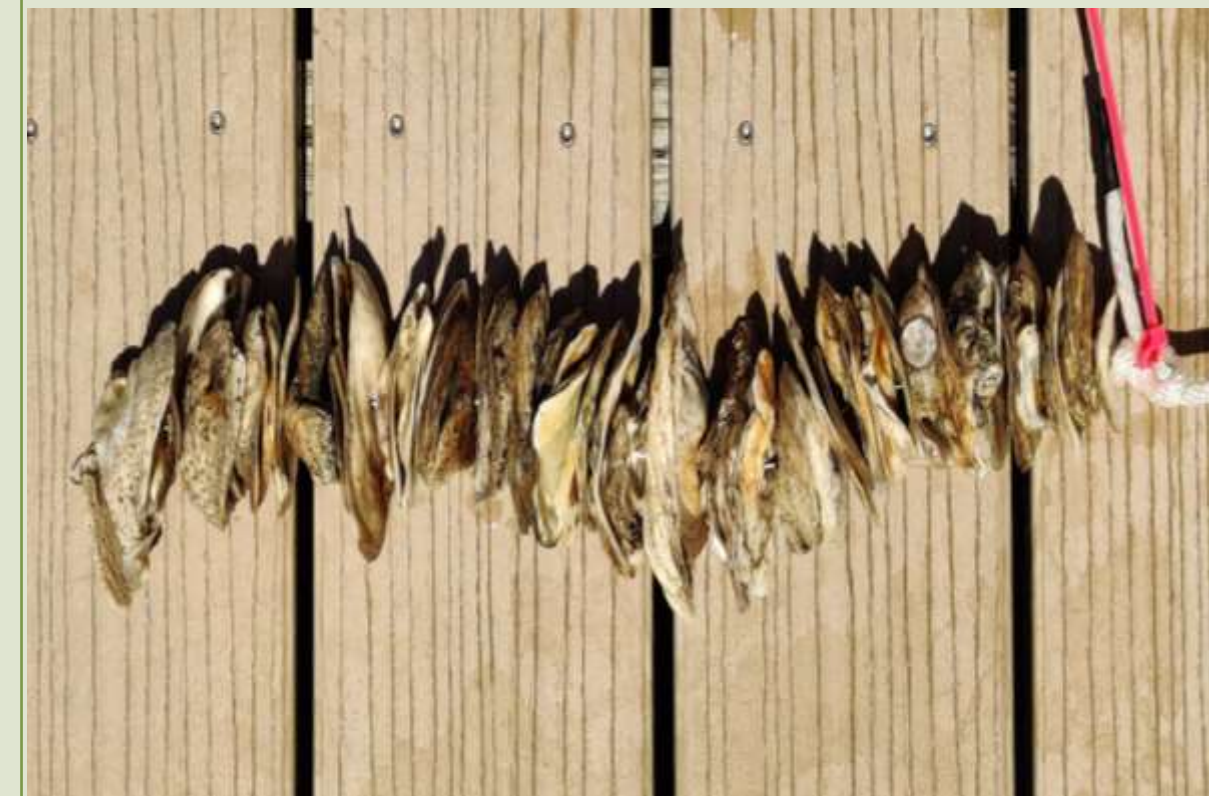
**Drilled Oyster Shell on Steel Wire**

Size: 2' x 3" x 3"

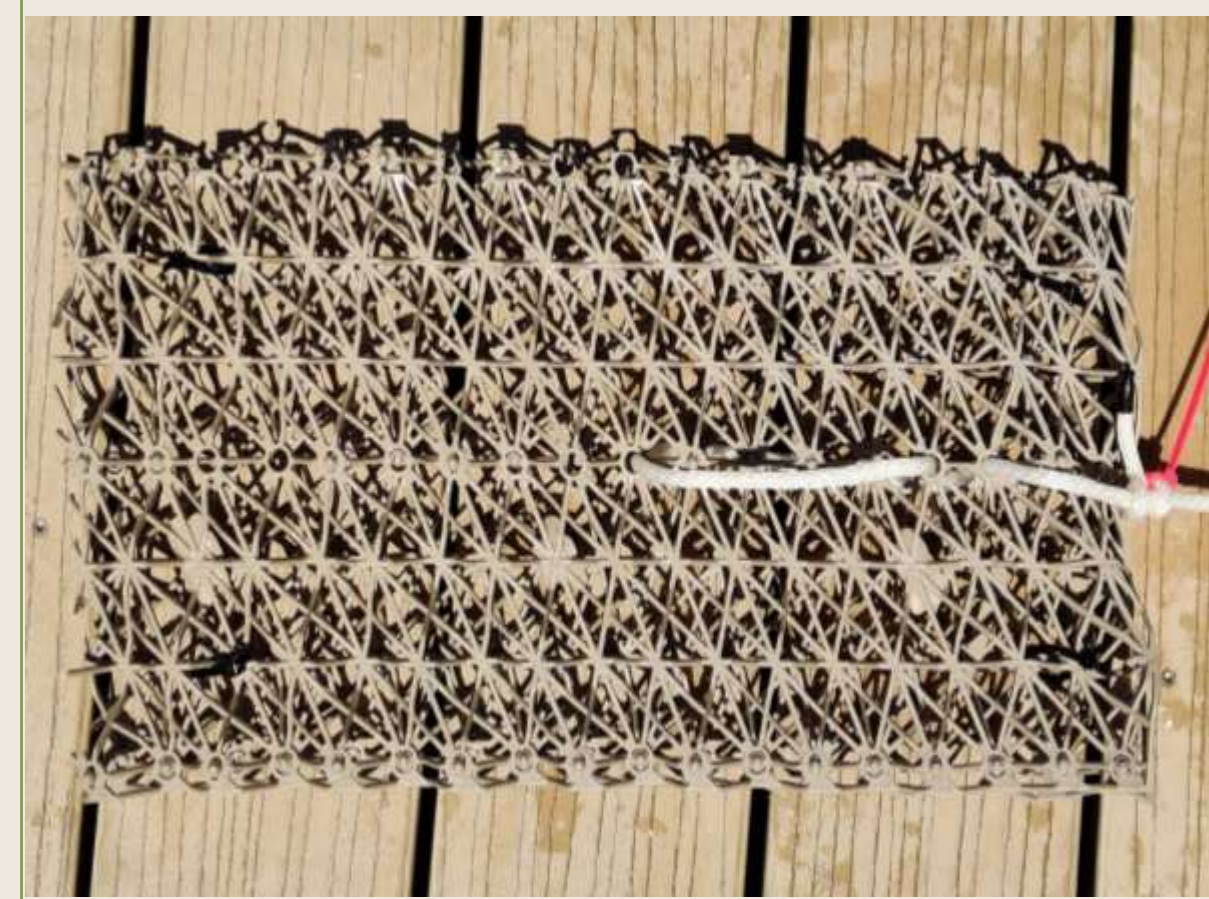
**BESE Biodegradable Plastic Matrix Panel**

Size: 3' x 1.5' x 3"

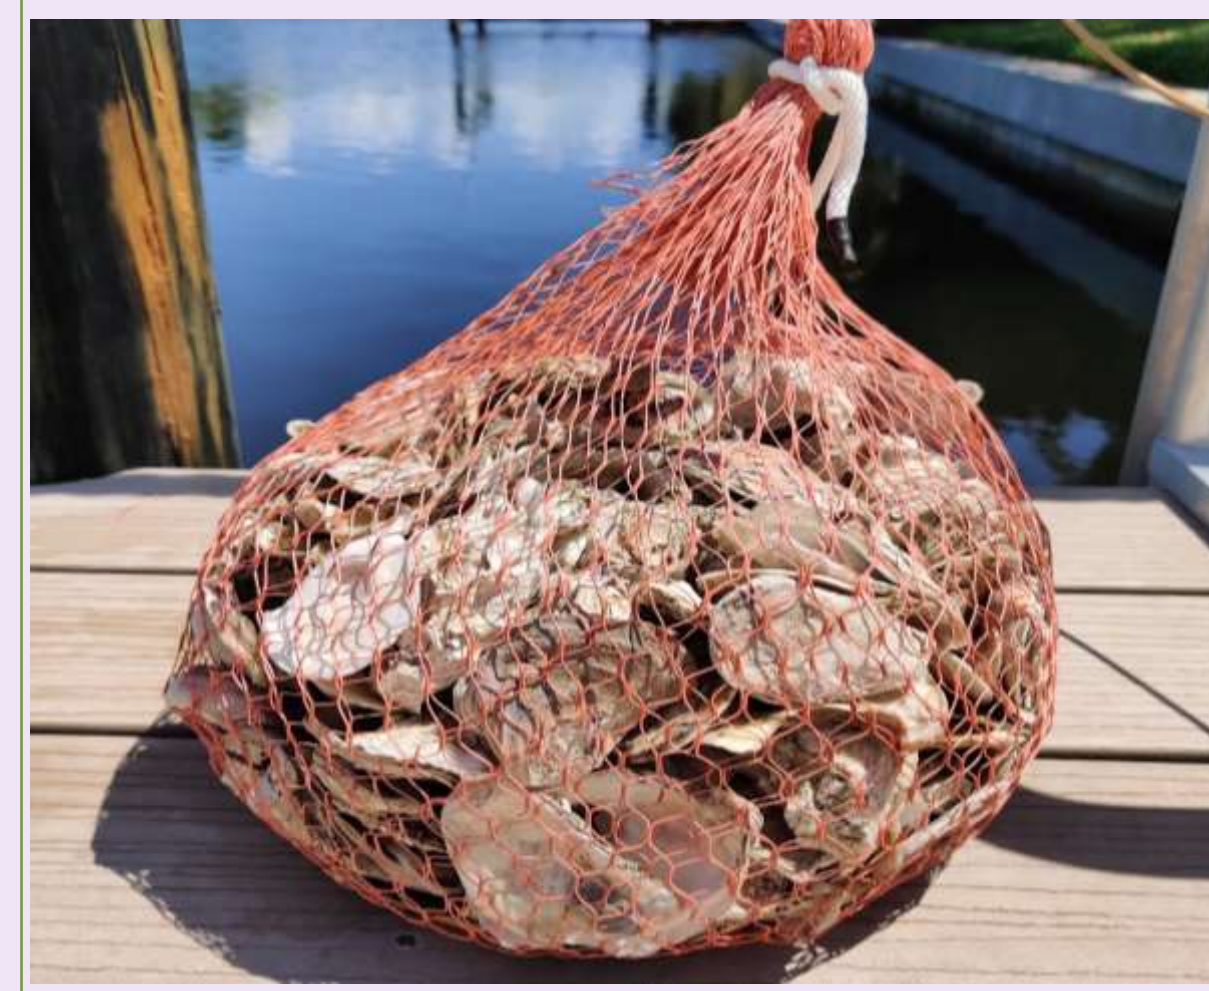
**BESE Biodegradable Plastic Mesh Bag + Oyster Culch**

Size: 1.5' x 1.5' x 1.5'

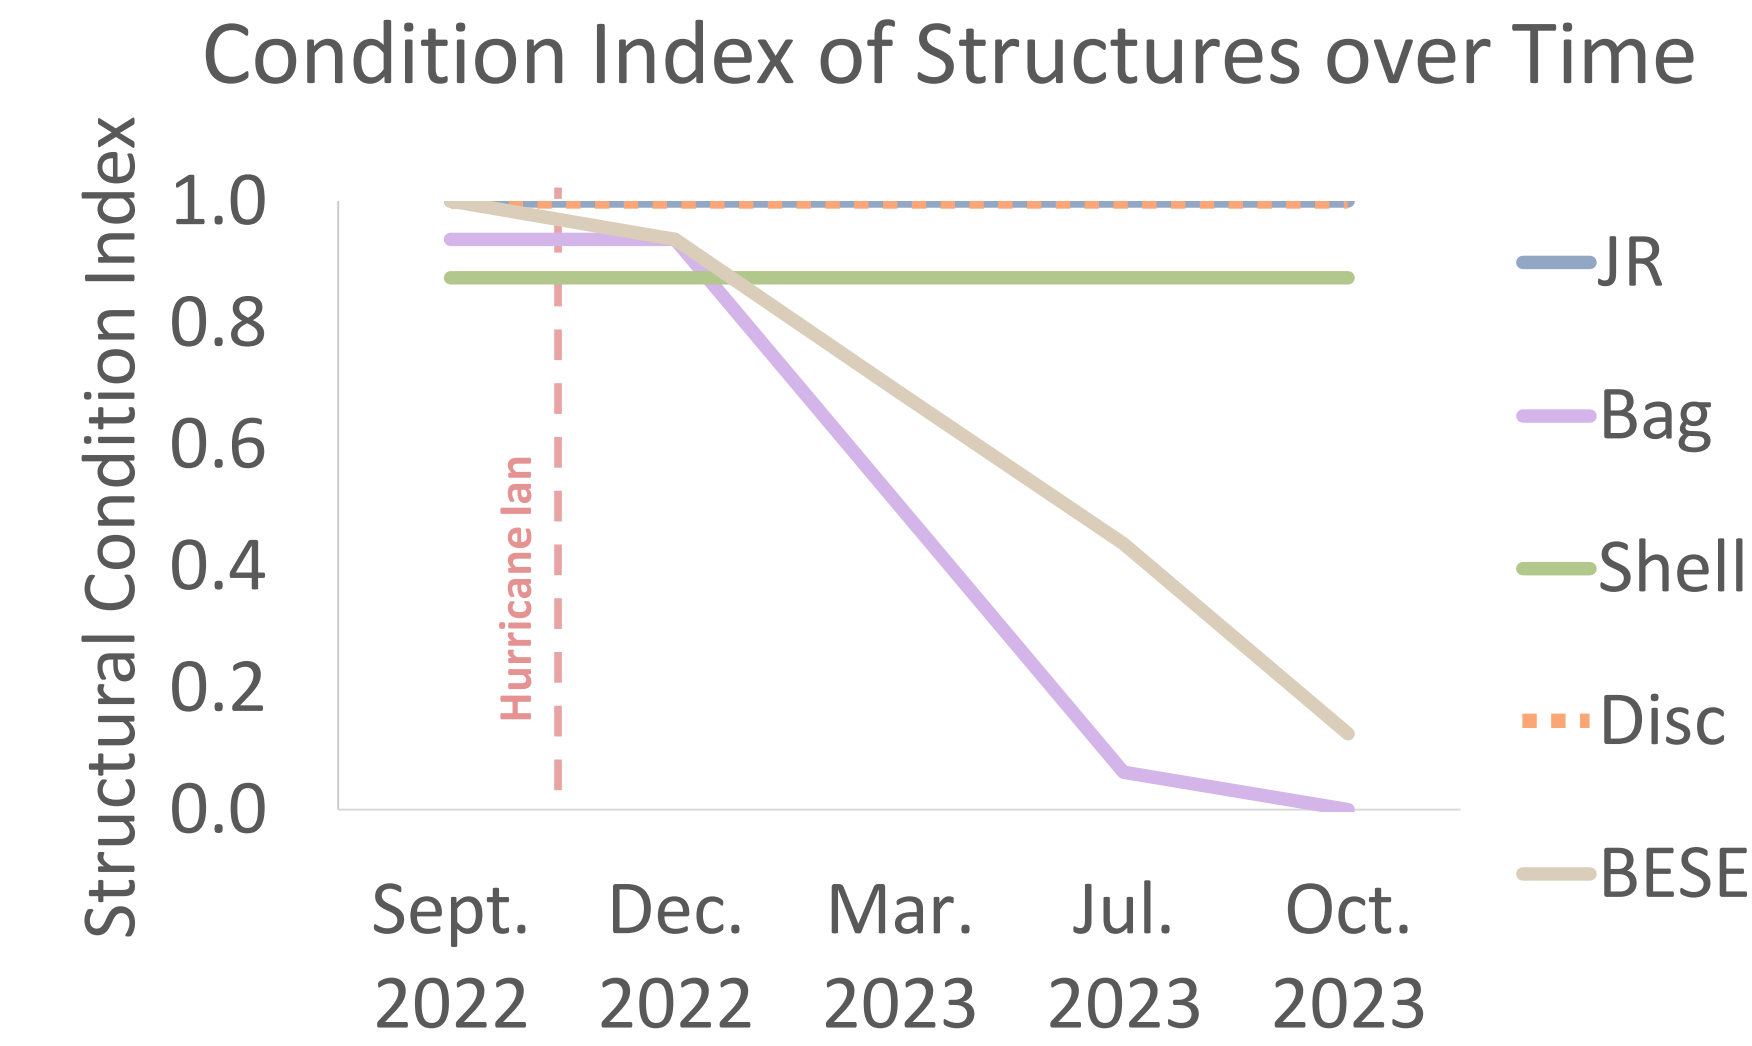
Structural integrity was rated on a three-point scale based on remaining garden mass and averaged to create a 0-1 condition index, with 1 indicating all structures fully intact

All JR and Disc structures survived the 15-month monitoring period; all but one Drilled Shell (Shell) structure survived

- All structures withstood Hurricane Ian, but both plastic structures almost entirely degraded in the following 12 months
- **JR structures** performed best for oyster recruitment/growth; JR and Disc had similar community development/diversity
- All structures tested had similar filtration rates

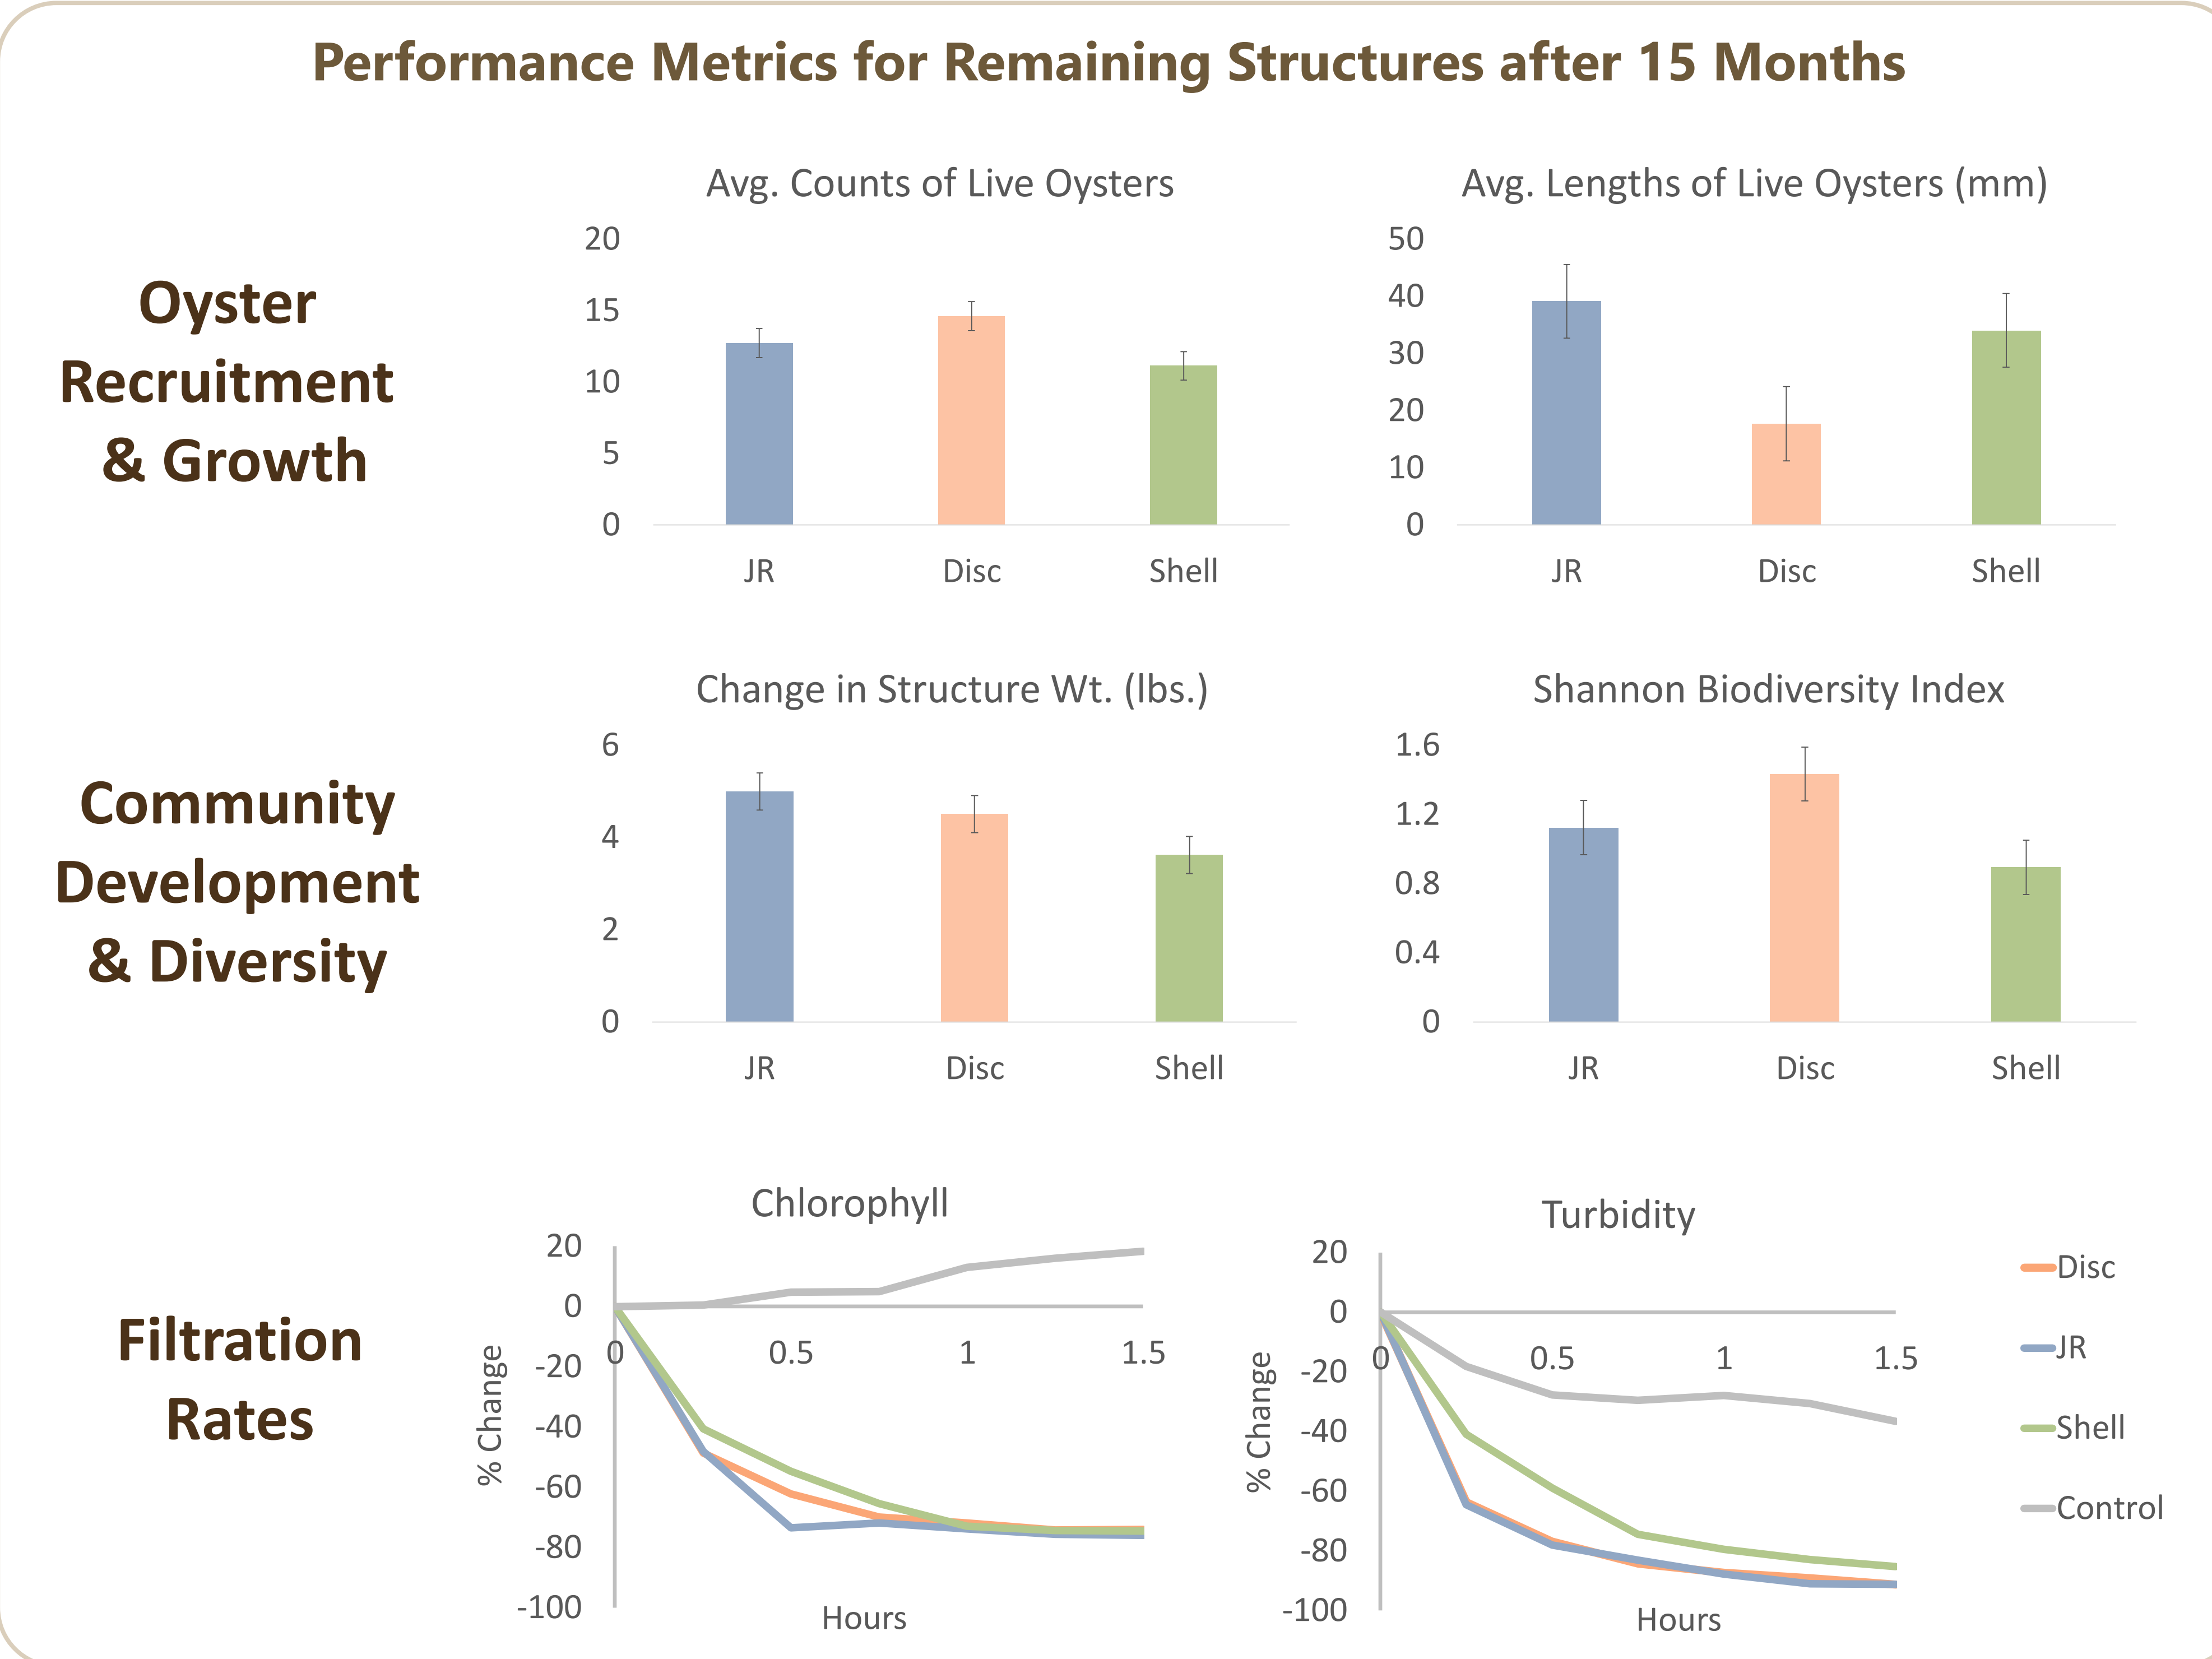
The following graphs are for the remaining structures following monitoring
