# Using Habitat Support Structures (HSS) to Address Habitat Deficits within Bayside Nearshore Hardbottom of the FKNMS

Hanna R. Koch<sup>1</sup>, William Sharp<sup>2</sup>, Andy Bruckner<sup>3</sup>, Carolyn Kalinowski<sup>4</sup>, Keith Mille<sup>4</sup>, John Hunt<sup>2</sup>

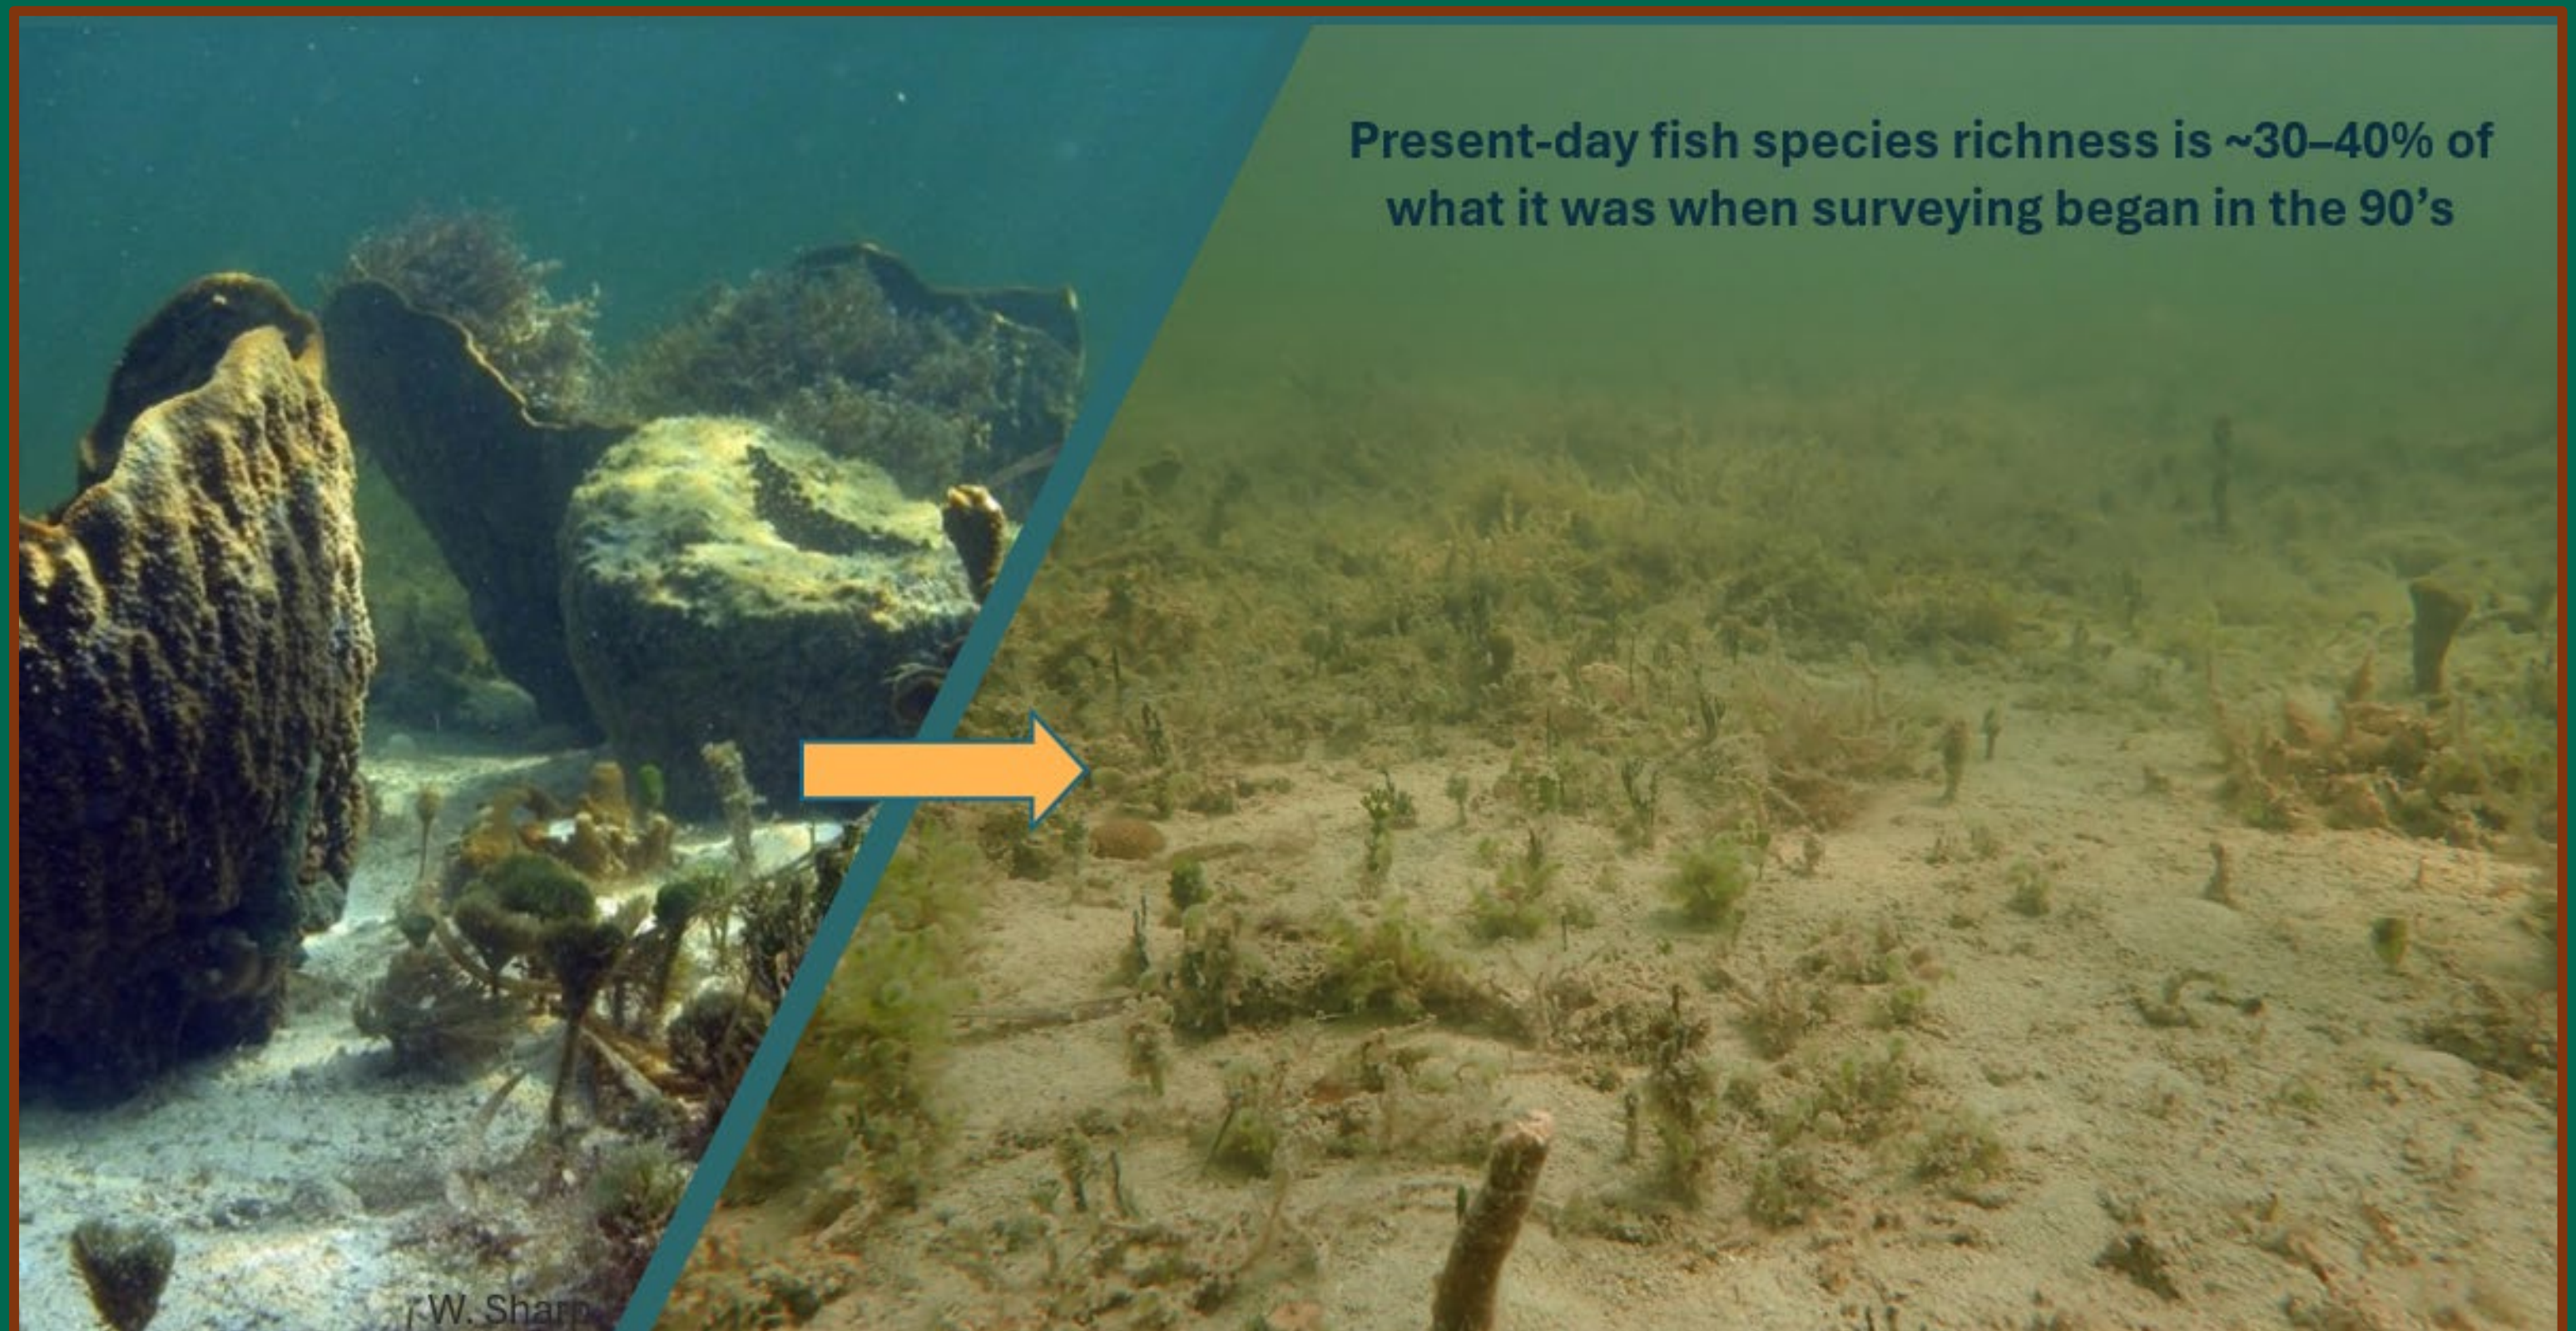
### Study Sites

**Middle Keys Bayside**  
**3 study sites**  
**6-8' deep**

Burnt Point (P01)  
Burnt Point (E01)

Long Key (J01)

**2 plots/site**  
**6 replicates/treatment**  
**1 treatment/3,700m<sup>2</sup>**  
**Randomized block design**

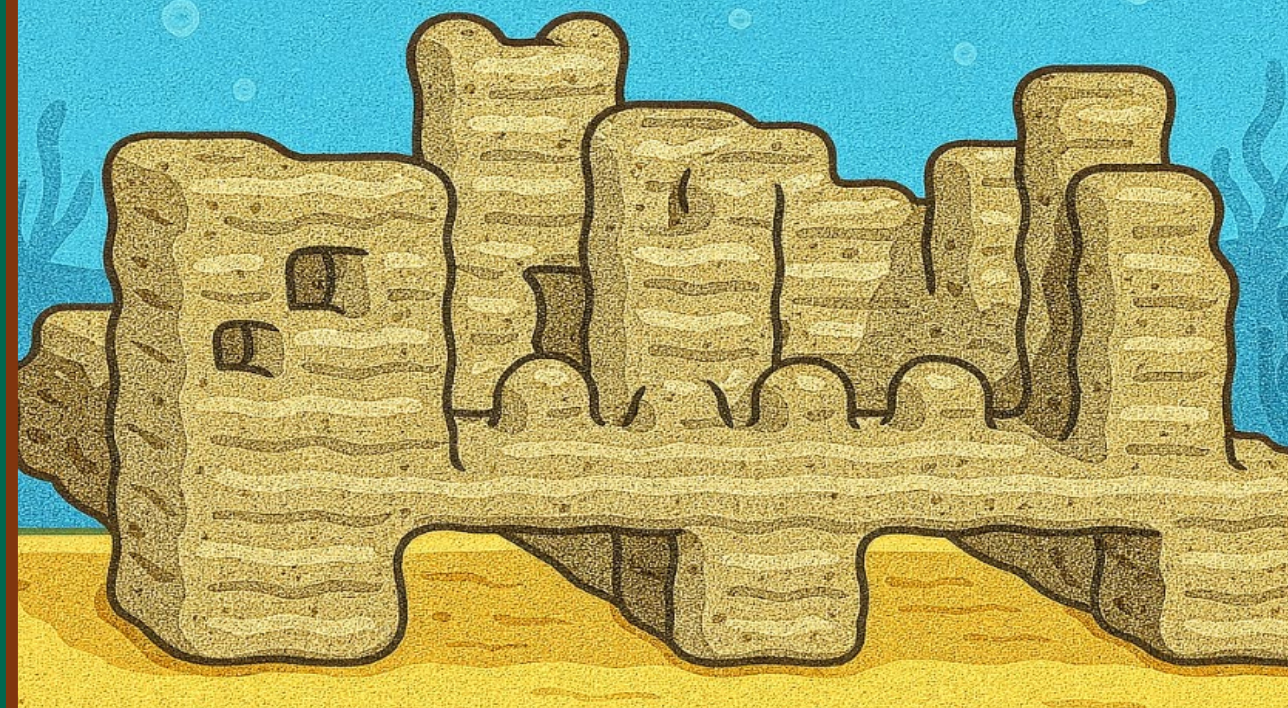
**Complex Physical Structure**

3DP Concrete

All Low Relief: 1.5' H x 3' W x 3' L

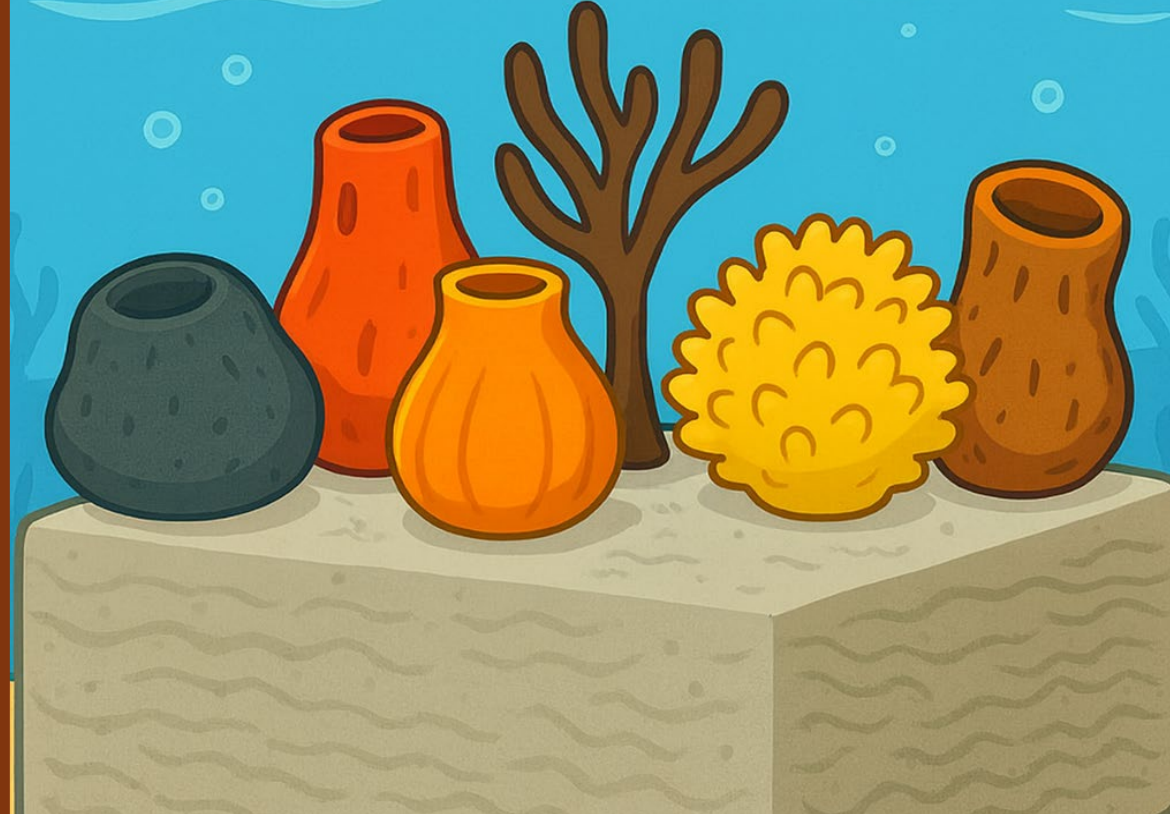
**Physical + Biological Structure**

~6-species sponge community

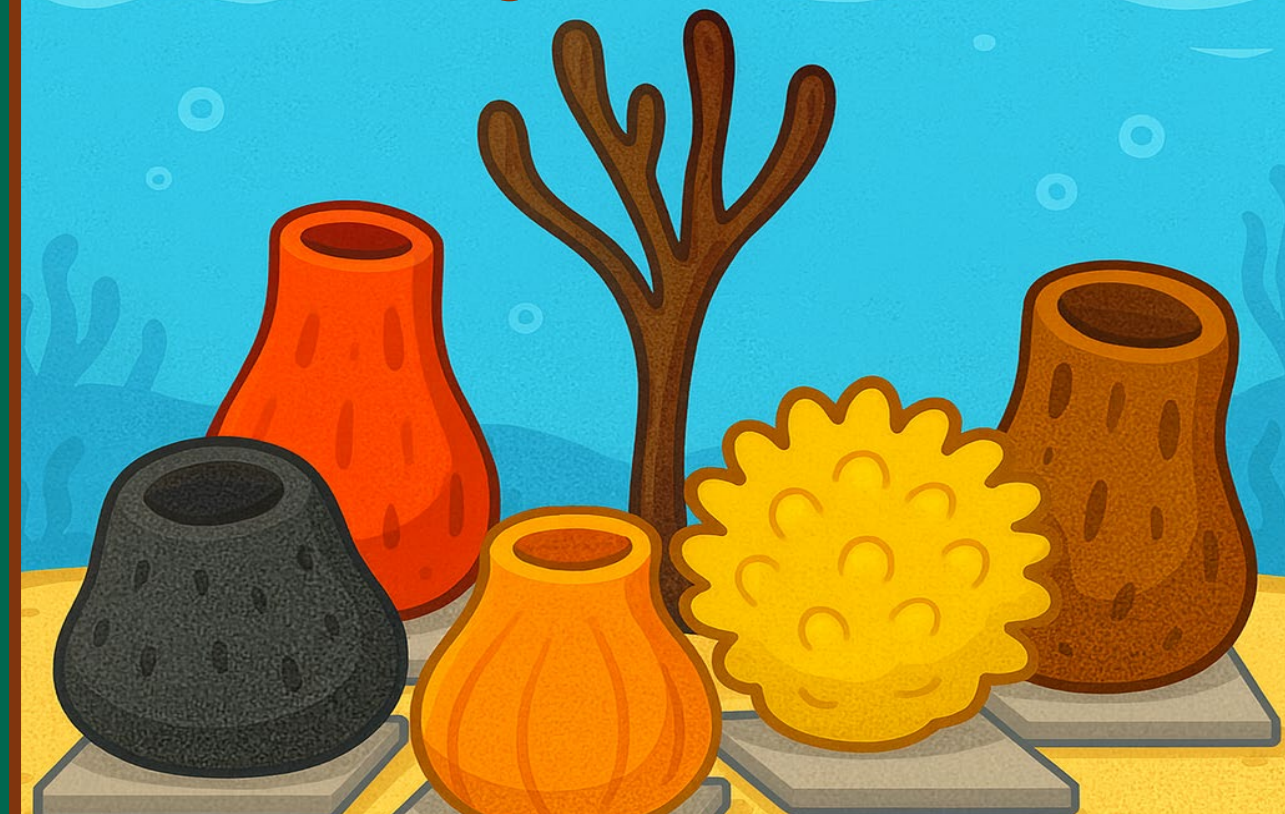
**Biological Structure**

6-species sponge community
