Groundwater salinization in the lower Florida Keys following Hurricane Irma storm surge

Danielle E. Ogurcak, René M. Price, Richard Dorrance, and Michael S. Ross

Florida International University, Miami, FL

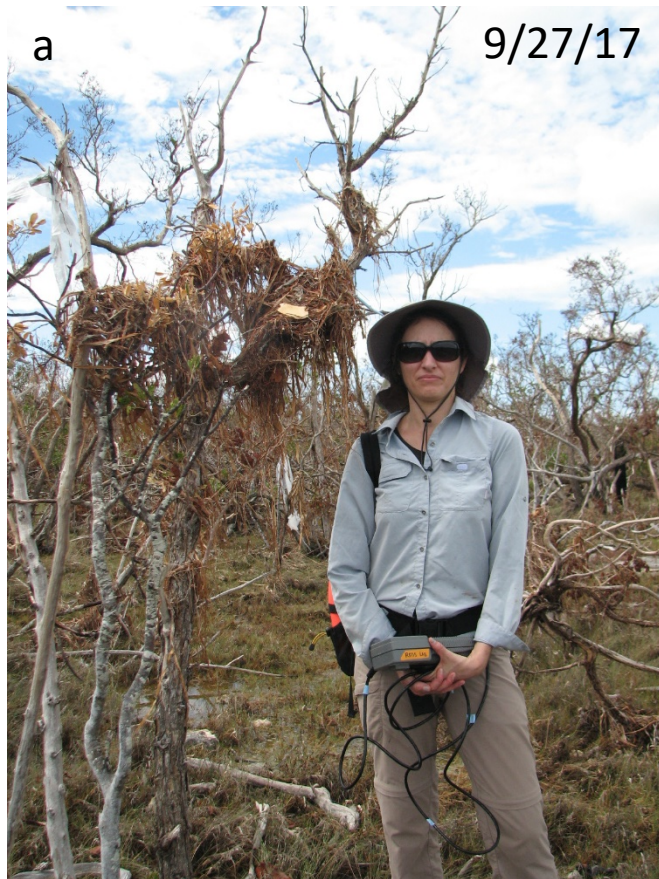
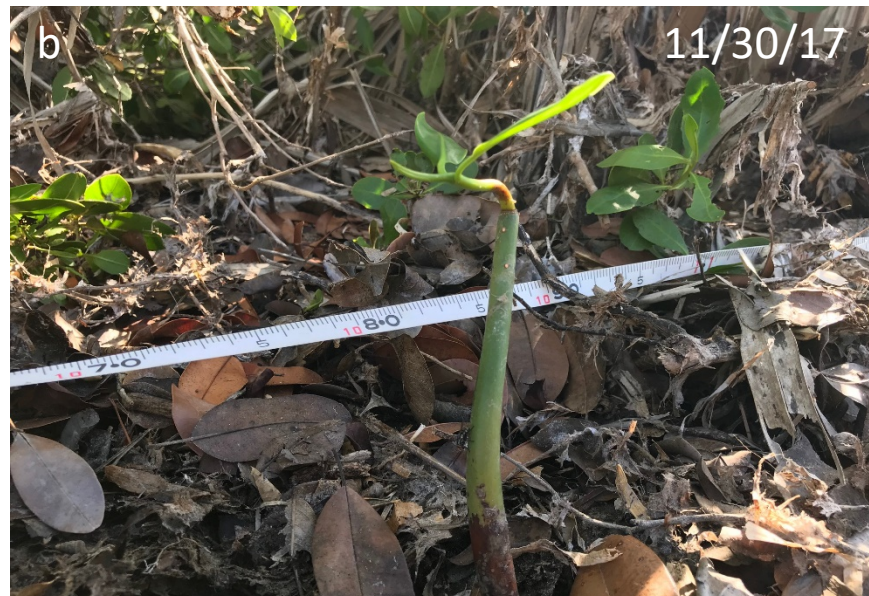
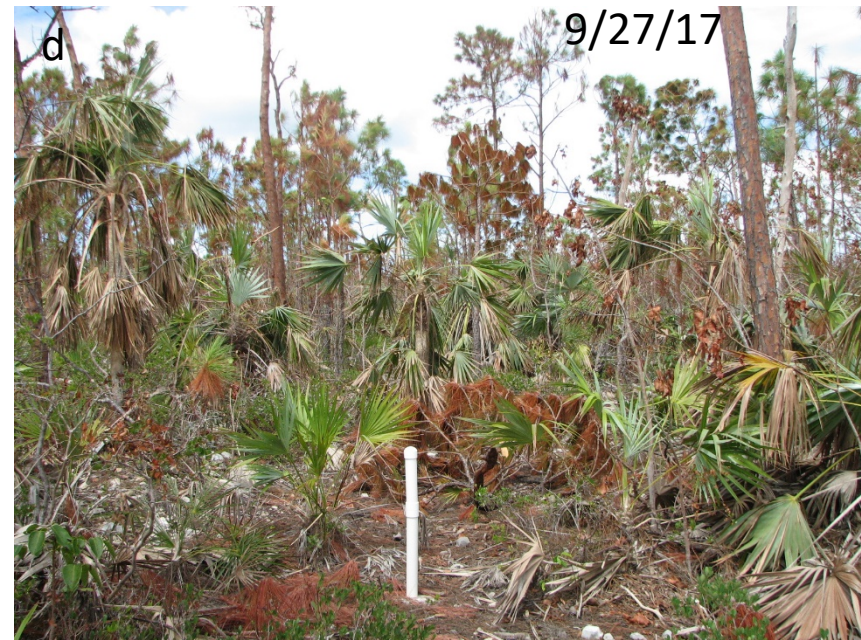
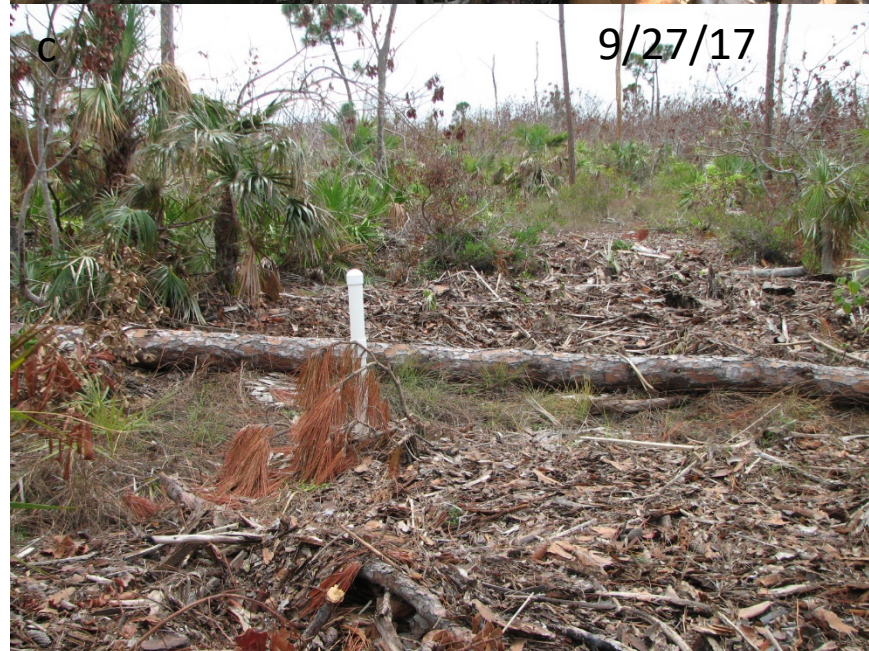
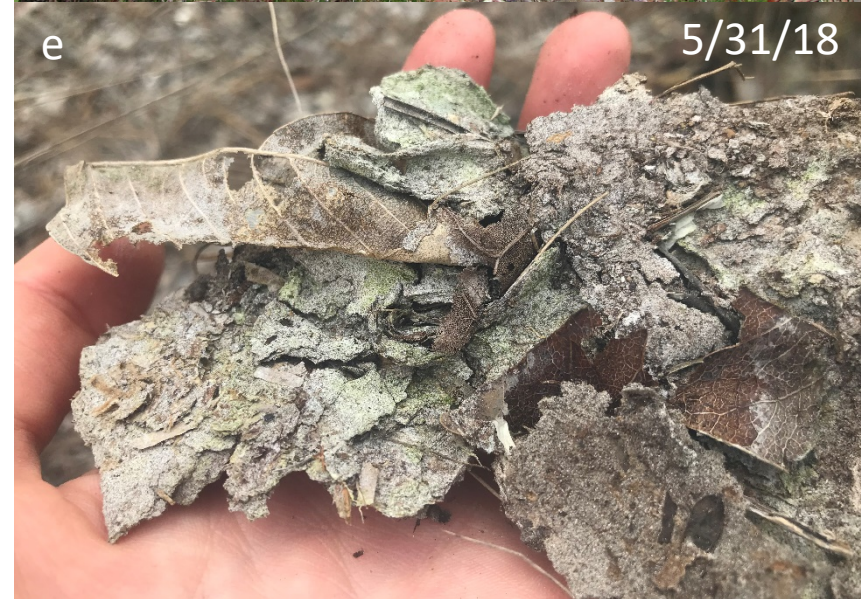
Evidence of storm surge on Big Pine Key

- a) Storm wrack in trees
- b) Red mangrove seedling in pine
- c) Storm wrack around wells
- d) Brown pine needles
- e) Marine marl in pineland
