An update on the biological monitoring of the Lake Trafford Restoration Project, Collier County, Florida: A case for monitoring during restoration

David W. Ceilley, Edwin M. Everham III, Serge Thomas, John A. Morris, and Kory M. Ross, Inland Ecology Research Group at Florida Gulf Coast University

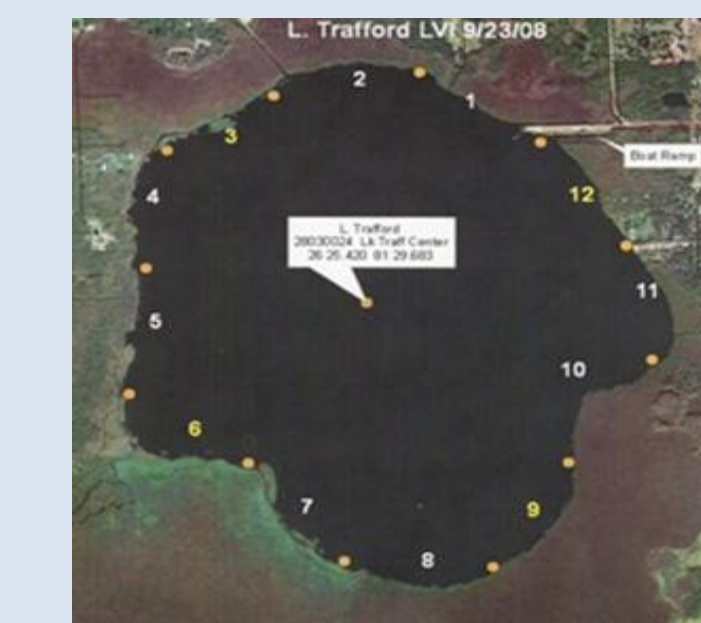
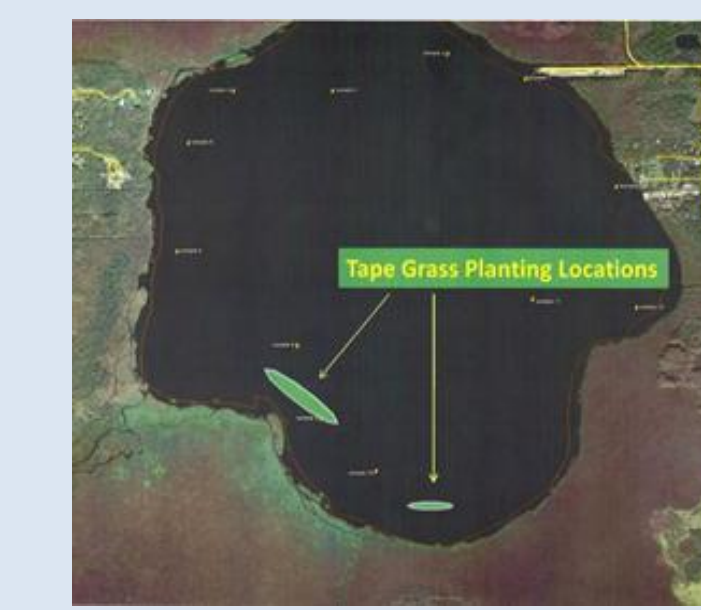
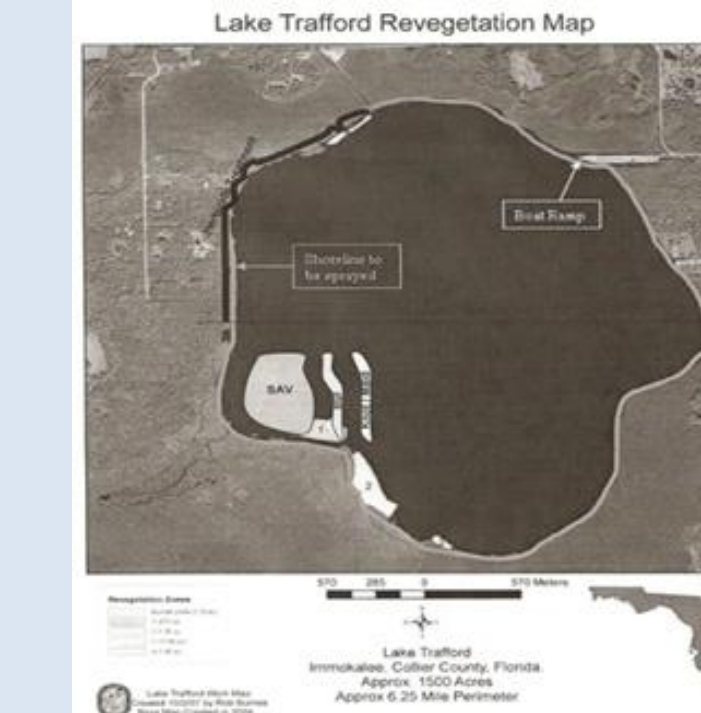
➤ **Transect profiles** of the Lake bottom and survey for submerged aquatic vegetation (SAV) were completed on 27 May 2010 using a Biosonics Echosounder™. General depth profiles of the Lake bottom were graphed along with signatures of a soft-bottom or unconsolidated flocculent organic material. Transects were ground-truthed at selected intervals using petite Ponar dredge and PVC pipe. No SAV were detected from the transects or grab samples. *Hydrilla verticillata* was found in three canals on 4/27/10 when touring the Lake with FWC Biologists. Locations of *Hydrilla* were GPS mapped and sent to FWC and SFWMD for herbicidal treatment for control.

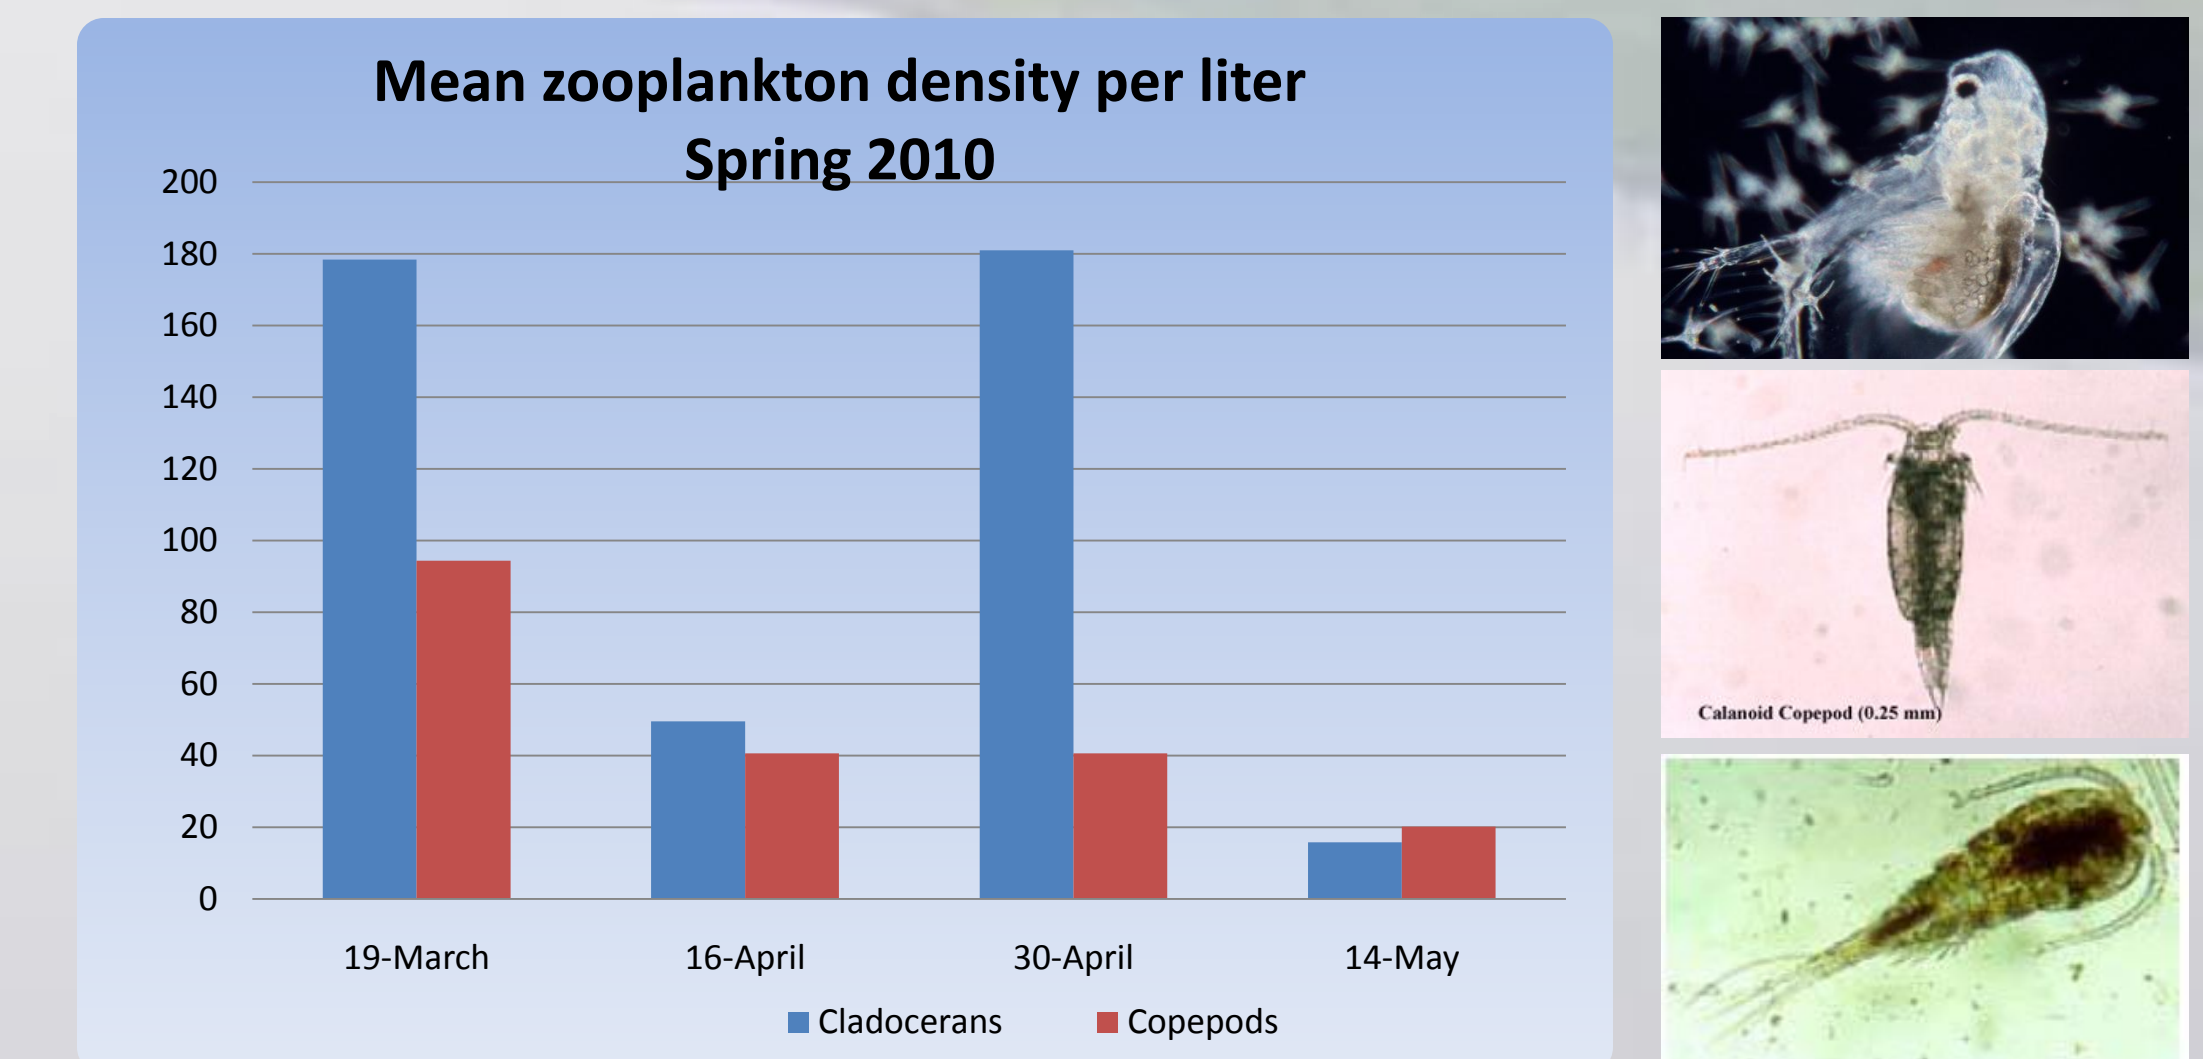
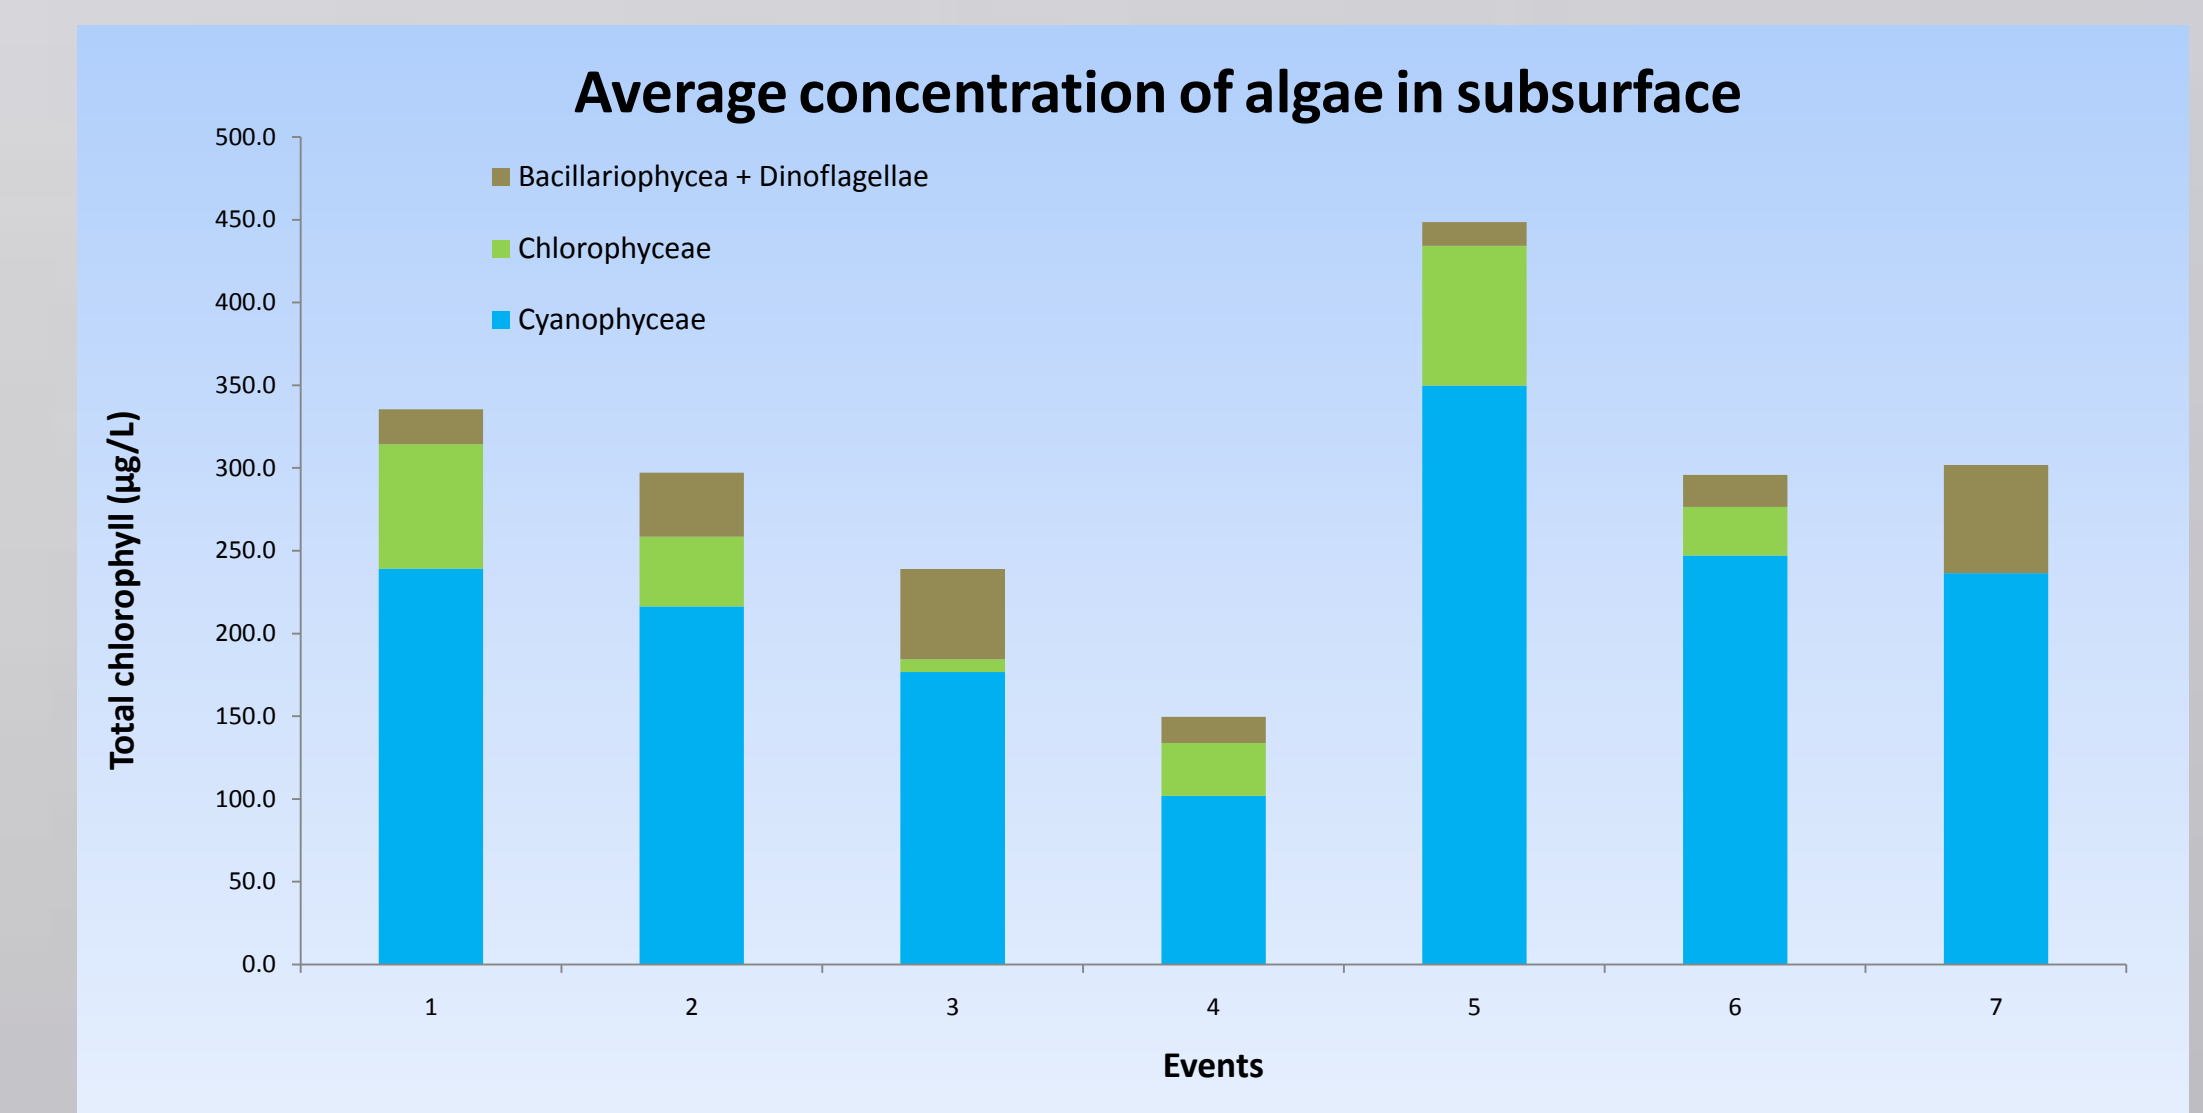
Performance Measures

➤ **Field water quality parameters and phytoplankton communities** have been sampled biweekly by boat since early March 2010 at 12 locations. Lake samples are returned to FGCU labs for analysis using PHYTO-PAM which calculates photosynthesis and can determine for each algal group present in the water sample (cyanobacteria, green algae and Diatoms/dinoflagellates pooled together).

➤ **Zooplankton communities** have been surveyed in conjunction with the phytoplankton sampling using standard 367-micron mesh plankton net to exclude nano-plankton. Organisms collected were identified to the lowest practical taxonomic level with density estimates for major taxa prepared based on length of tow, diameter of the net aperture, and Sedgewick-Rafter cell counts. Zooplankton counts were averaged from five sites (T-1, T-4, T-6, T-11 and T-12) for each date for this progress report.

➤ Lake Trafford abiotic gradients – turbidity, temperature, and light (PAR) attenuation are problematic and the Lake remains phytoplankton dominated. Water clarity should become a performance measure to allow SAV recovery.
