# Revisiting Ecological Integrity on the Kissimmee River

“Are we there yet?”

Erik Powers, EPJV  
Cathy Byrd, USACE

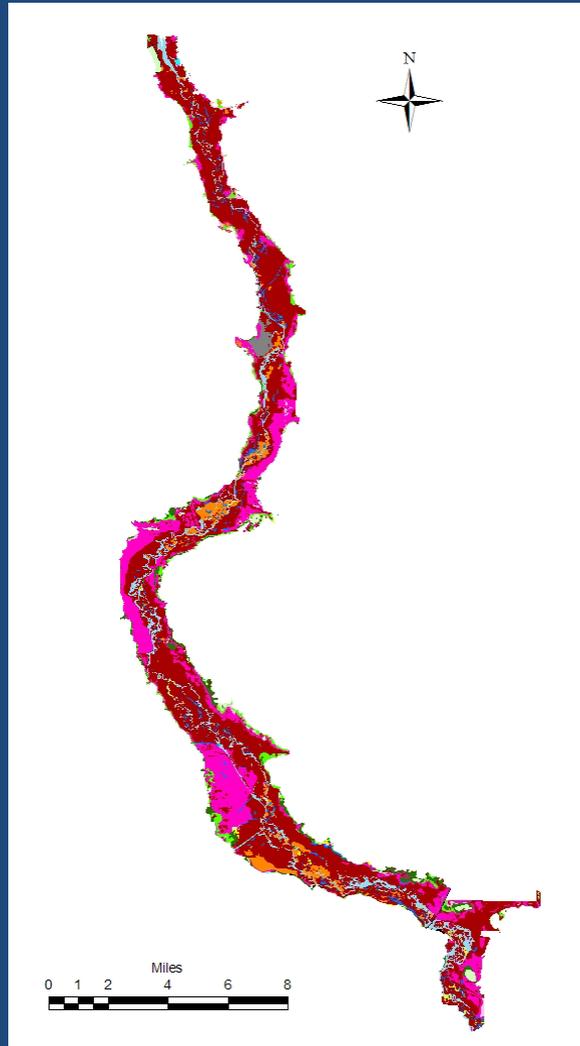
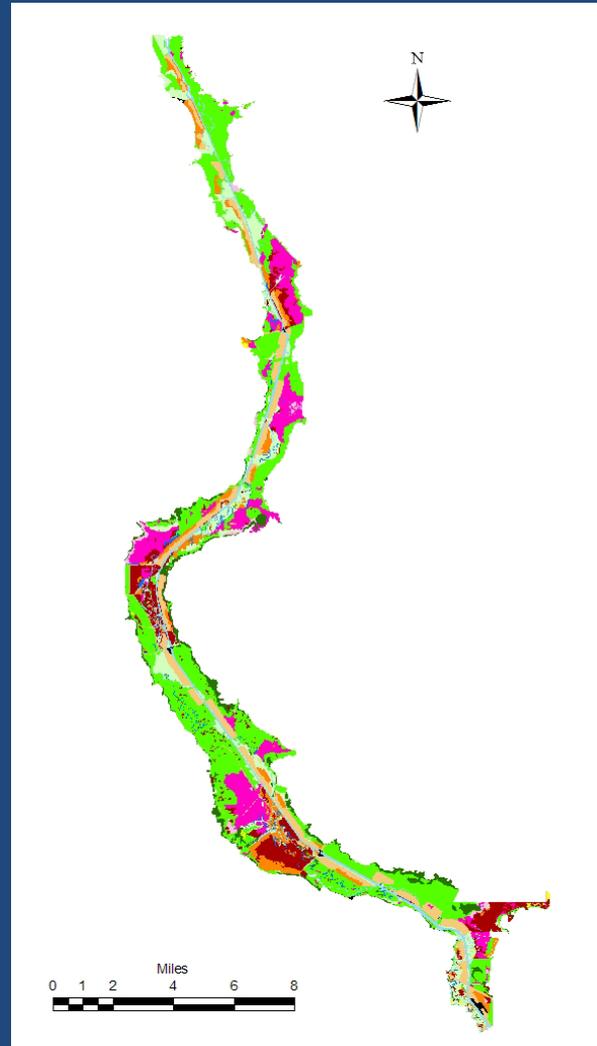
# Floodplain Vegetation

1950

1970

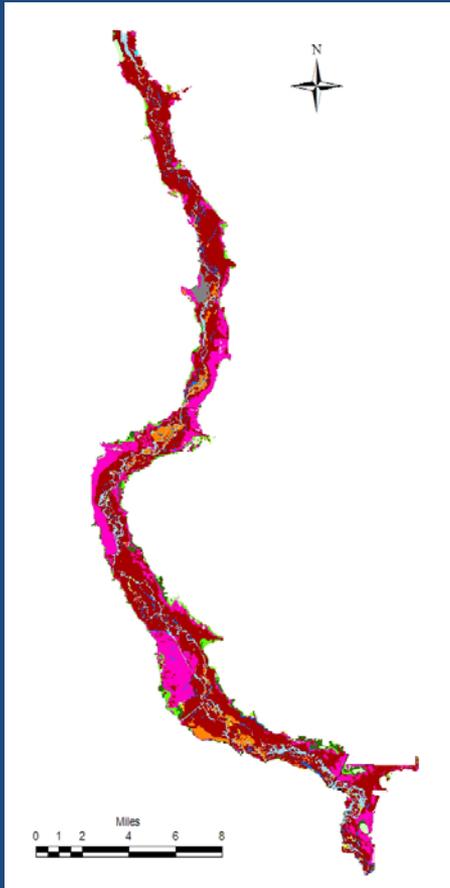
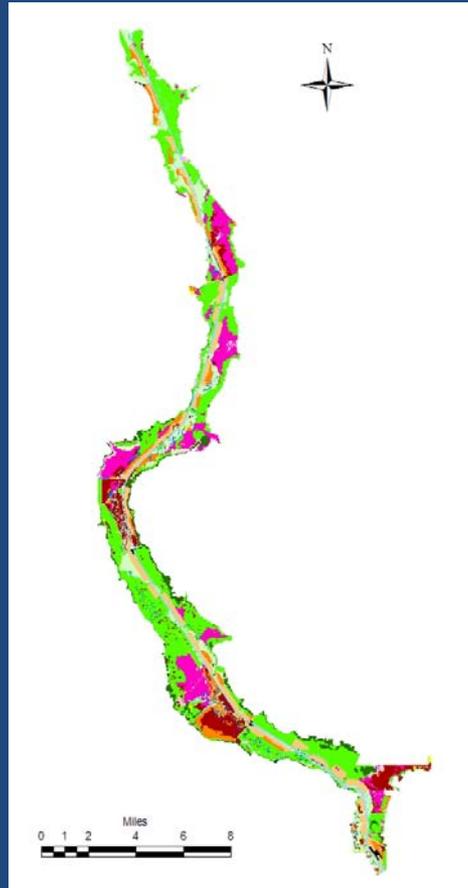
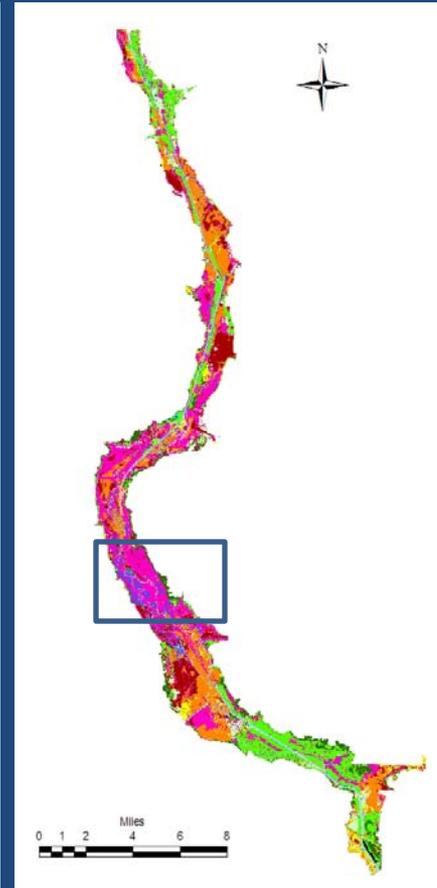
# Floodplain Vegetation

1950

1970

2008

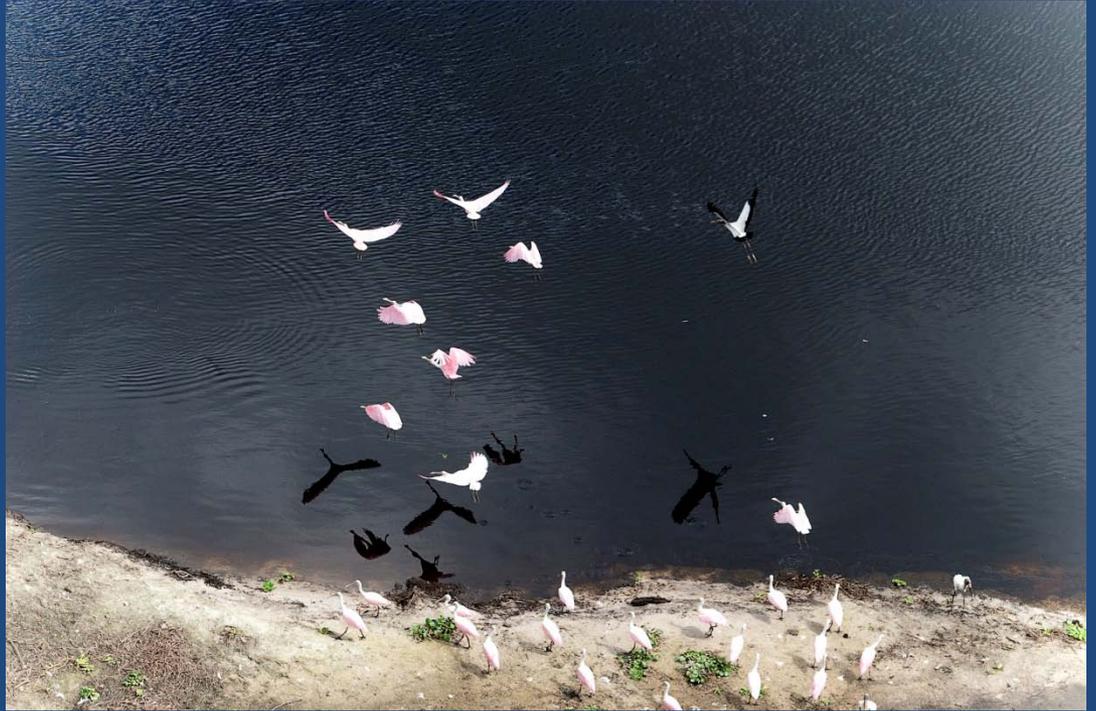
# Wading Bird Utilization

- Target (30.6 birds/km<sup>2</sup> during the dry season) achieved most years
- Dry years result in substantially lower wading bird densities.

- Nest abandonment is common
- Increasing the magnitude of flooding is necessary.
- Potentially a population “sink”.

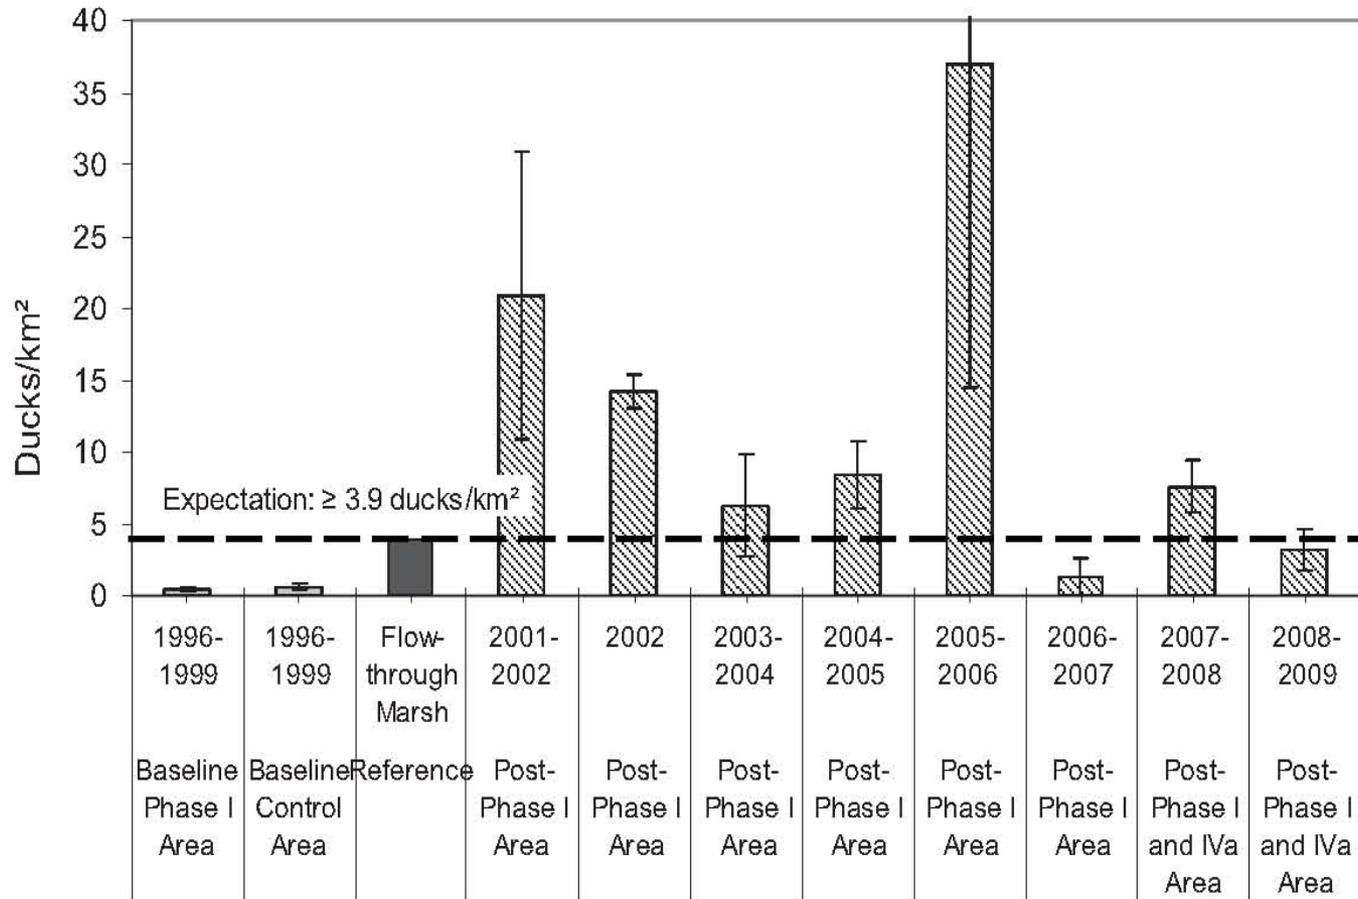
# Densities of Waterfowl

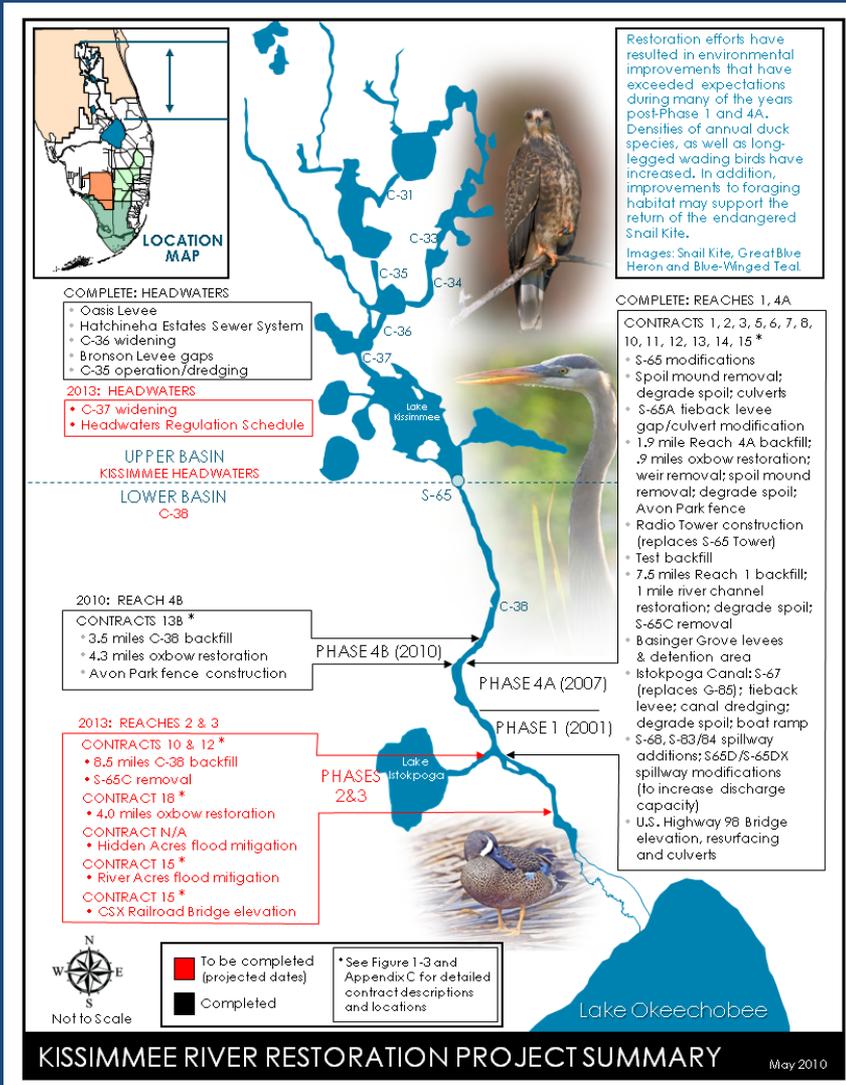
# Project Status

- 13 miles of filled channel; 9 miles remaining
- Final phases expected to be complete in 2014
- New schedule raises water levels 1.5 feet and increases water storage capacity in the upper basin by 100,000 acre-feet
- Appropriation of additional funds needed to complete

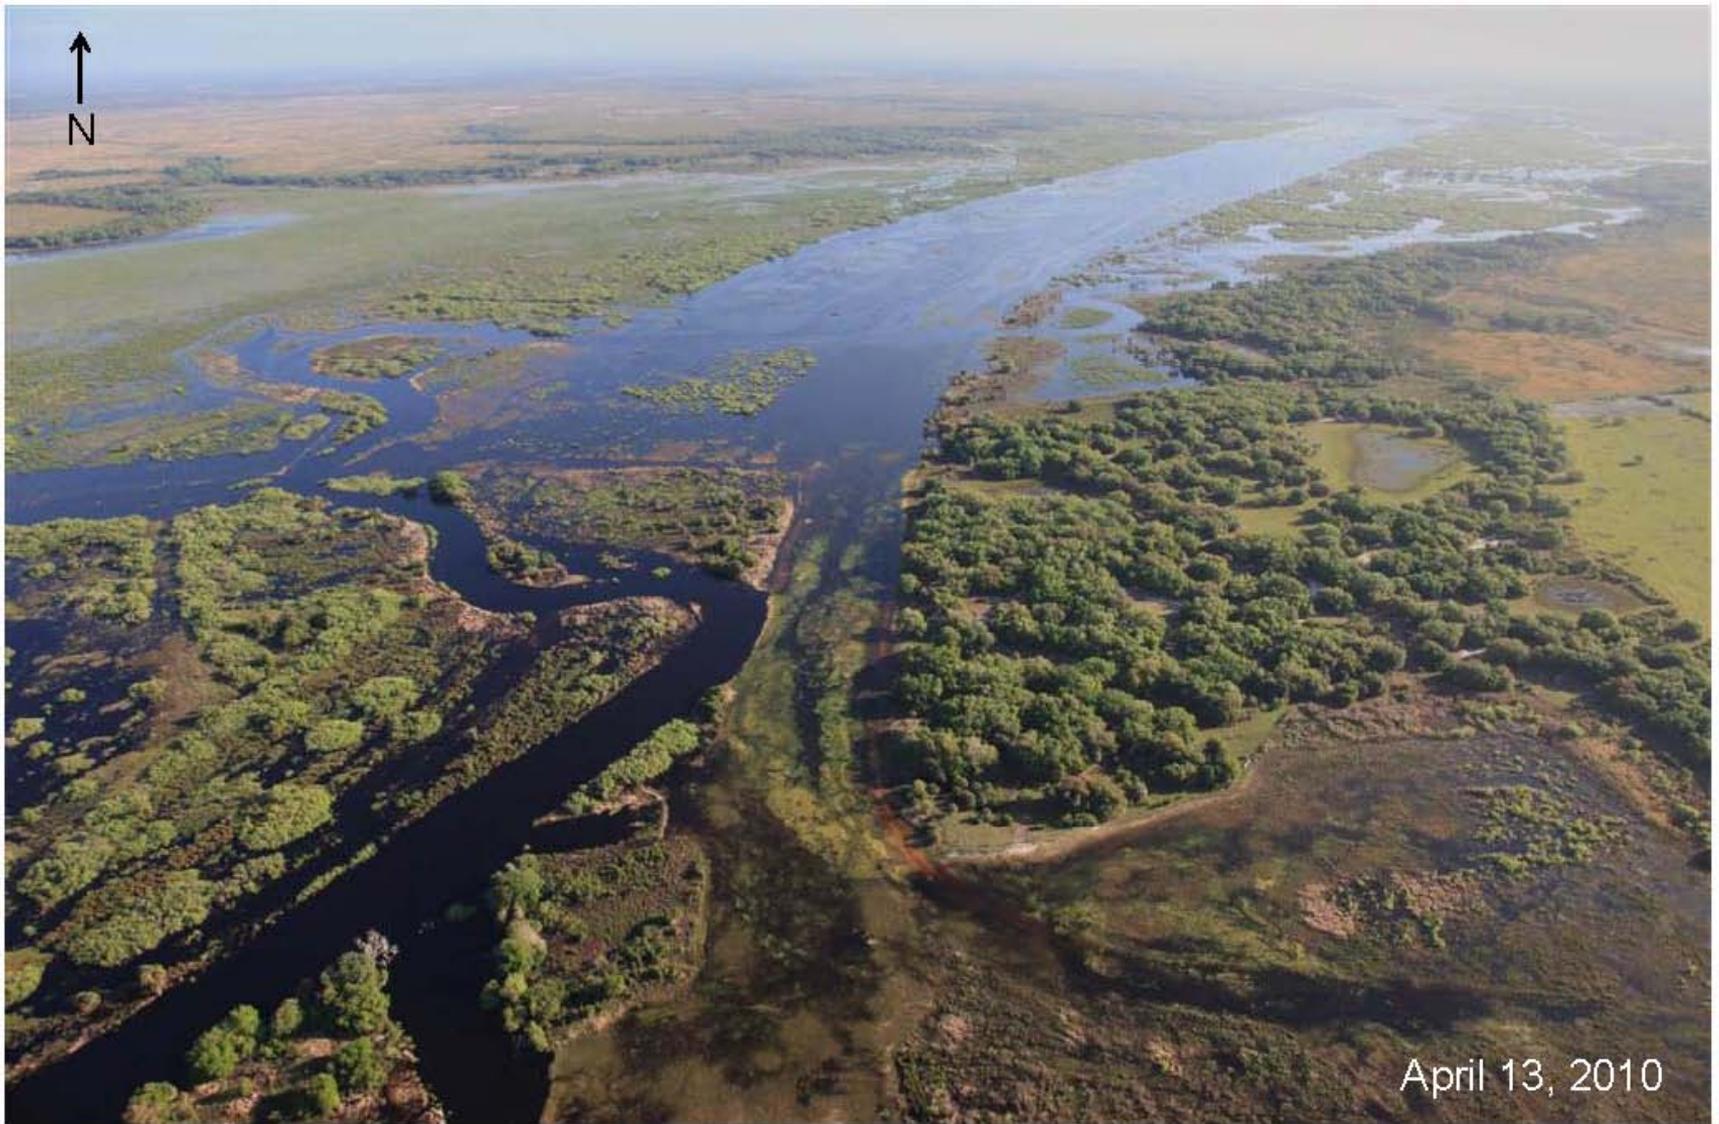
Phase IVB restoration area looking north from southern extent.

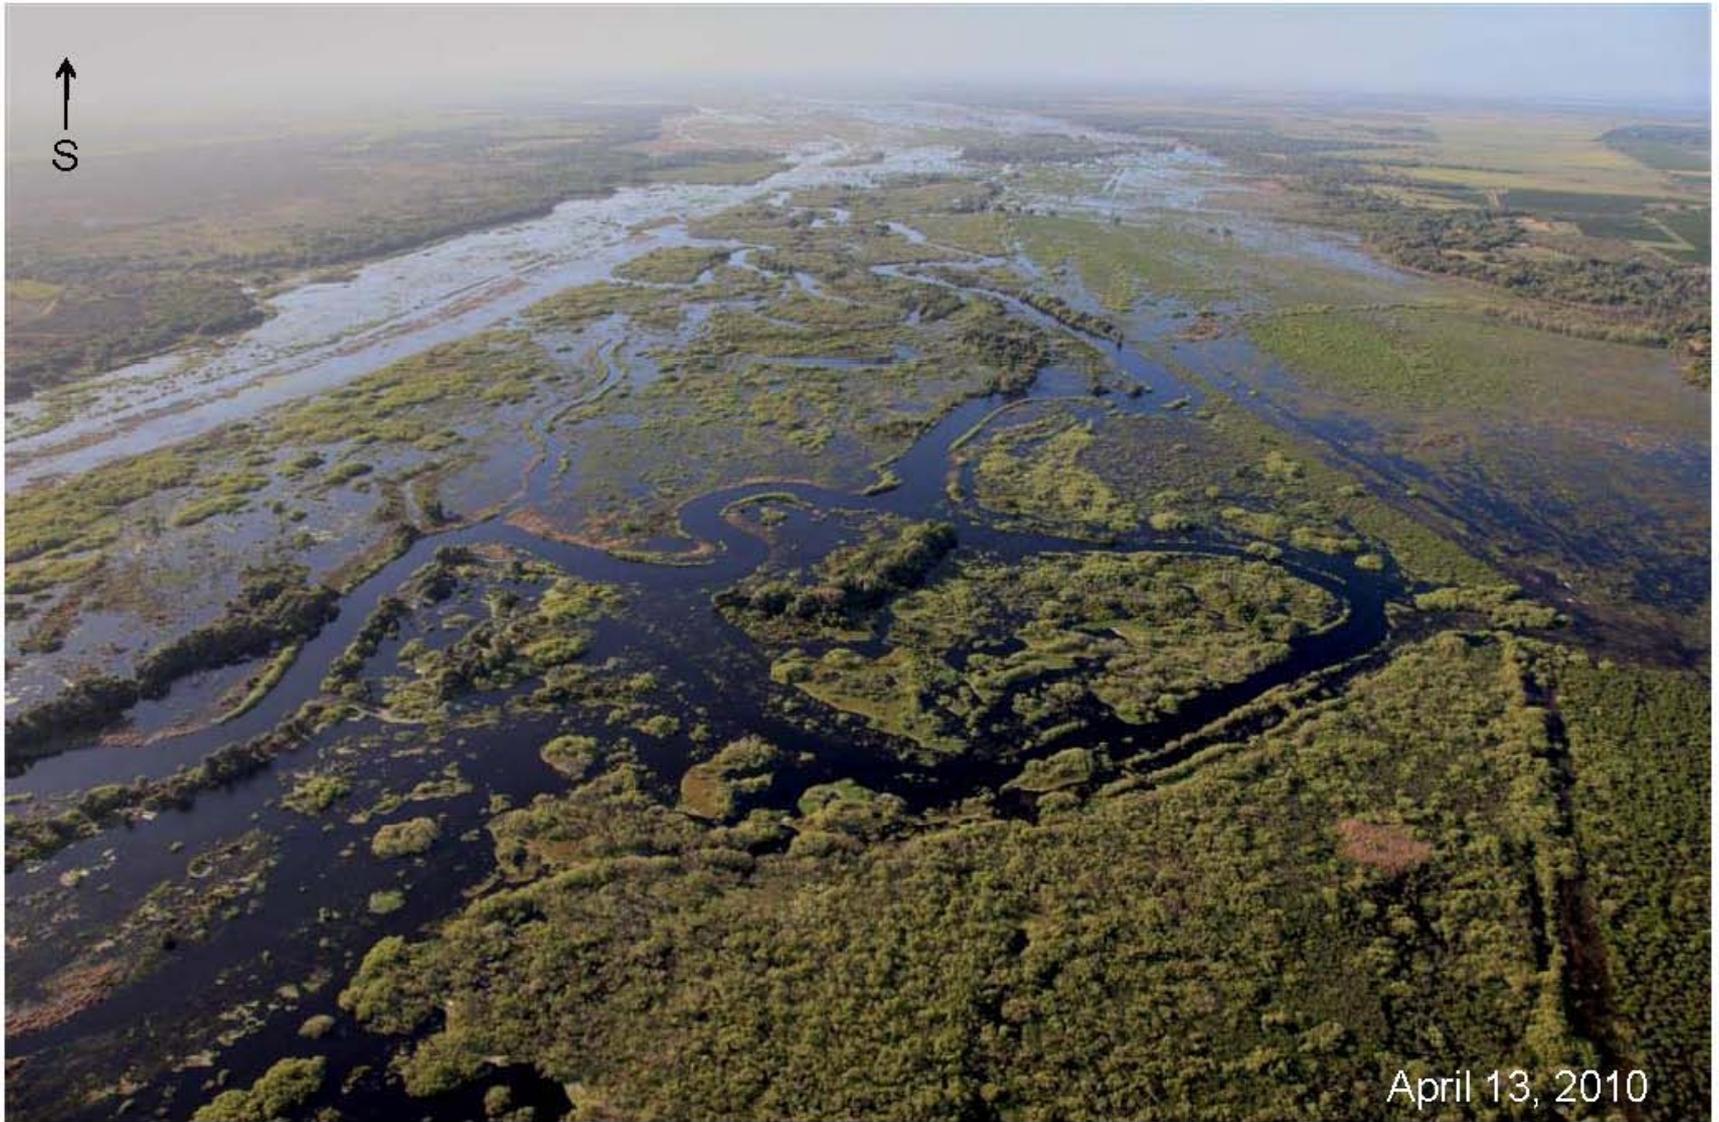
Phase IVA restoration area looking south from northern extent

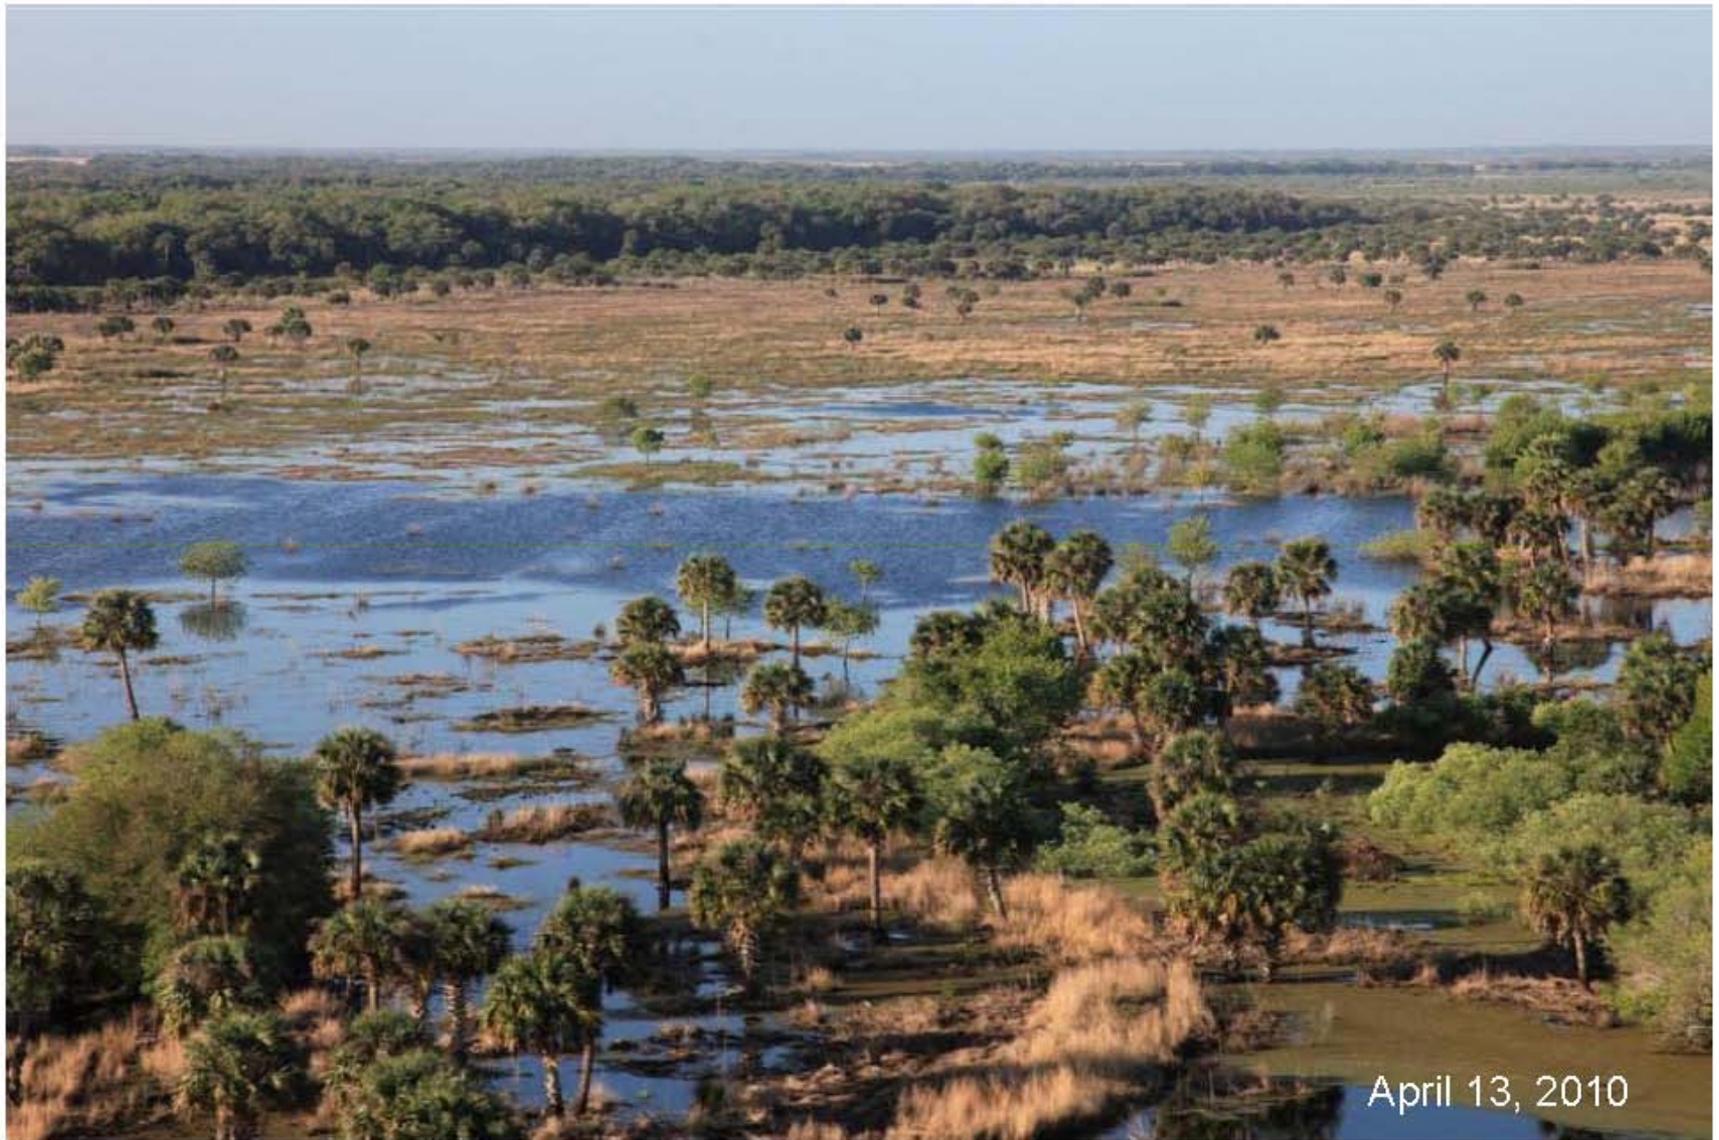
April 13, 2010

Phase IVA floodplain looking east toward oakline.

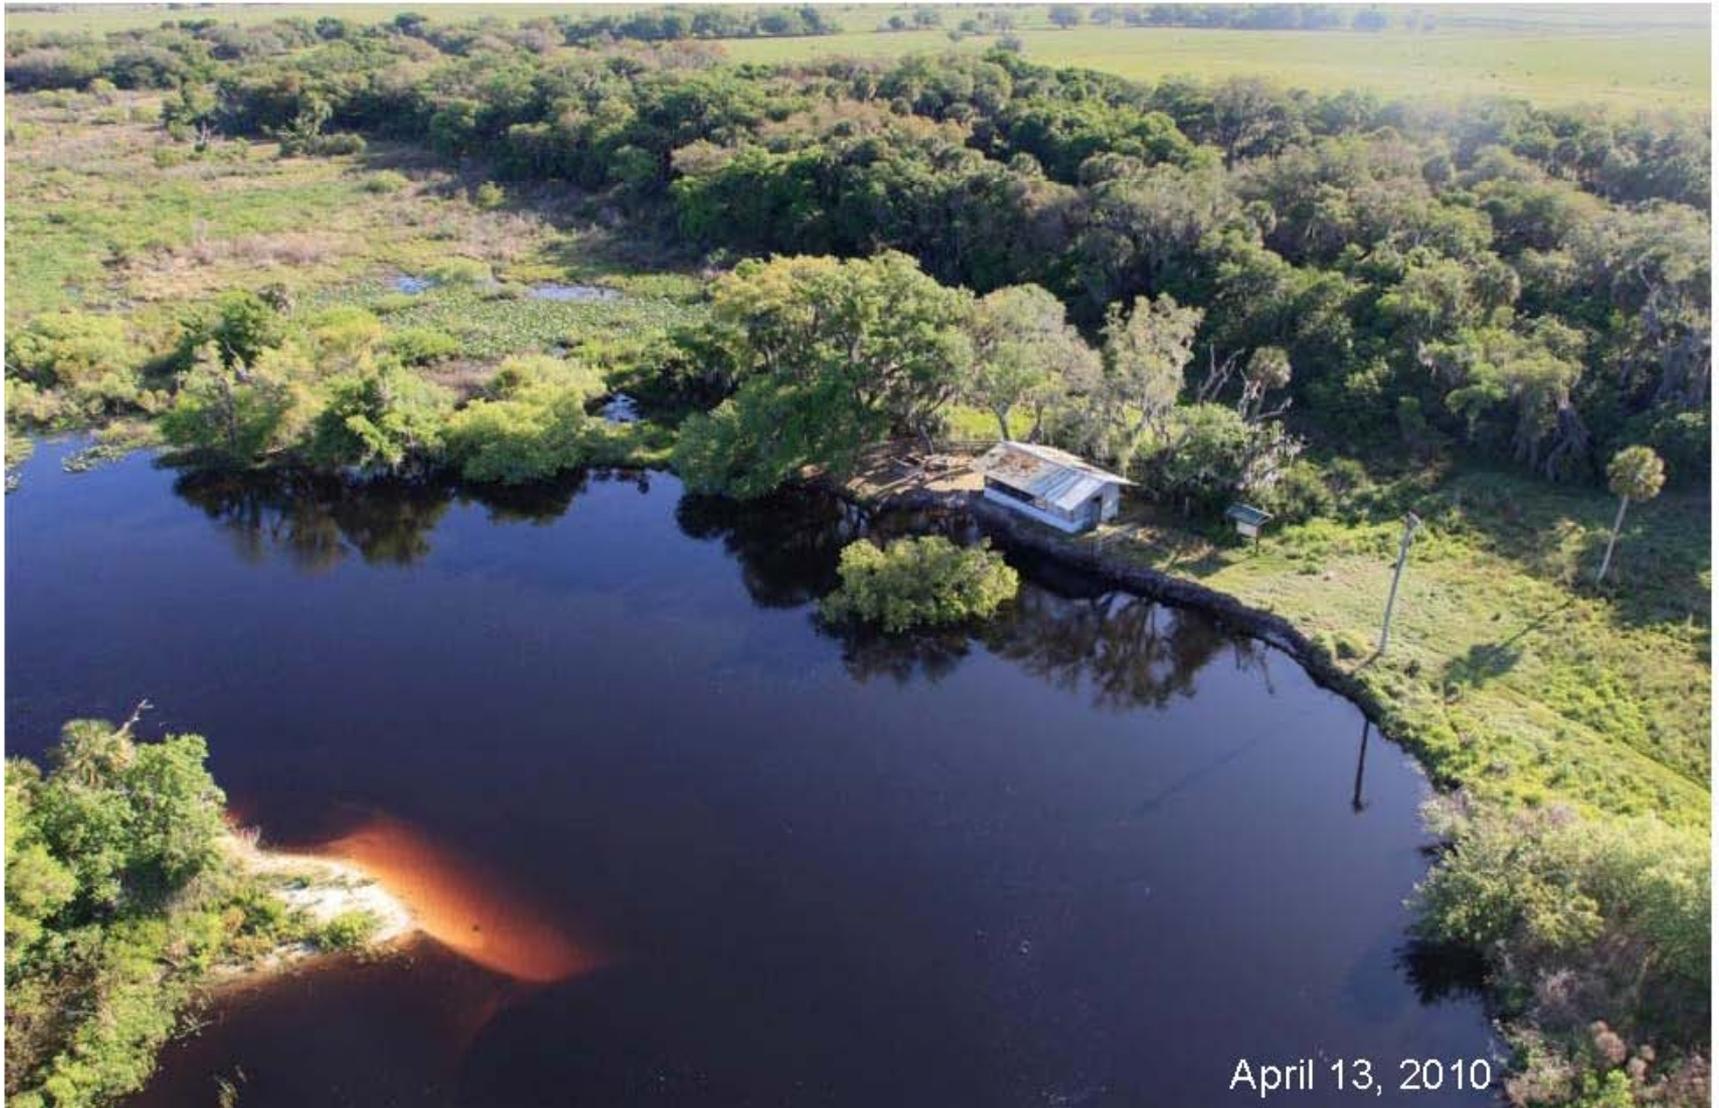
April 13, 2010

Continuous high flows this winter scoured the bank near the Micco Shelter, and it will have to be removed. This is a very sad time since the Micco Shelter has been used as a shelter from storms during field work since the project began.

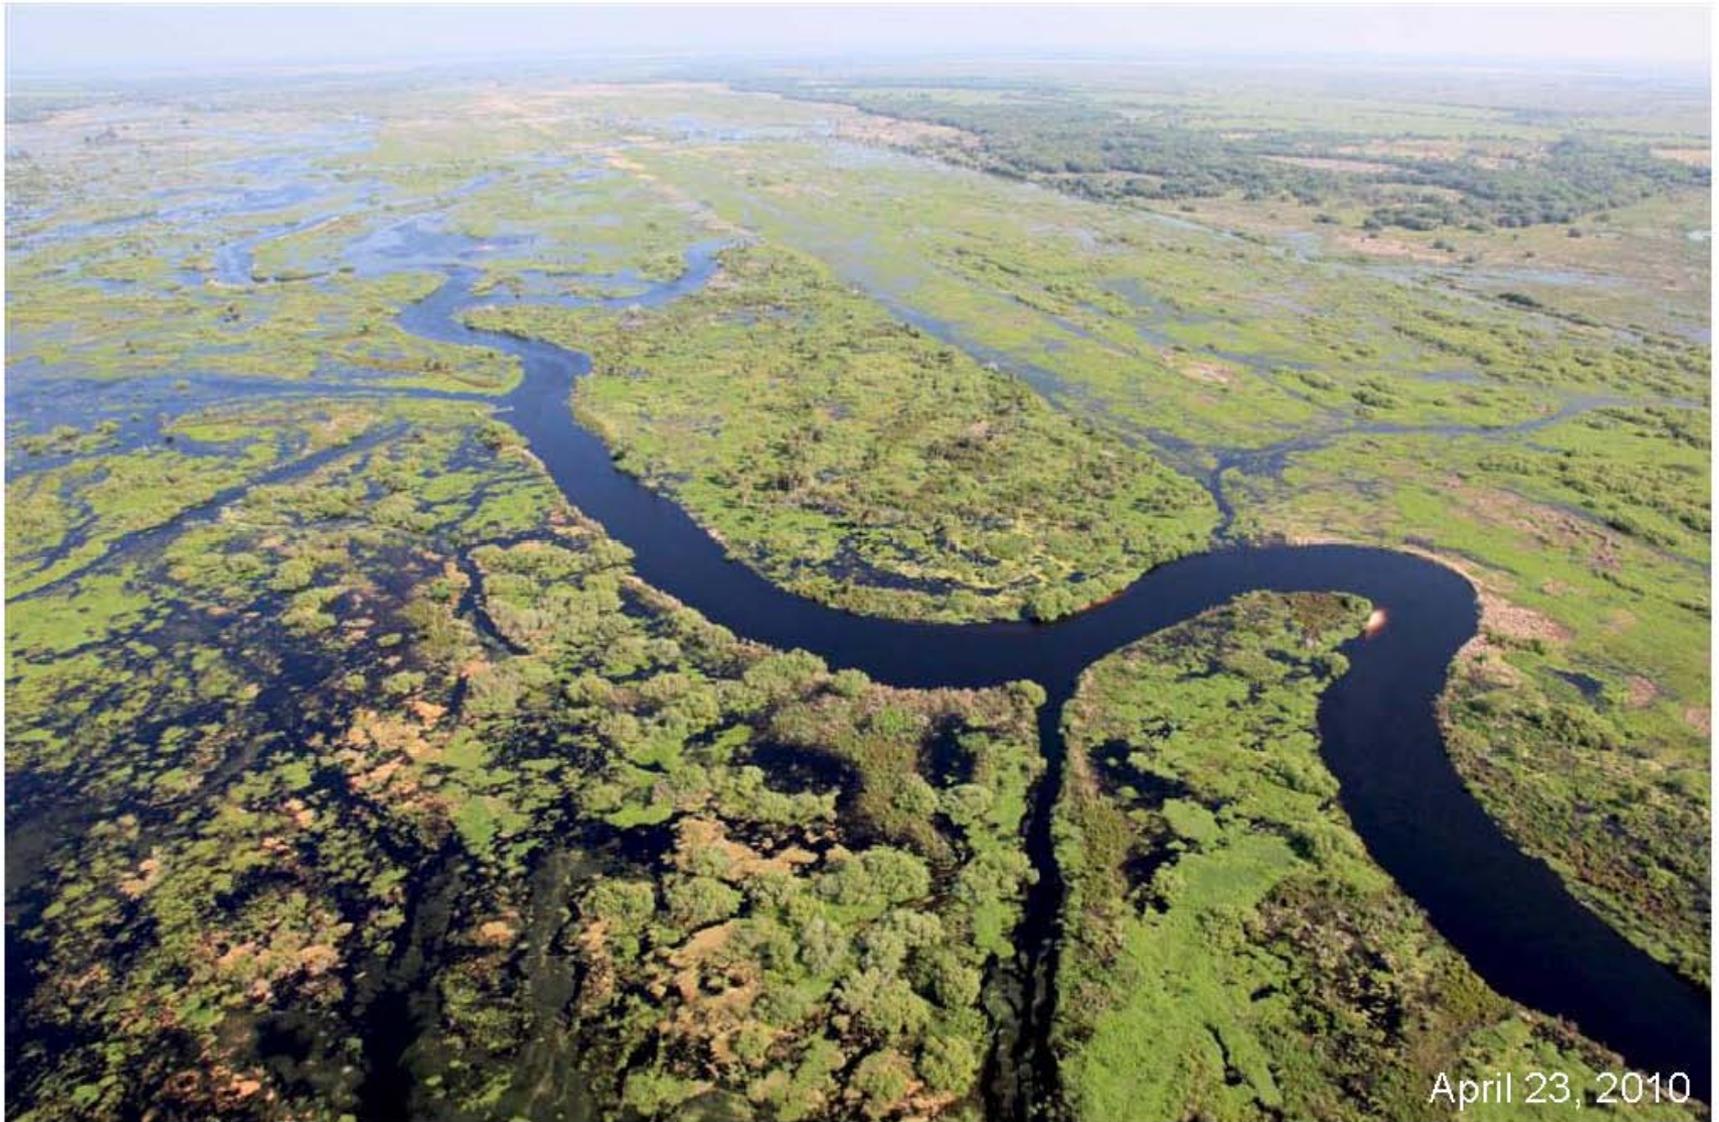
Phase I restoration area looking north. The re-vegetated C-38 backfill scar can be seen here in the upper right.
