Vallisneria americana restoration in the Caloosahatchee river & estuary: building coastal resiliency through partnerships, applied research & adaptive management.

Brett Fitzgerald¹ David W. Ceilley,² Edwin M. Everham, III³ James G. Douglass, Carter E. Henne⁴, Ryan C. Bushwood⁴ and James F. Anderson⁴
 1 Angler Action Foundation, 2 Johnson Engineering Inc. Ft Myers, FL dceilley@johnsoneng.com, 3 Florida Gulf Coast University, Ft. Myers, FL, 4 Sea and Shoreline LLC, Ruskin, FL

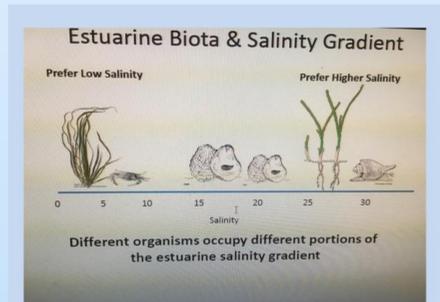
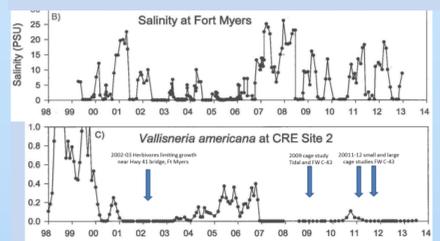
Vallisneria "Average Proportion Vegetated/m2" System Status Report 2014 (J. Douglas, Ph.D. FGCU). Vallisneria appears to be "down for the count"

Historic distribution and density of SAV species reported from the Caloosahatchee River estuary in Fort Myers - Cape Coral area of SW Florida (left) and *Vallisneria americana* density (right). Virtually all of the 1,200-acres of *Vallisneria americana* (and seed bank) has been lost since 2001. The project goal is to restore these grass beds in the upper estuary.

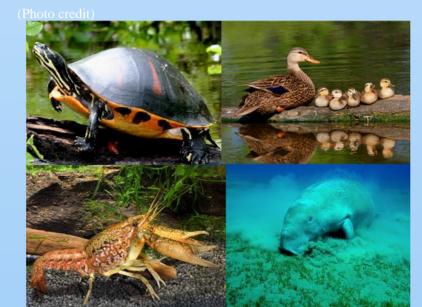
Grazers (above) must be excluded until grass beds become established.
