The Effect of Hurricane Irma Storm Surge on the Freshwater Lens in Big Pine Key, Florida using Electrical Resistivity Tomography

Greater Everglades Ecosystem Restoration 2019

April 24, 2019

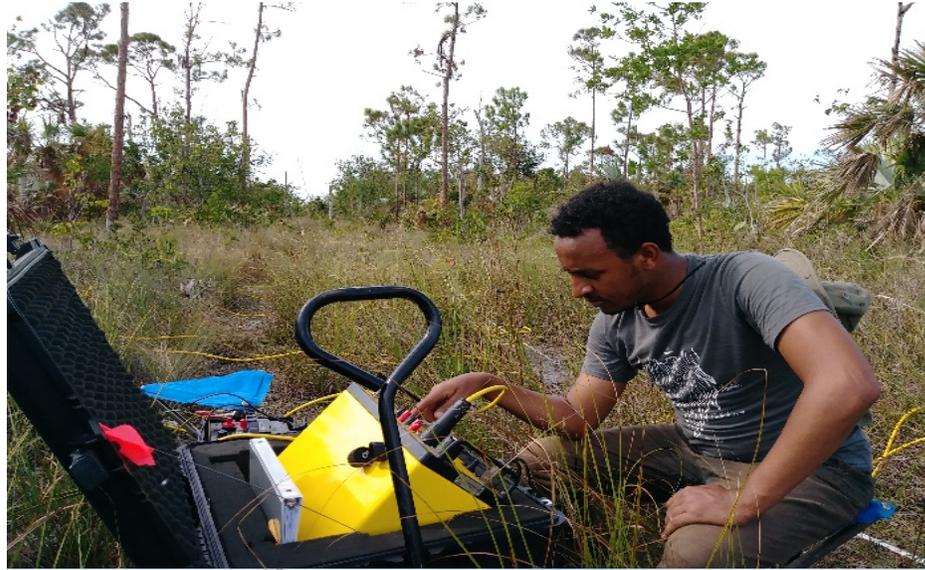
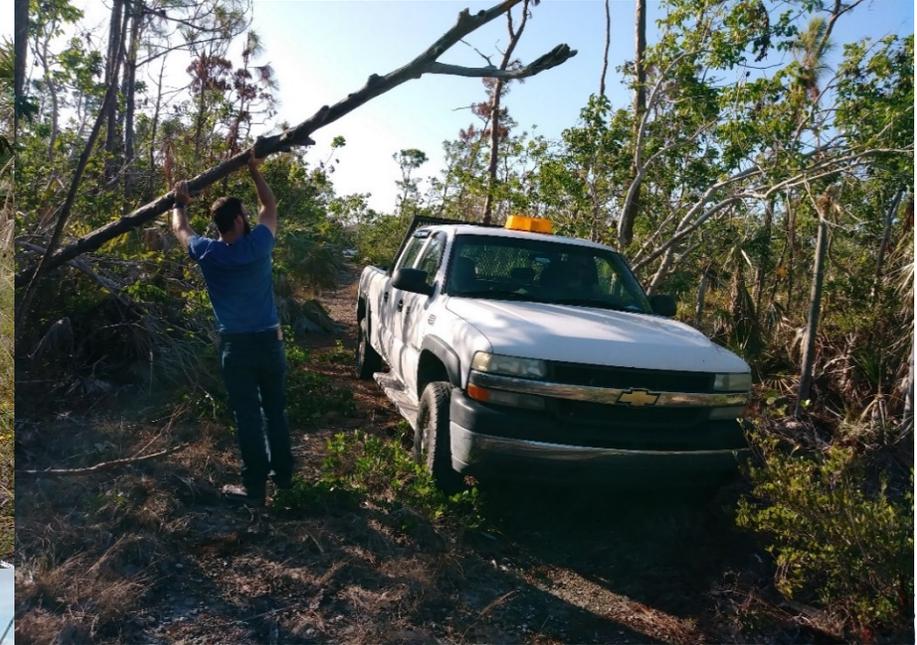
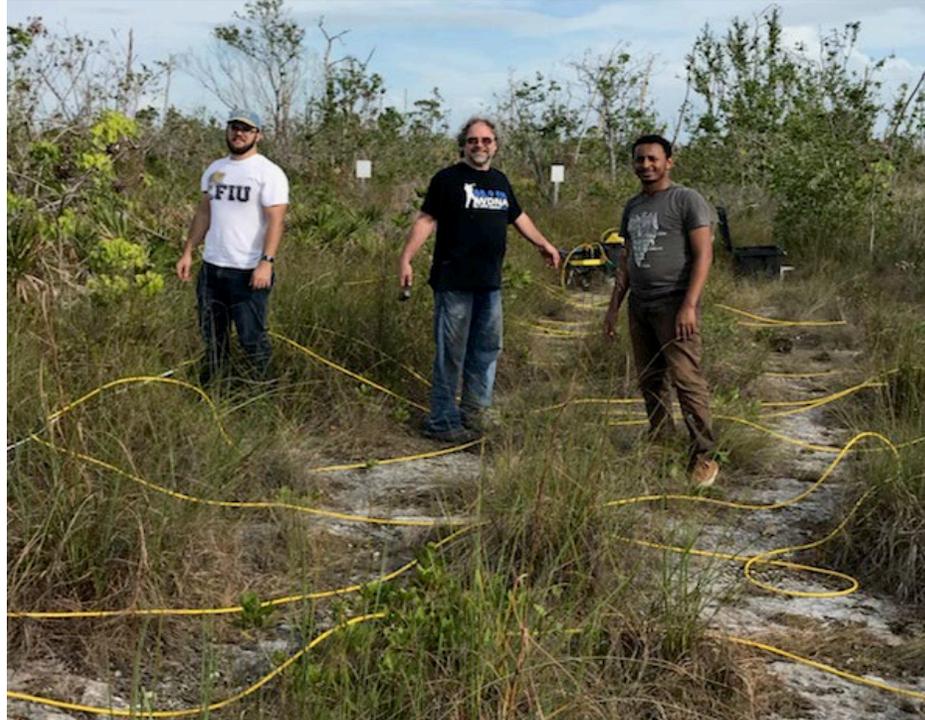
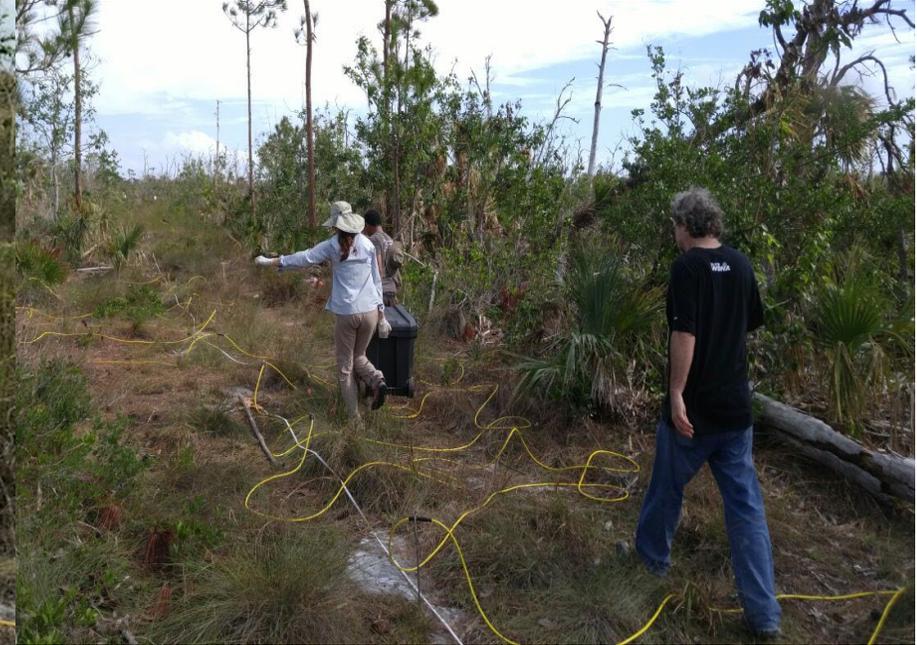
Experimental setup

The survey was performed using:

- ✓ 28 electrode cable
- ✓ 2m spacing
- ✓ roll along Wenner array configuration
