# PART 4. The Future – Lessons Applied

**Roy R. “Robin” Lewis III, MA, PWS**  
**Laura L. Flynn and Benjamin M. Brown**  
**Coastal Resources Group, Inc. [501(c)(3)]**  
**Salt Springs, Florida, USA**

# ALTERNATIVE APPROACHES TO MANGROVE RESTORATION/REHABILITATION

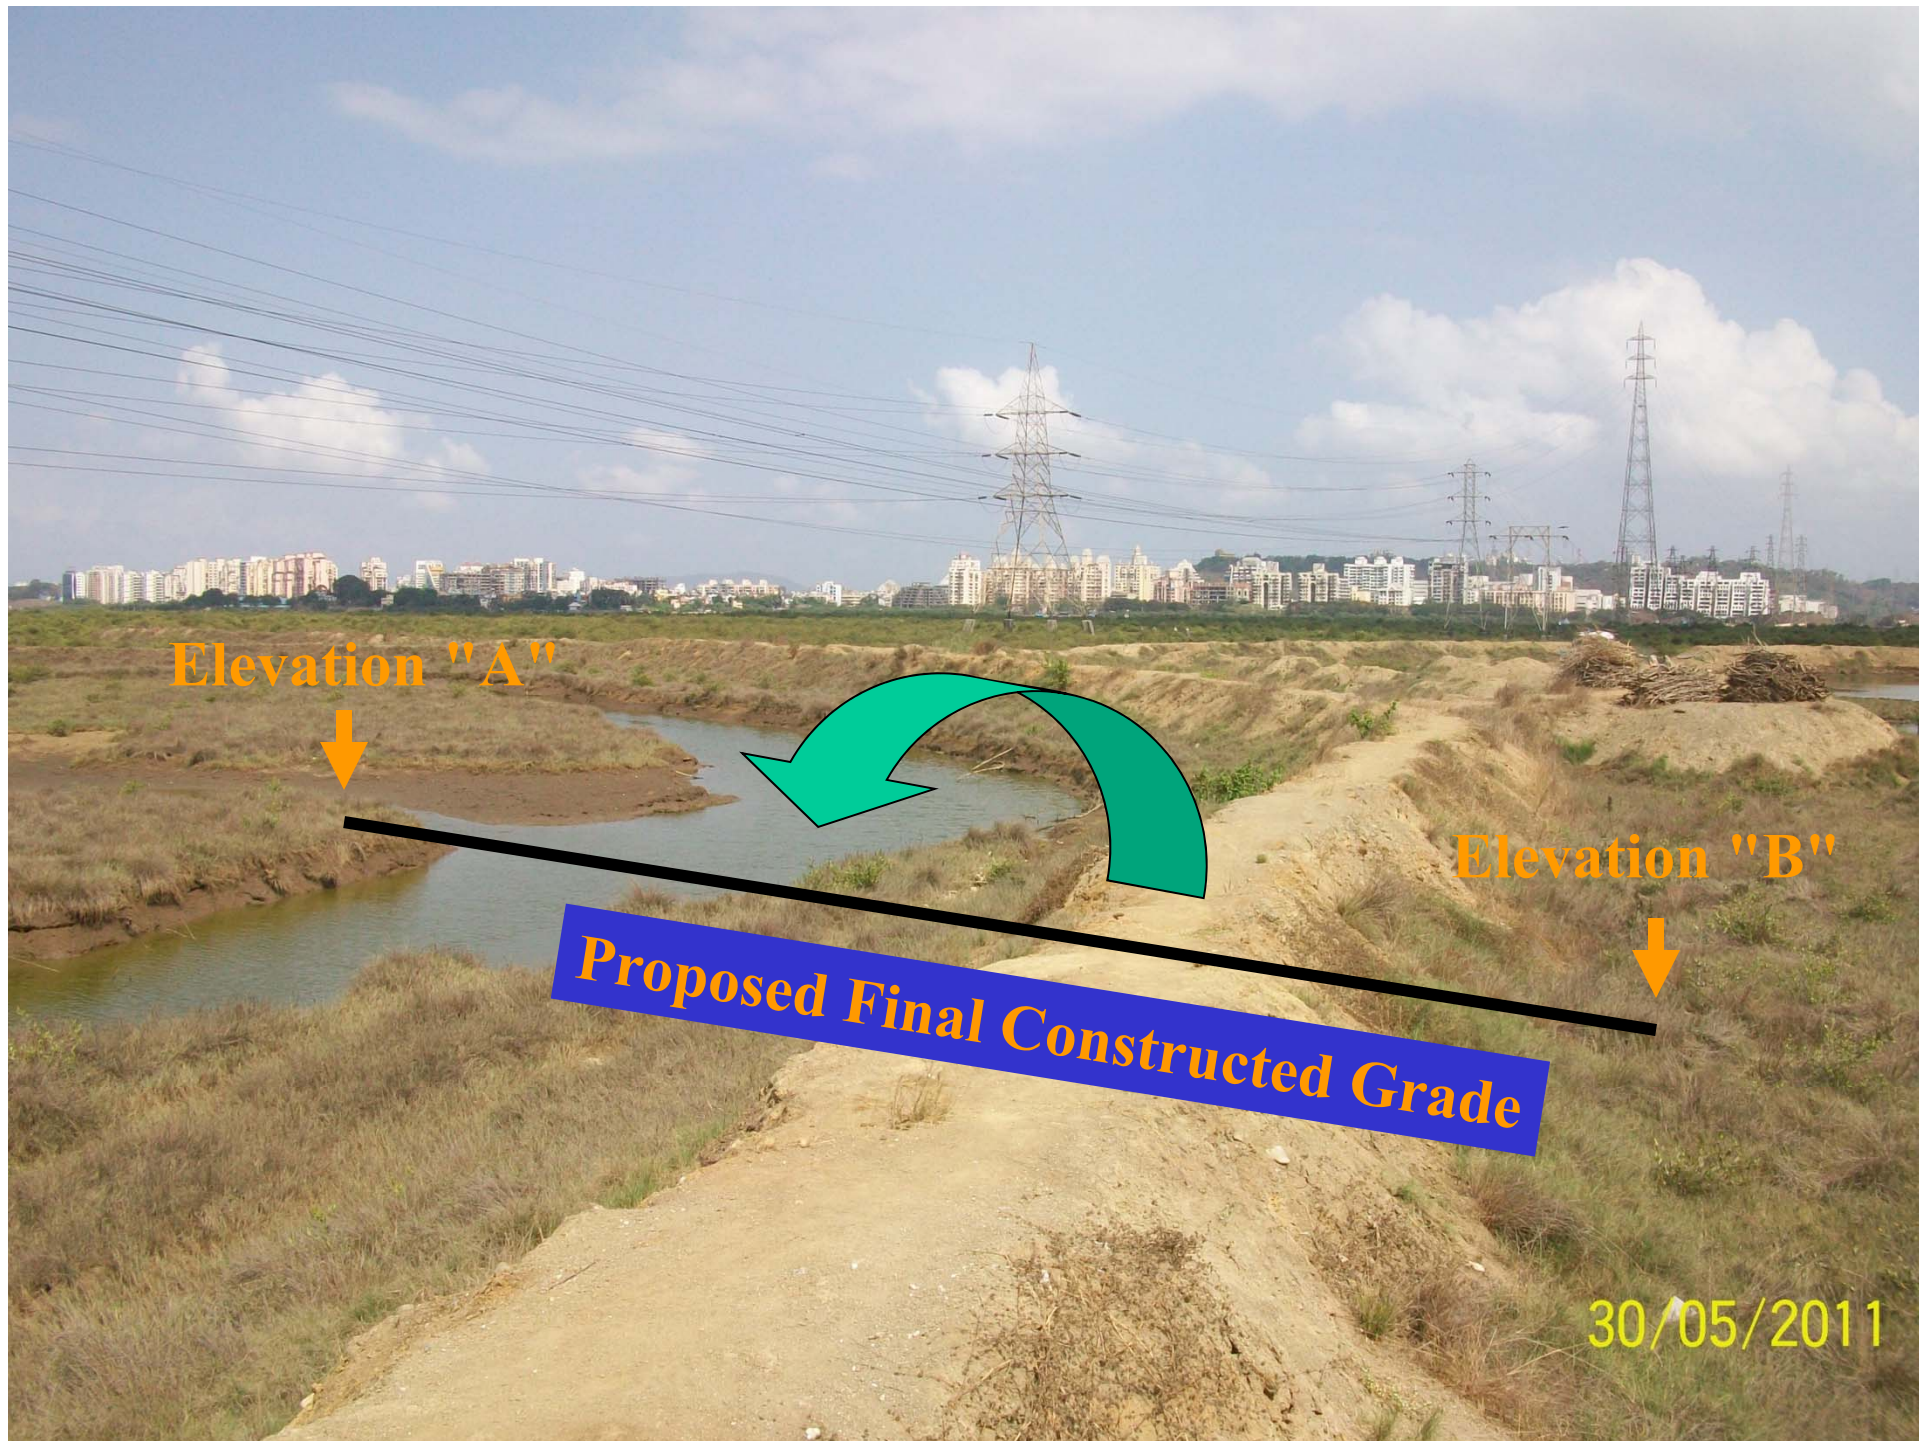
**Proposed Final Constructed Grade**

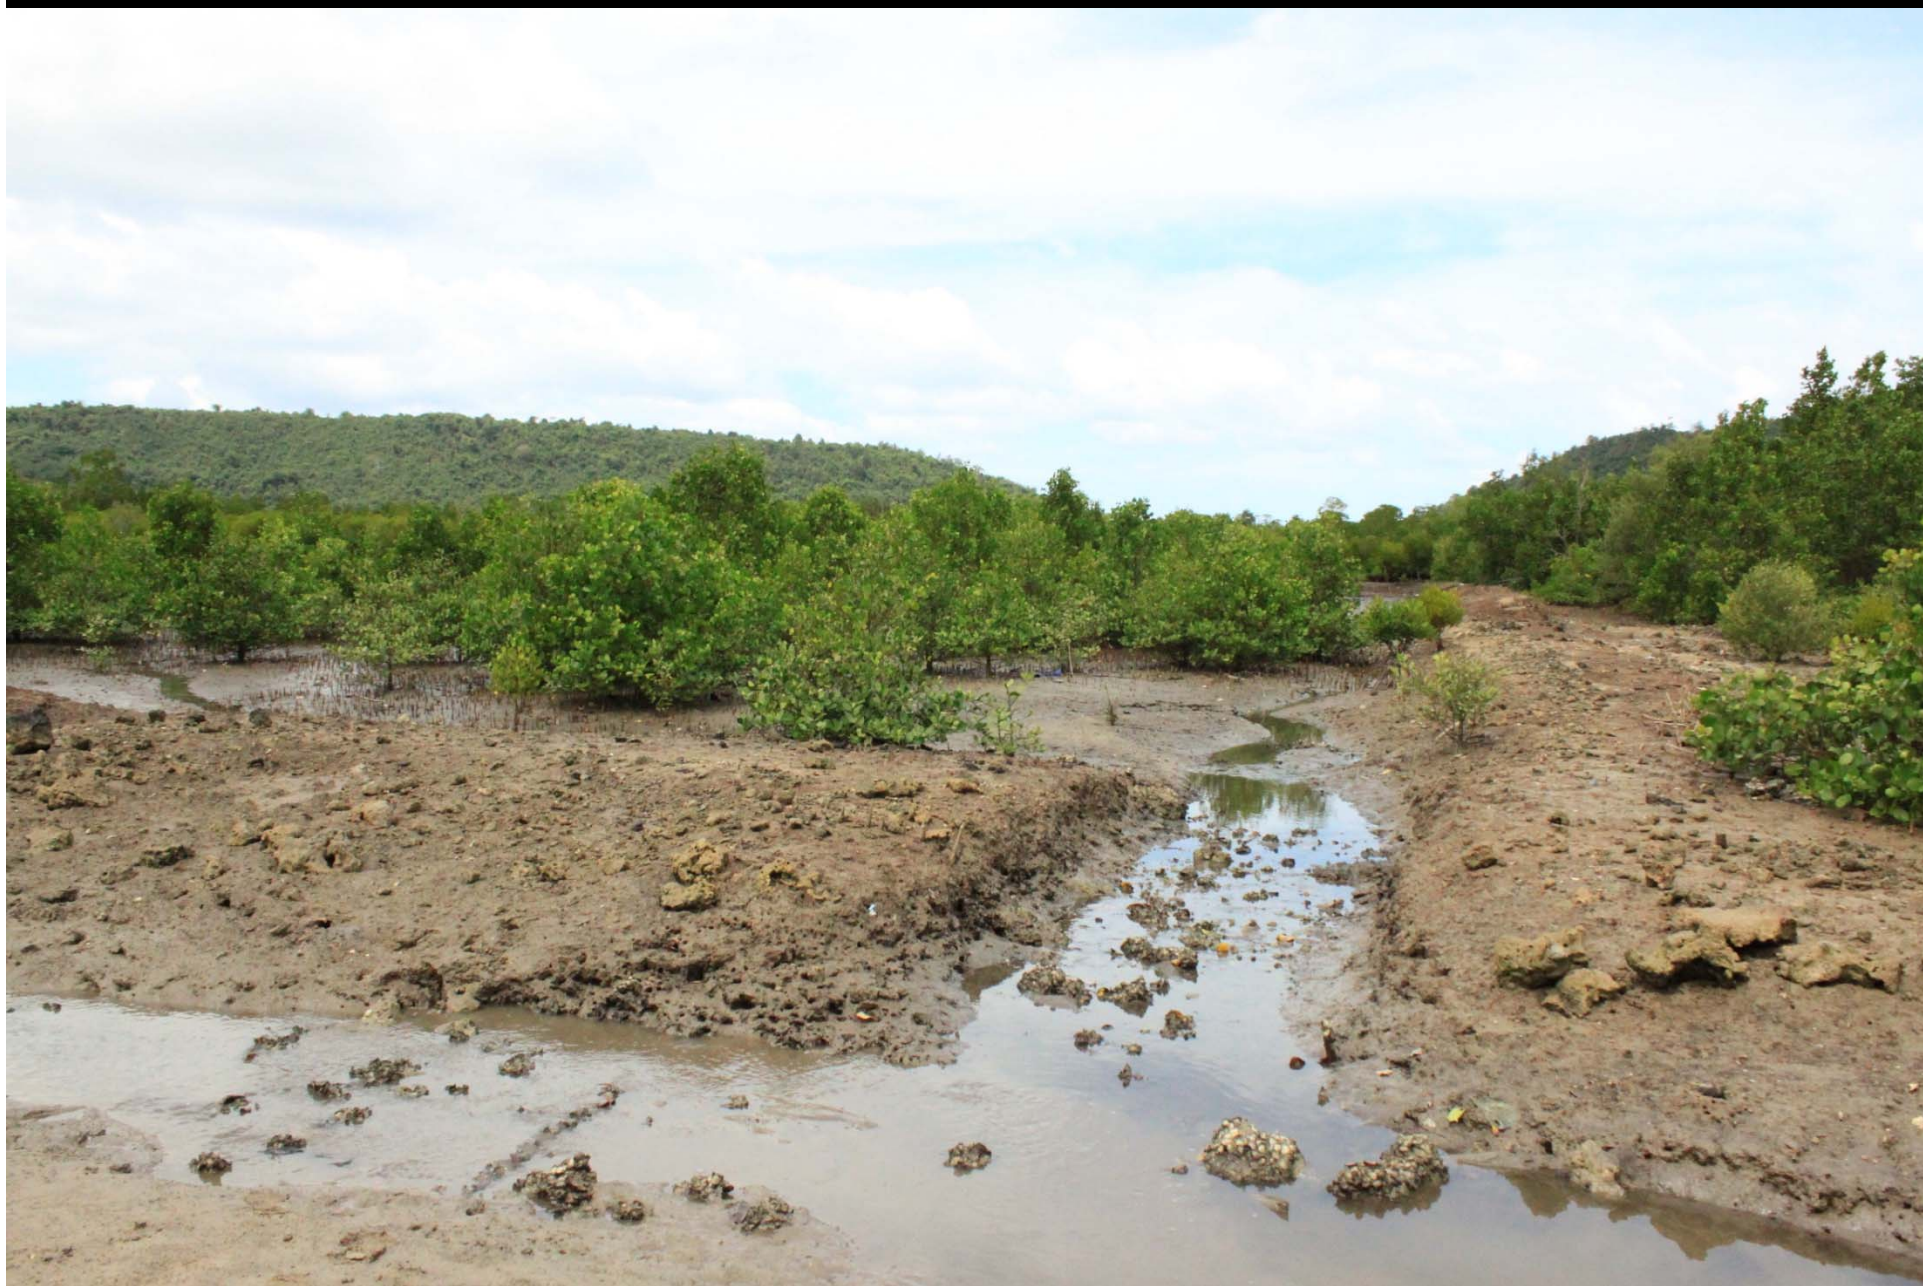
**Site 7**

**VERY IMPORTANT: Breaches are NOT placed randomly. They are STRATEGICALLY placed, and while larger rather than smaller, MORE are not BETTER. Why is that important?**
