Middle Rio Grande Bosque Habitat Restoration Holds Promise for Threatened and Endangered Songbirds

Restoration Projects Background

The Middle Rio Grande Restoration Project (MRG Project) was designed and constructed by the Corps to expand, create, and improve floodplain habitat conditions for fish and wildlife along a 22-mile segment of the Middle Rio Grande between

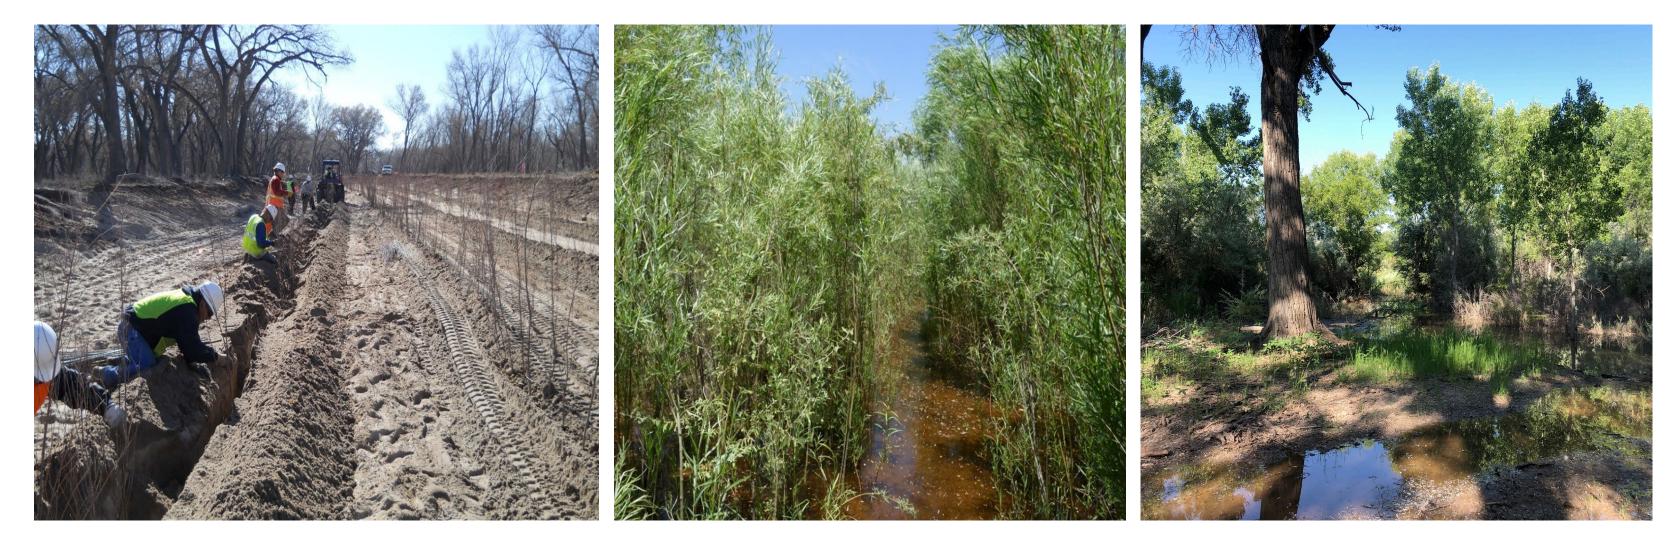
Planting a willow swale at Site 5B; willow swale at site 1G flooded during spring runoff; mature and young planted cottonwoods at site 5B

- Water features: Bank scallops, backwaters, high-flow channels
- **Excavated floodplain features:** Bankline terraces, willow swales, moist soil depressions
- Vegetation Management: Fuel reduction, invasive species removal
- **Revegetation** with native tree and shrub species
