# Nine Mile Run Aquatic Ecosystem Restoration

From STINK CREEK  
to  
Beautiful VALLEY

## NMR Sec 206 Aquatic

## Ecosystem Restoration Project

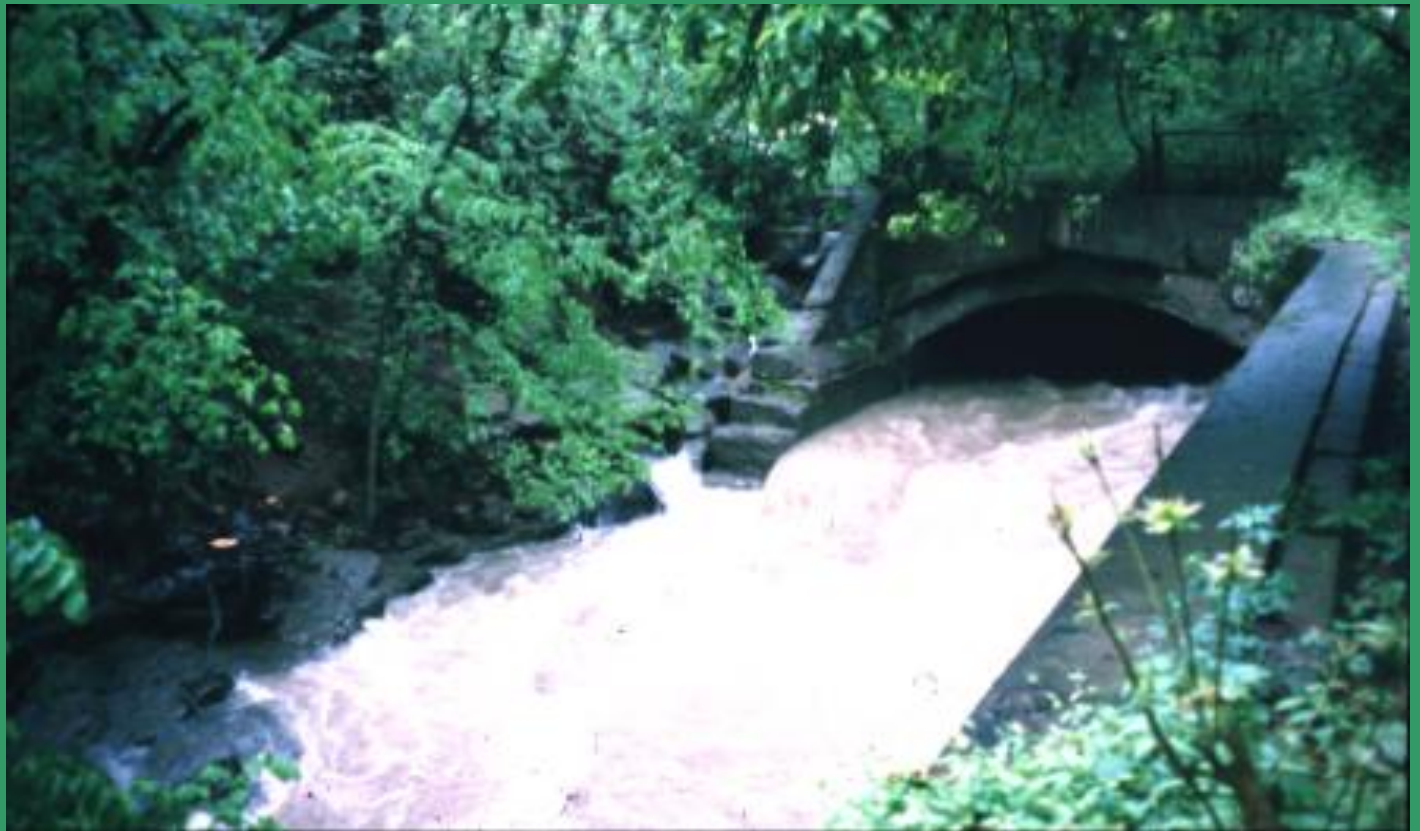
Braddock  
Avenue  
Culvert

## Storm Water Discharges

Wet  
Weather

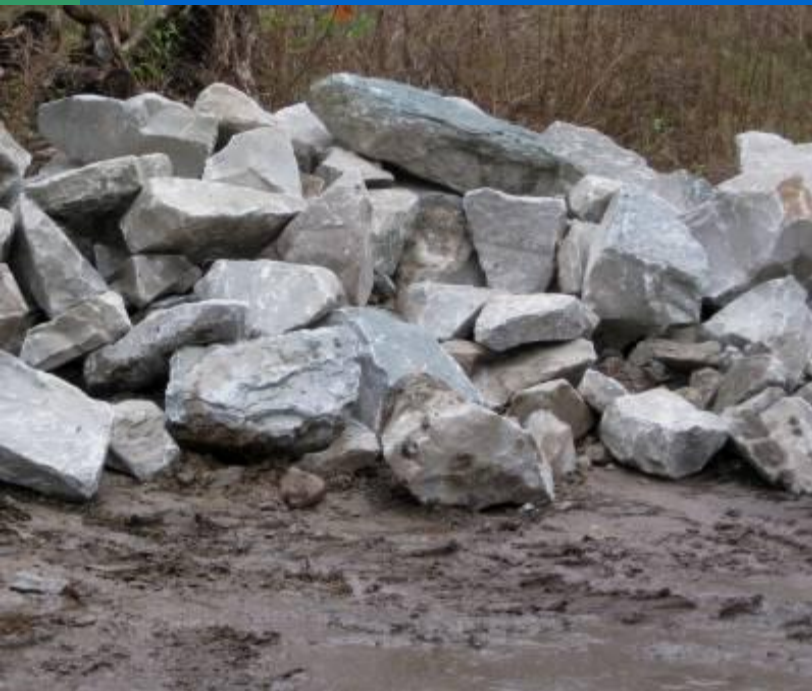
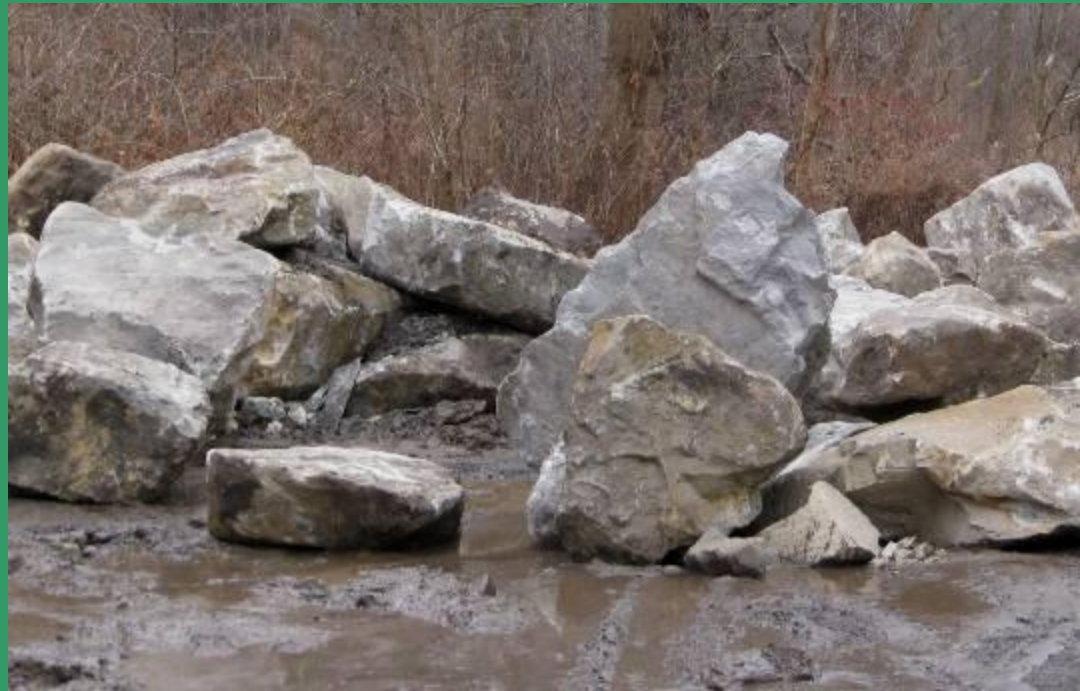
R-5 & R-6 stone on left (used for key & to choke larger stone), large riprap on right used for Engineered Rocked Riffles (ERR), Single Stone Bendway Weirs (SSBW), & bank stabilization.

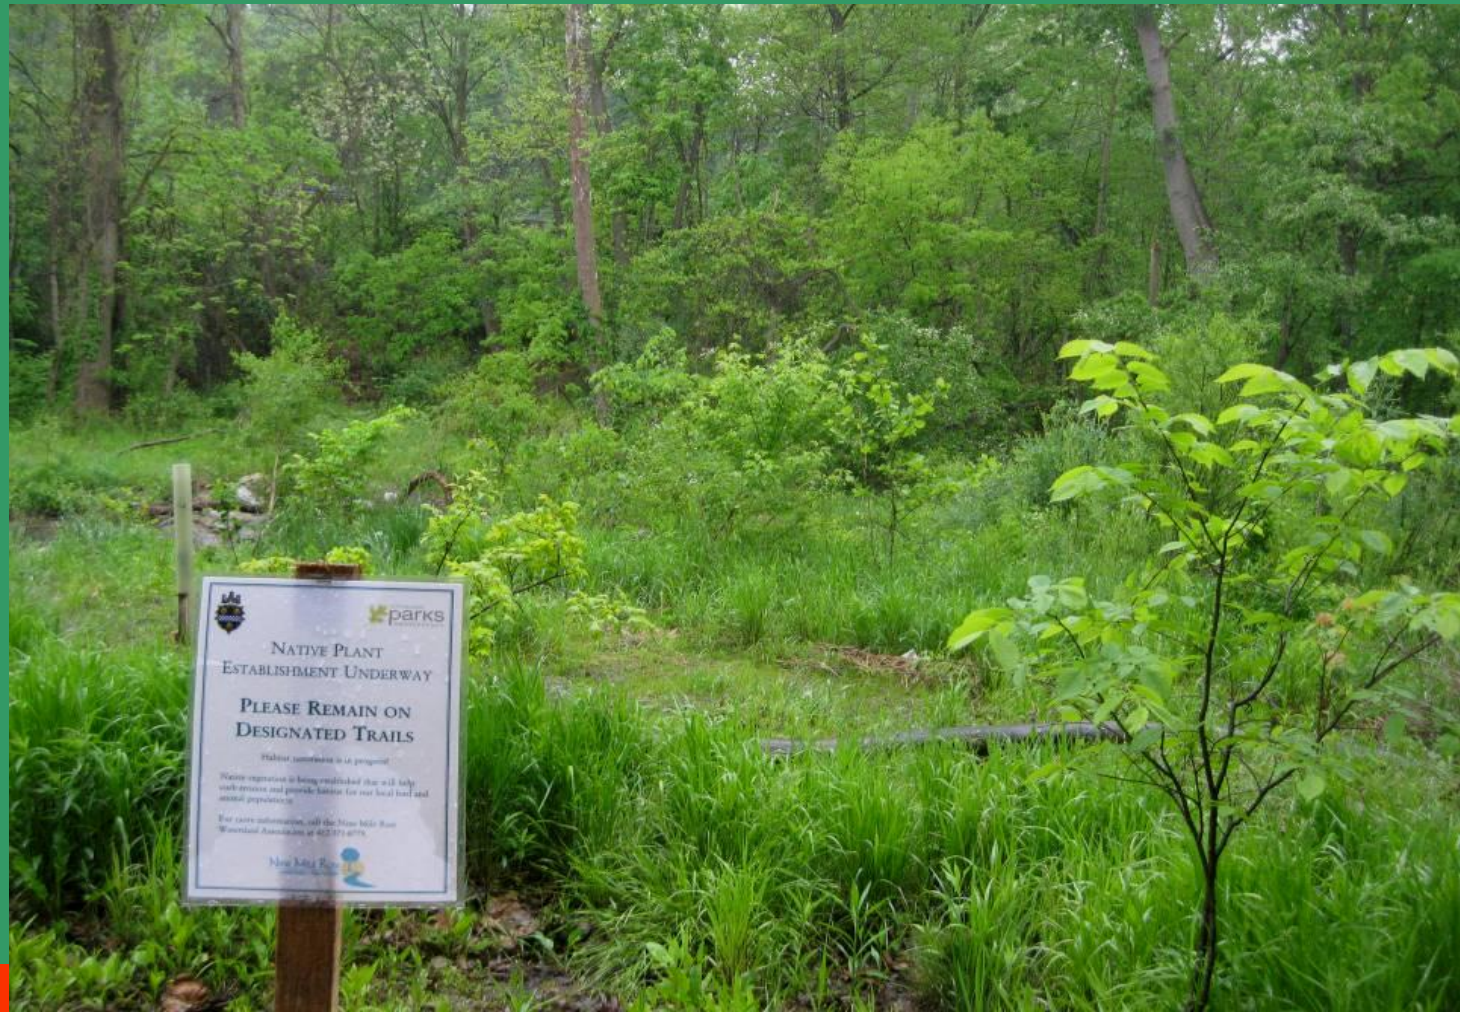
Bend #2

Reconstruction Dec. 2009  
from big summer storm (June 9)  
damage

Rebuild the Engineered Rocked Riffle  
& extend & vegetate keys.

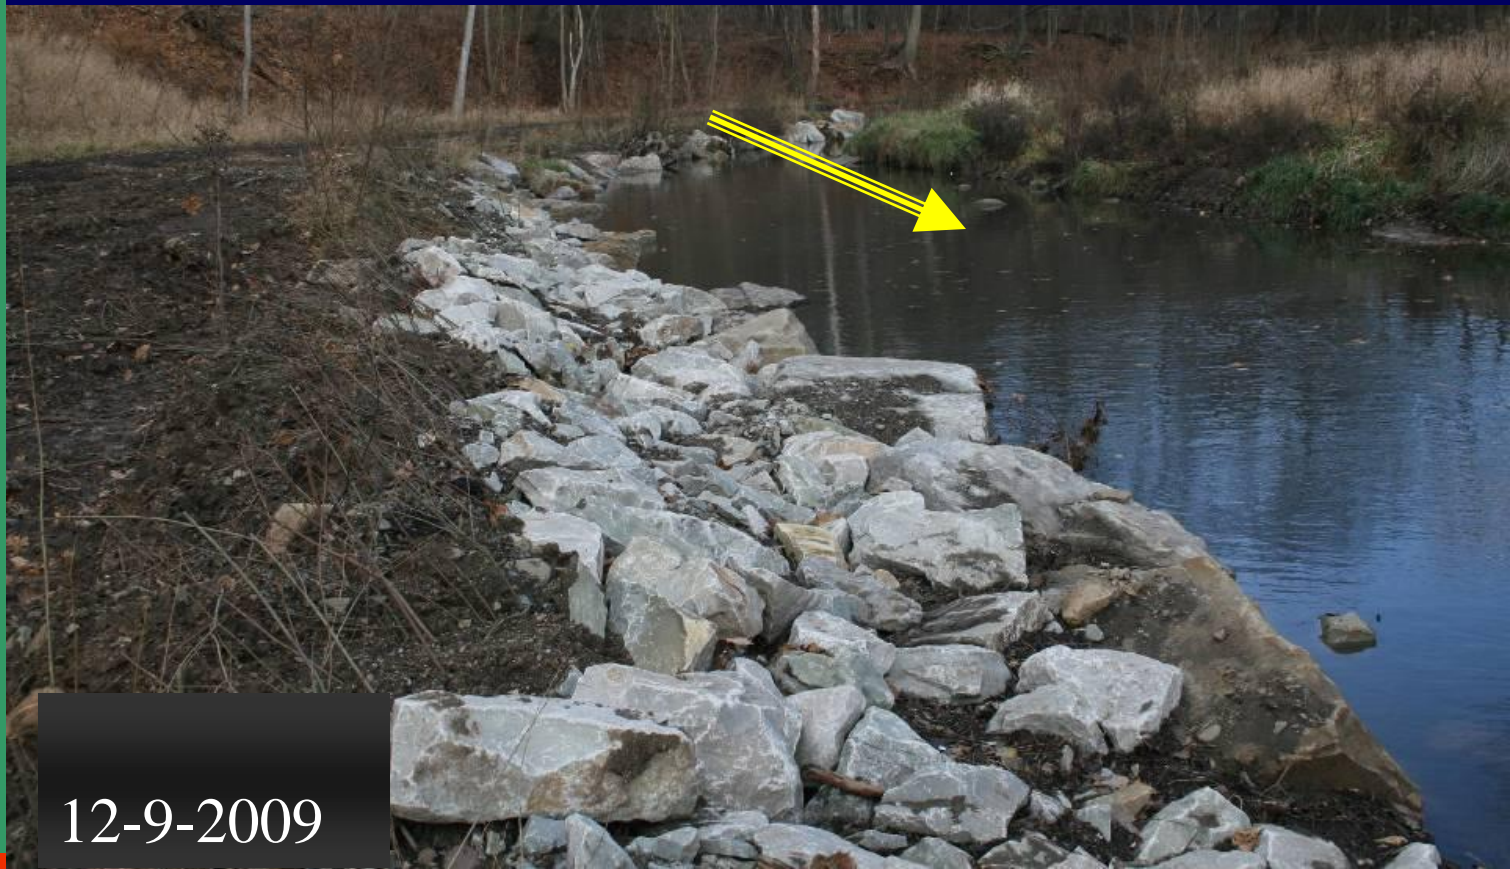
bank protection, veg, & Single Bendway Weir . Flat bench will provide flow to the DS point bar.

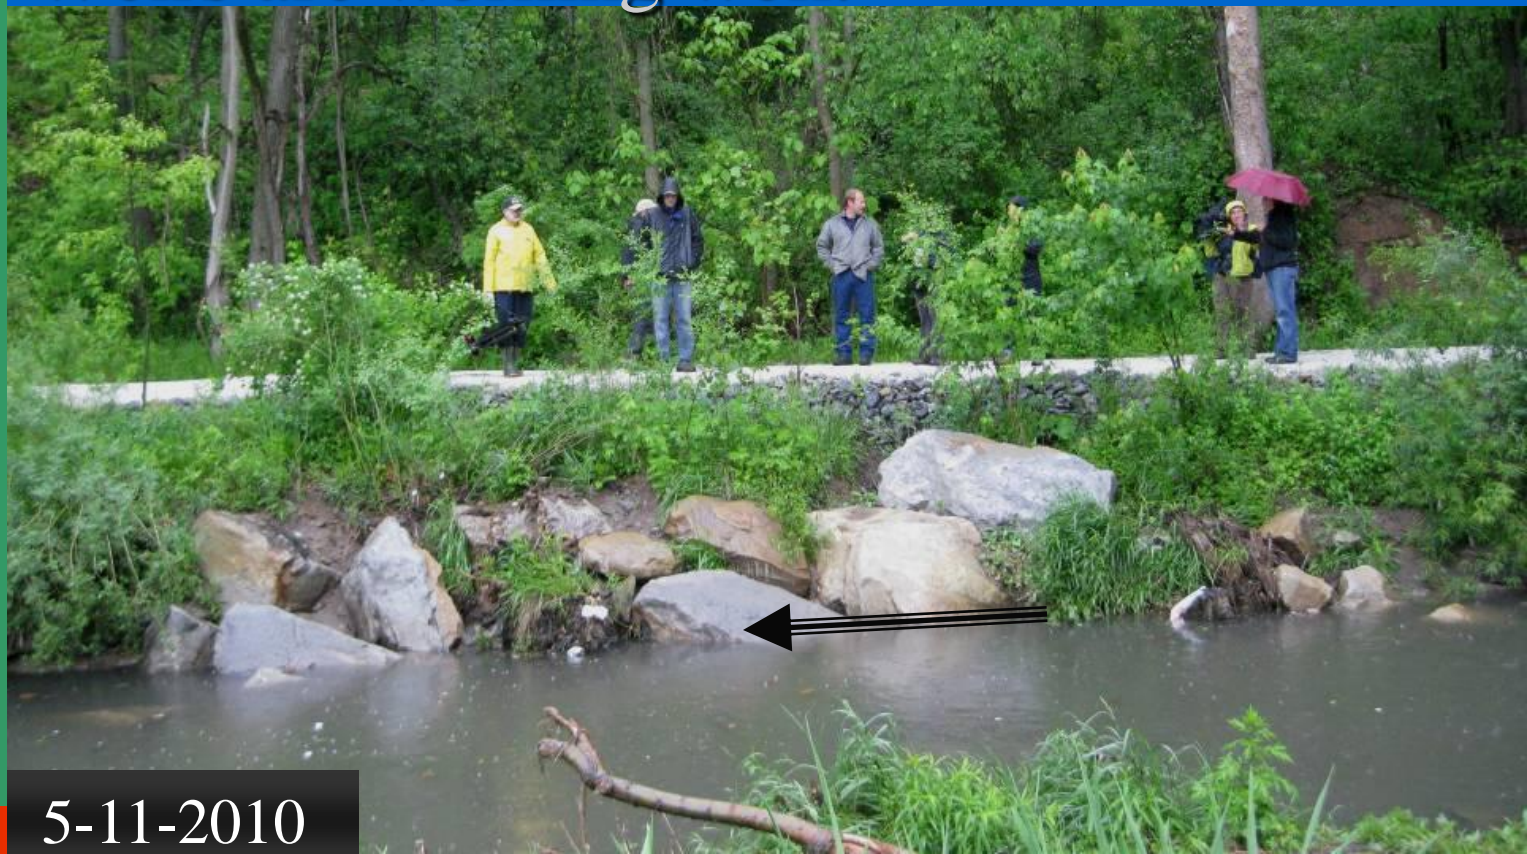
RAIN & HIGHER FLOW-Looking @ a right bank repair. Deep but Bendway Weirs are working well.

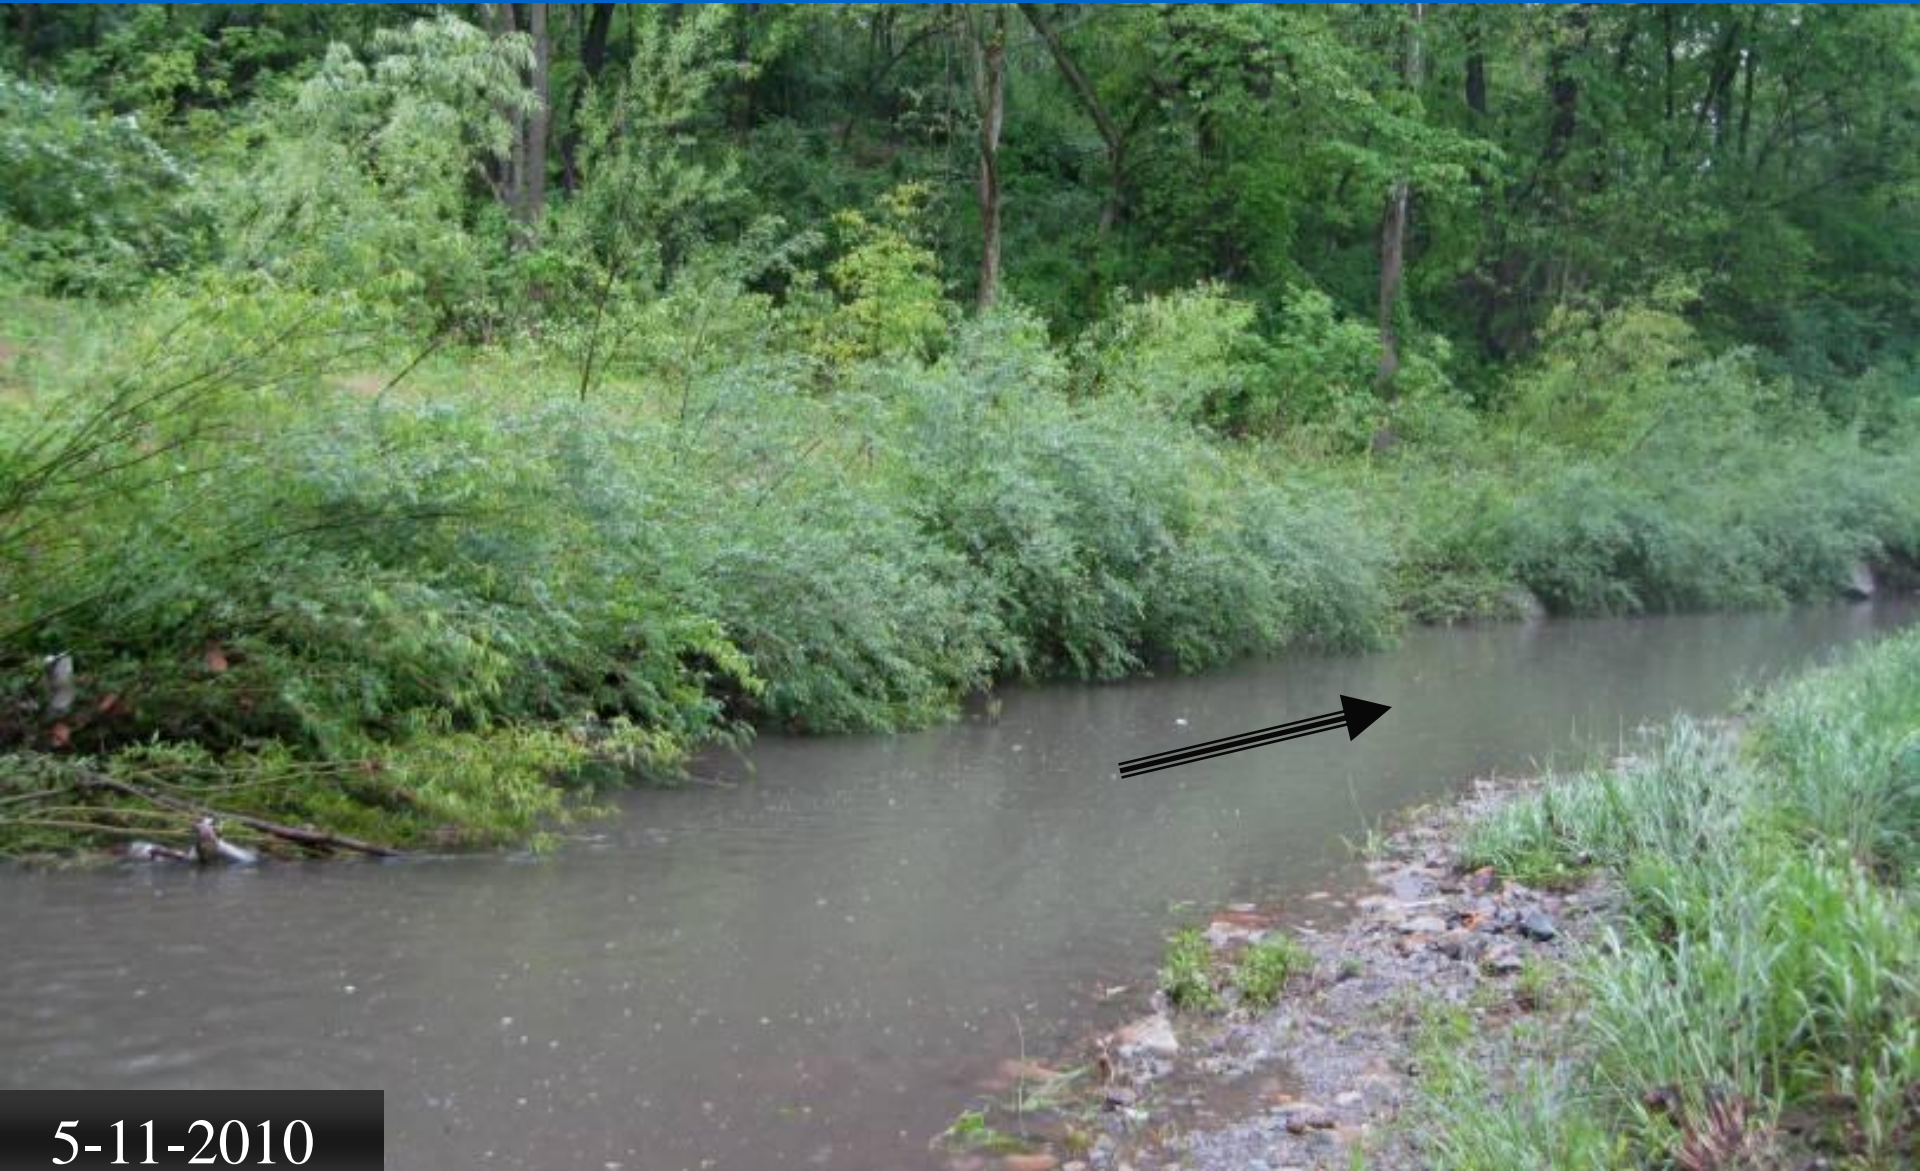
# RAIN & HIGHER FLOW-Looking DS @ great Bend #4 veg.

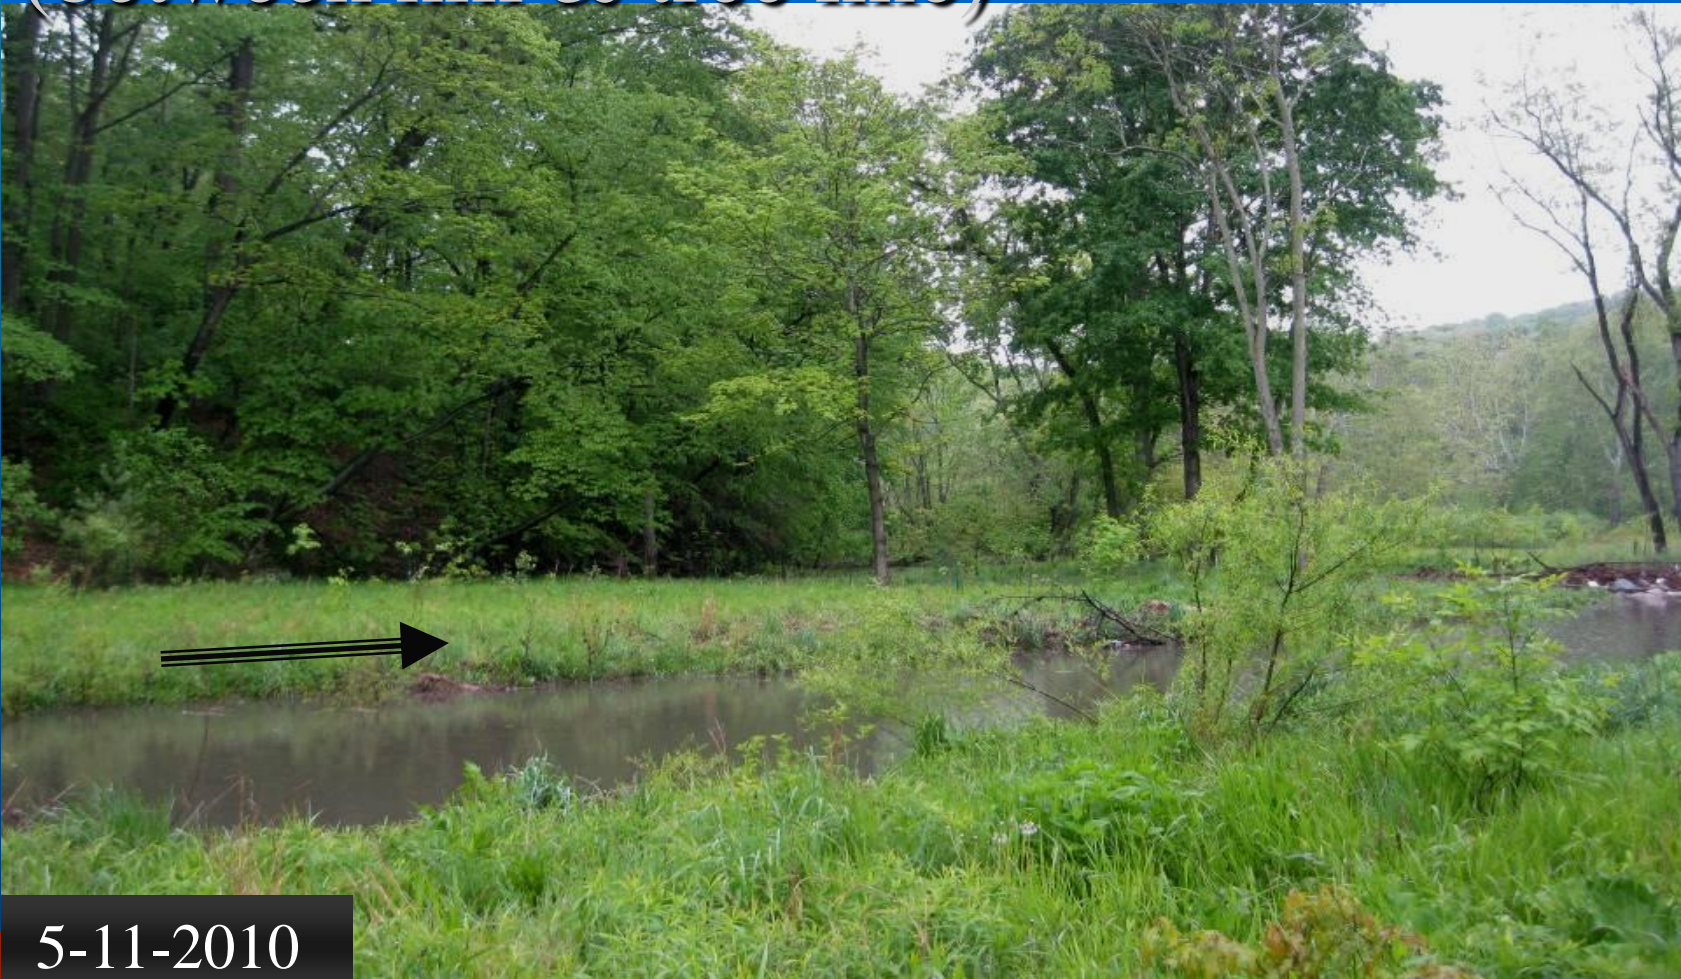
RAIN & HIGHER FLOW-Looking DS @  
where the old channel was located  
(between hill & tree line)

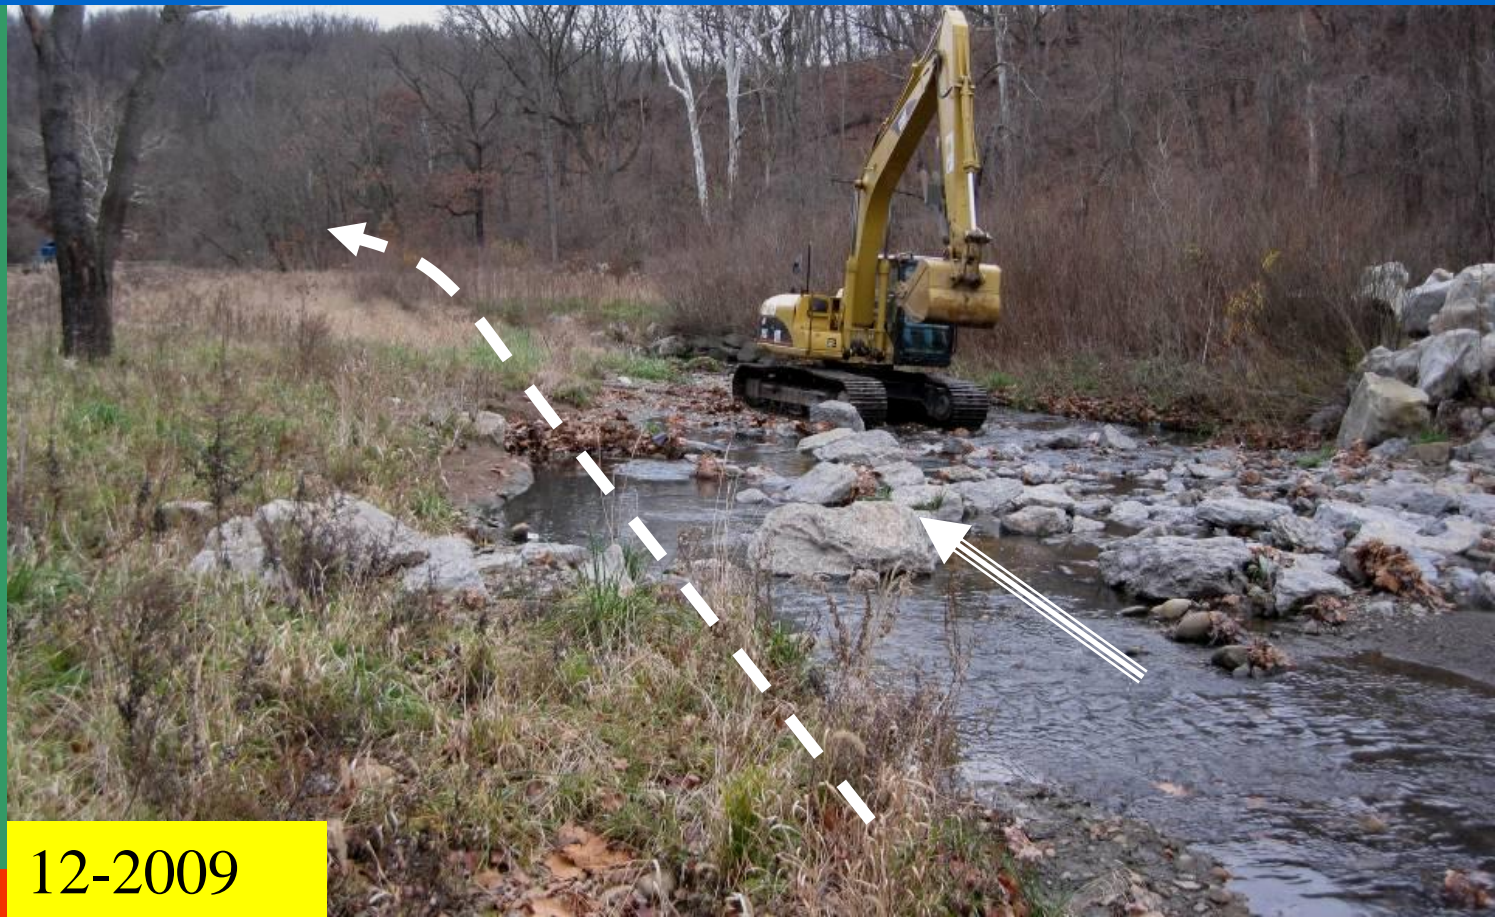
Looking DS @ blown out left key & left bank of the Bend #5 ERR (all to left of dotted line).

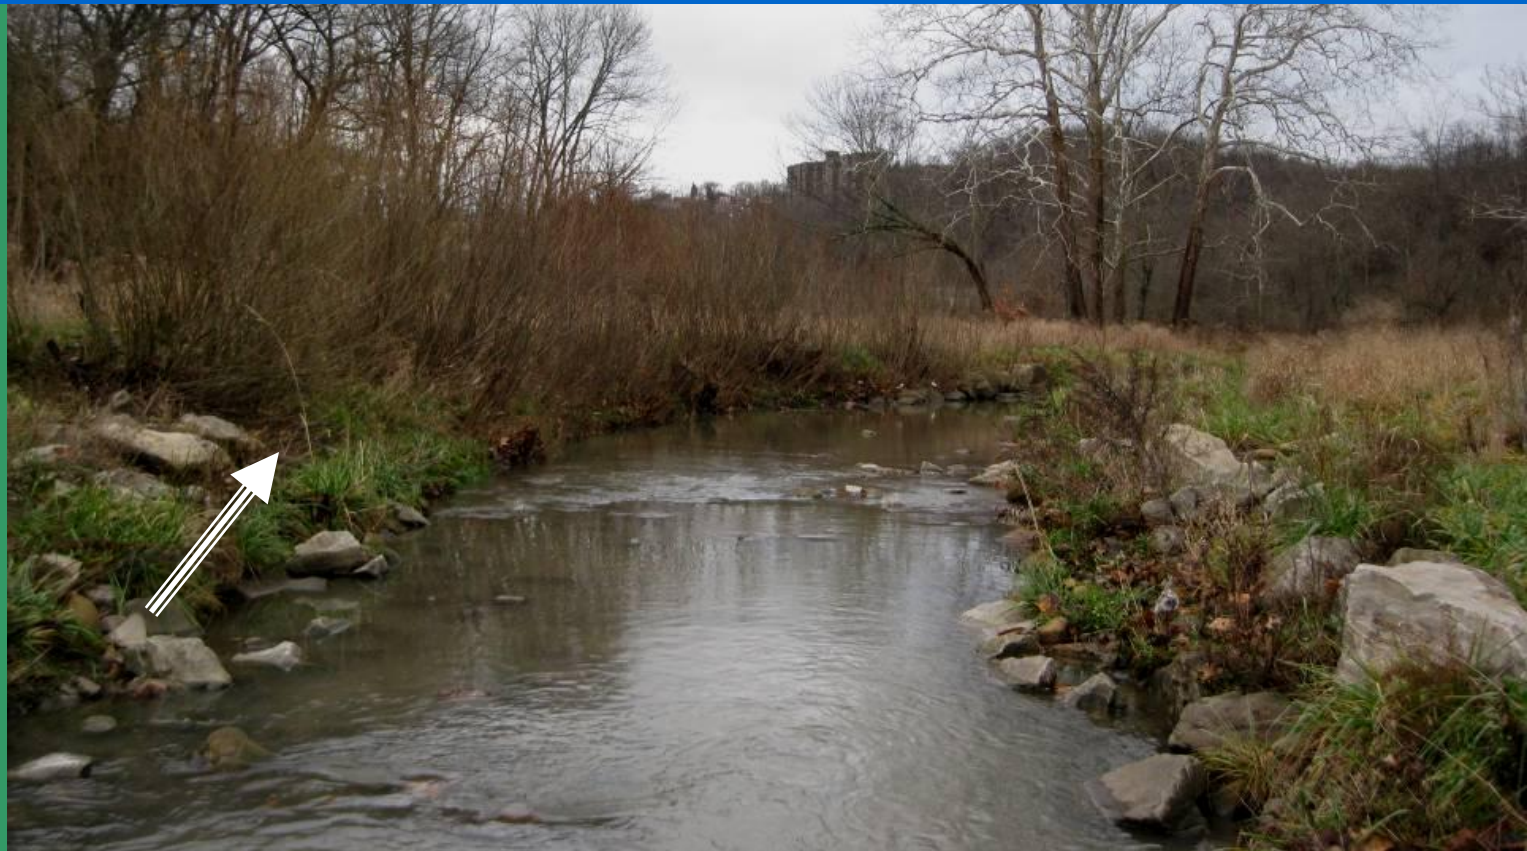
Looking DS into Bend #6. Bend protection is in good shape, willow growth is dense & vigorous.

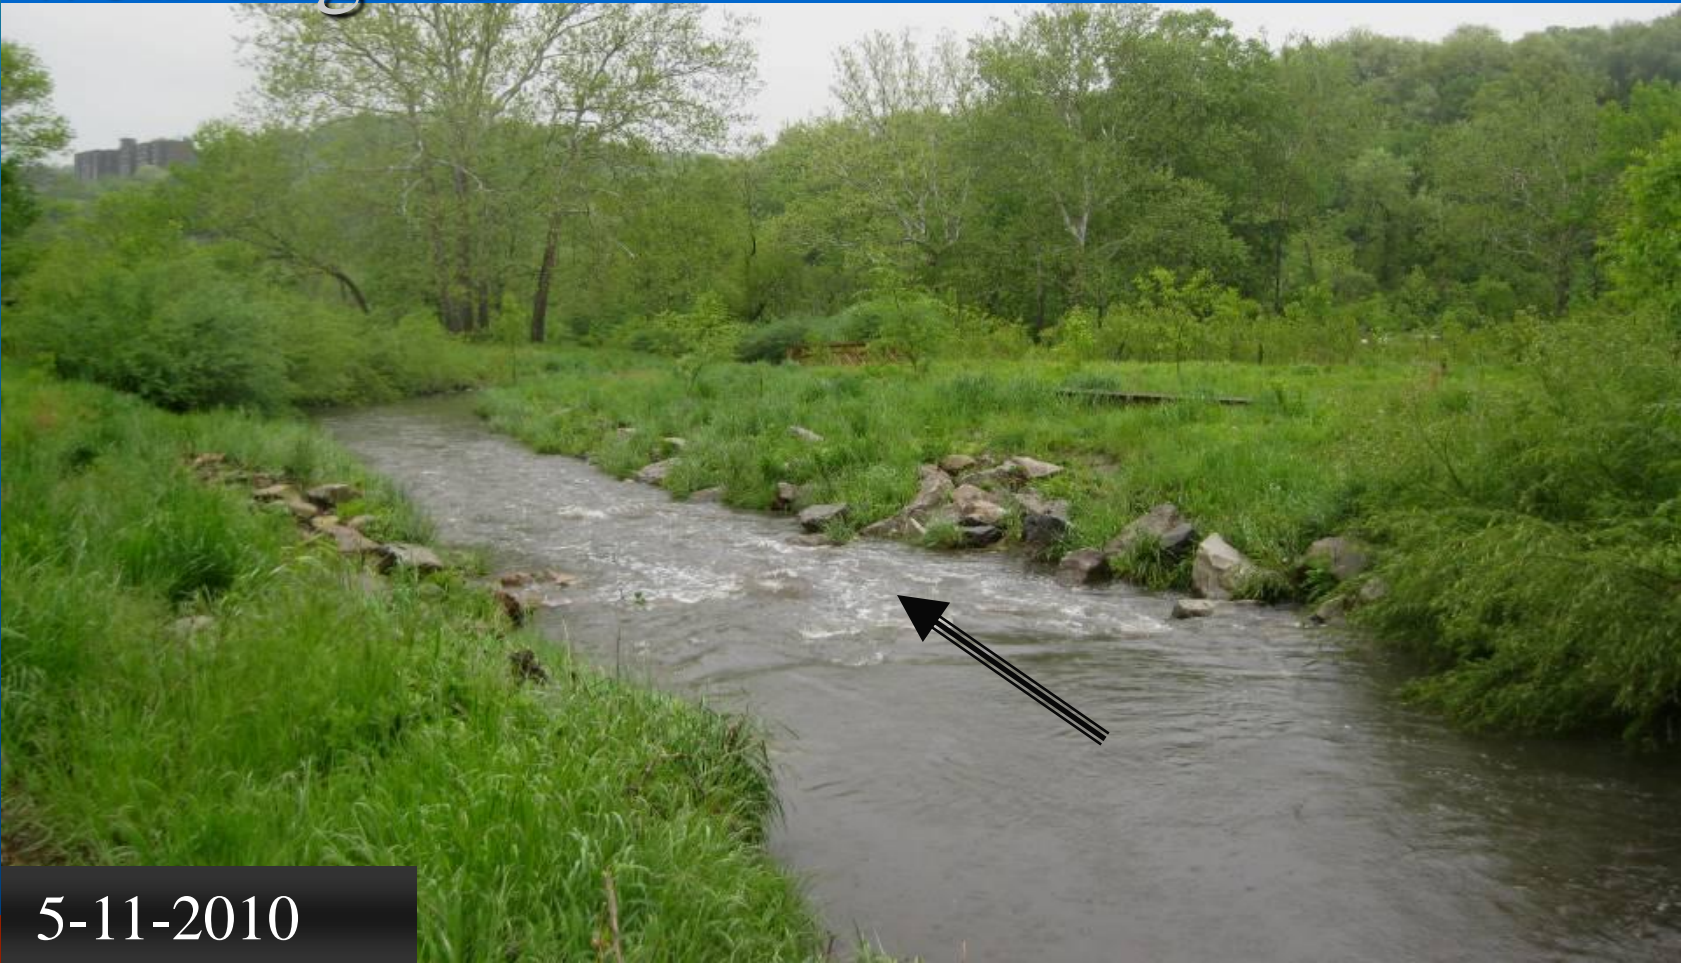
RAIN & HIGHER FLOW-Looking DS @  
the DS crossing & into Bend #6. Flow  
well-aligned.
