Responses of Floodplain Wetland Vegetation to Kissimmee River Restoration Project PHASE I

Staff Environmental Scientist
Lake and River Sciences Section
Applied Sciences Bureau

*South Florida Water Management District
West Palm Beach Florida*

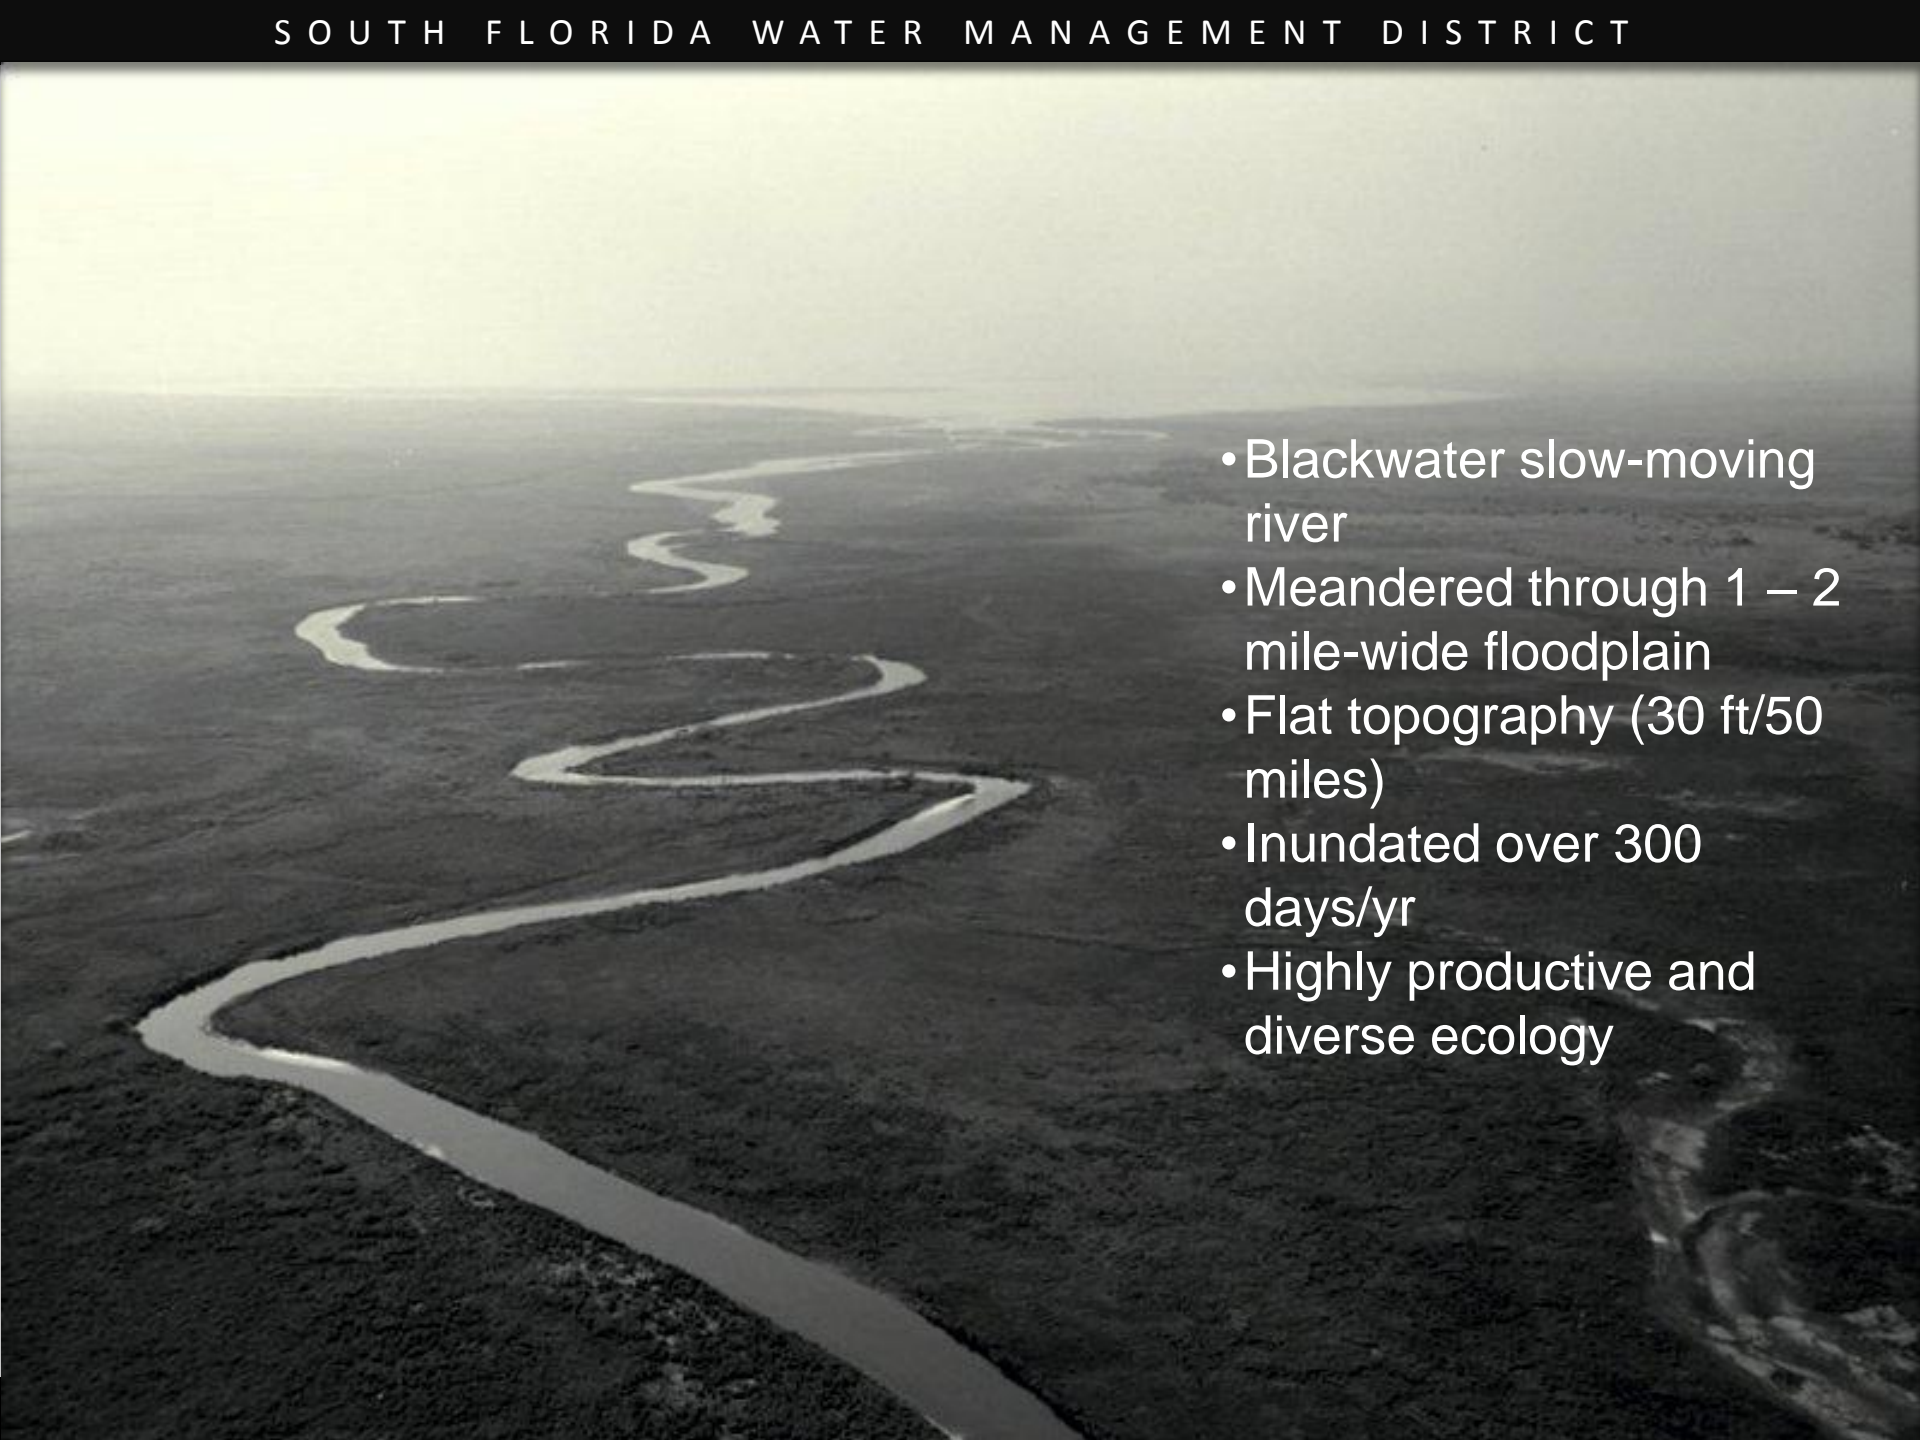
- An aerial photograph showing a wide, meandering river flowing through a vast, flat floodplain. The river's path is highly irregular, with several large loops and turns. The surrounding land is dark and appears to be a mix of vegetation and open fields. The sky is a pale, hazy grey, suggesting an overcast day or a misty atmosphere. The overall scene conveys a sense of a slow-moving, undisturbed natural waterway.
- Blackwater slow-moving river
 - Meandered through 1 – 2 mile-wide floodplain
 - Flat topography (30 ft/50 miles)
 - Inundated over 300 days/yr
 - Highly productive and diverse ecology

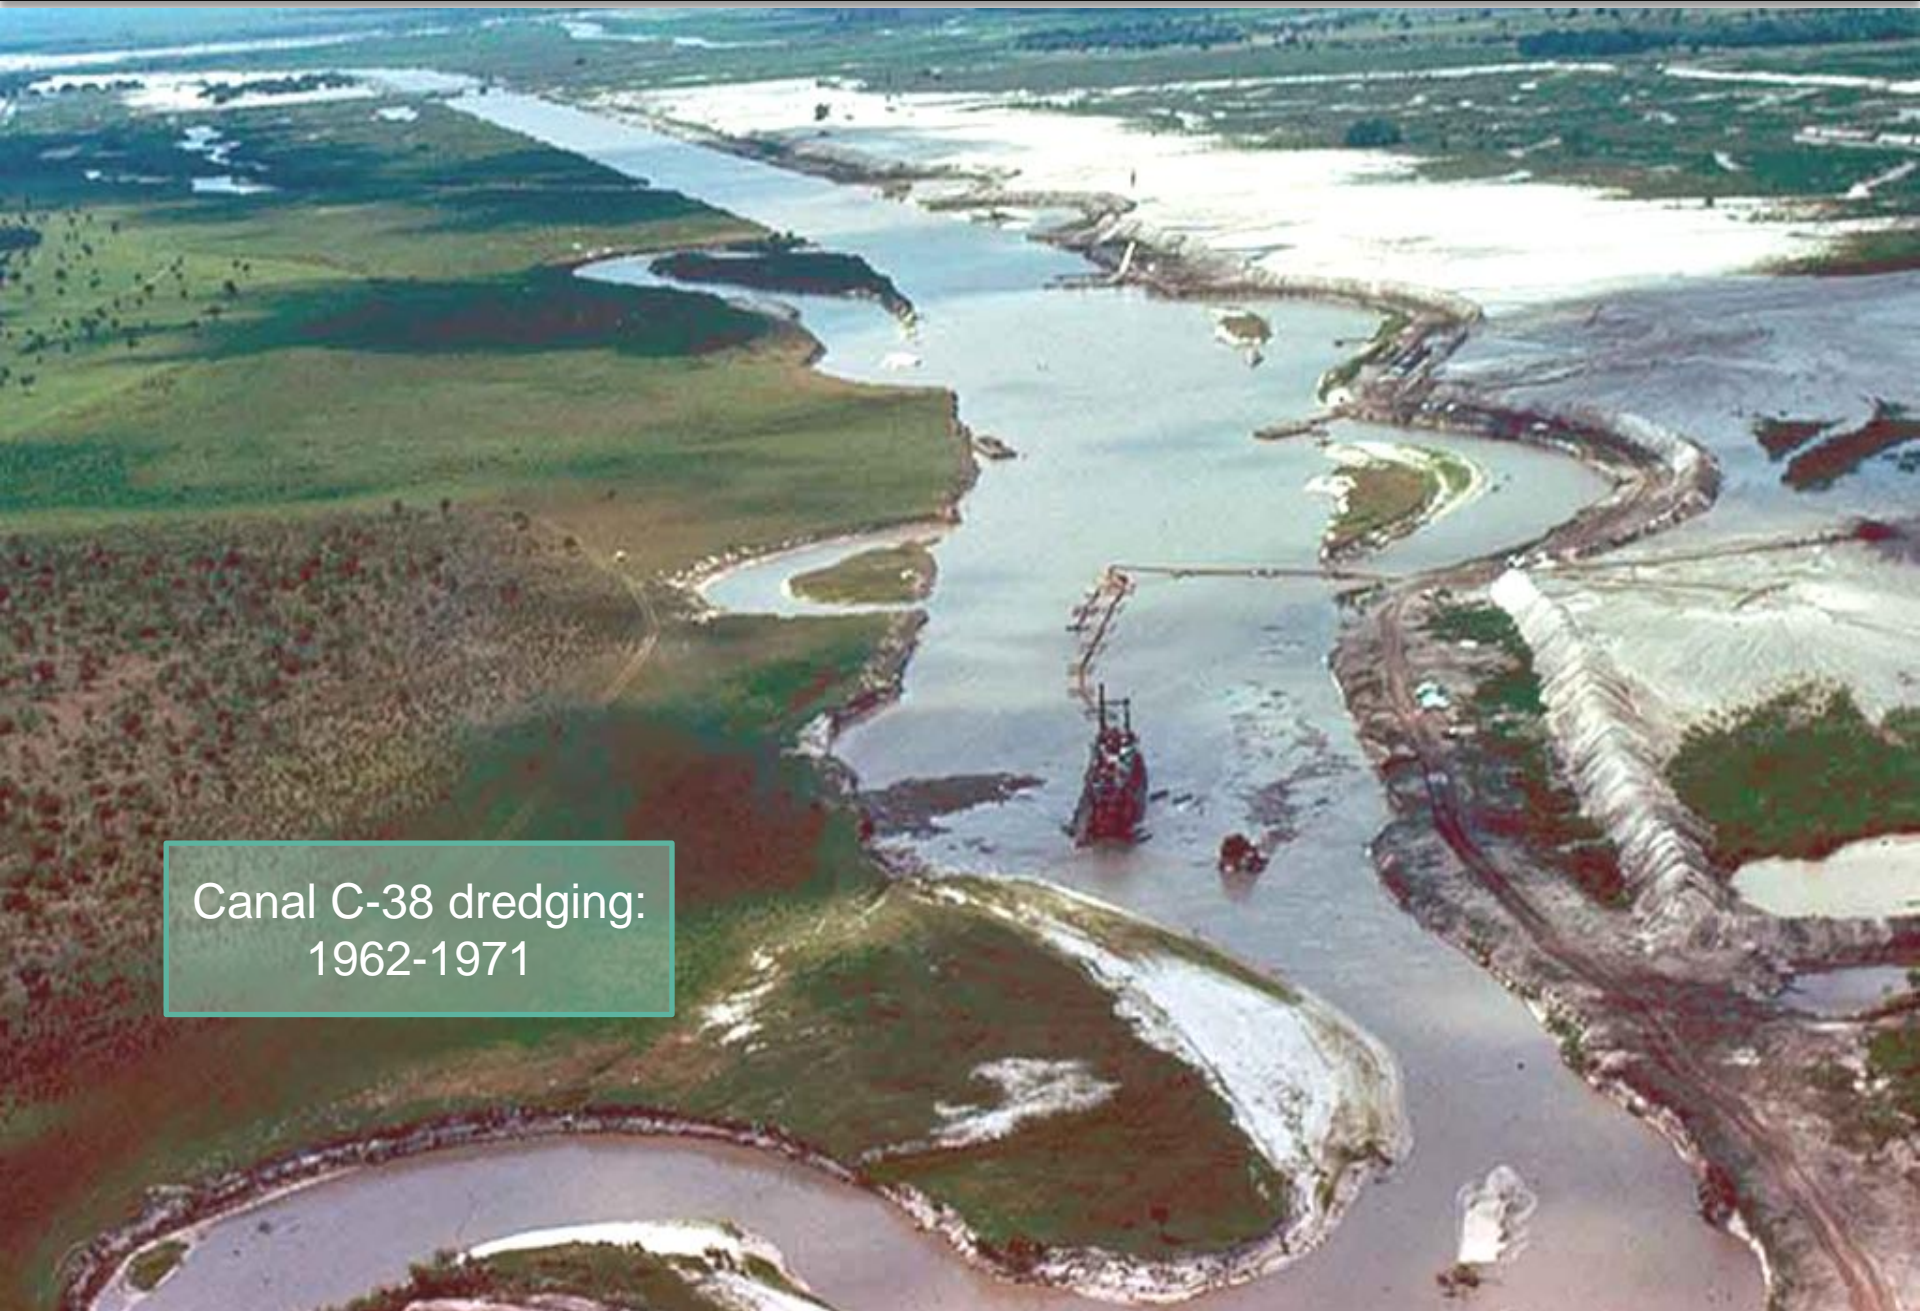
Canal C-38 dredging:
1962-1971

C-38 Characteristics:

- 50-100 m wide
- 10 m deep
- 6 water control structures
- 5 flat water pools
- Drained thousands of hectares of wetlands
- Fish and wildlife diversity plummeted

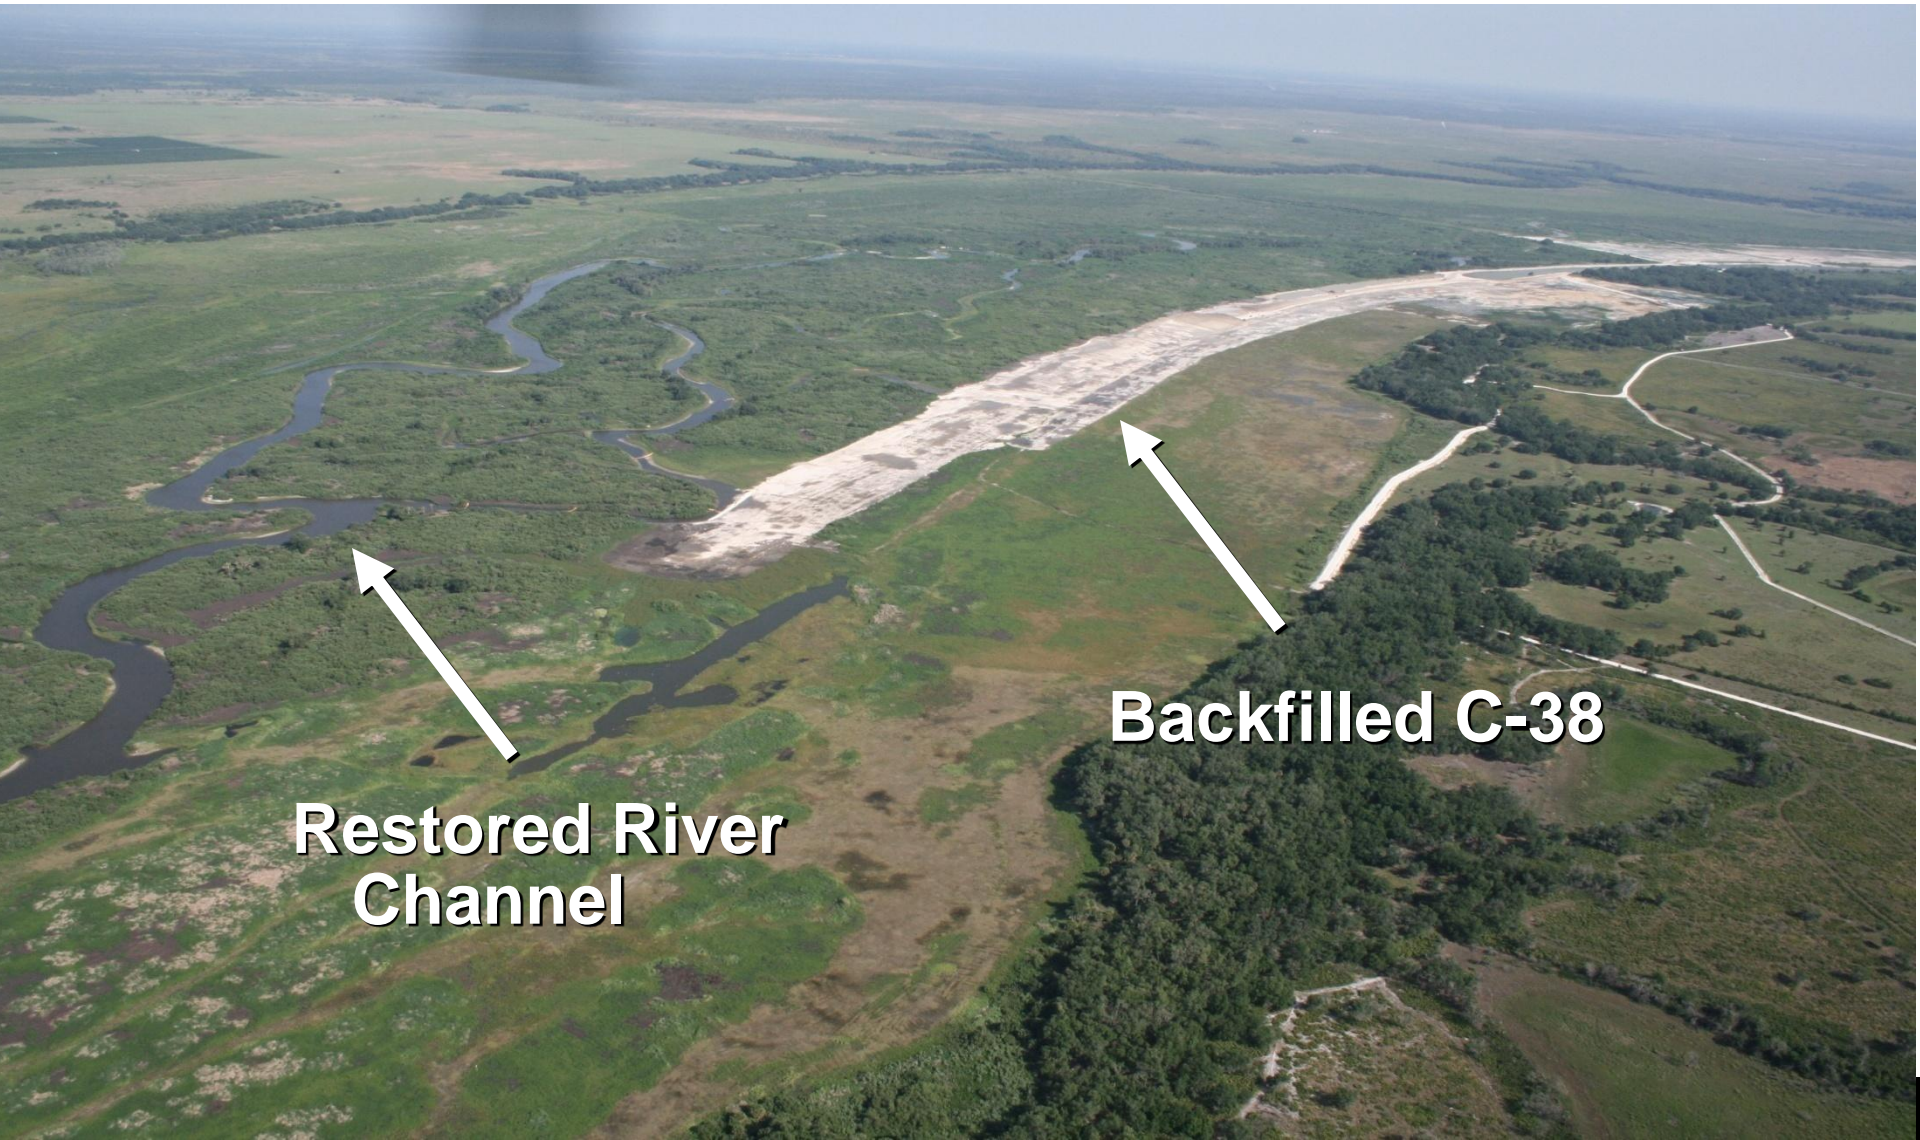
Reconstruct the Physical Form

**Restored River
Channel**

Backfilled C-38

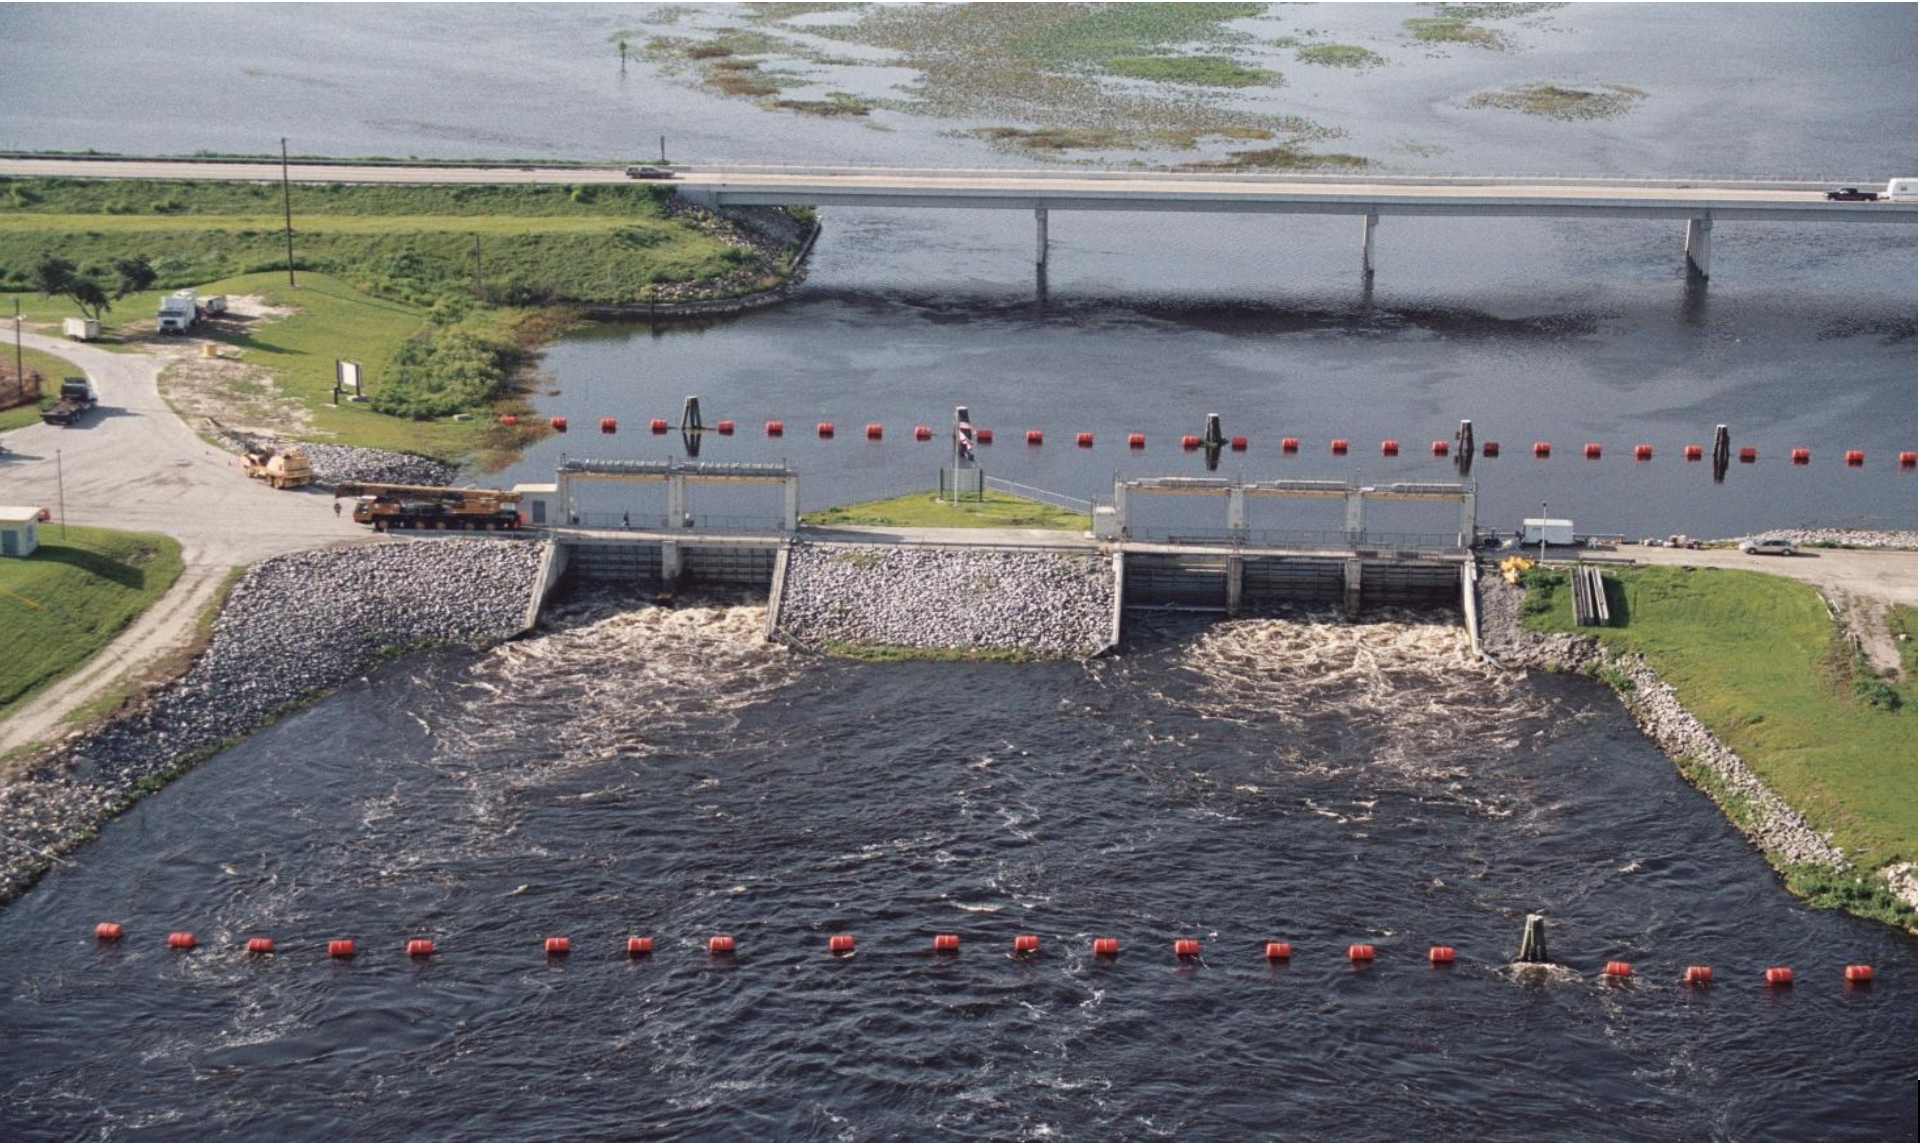
Operate the System to Mimic Natural Flow and Stage Patterns

Changes to Operations

- “Interim Management” –
in effect since Phase I complete in 2001
- System is operated under an interim schedule to mimic natural system **as much as possible**
 - Flood pulses in correct seasons
 - Constant water flow
- However, incomplete construction of remaining project features, interim flood control requirements, and certain other perturbations mean that the current system cannot deliver inflows as expected
- Headwaters Revitalization Project
 - Increase storage capacity upstream of the river
 - Alter management to take advantage of added storage

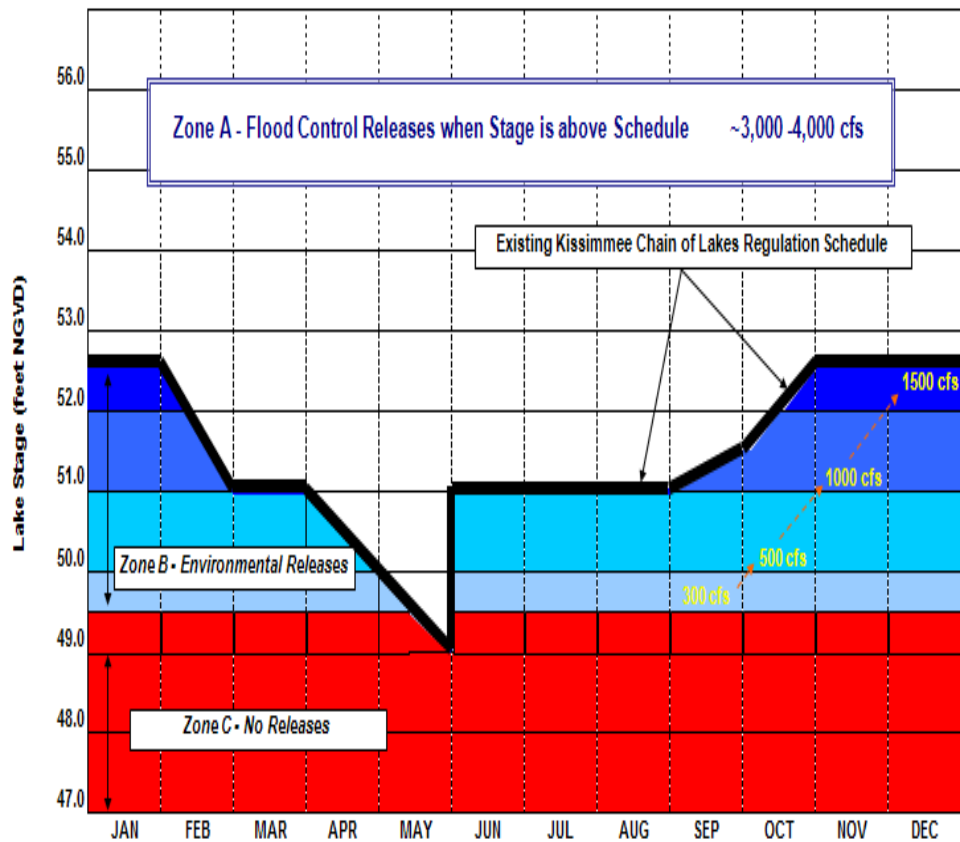
Interim Schedule

Interim Operational Schedule for the Upper Kissimmee Basin Chain of Lakes @ October 2000
(Lakes Kissimmee-Hatchineha-Cypress-Tiger controlled by S-65)

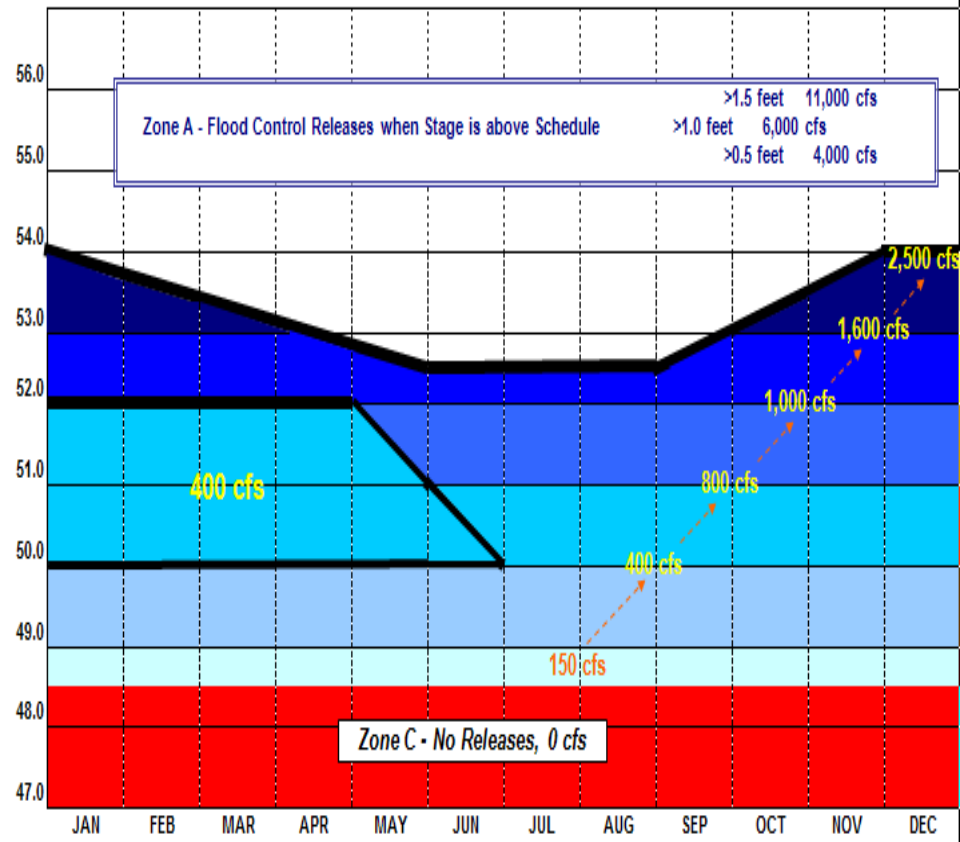
Final Headwaters Schedule

Revised Regulation and Operational Schedule for the Upper Kissimmee Basin Chain of Lakes
(Lakes Kissimmee-Hatchineha-Cypress-Tiger controlled by S-65)
