Developing and Testing a Biotic Functional Assessment to Guide Adaptive Management Along the Middle Rio Grande, NM

Steven Albert, Parametrix, Inc.

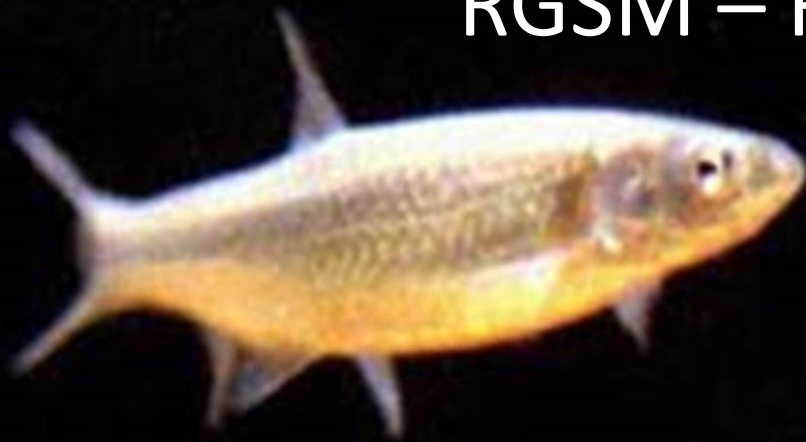
RGSM – Function Attributes

Floodplain Spawning & Rearing

- Duration of Spring Inundation
- % Ground Cover
- Velocity
- % Inundation

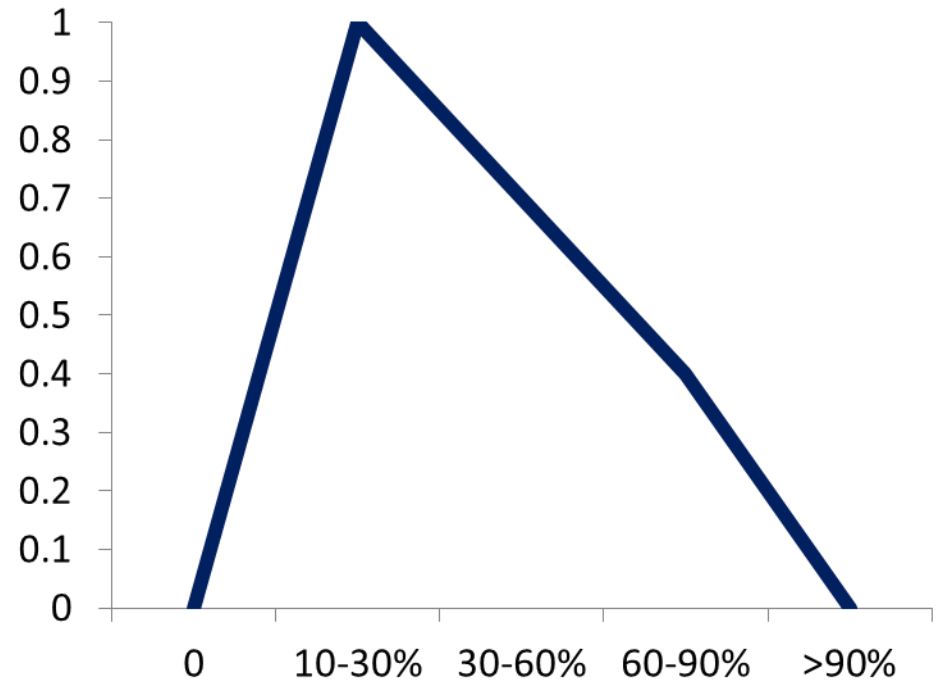
Attribute Scoring - Field Data

Canopy Cover	Score
<10%	0
10-30%	1.0
30-60%	0.7
60-90%	0.4
>90%	0

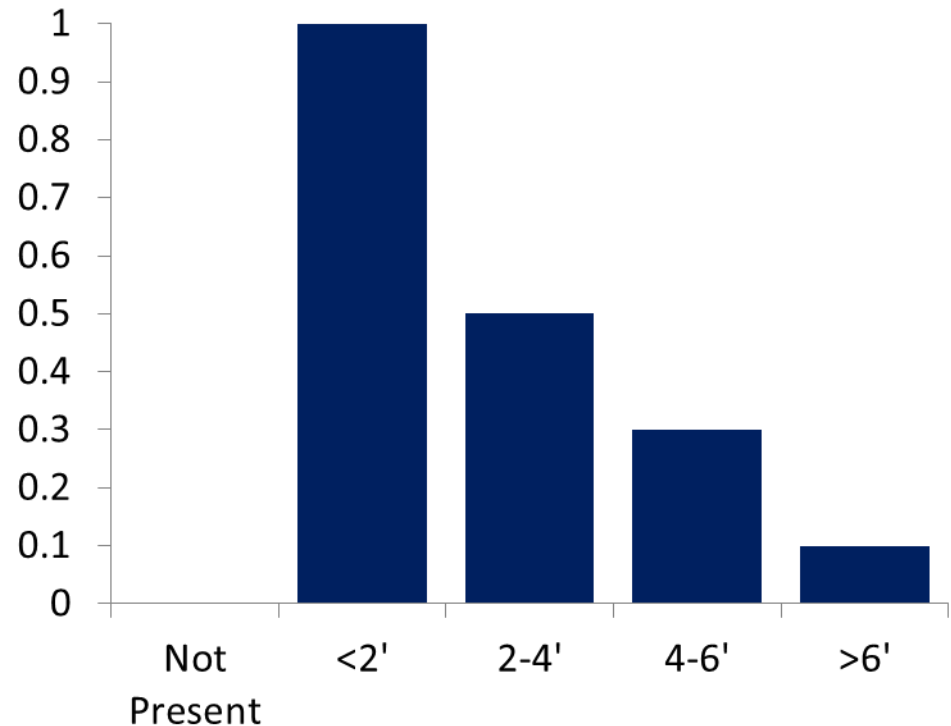
Attribute Scoring - Hydrographic Data (HEC-RAS)

Seasonal Inundation Depth	Score
Not Present	0
<2'	1.0
2-4'	0.5
4-6'	0.3
>6'	0.1

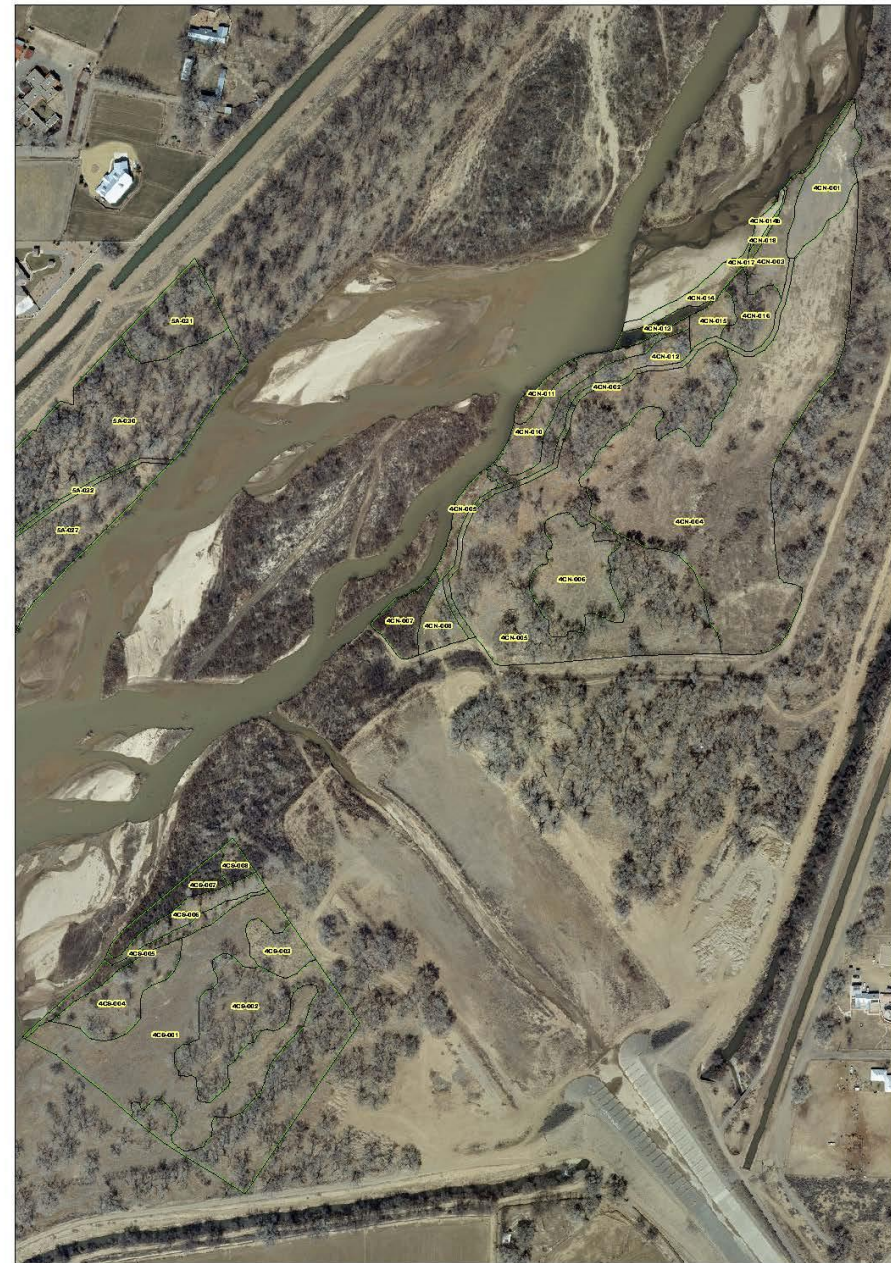
Map Unit Level Assessment

Functional Performance Score for each MU (the unit of management)

Site Functional Acres - weighted by MU.

Functional Acres are the Currency of Evaluation.

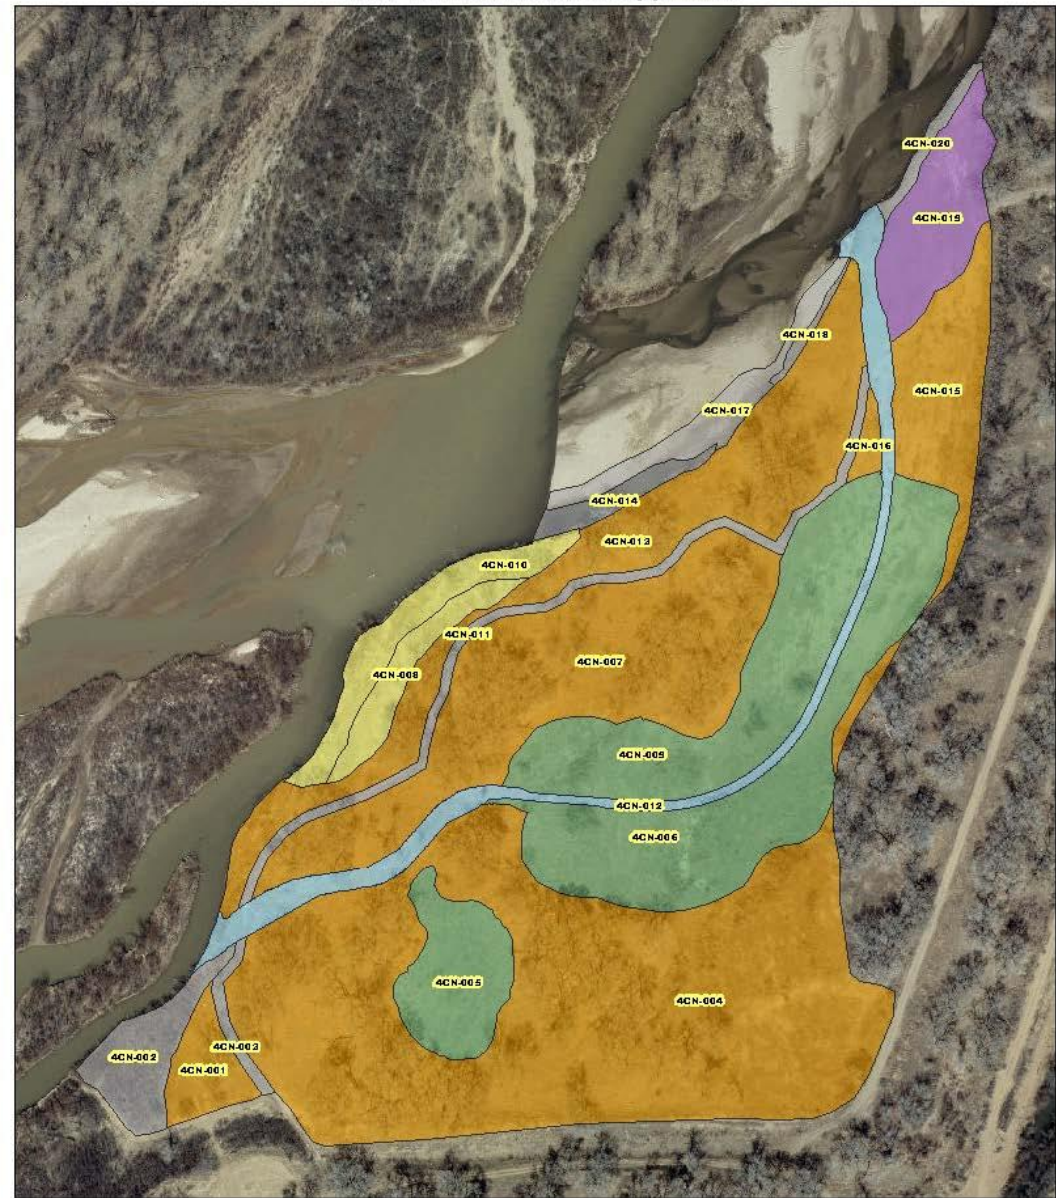
Work Planned

- Non-native fuels reduction
- Re-vegetation
- Bankline terracing (lowering)
- High-flow channel
- Willow swale

Map created by Chad McKenna,
GeoSystems Analysis, Inc. 01/22/2013
Restoration approach based on GPS
perimeters of Corps restoration features.

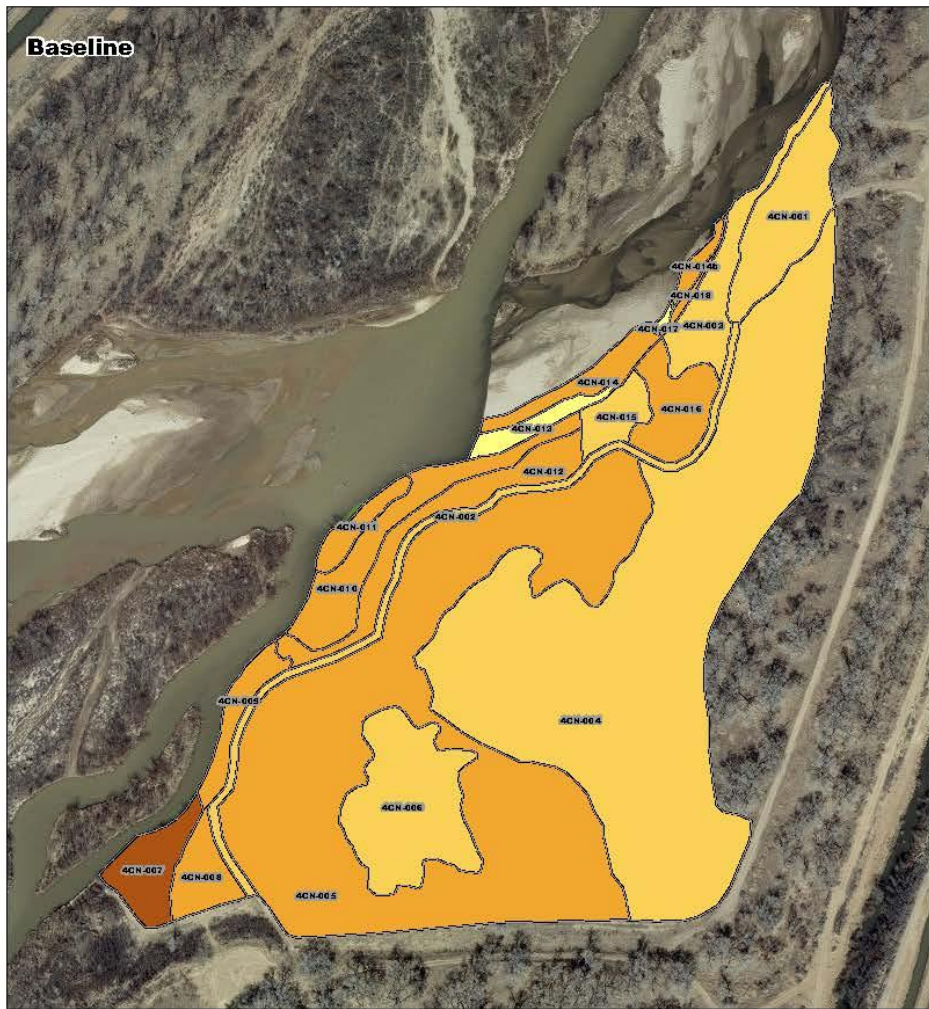
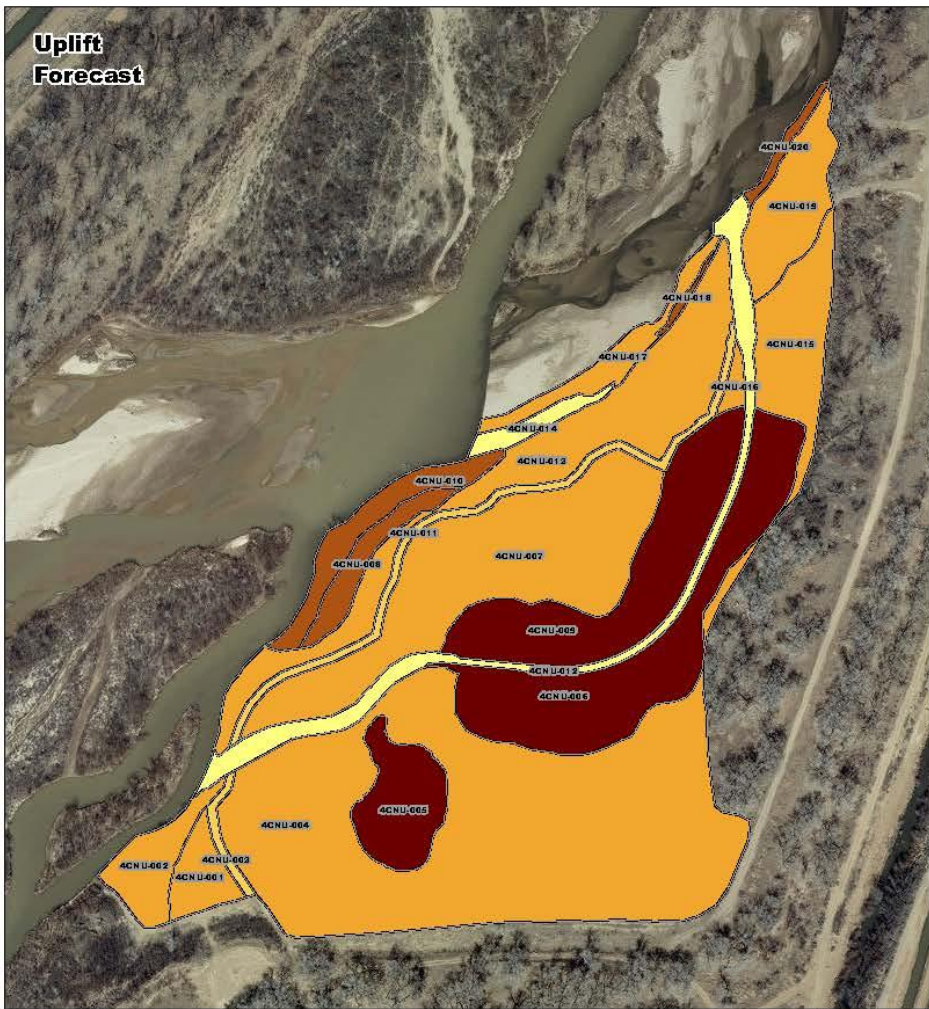
Baseline vs. Restoration - SWFL 3500 cfs at 10 years post-restoration

Site 4C Flycatcher Habitat Performance (3,500 cfs): Baseline and Uplift Forecast Score

- Considerable uplift for RGSM
 - Swale connection via high-flow channel
- SWFL scores increase due to willow swale and ephemeral channel treatment
 - No difference between 3,500 cfs & 5,000 cfs (wetted area stays the same).

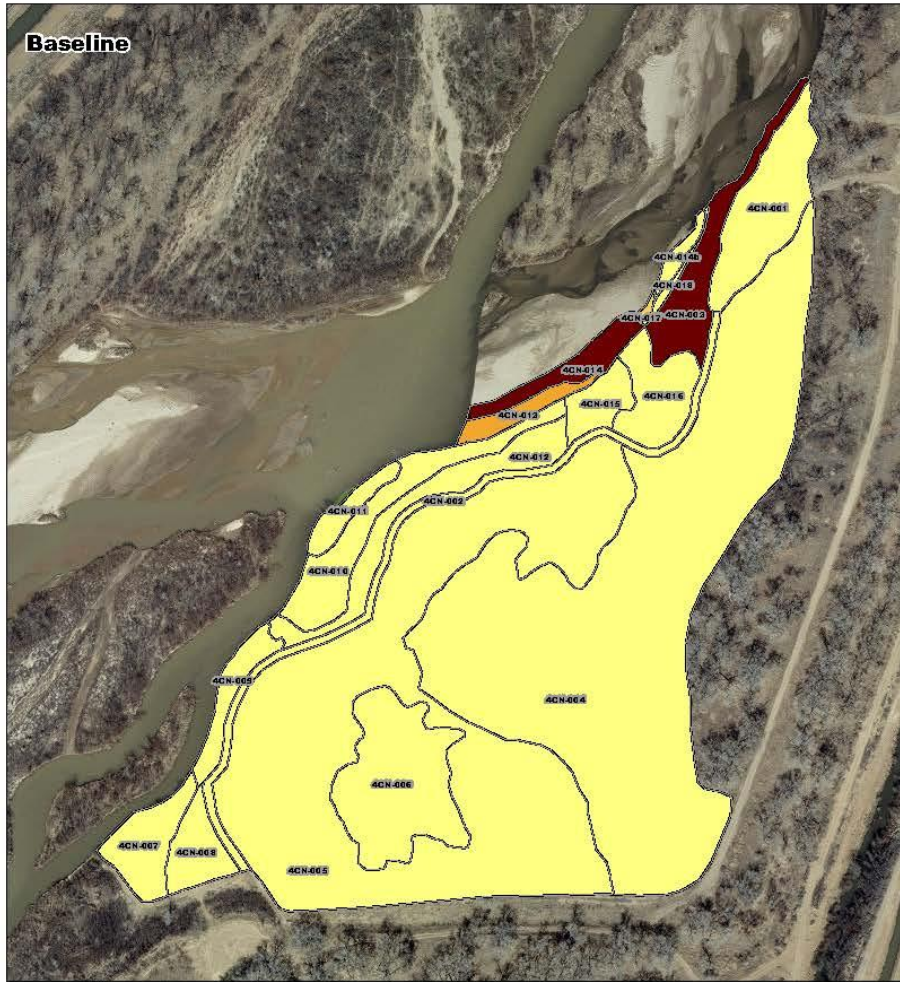
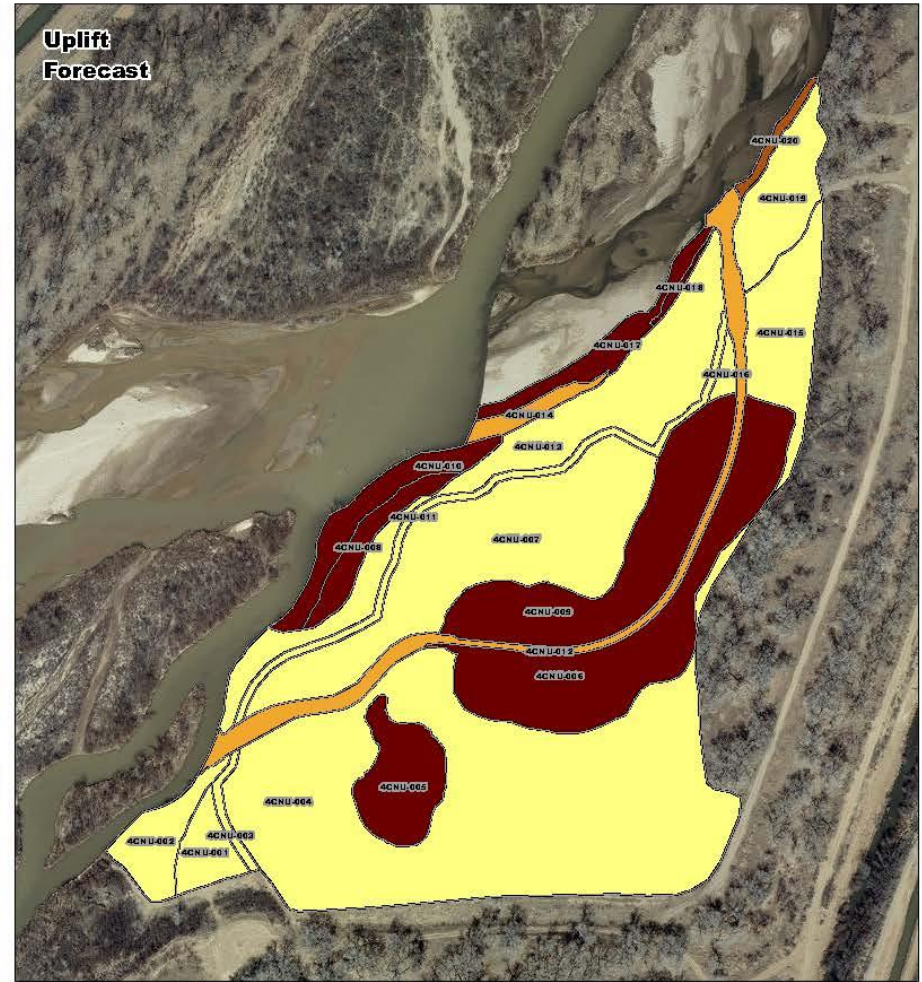
Baseline vs. Restoration - RGSM 3500 cfs at 10 years post-restoration

Site 4C Silvery Minnow Habitat Performance (3,500 cfs): Baseline and Uplift Forecast Score
