Using Native Cottonwood to Improve Water Quality in Urban Streams

Re-Inventing the Nation's Urban Water Infrastructure

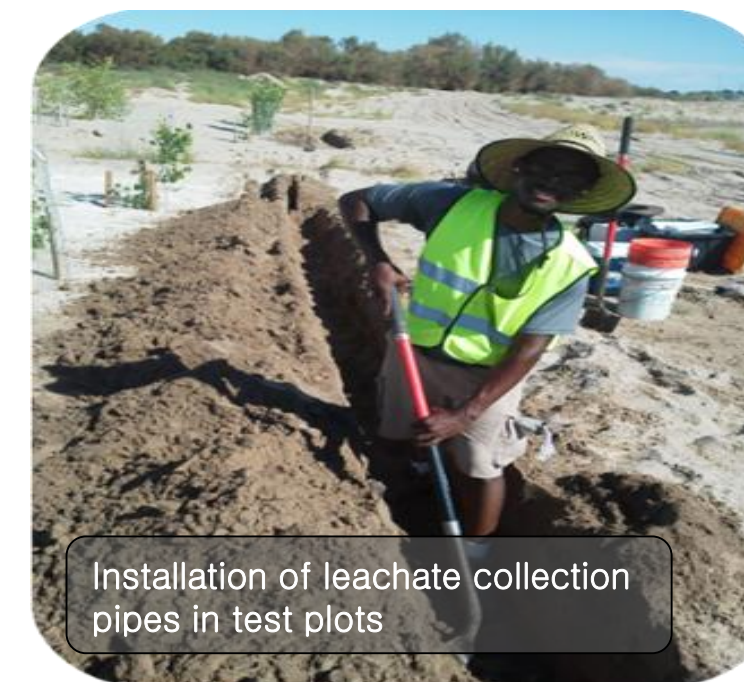
Installation of leachate collection pipes in test plots

- 1) Maintenance on the cottonwood test plots was conducted. Maintenance involved removing weeds within plots and constructing fences around the plants to protect them from beavers.
- 2) Conducted weekly plant health assessments during which qualitative and quantitative data was collected for each plant in every plot.
- 3) Surface soil samples were collected from every plot for the summer season to be tested to determine its chemical and hydraulic properties.
- 4) Leachate collection pipes were installed roughly 8 to 10 inches below the soil surface in each plot. Care was taken to ensure that the pipes would not collect ground water.

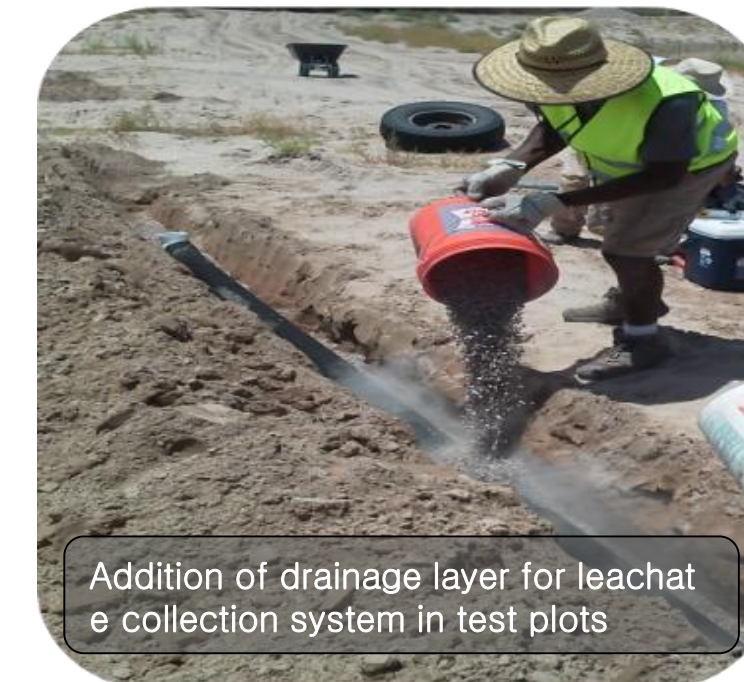
Addition of drainage layer for leachate collection system in test plots

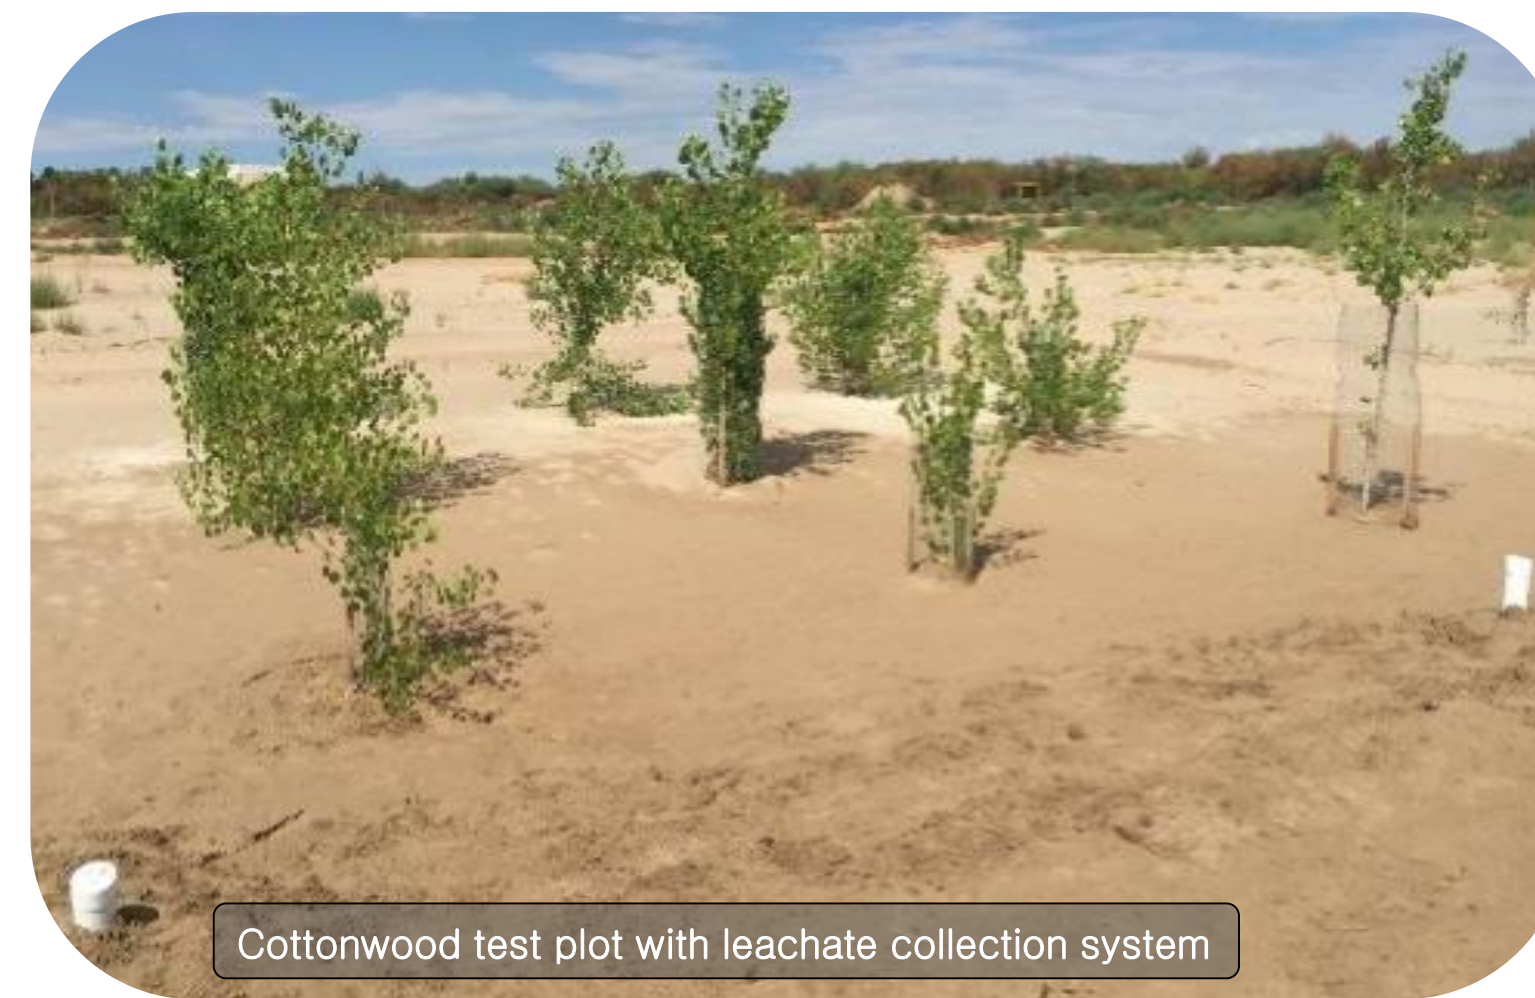
Cottonwood test plot with leachate collection system

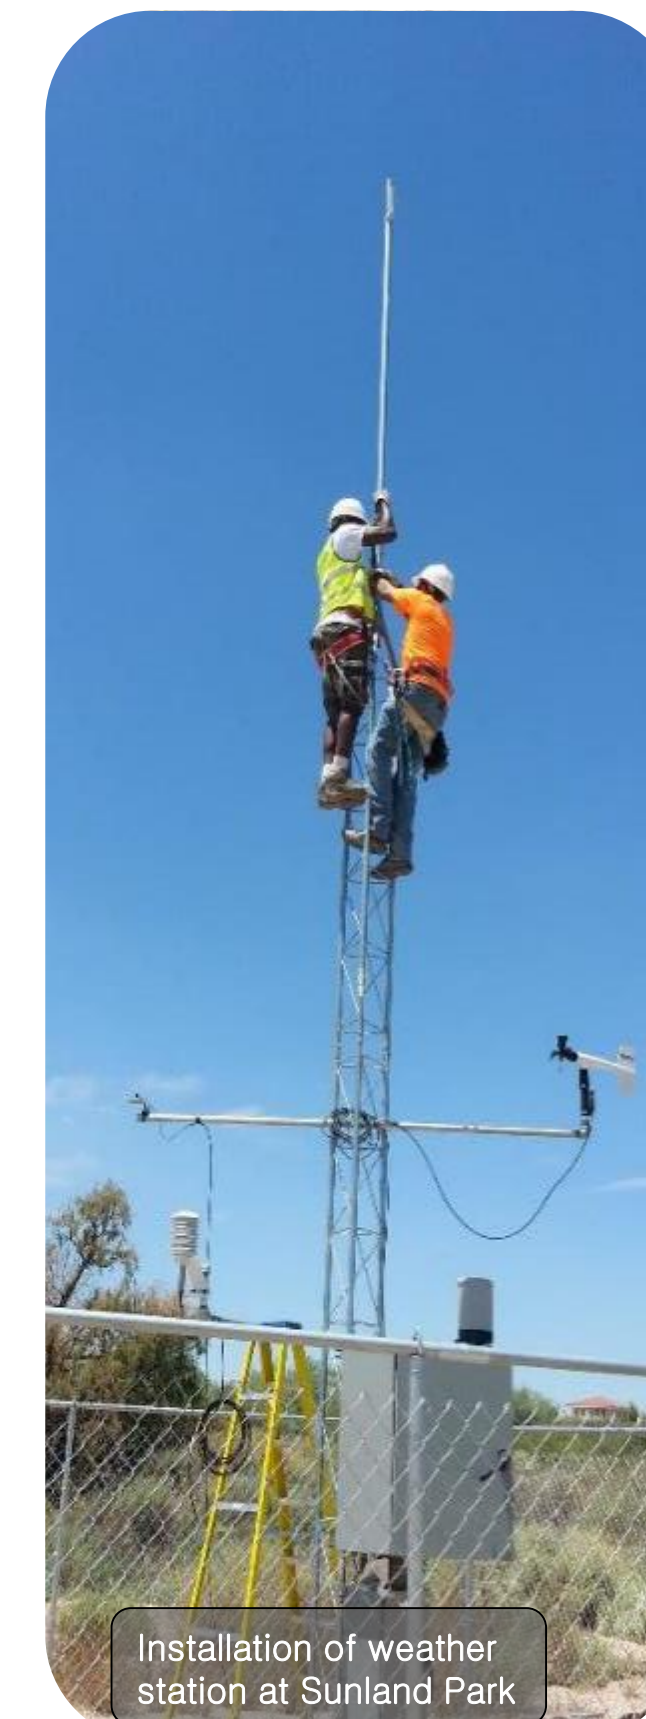
Installation of weather station at Sunland Park

- 5) A weather station was installed onsite. The weather station has sensors to record the amount of precipitation, solar radiation, humidity, wind speed and direction, and temperature.
- 6) Soil samples were tested to determine the particle size distribution, pH, nutrients, salinity, conductivity, cation exchange capacity (CEC), organic matter content, and sodium adsorption ratio (SAR).
- 7) Leaf samples were taken from plants in each plot and sent to Harris AgSource Lab to have the nutrient content determined.
- 8) Depth to groundwater was measured at 4 wells throughout the site on a weekly basis throughout the months of June and July.
