# IMPACTS OF LARGE-SCALE BREAKWATERS ON SHORELINE VEGETATION IN HIGH WAVE ENERGY ENVIRONMENTS

- 4.8 km of eroded shoreline in Bon Secour Bay, AL
- 4 Breakwater study areas: North No Breakwater (NNBW), Recent Breakwater (RBW), Old Breakwater (OBW), and South No Breakwater (SNBW) areas
- Plot treatments: Planted *Spartina alterniflora*, Natural *Spartina alterniflora*, and Bare

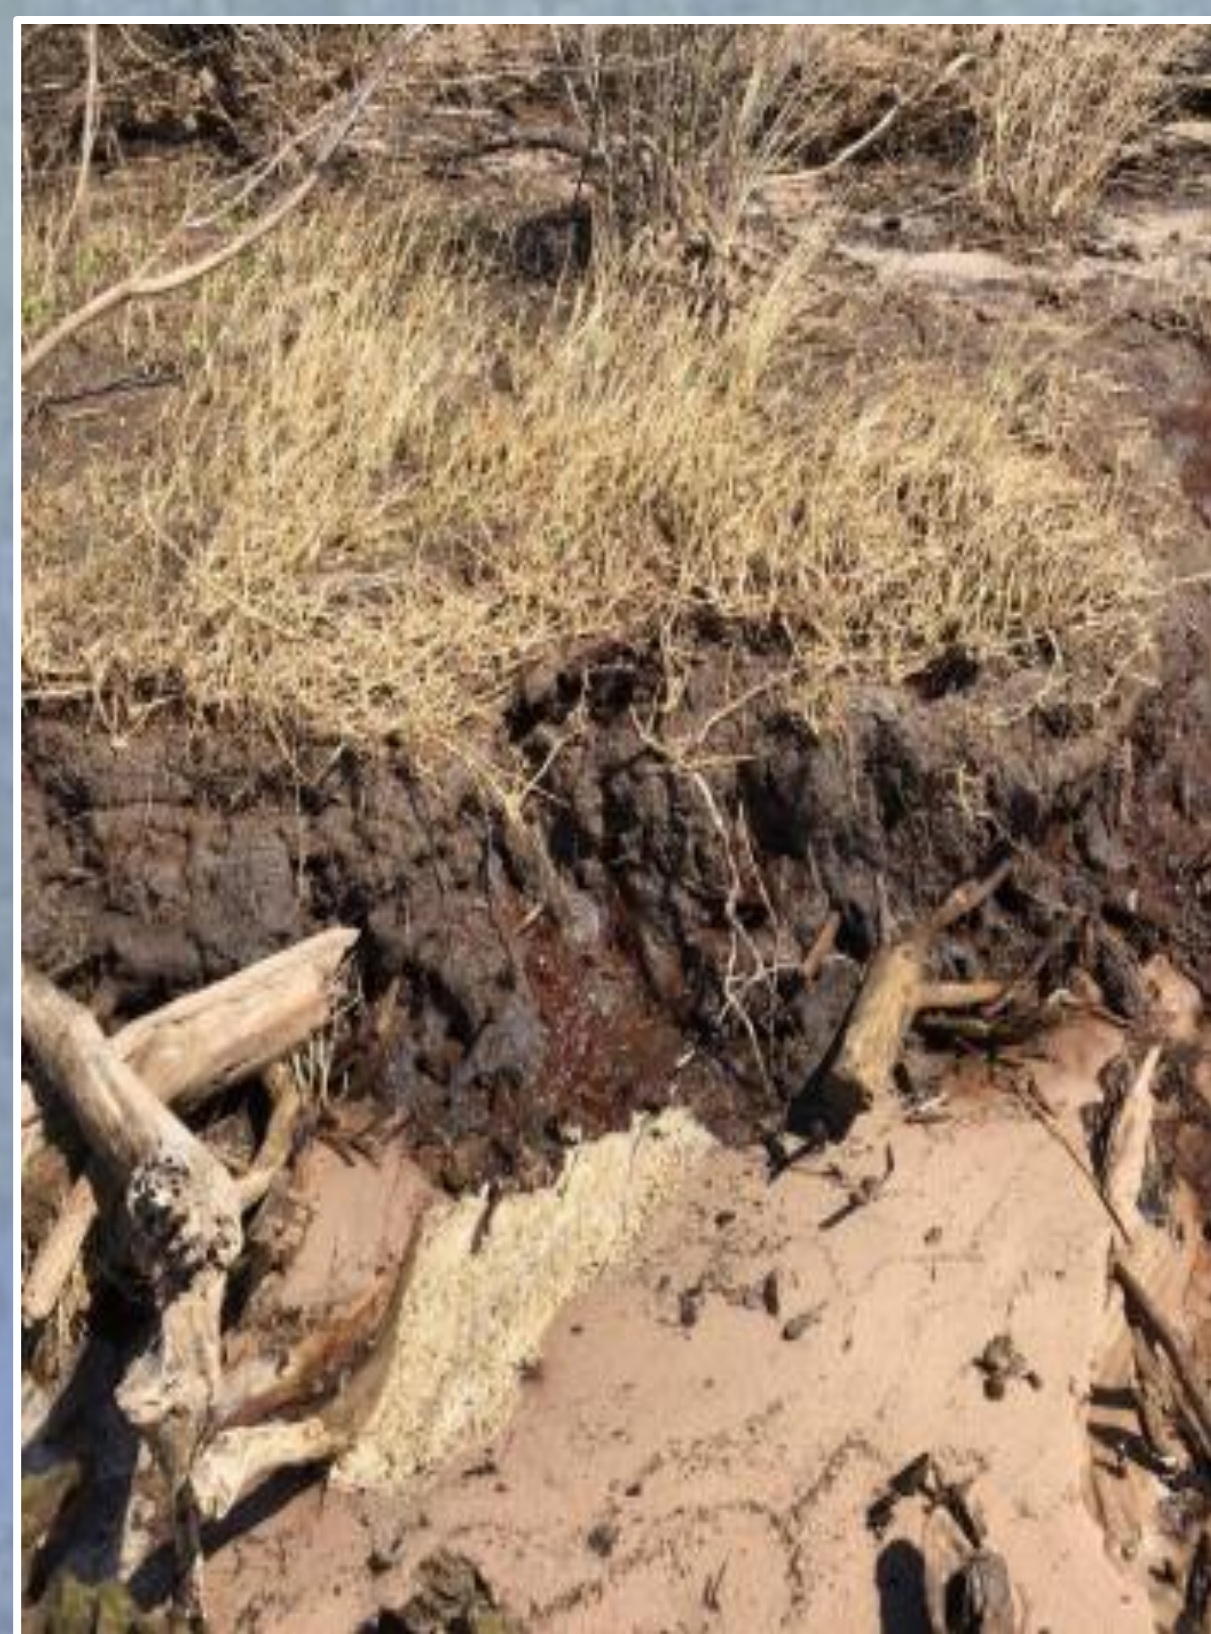
**Figure 2.** Photo from study site showing the high level of erosion along the shoreline.

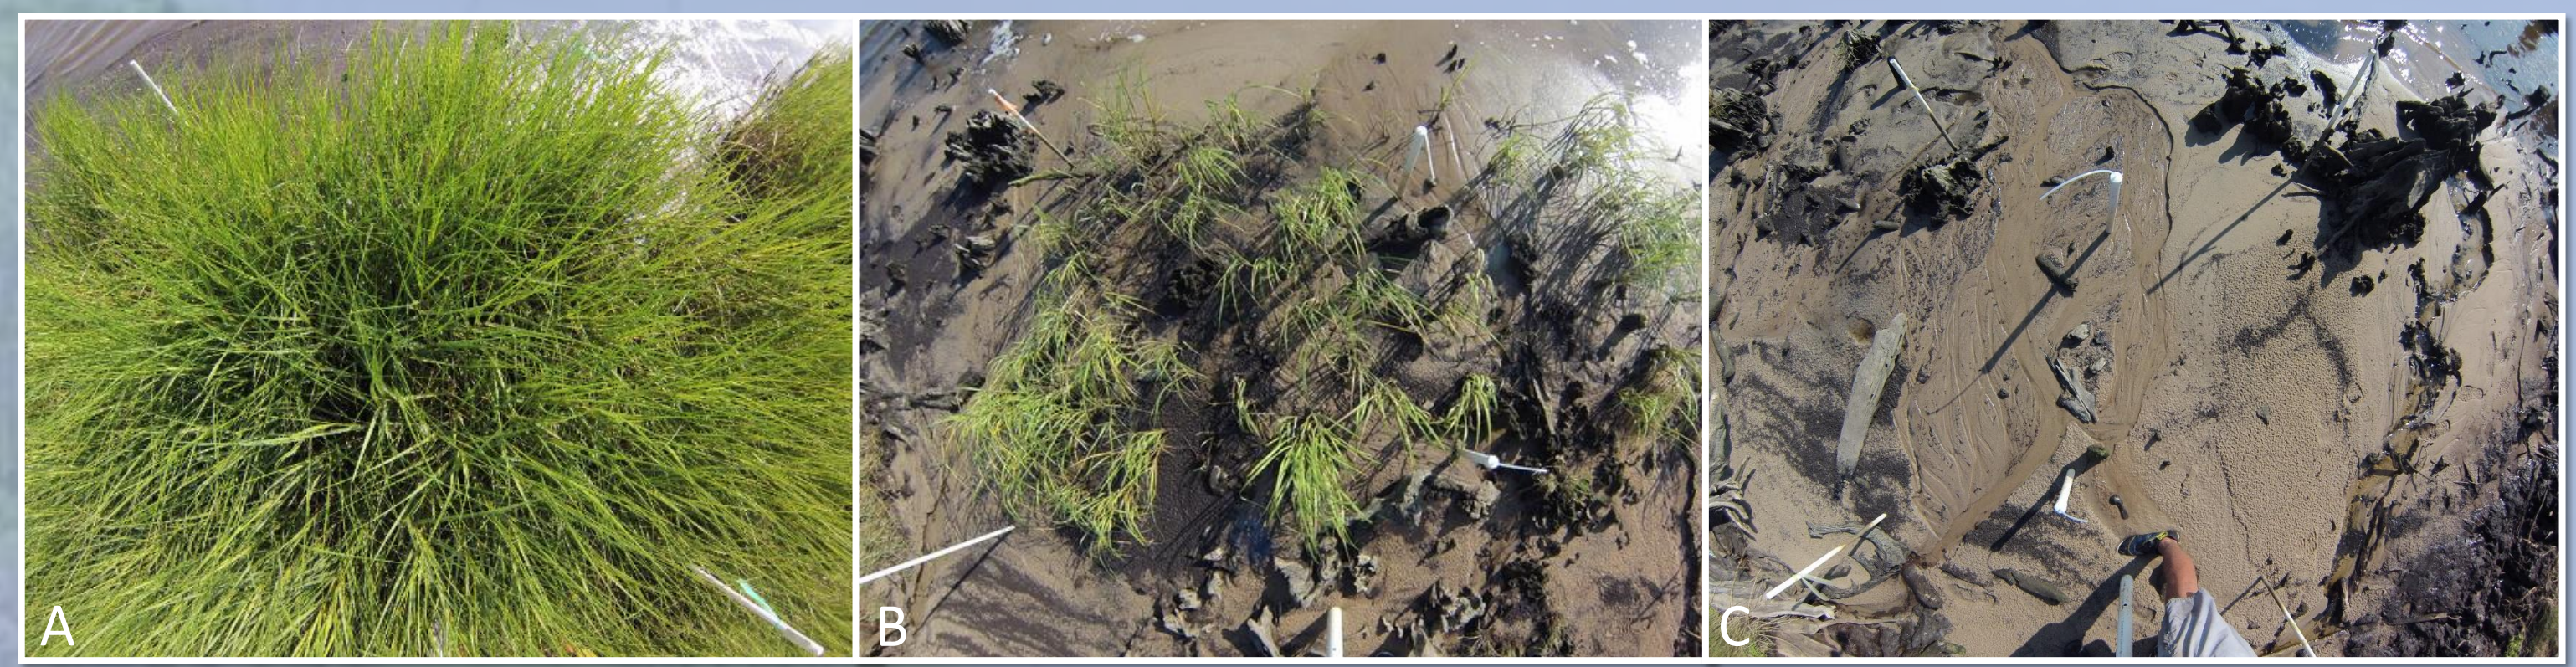
**Figure 3.** Example photos of: A) Natural plot; B) Planted plot; C) Bare plot

- Sampling has been done 7 times over 3 years in the OBW and SNBW study areas
- Plant heights and species percent cover data was collected in each plot at every sampling date

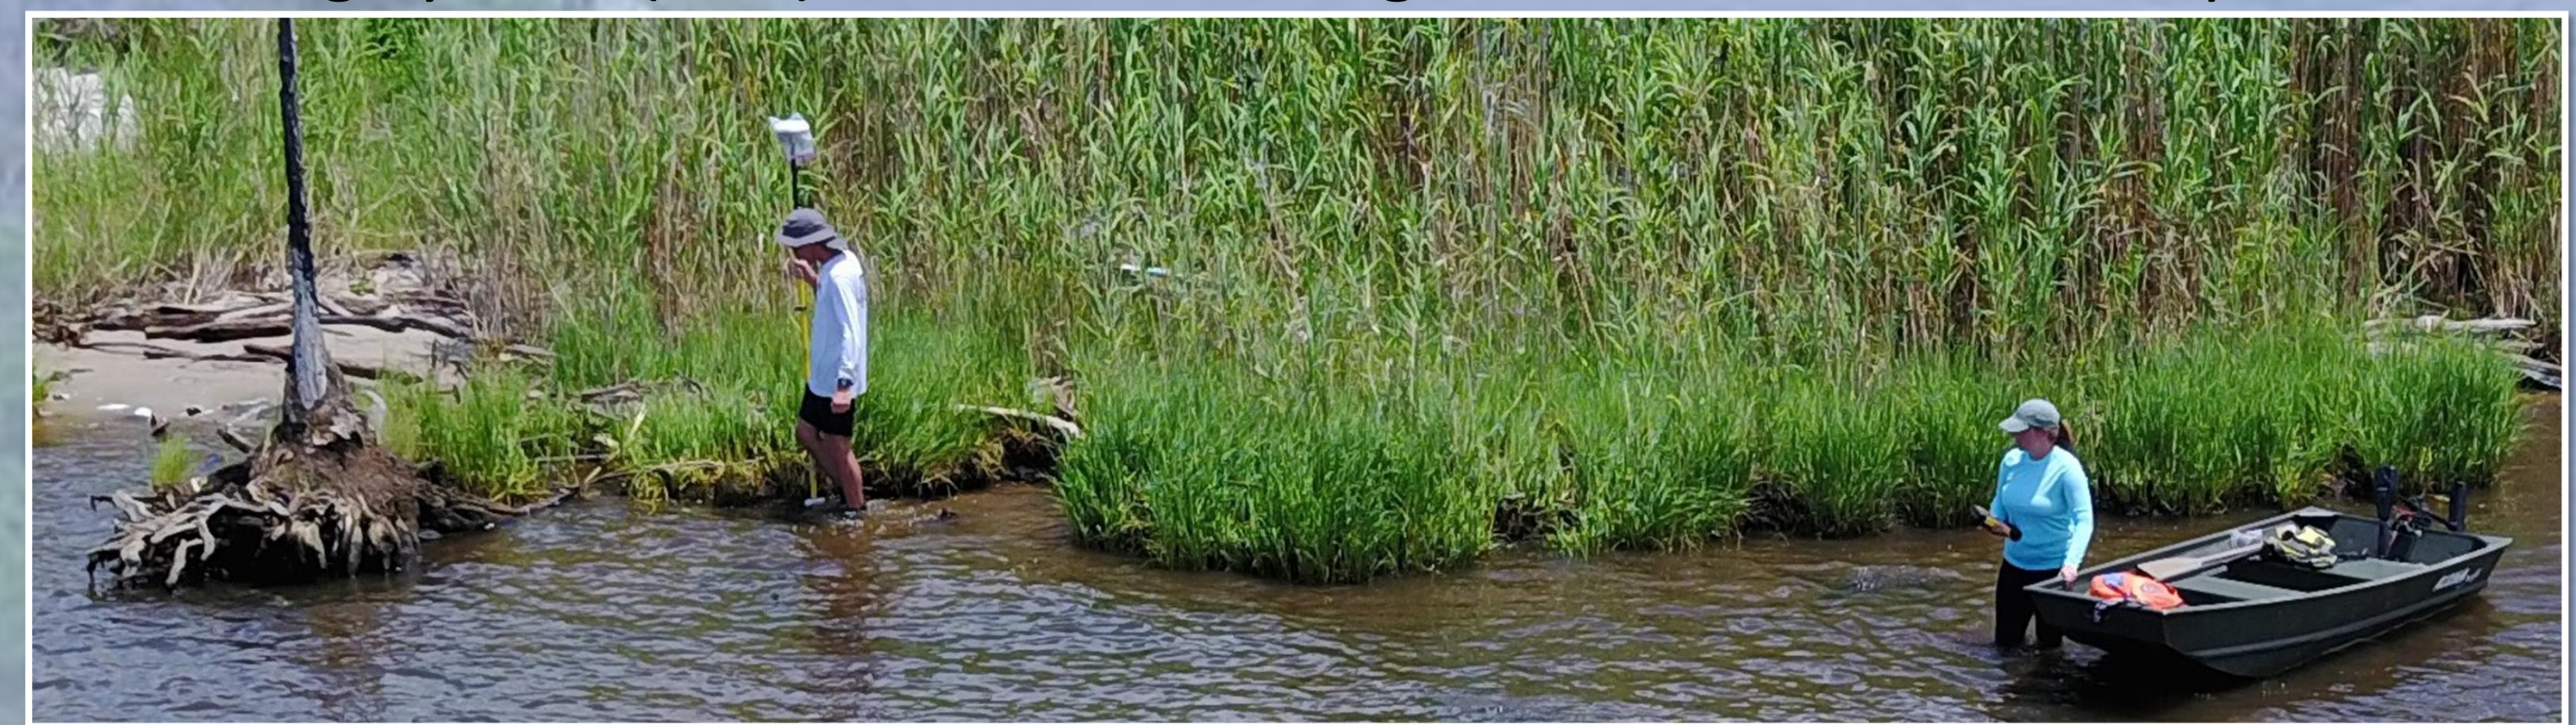
**Figure 4.** RTK survey of a natural *Spartina alterniflora* patch along the study shoreline.

- All study areas of the shoreline have been surveyed 3 times using a Real Time Kinetic (RTK) Global Positioning System (GPS) to monitor changes in natural stands of *Spartina alterniflora*.
