REACH BASED RESTORATION : *SUCSESSES AND LESSONS LEARNED FROM DECADES OF ECOLOGICAL RESTORATION*

John DiRocco, Senior Project Manager
Restoration Projects Group
Toronto and Region Conservation Authority

August 28, 2018

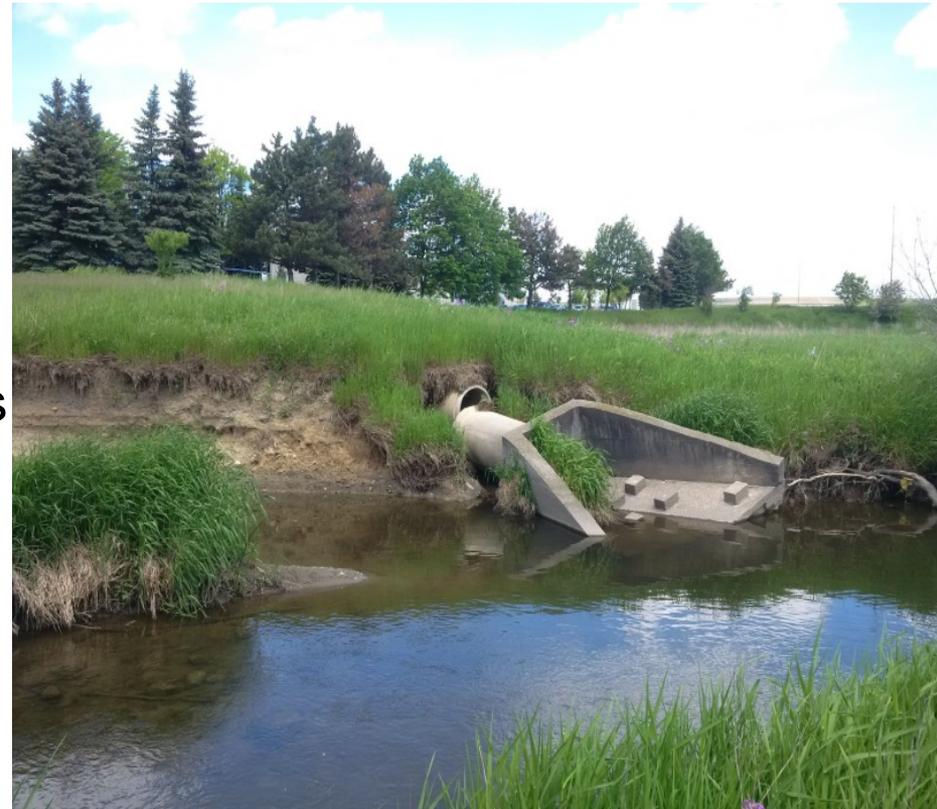
Restoration Challenges in an Urban System (end of the pipe)

- Hardened stream features, degrade over time (limited lifespan)
- Not connected to floodplains/incised creek channel
- Uncontrolled storm water inputs
- Lack of vegetation and impervious surfaces
- Flood prone areas and lack of flood storage
- Poor habitat quality
- Poor water quality

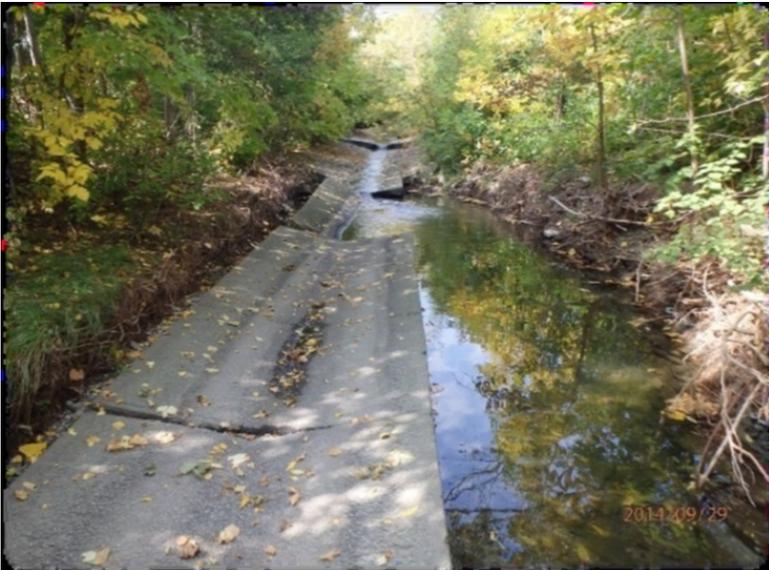
Past Design Techniques

- Past focused on fixing end-of-pipe (e.g. erosion) rather than system fixes or reach base restoration
- Spot fixes rather than reach based solutions
- No consideration of upstream and downstream issues (i.e. transferring the root problem)
- Lack of incorporating critical habitat components into designs
- Heavy focus on armoured in areas where a softer approach would be more beneficial

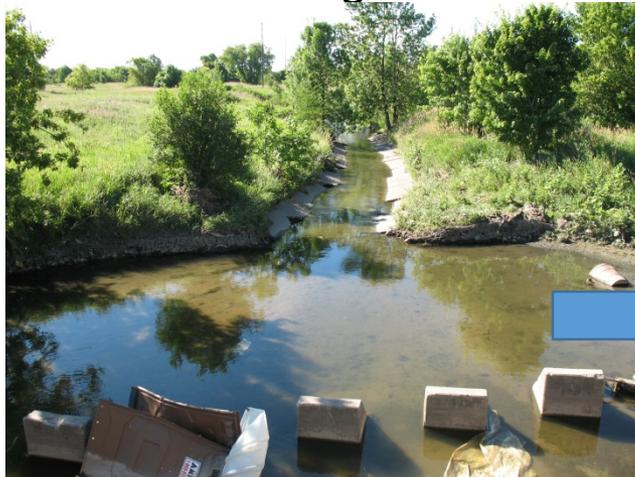
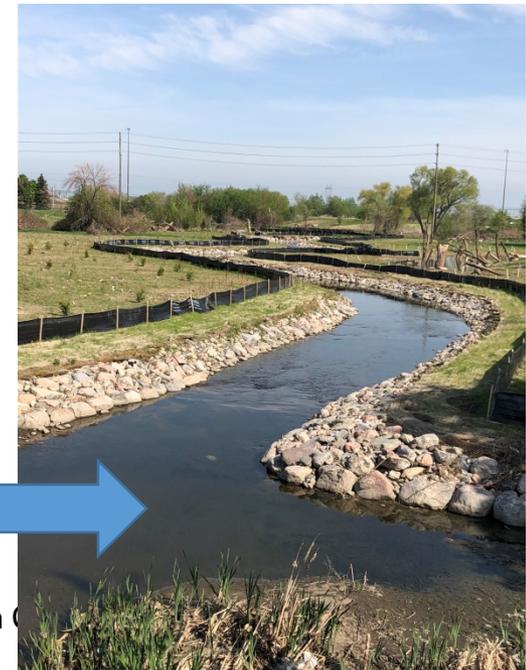
Current Design Techniques

- Dealing with all aspects of the impairment/features not just the impact
- System based approach
- Reconnecting to floodplain
- Reconstructing low flow channel to convey proper flows
- Wetlands and other associated habitat in the floodplain
- Natural cover and soil stability
- Wetlands at storm outlets for water quality
- Floodplain roughness and direction within entire width of floodplain using woody debris, rocks, plantings
- Structural habitat: in-stream and in the floodplain (riffle:pool, bank habitat/protection)
- Incorporating storm water treatment and green infrastructure

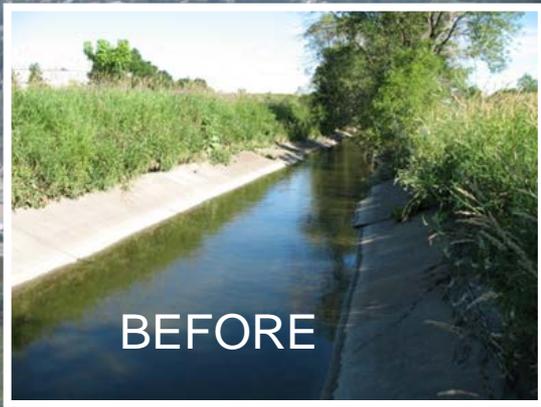
Northern reach: Previously straightened concrete channel, restored to natural channel

Floodplain cut to increase flood storage and reconnect to channel

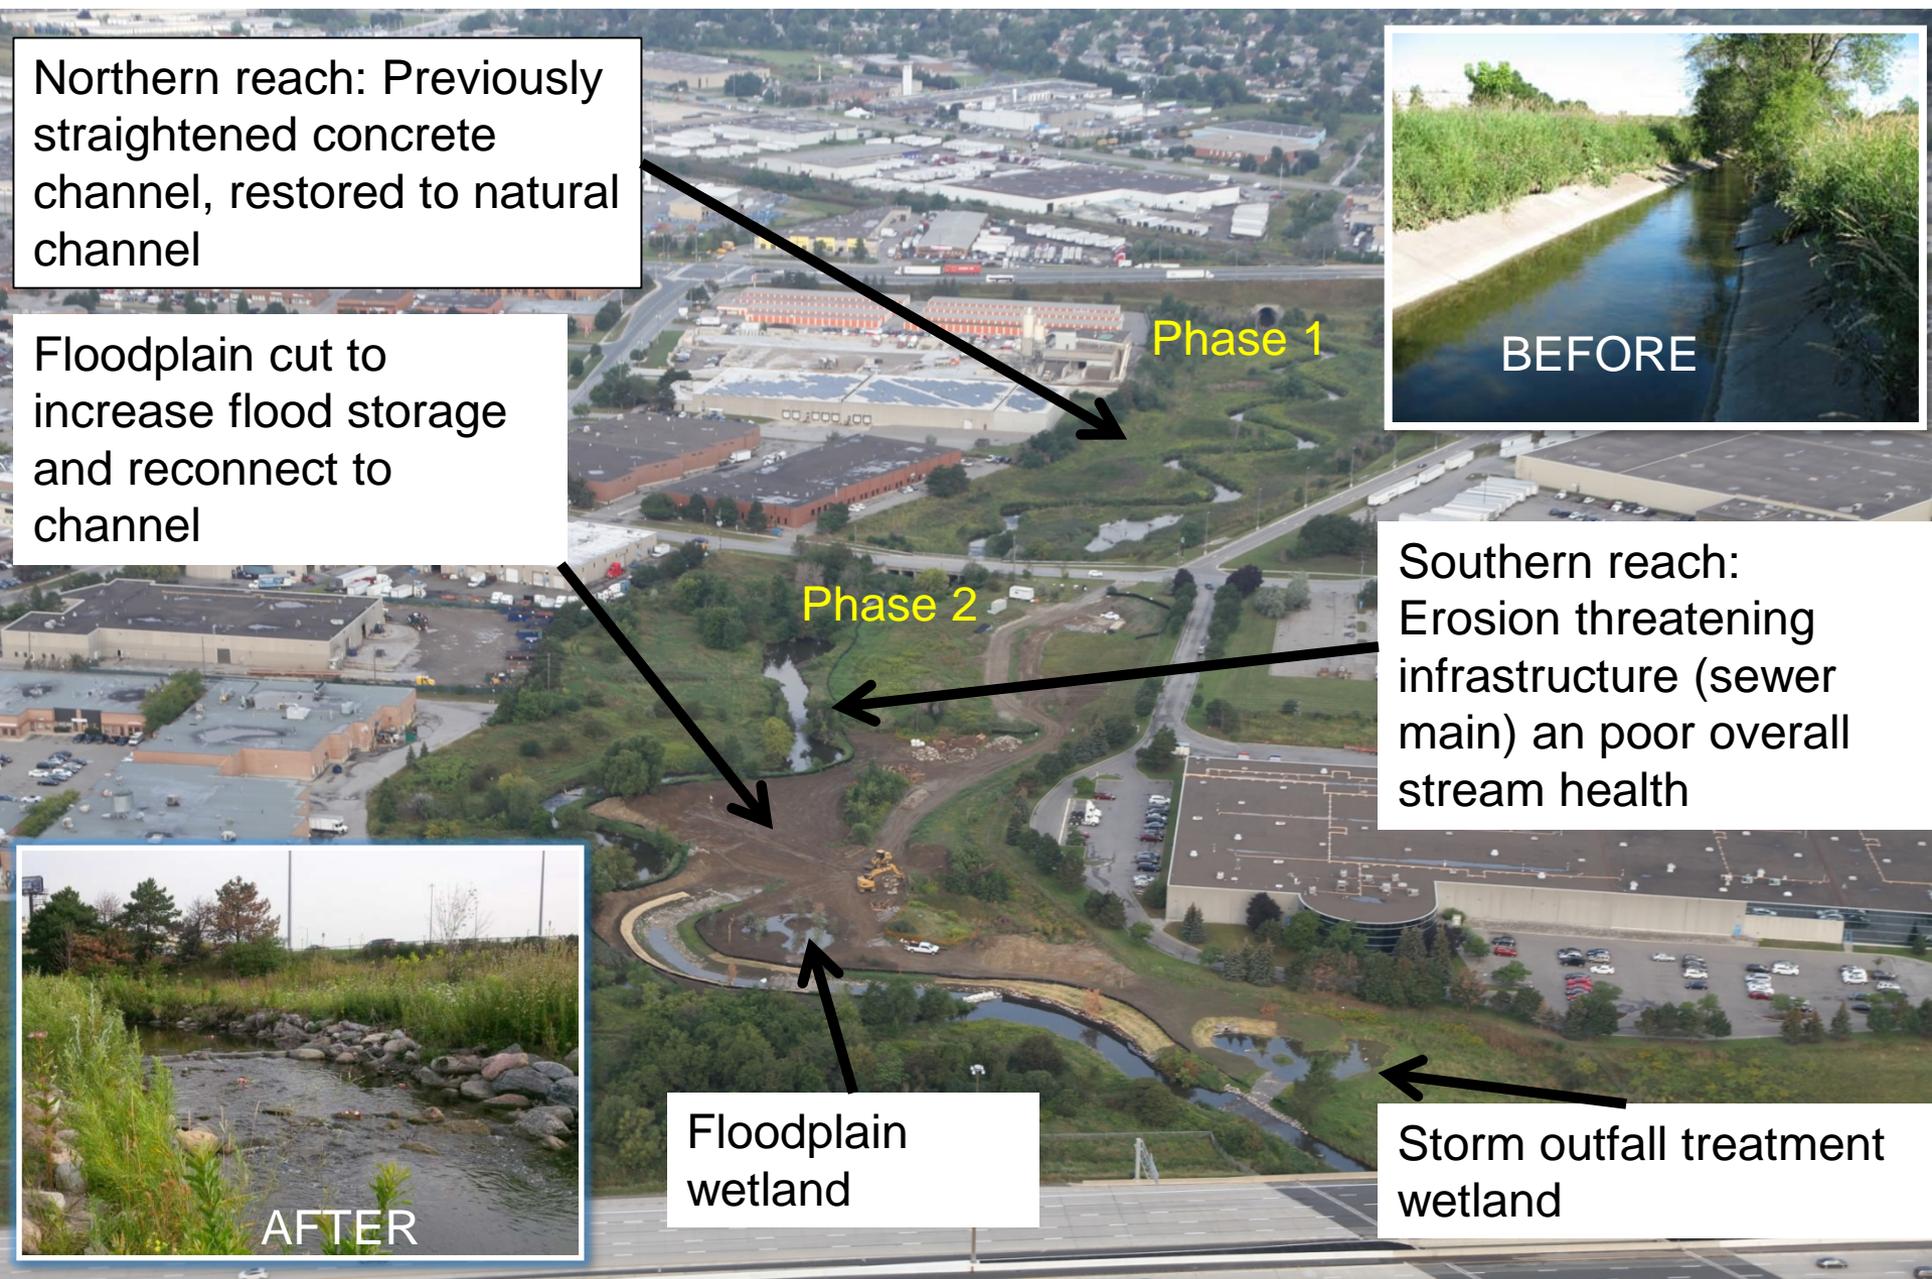
Floodplain wetland

Storm outfall treatment wetland

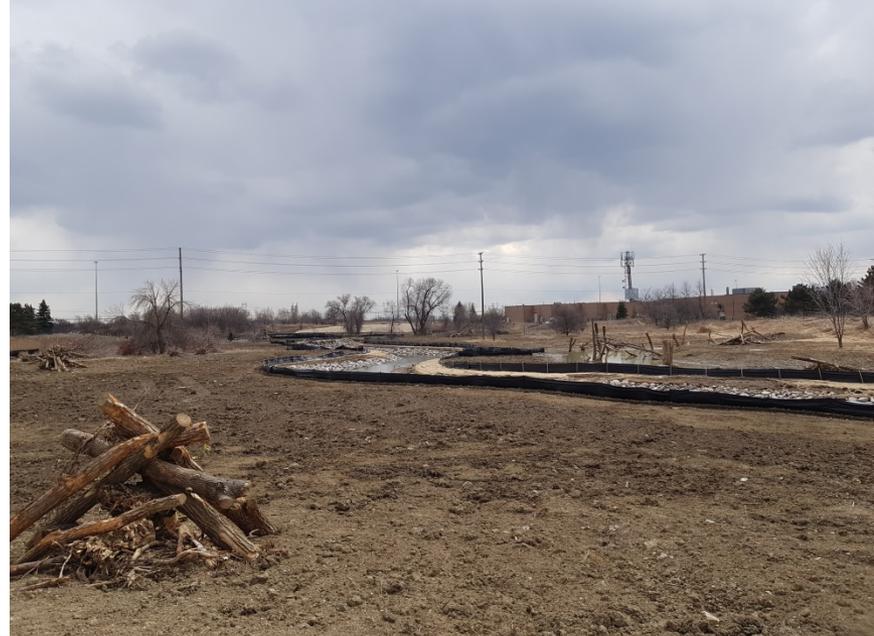
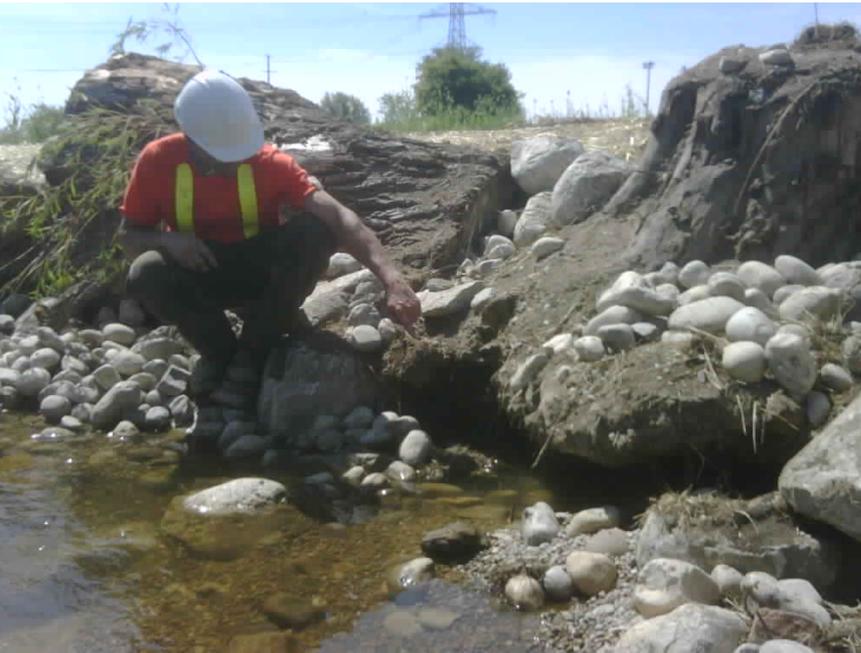
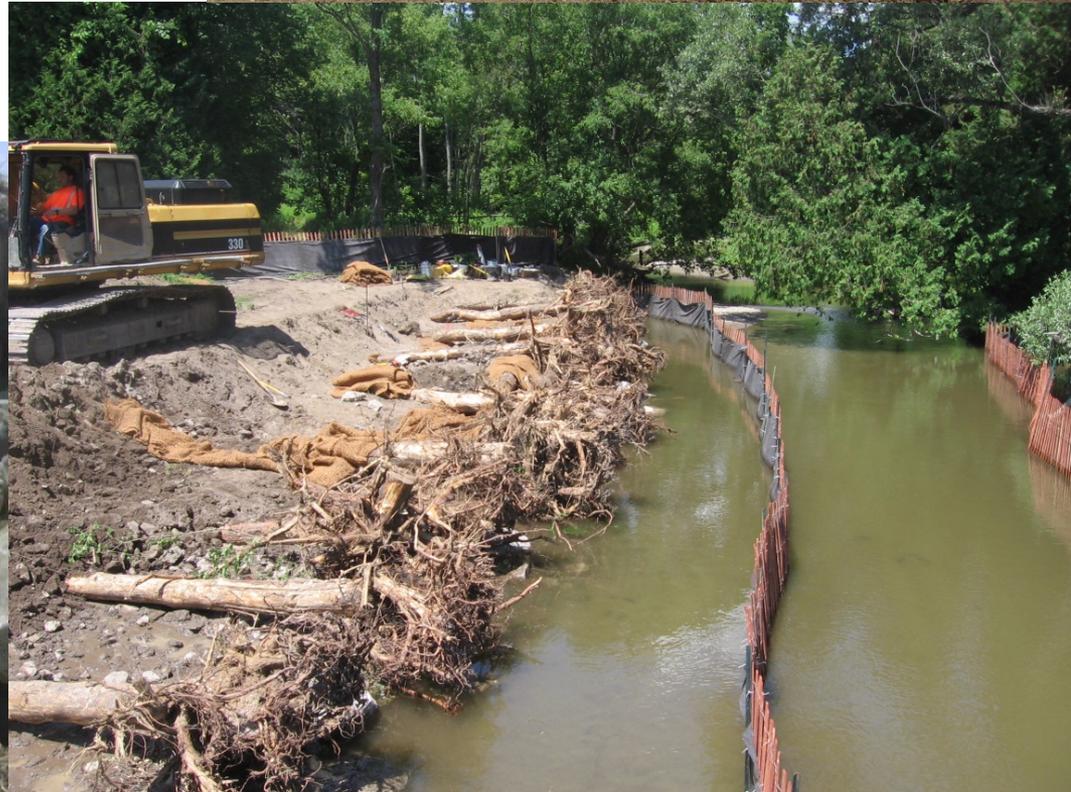
Use of Woody Material

- Replaces structure loss from clearcutting
- Provides habitat for wildlife
- Can be used for bank protection
- Provides important fish habitat
- Increases surface roughness

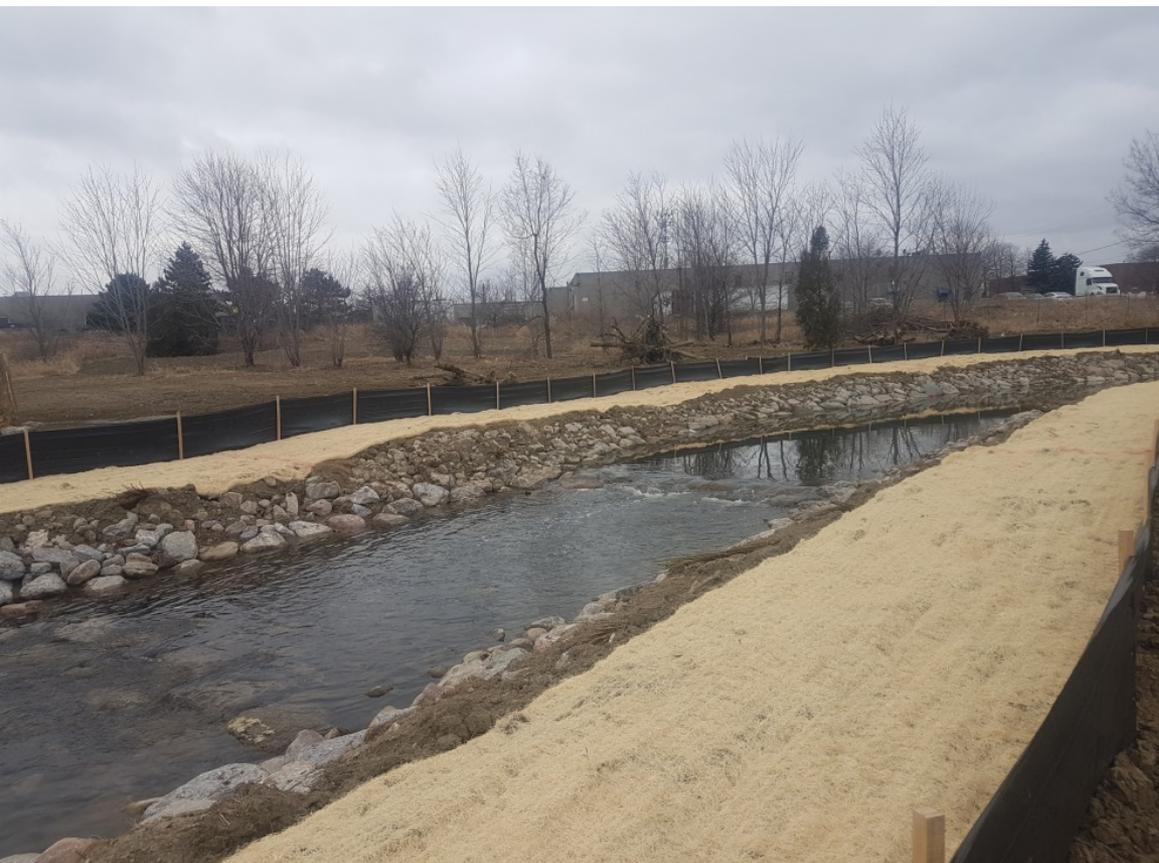
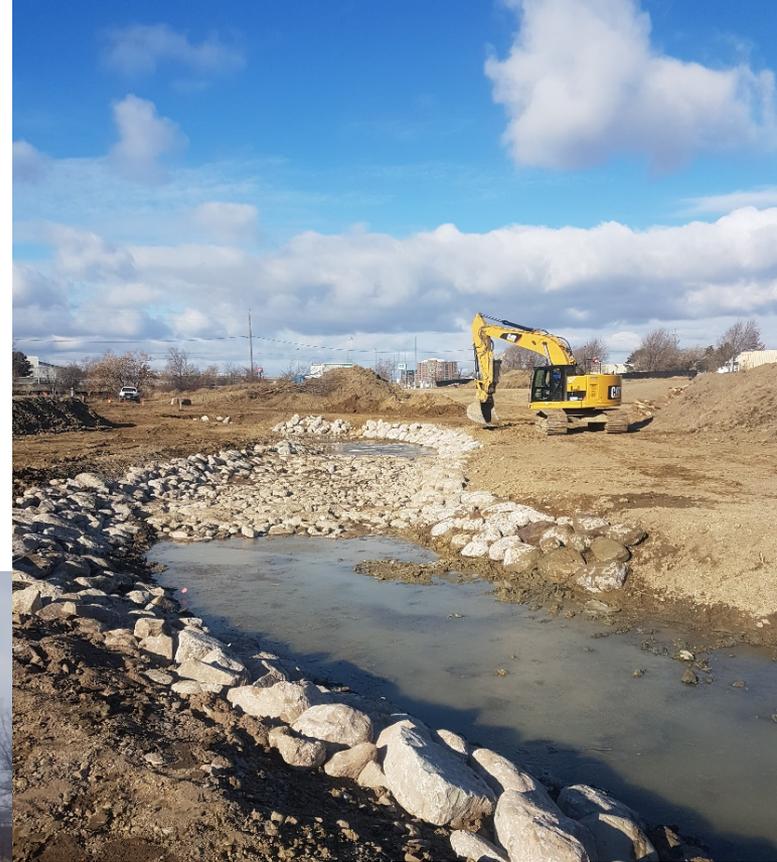
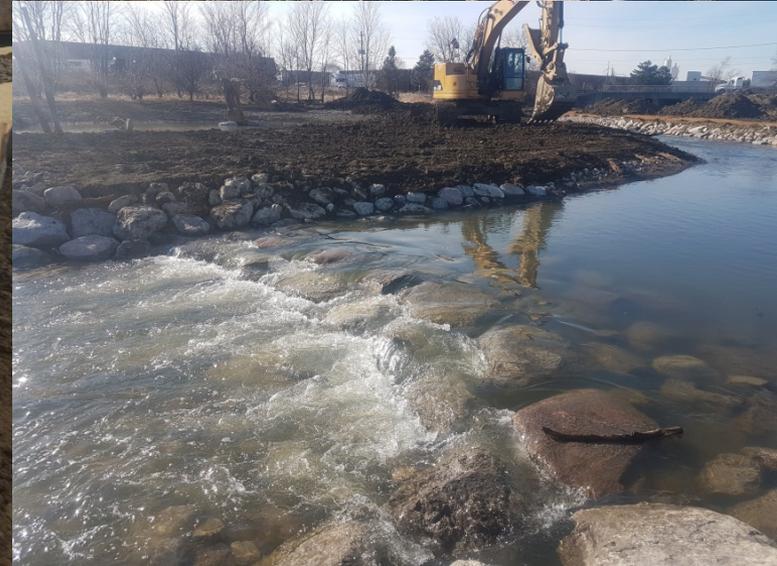
Use of Stone Material

- Critical bank projection
- Fish habitat (riffle:pool)
- Hard features control flows (vortex weirs)
- Other floodplain habitat

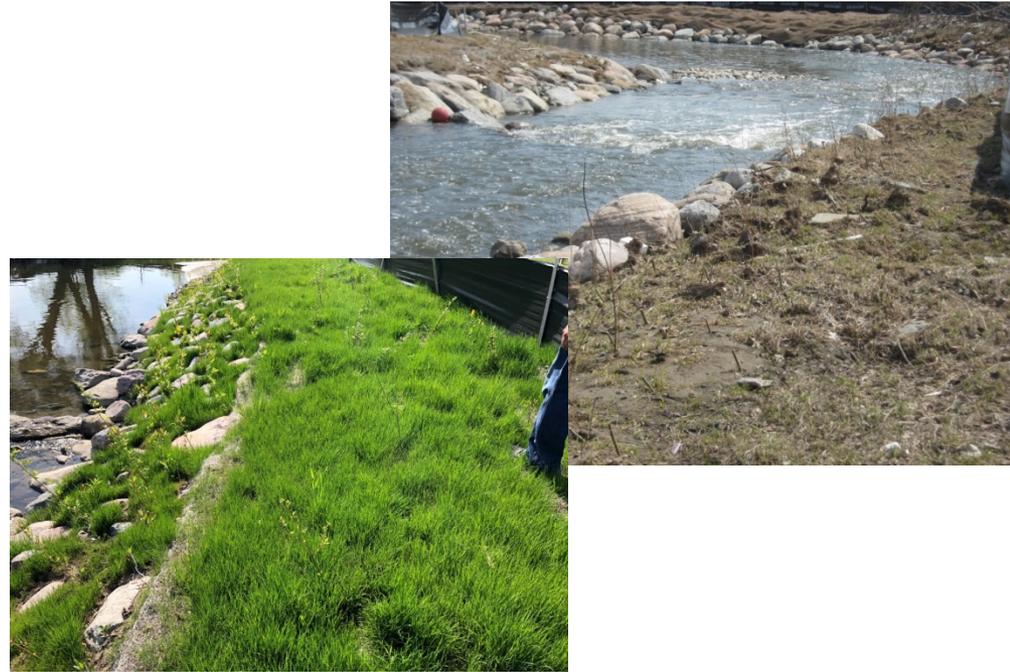
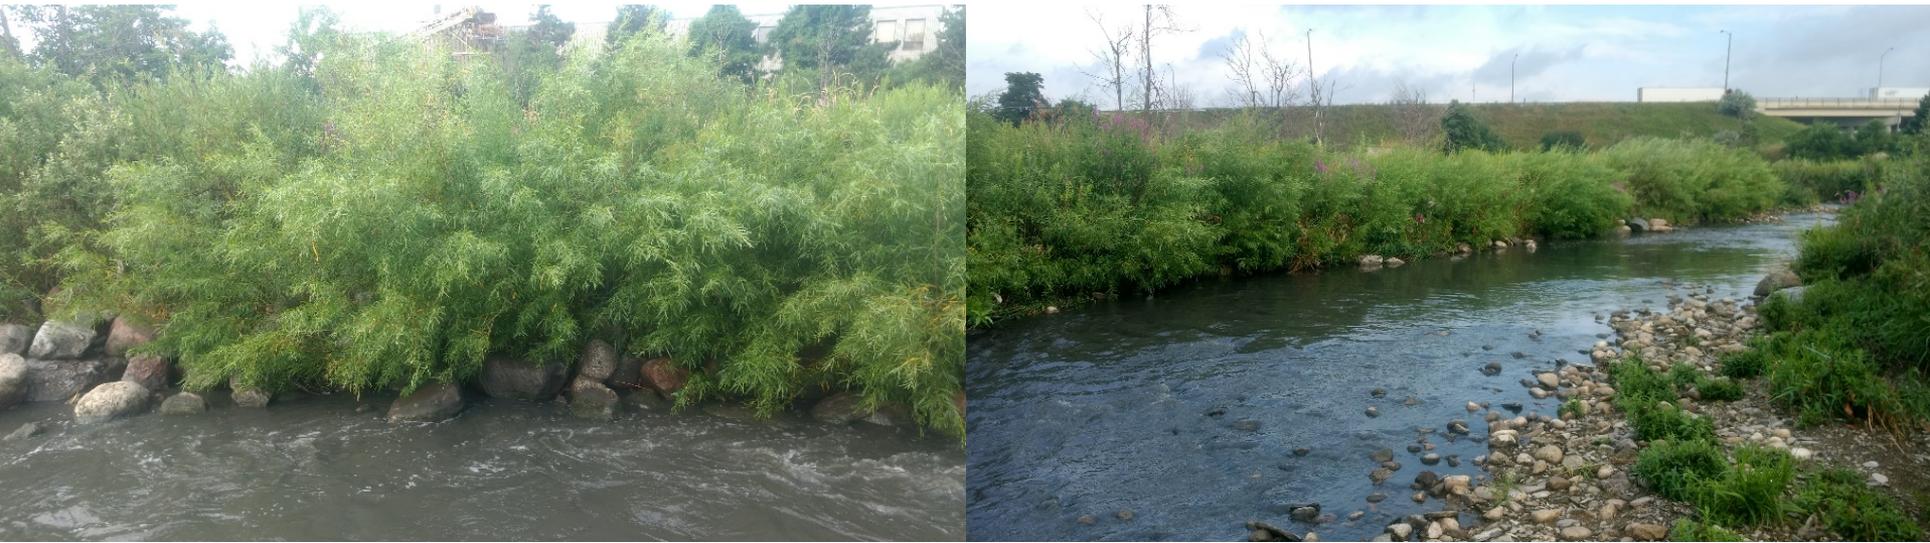
Use of Vegetation (Bio-engineering)

- Soil stabilization
- Bank Protection
- Overhanging vegetation for food and cover
- Alternative to hardened surfaces

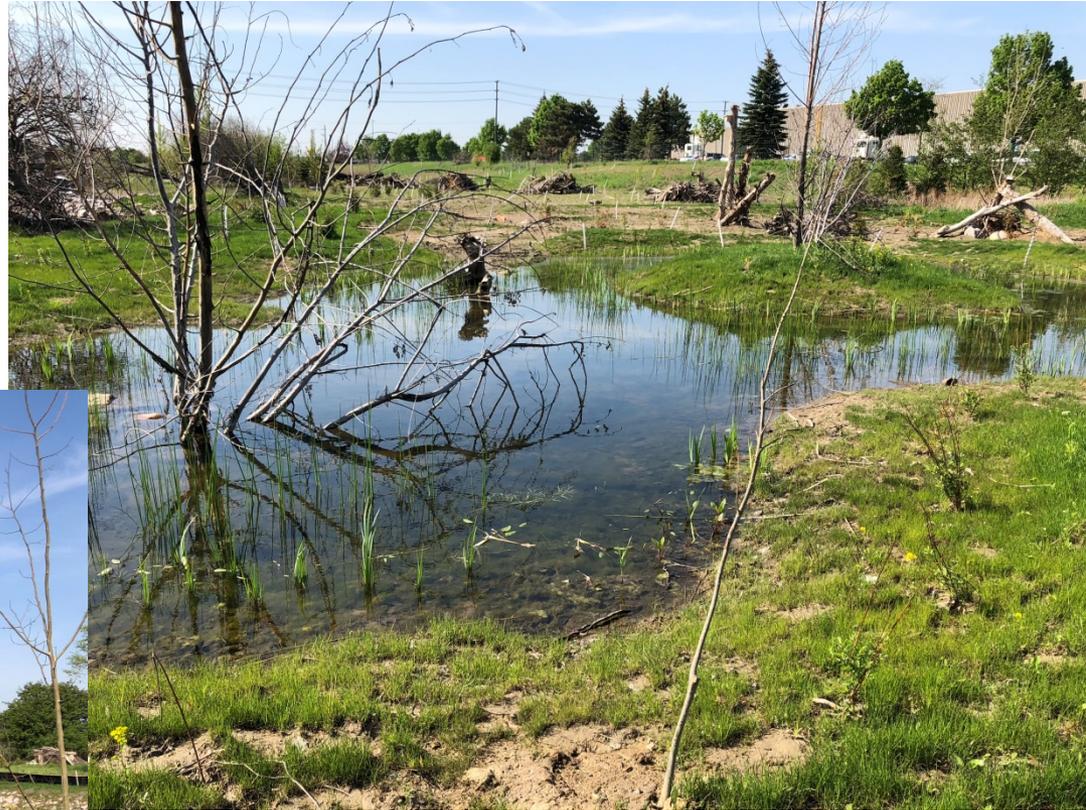
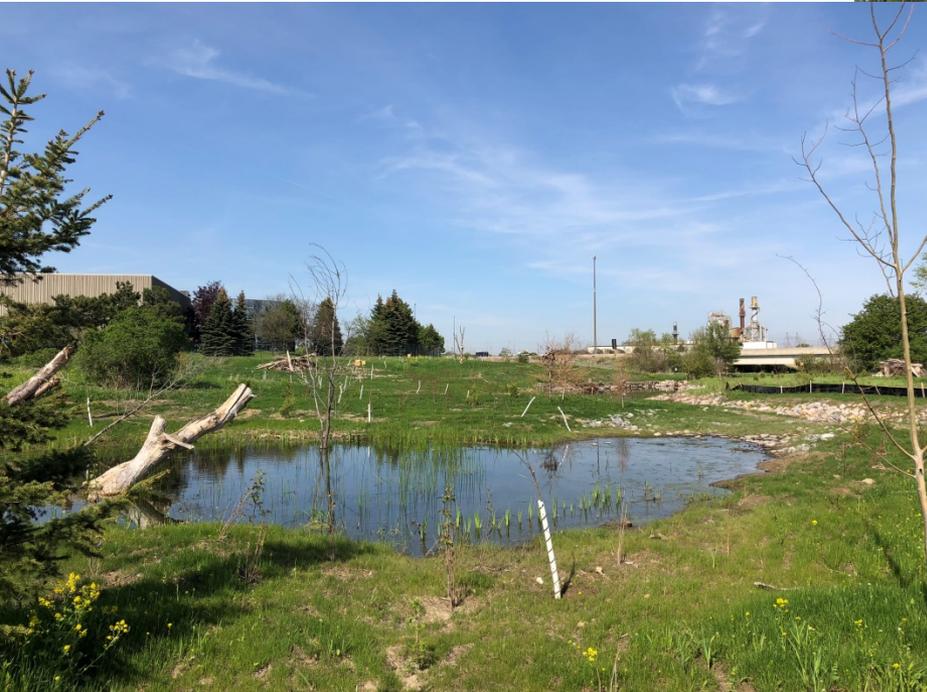
Wetlands and Floodplain Storage

- Increased flood capacity
- Reconnects channel to floodplain
- Provides habitat for wildlife using valley corridor
- Water quality treatment when intercepting uncontrolled storm flow

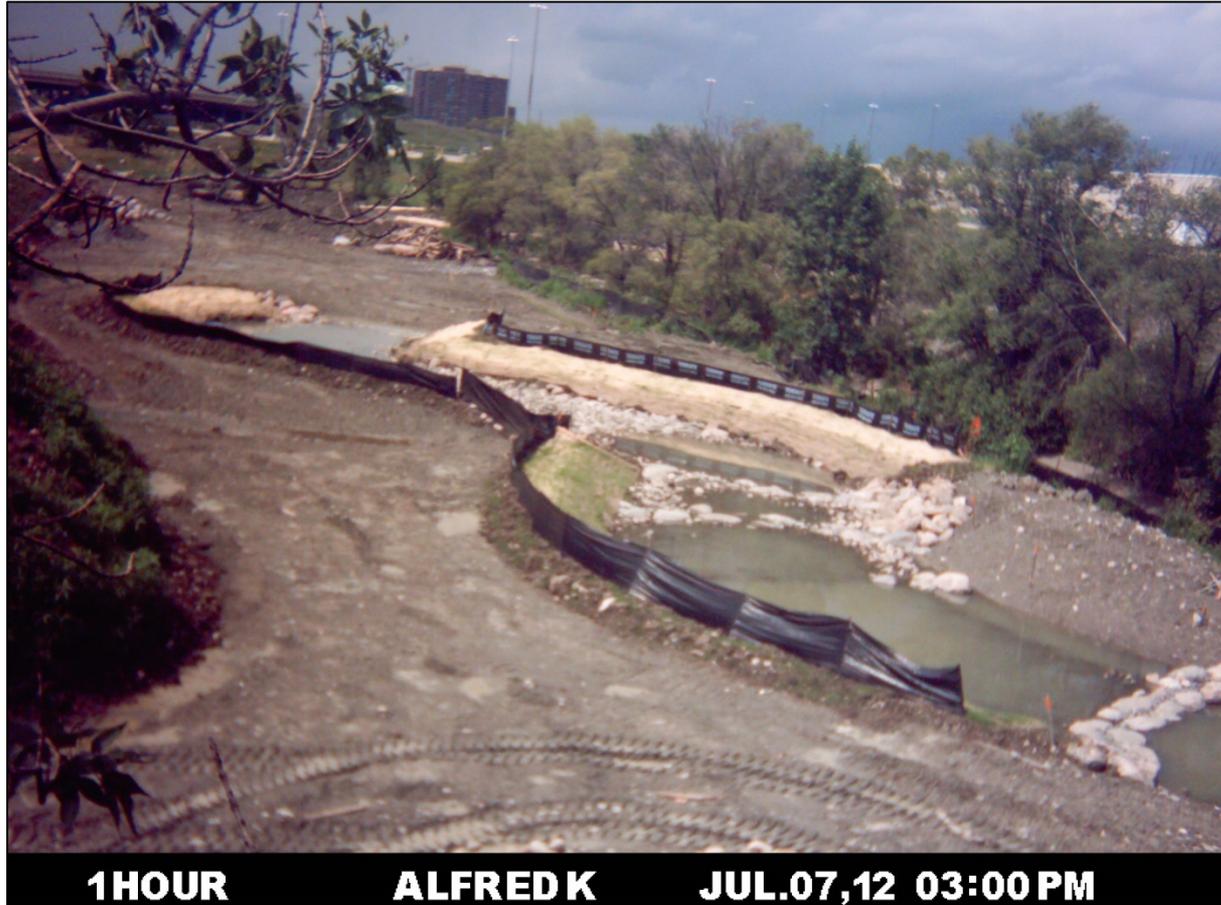
Other things to consider During Construction (Weather)

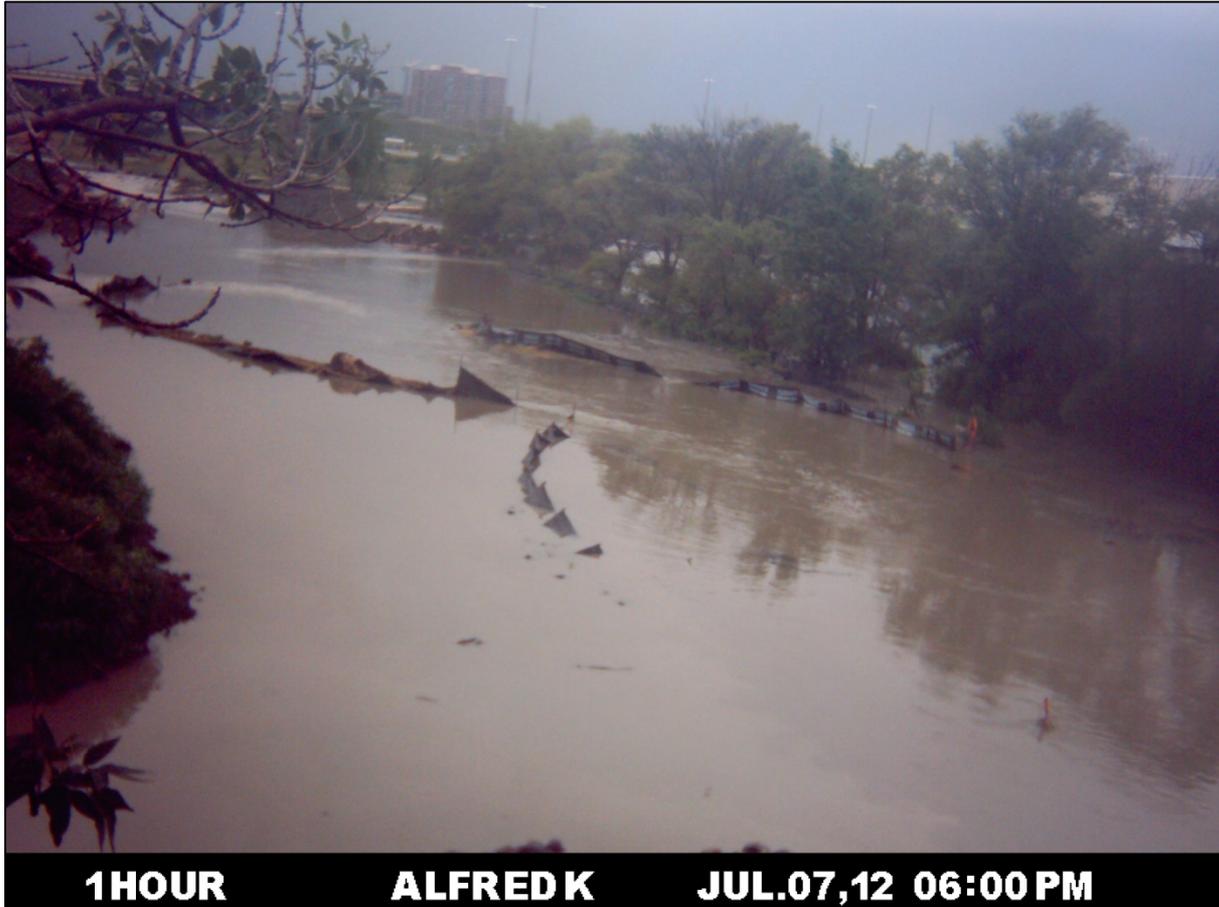
Other things to consider During Construction (Weather)

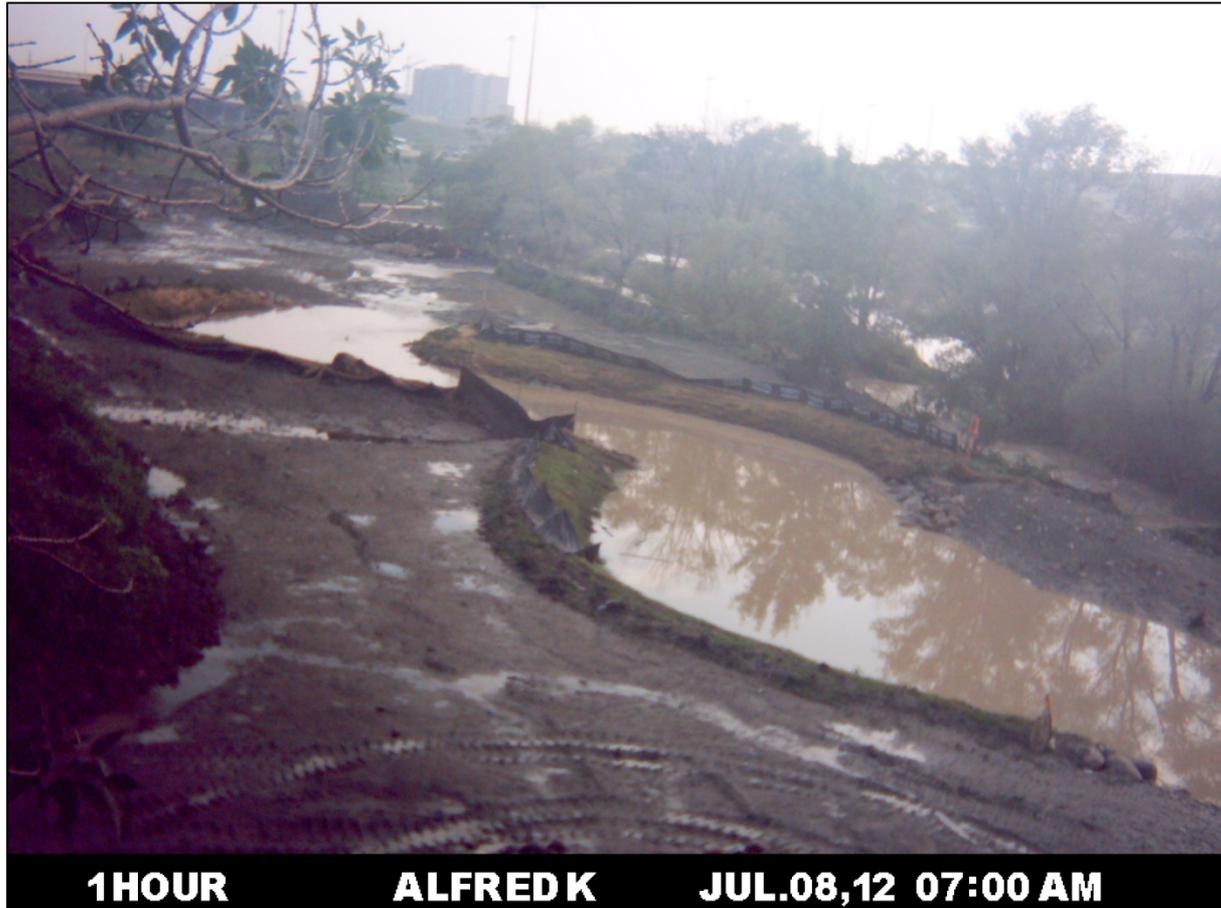
Other things to consider During Construction (Weather)

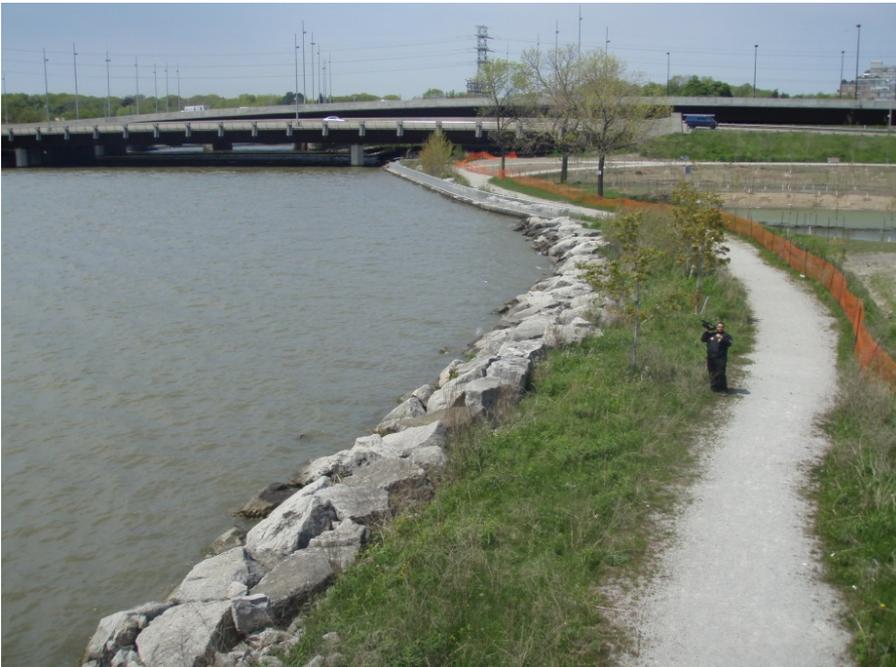
Before

Hardened Bank with no habitat structure

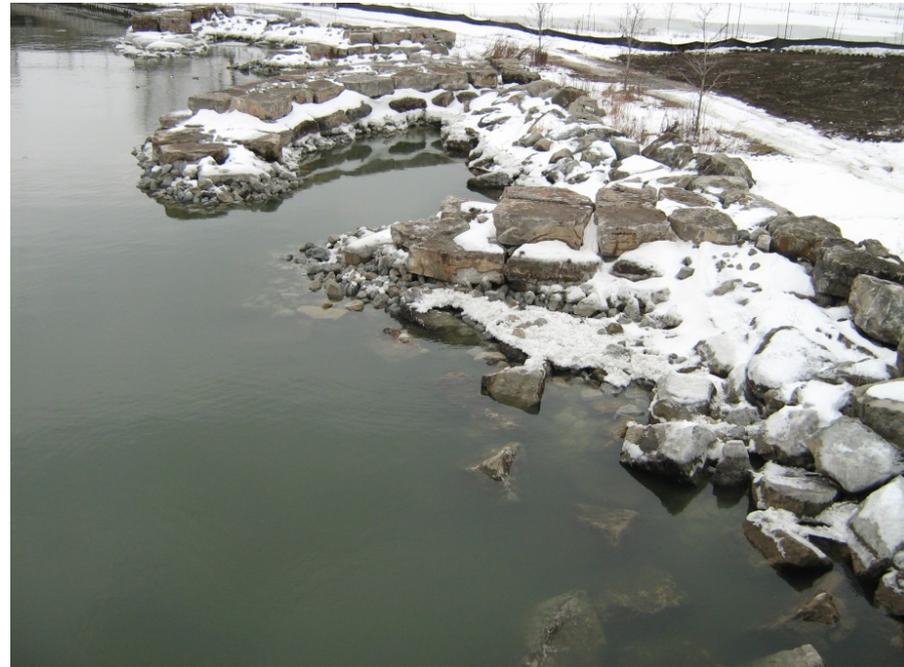
After

In water habitat added with bank protection

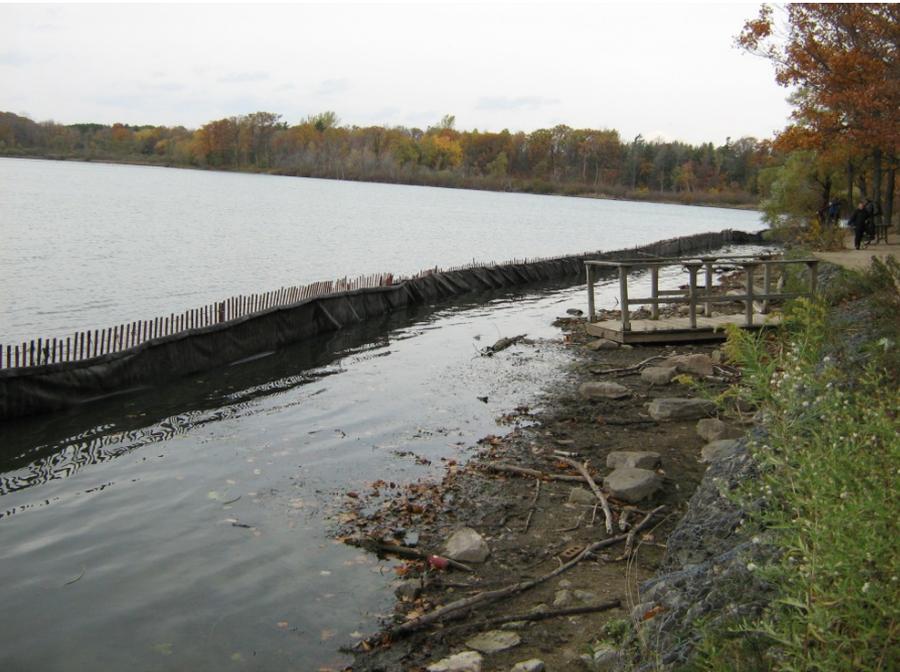
Before

Degraded Shoreline with failed gabion baskets

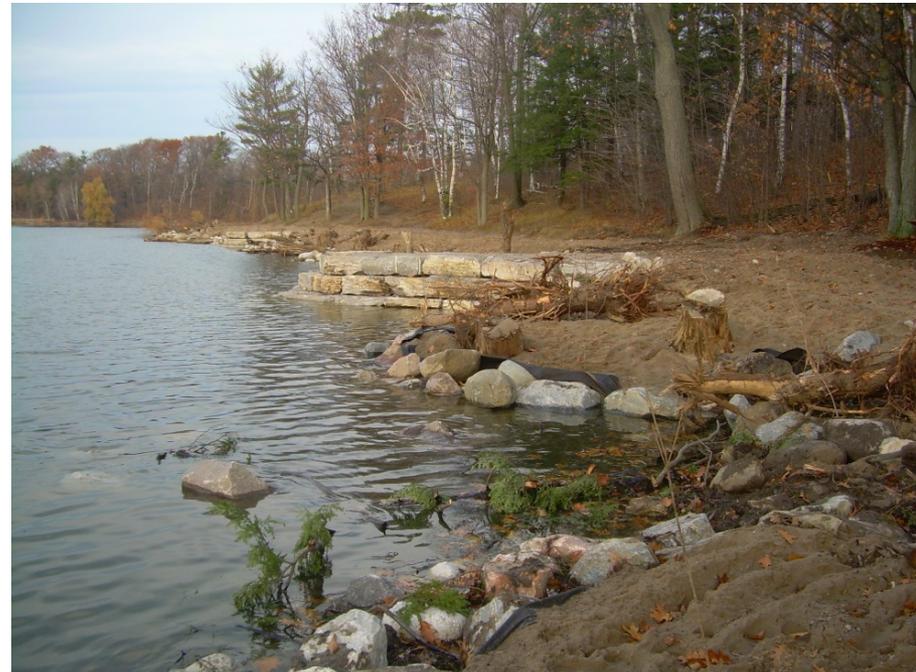
After

Restored Shoreline with habitat features, trail, and fishing node

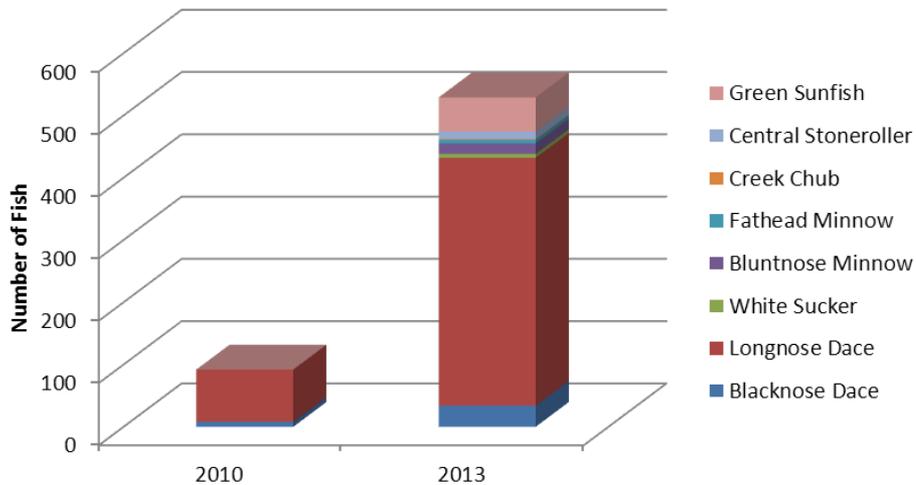
Fish Captured

2010	2013
Blacknose Dace	8	34
Longnose Dace	84	398
White Sucker	0	6
Bluntnose Minnow	0	17
Fathead Minnow	0	6
Creek Chub	0	1
Central Stoneroller	0	12
Green Sunfish	0	55
TOTAL	92	529

2010 Pre-restoration: 92 fish were sampled. Only 2 species

2013 Post restoration: 529 fish were sampled. 8 species

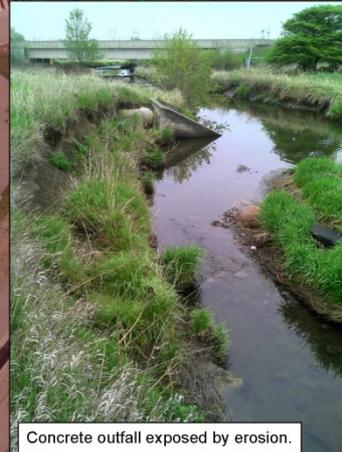
Opportunity to impound and treat discharge from multiple outfalls with the construction of treatment wetlands.

Straightened and hardened channel with failing rip-rap and gabion basket revetments could be naturalized.
