Gold Ray Dam Removal
Removal of the Last Fish
Barrier on the Lower
Rogue River
Shane K. Cline, PE
HDR Inc, Portland, OR

Project Overview

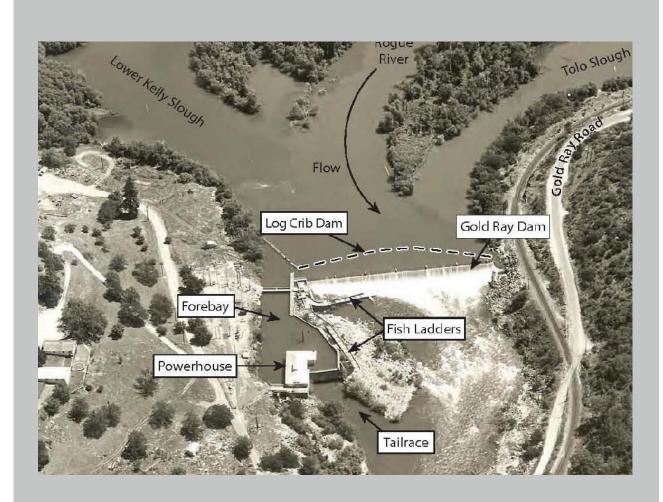
- Located in Jackson County on the Rogue River
- Log crib dam built in 1903
- Concrete dam built in 1941
- During construction found a third unknown concrete dam

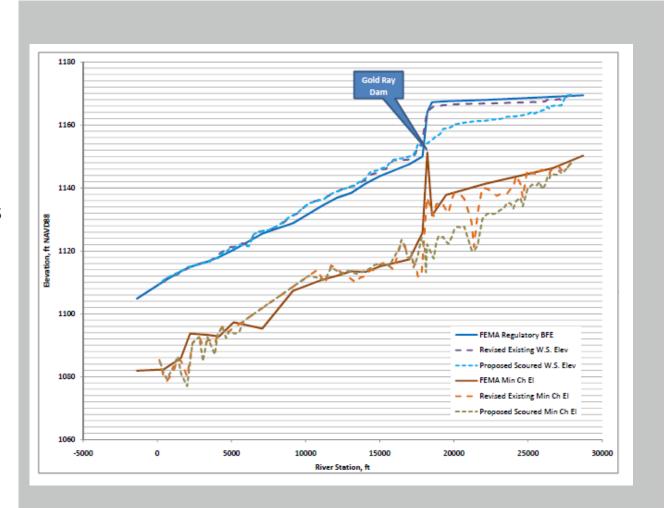
- Hydraulic and Sediment Analysis HEC-RAS modeling
- Hydraulic Analysis Results
 - Water level behind the dam estimated to drop up to 22 feet
 - Sediments behind the dam would be transported downstream
 - Minor long-term deposition downstream

- Sediment sampling behind dam indicated no contaminants of concern present
- Investigated several alternatives for sediment management per BOR
 - No Action Alternative
 - River Erosion Alternative
 - Mechanical Removal Alternative
 - Sediment Stabilization Alternative
- Due to clean sediment and cost constraints, River Erosion was selected for sediment management

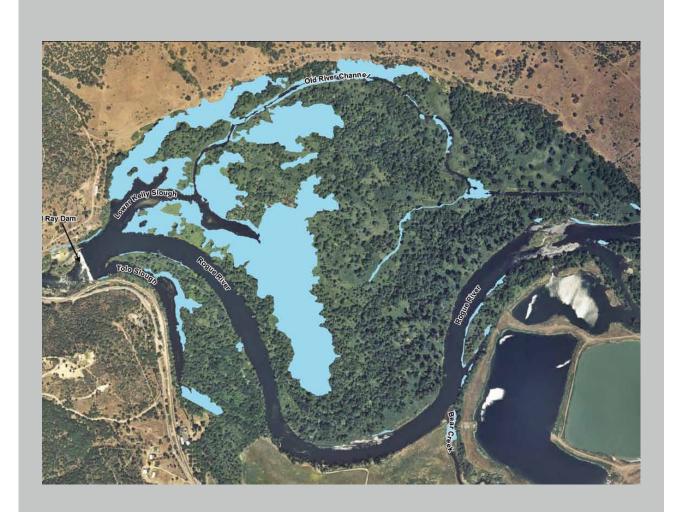
- Wetland Complex had evolved following construction of the dam.
- Proposed removal would impact wetlands upstream of dam
- Analysis showed that wetlands would reform along the fringes
- No loss of function anticipated
- No mitigation required

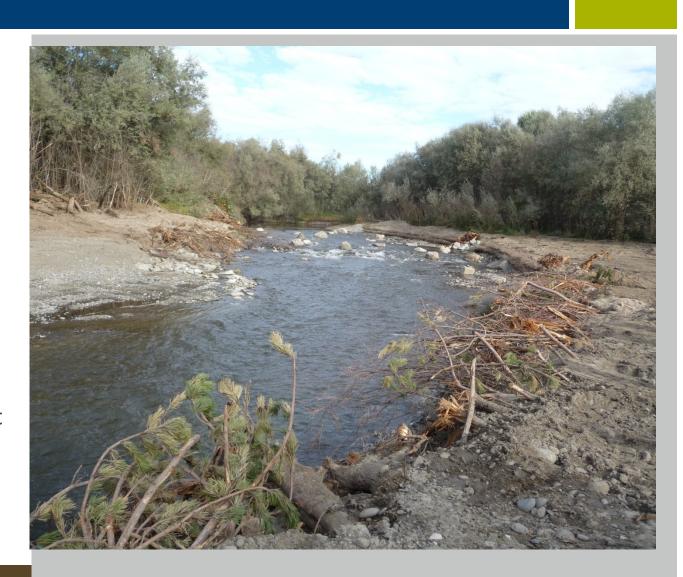
- Lowering of water level could increase potential for head cuts
- Bear Creek confluence anticipated 5 to 7 foot drop
- Included several riffle structures and large woody debris to prevent headcut migration

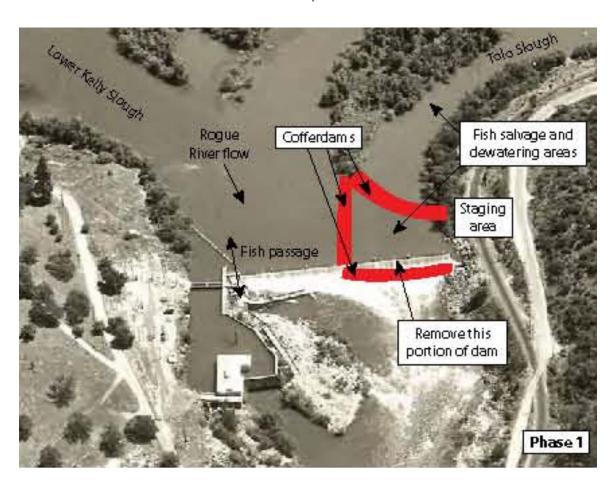
Two-phase Removal of Dam

1. Isolate and remove southern portion

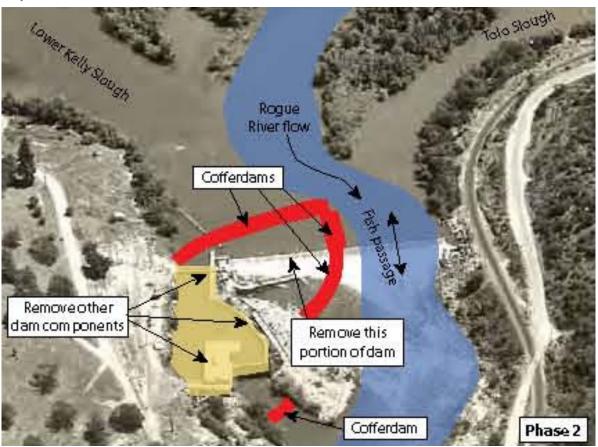
Two-phase Removal of Dam

2. Isolate and remove northern portion and other components (powerhouse, etc.)
