## Valley Creek Watershed and Stream Restoration

# 4<sup>th</sup> National Conference on Ecosystem Restoration

Jeffrey Lee, Tom MacDonald, and Jeff Weiss
Barr Engineering Co.
August 2011

# Habitat Improvement on Valley Creek

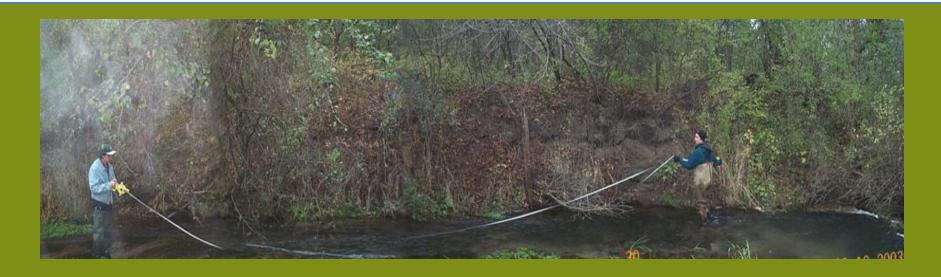
## **2005 Erosion Inventory**

- 90 Erosion Sites in 7 Tributary Ravines
- > 60 In-Stream Erosion Sites
- 33 Road Runoff Erosion Sites

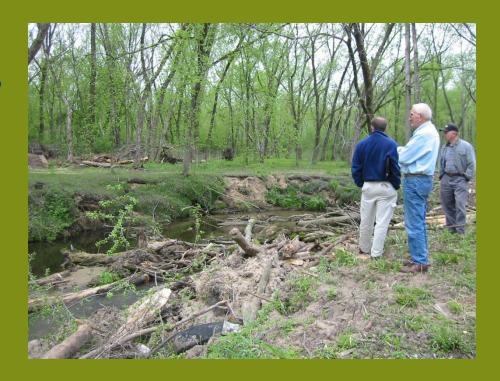
## **Challenges - Johnson Property**

Severely incised/widened

channel

- Sand bed and banks
- Poor vegetation
- "Active" landowner

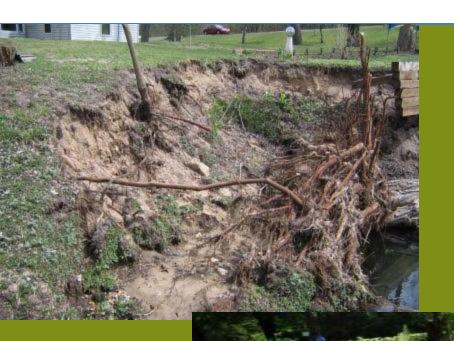
## Stabilized 2,500 feet of the creek on three upstream properties

#### **Design included:**

- Bank shaping/500 feet of shoreline biolog
- 1 boulder cross vane grade control; 2 boulder vanes for bank protection/direct flow
- 3 root wads

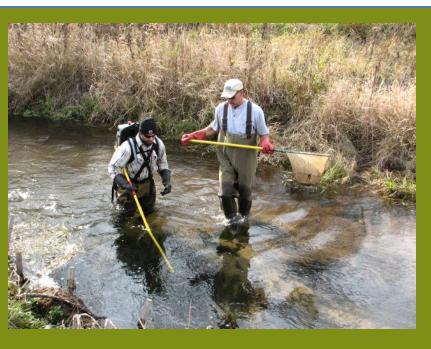
# Fish and Aquatic Macroinvertebrate Monitoring

- Site I located upstream of CSAH 18 bridge, downstream of VBWD project
- Site II (control site) located upstream at Stagecoach Road
- Both sites also sampled by MNDNR in 2006
