Geomorphic Response of the Souhegan River to the Removal of the Merrimack Village Dam, Merrimack, New Hampshire

Adam J. Pearson, Noah P. Snyder, and Mathias J. Collins

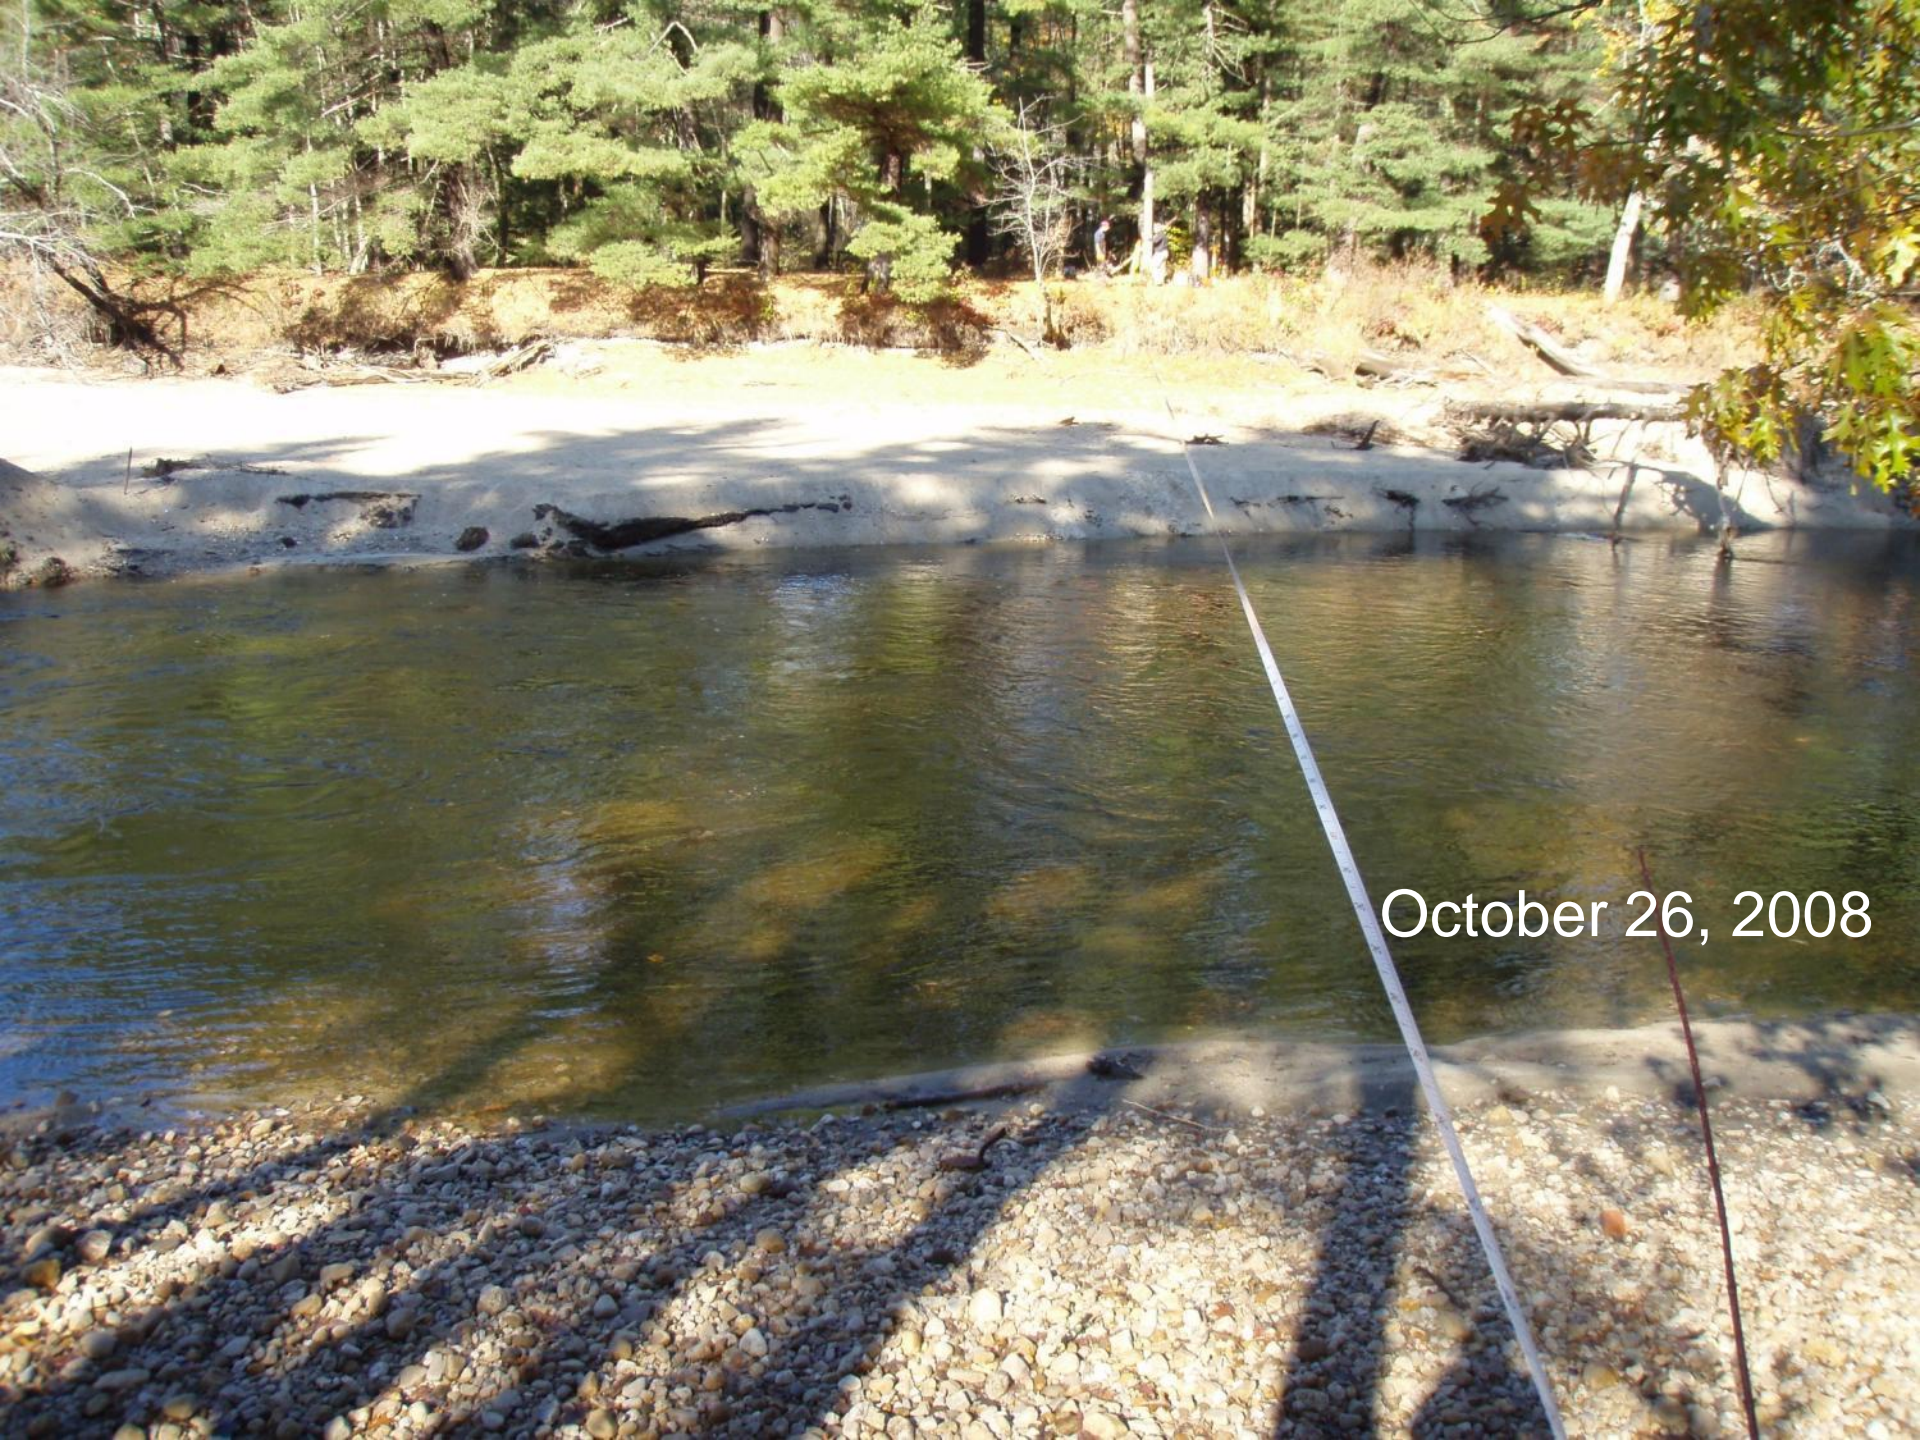
October 26, 2008

Gravel bar deposition

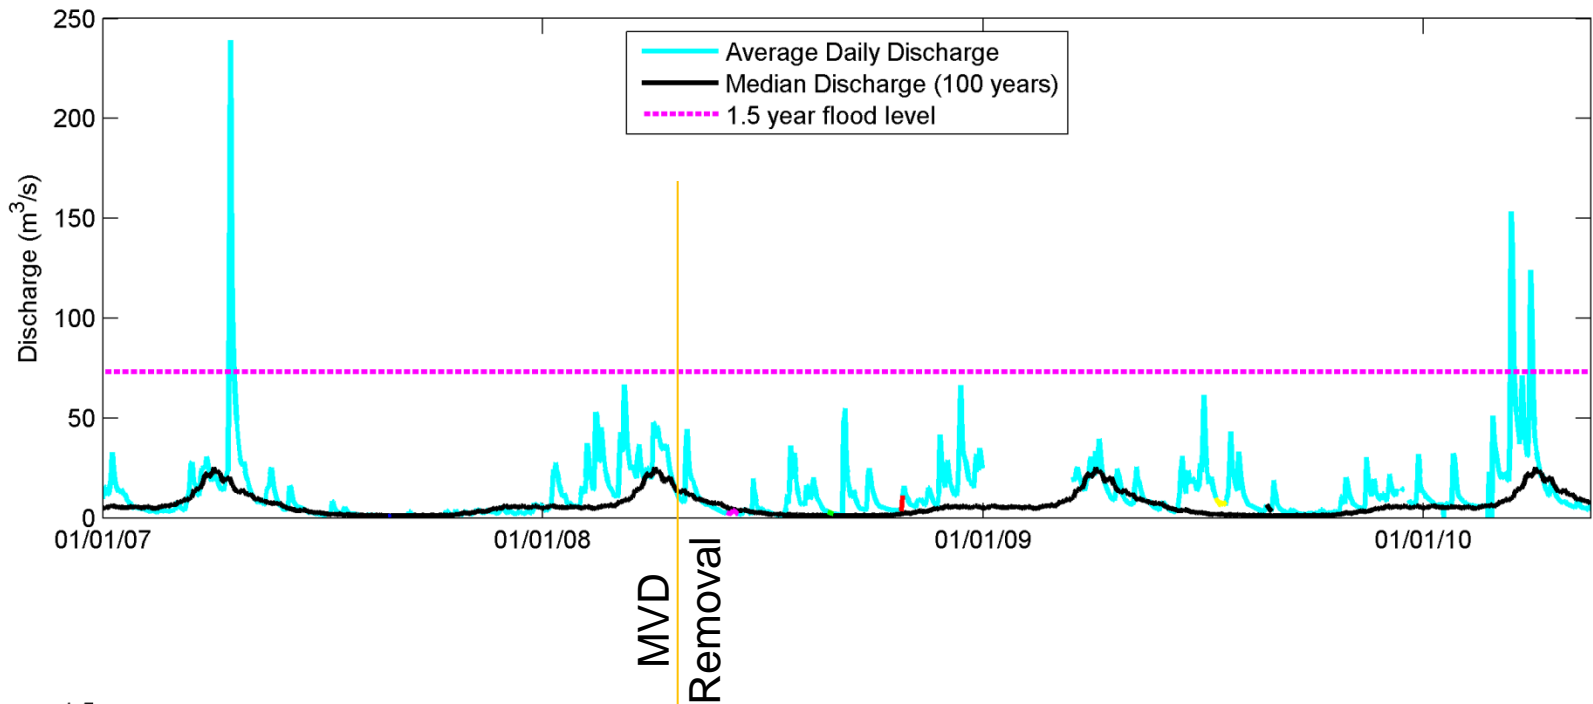
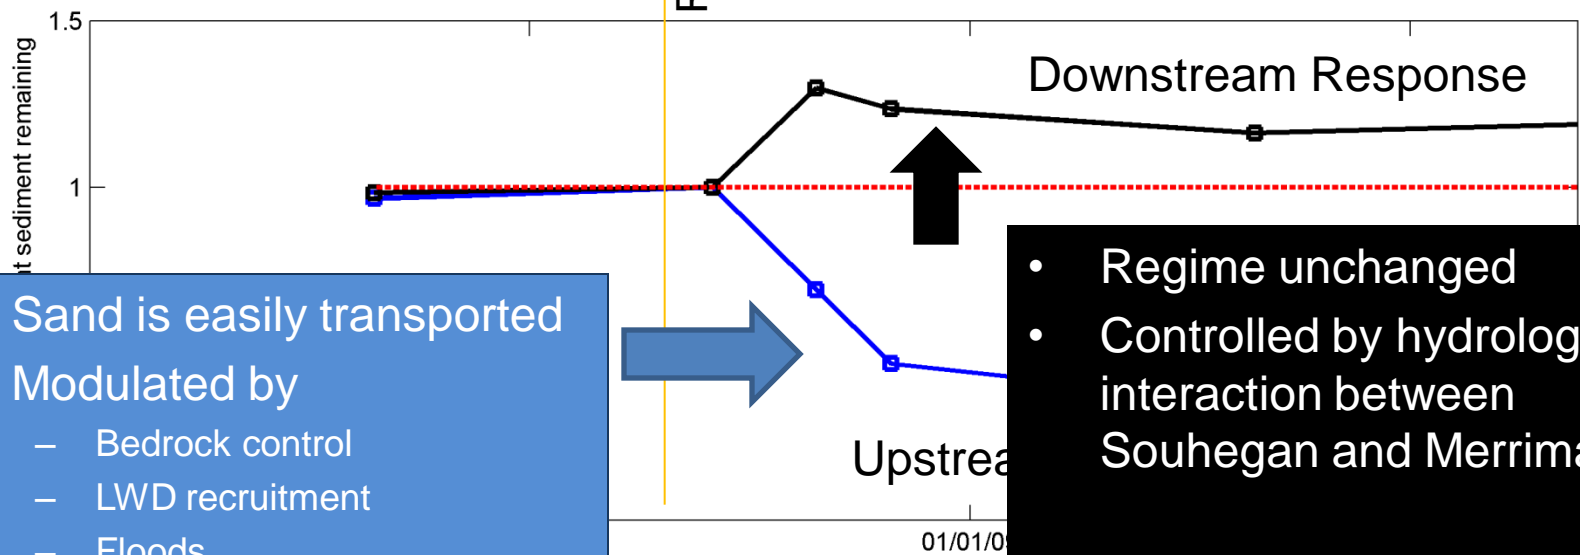
- Sand is easily transported
- Modulated by
 - Bedrock control
 - LWD recruitment
 - Floods
