# Lower Columbia River Pile Dike Assessment

August 2, 2011

# USACE Portland District Pile Dike Assessment

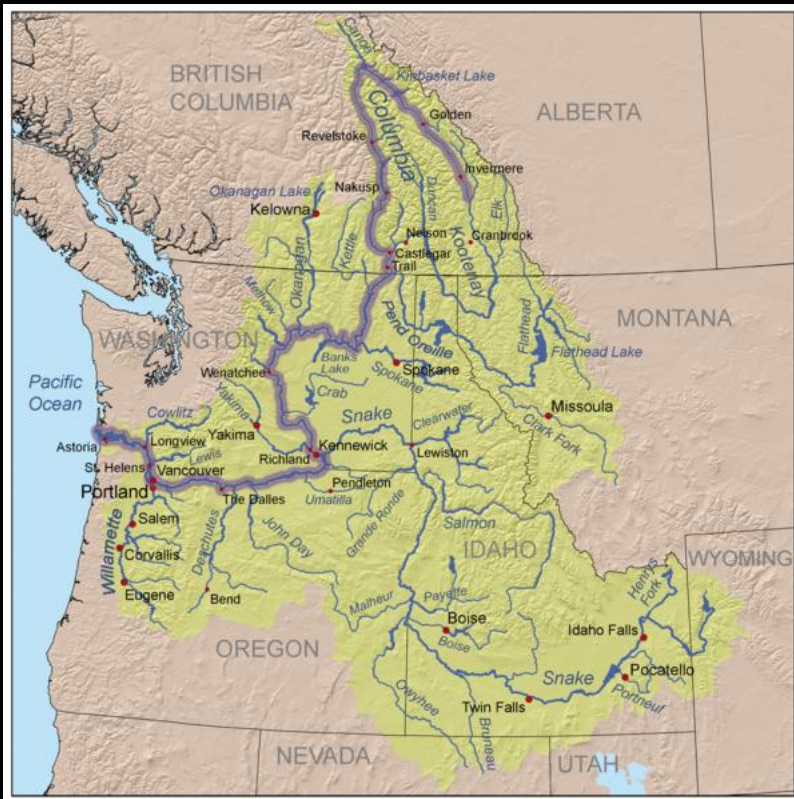
## Basin Map

- Basin Area is 258,000 Sq. Miles
- Drains 7 States and BC
- 1243 Miles Long
- Largest River Flowing to Pacific Ocean from North America
- Supports Many Species of Anadromous Fish

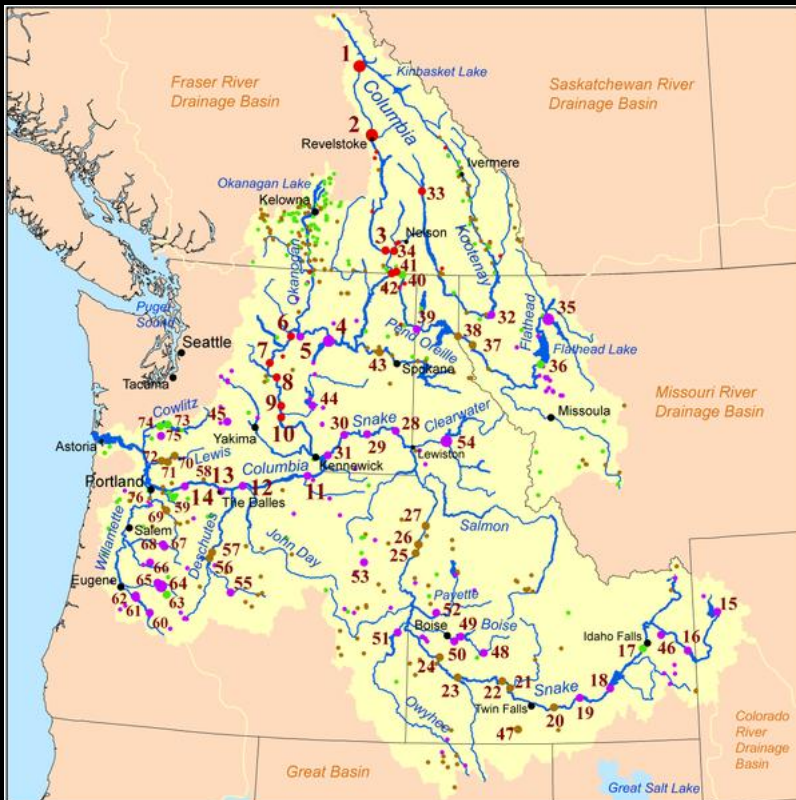
# Federal Columbia River Power System

- USBR and USACE Own and Operate 31 Dams
- Built and Operated by the Federal Government
- System Provides:
  - Hydropower
  - Navigation
  - Flood Control
  - Irrigation
- Has impacted 13 Federally Listed ESA Fish Species

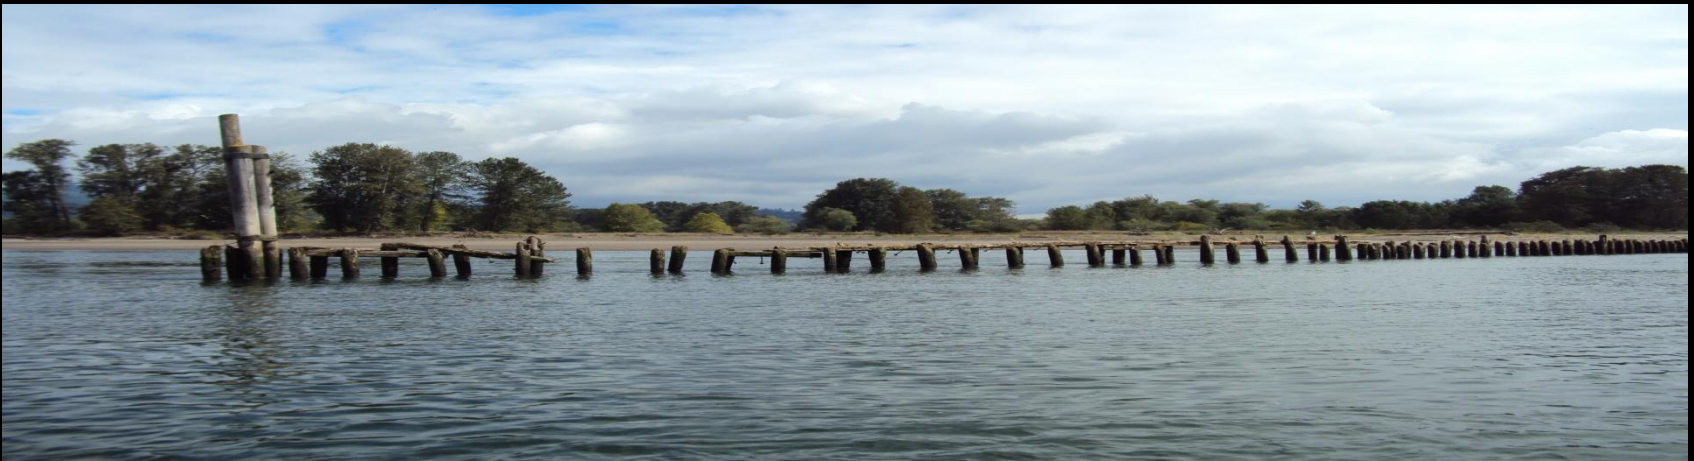
- BiOp Obligation and O&M
- AECOM Assessed Each of 233 Pile Dikes For:
  - Structural Integrity
  - Functional Integrity
  - Potential Impact On Juvenile Salmonids

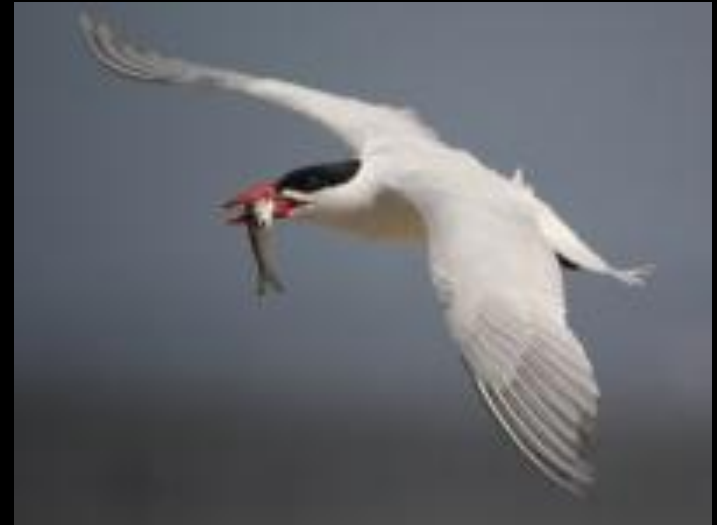
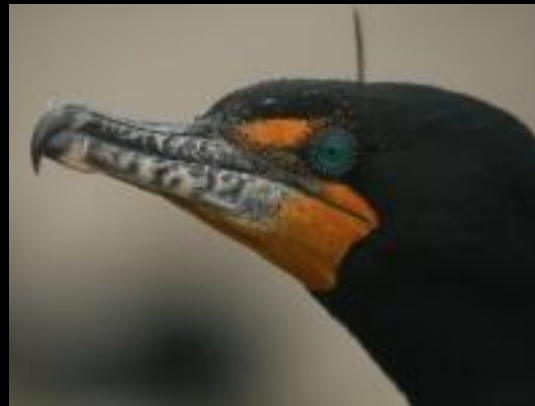
# Suspected Pile Dike Impacts to Juvenile Salmonids

- Contaminants Leaching From Treated Piling
- Cover For Piscivorous Fish
- Perches For Avian Predators
- Shallow Water Habitat

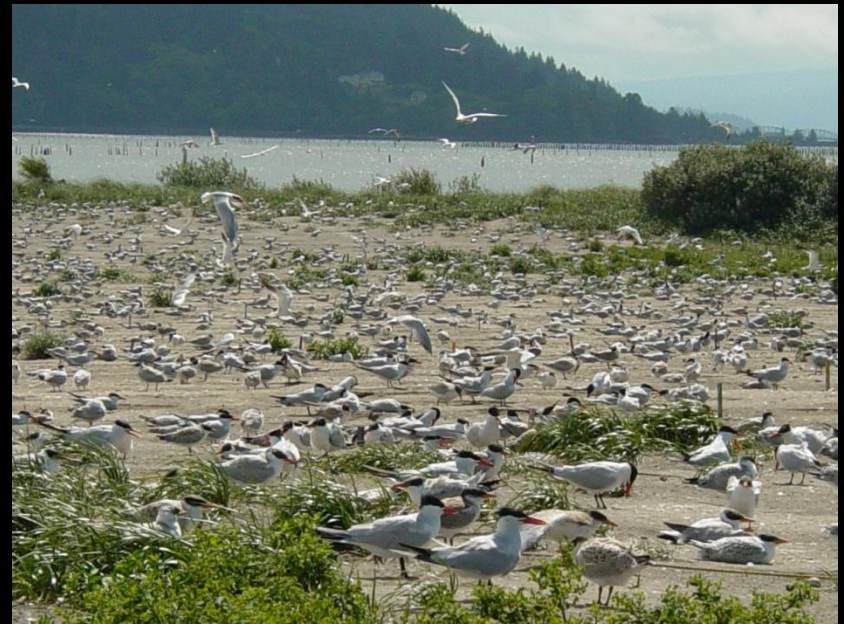
# East Sand Island – Lower Columbia River

- World's Largest Tern and Cormorant Colonies
- Tern Average Annual Juvenile Salmonid Consumption = 5.3 Million
- Cormorant Consumption Likely Similar
- Island Constructed Of Dredge Material Protected By a Pile Dike System

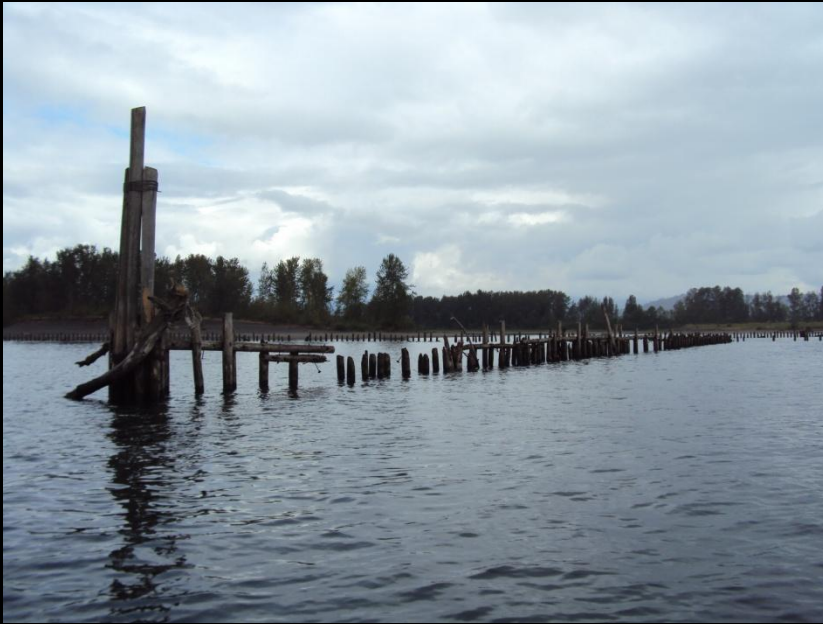
# Pile Dike Assessment Habitat Impact Findings

- Very Few Treated Piling – Not a Contaminant Threat
- Piscivorous Fish Activity Unobservable – Impact Inconclusive
- Avian Perching Observed (Primarily Cormorants) – Impact Inconclusive

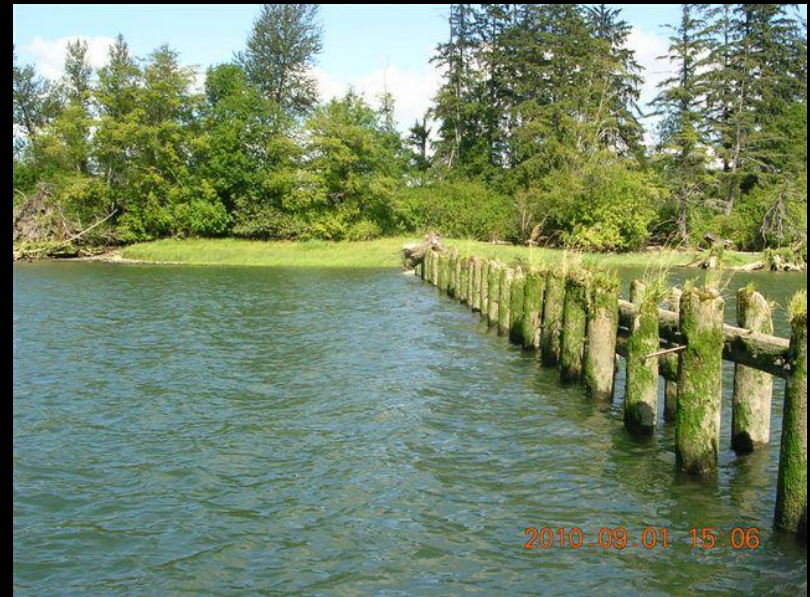
# Pile Dike Assessment Habitat Impact Findings

- Juvenile Salmonid Rearing Habitat
  - Creation of Shallow Water Habitat (SWH)
  - Protection of 3800 Acres SWH
  - Bed Erosion Not Noted
  - Adjacent Areas Will Support Creation of SWH
  - Addition of LWD Not Warranted In Main Channel
  - Additional Studies Recommended

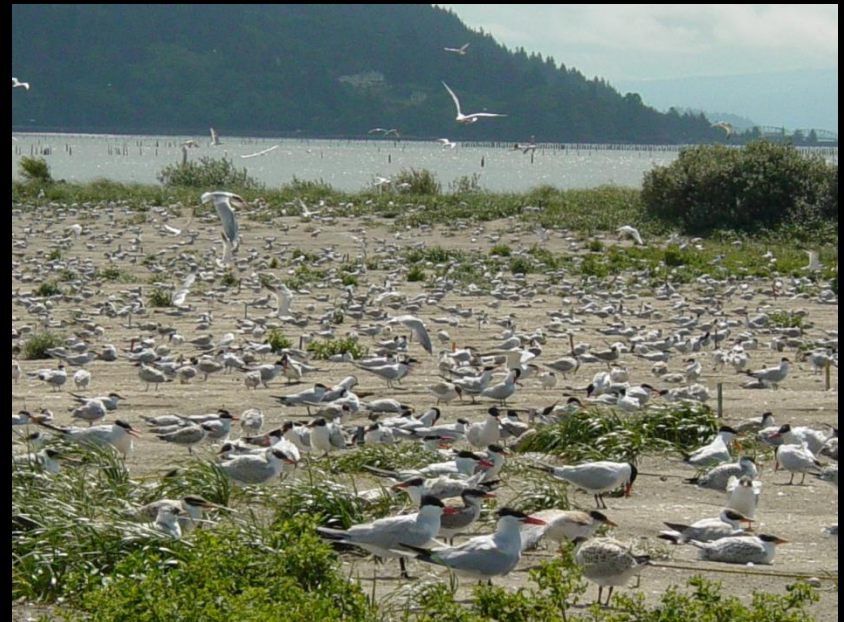
# East Sand Island – Lower Columbia River

- Island Constructed Of Dredge Material Protected By a Pile Dike System
- Removal of Pile Dikes May Allow Natural Reworking of Dredge Material
- Role of Large Predators
- 2011 Bald Eagle Harassment of Nesting Colonies: 90-100% Reproductive Loss
