RESTORATION OPPORTUNITIES SPURRED BY STEELHEAD RECOVERY IN SOUTHERN CALIFORNIA

San Juan and Trabuco Creeks Steelhead Recovery Watershed Management Plan (Orange County, CA)

MALIBU CREEK Ecosystem Restoration Feasibility Study

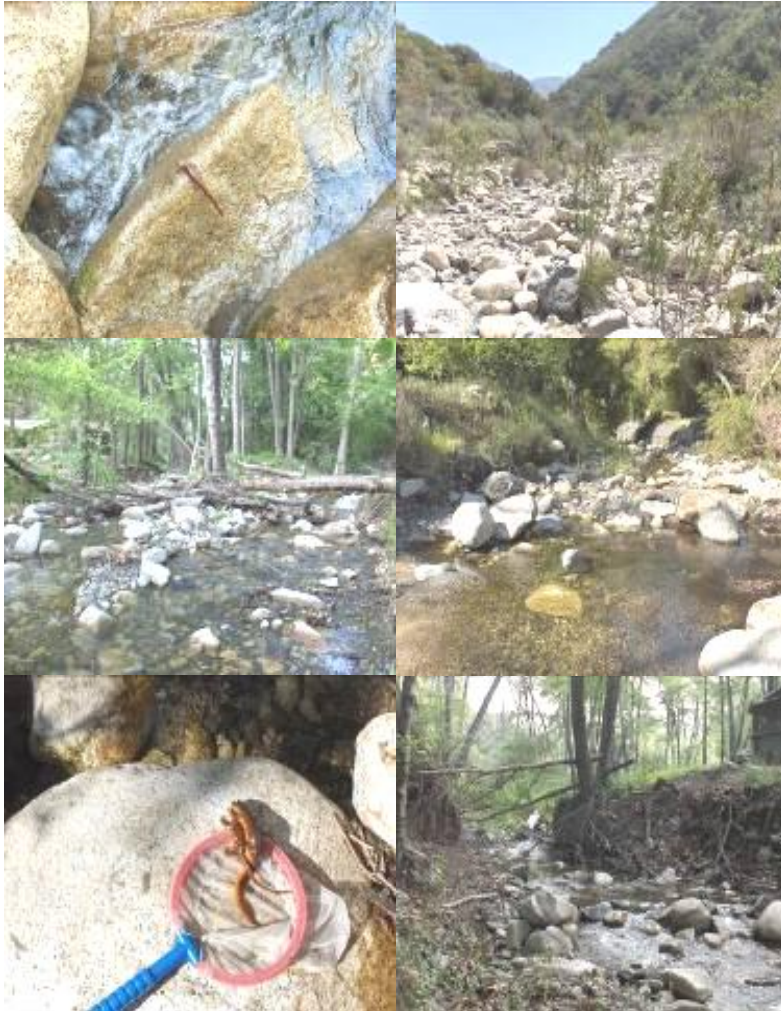
Upper Watershed Suitable for Spawning

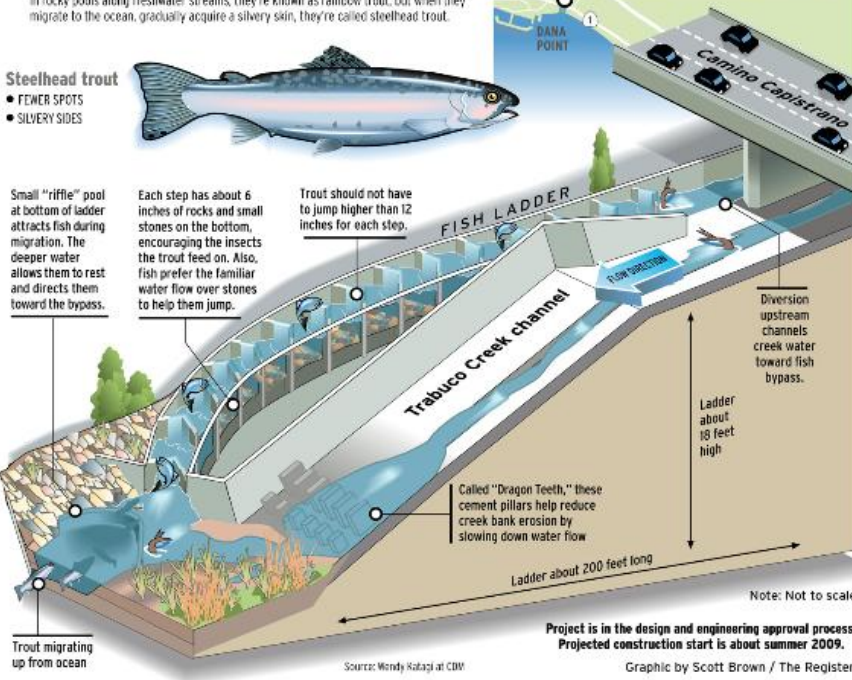
Trabuco Fishway at I-5

Barriers inside Trabuco Creek are preventing steelhead trout from migrating upstream to spawn. The latest design to help in the fish's journey is a fish bypass, which is a series of small pools so the trout can jump its way up a steep slope near Camino Capistrano. Here's a look at the design proposal:

Small "riffle" pool at bottom of ladder attracts fish during migration. The deeper water allows them to rest and directs them toward the bypass.

Each step has about 6 inches of rocks and small stones on the bottom, encouraging the insects the trout feed on. Also, fish prefer the familiar water flow over stones to help them jump.

Trout should not have to jump higher than 12 inches for each step.

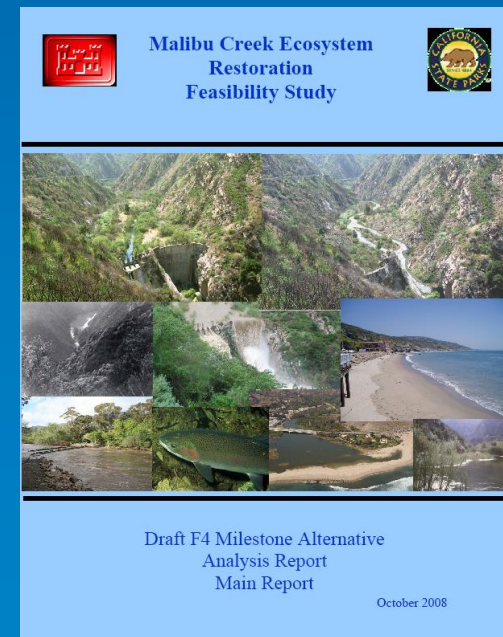
An aerial photograph of a dam on Malibu Creek. The water is turbulent and white with foam as it flows over the dam structure. The surrounding area is rocky and has some green vegetation. The text is overlaid on the image.
